project  
**Reading Town Hall,  
Alterations & Improvements**

title  
**Photosheet Of Existing  
Roof RF20**

| job no.<br><b>997</b> | dwg no.<br><b>120</b> | status/revision<br><b>PL00</b> |

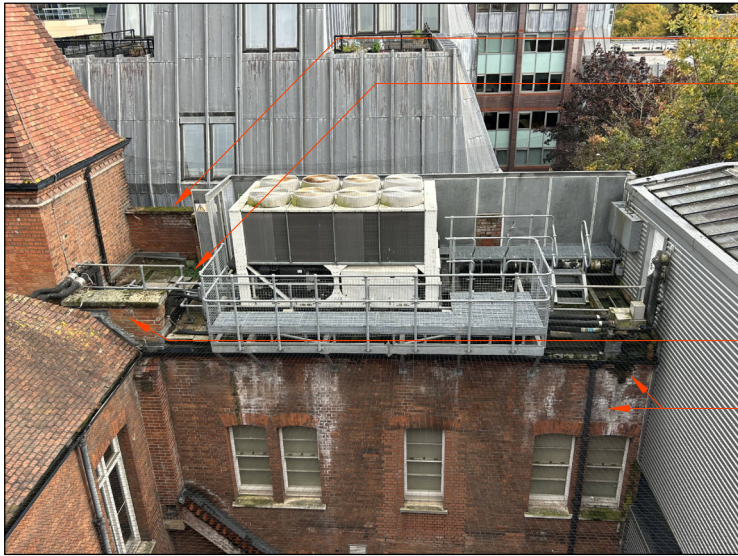
**01** FLAT ROOF AND PLANT RF20-PLANT.01  
NTS - Date Taken: 08/10/24

- Algae and moss on coping stones on parapet wall
- Vegetation growth across flat roof
- Algae and moss on coping stones on parapet wall
- Efflorescence present on parapet wall
- Isolated defective/open mortar joints and damaged/defective bricks to chimney
- Isolated defective/open mortar joints and damaged/defective bricks in parapet wall
- Algae, efflorescence, and staining, indicating possible leaks in gutter
- Failed mortar joint in parapet wall to lead flashing
- Severe vegetation growth across flat roof and along upstand

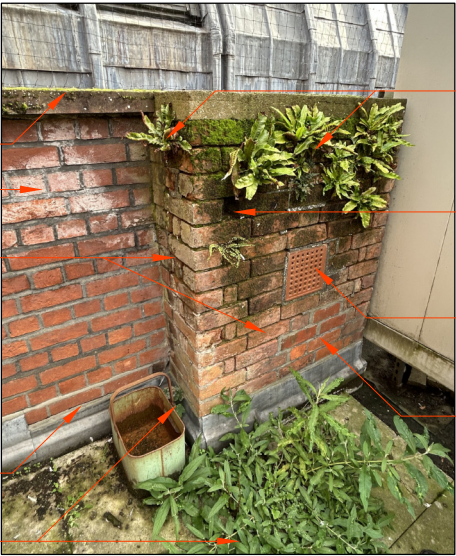
**02** CHIMNEY RF20-CH.01  
NTS - Date Taken: 17/10/24

- Algae growth to top of chimney
- Severe algae and vegetation growth to top of chimney
- Isolated defective/open mortar joints and damaged/defective bricks to chimney
- Loose / missing brick due to failed mortar joints
- Vegetation growth in open mortar joints
- Loose vent grille with failed mortar joints
- Efflorescence present on chimney
- Recently replaced bricks
- Defective / delaminating bricks
- Loose brick due to failed mortar joints
- Loose vent grille with failed mortar joints

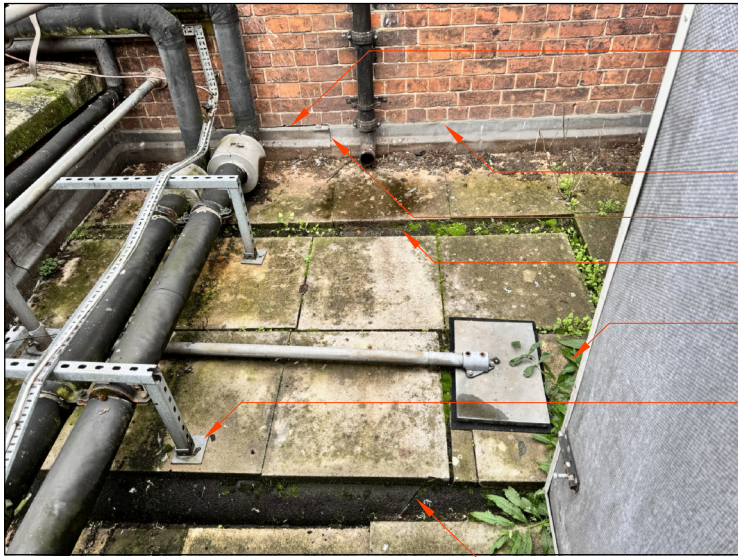
**04** FLAT ROOF COVERING RF20  
NTS - Date Taken: 10/10/24

- Failed mortar joint in external wall to lead flashing
- Algae and moss on coping stones on parapet wall
- Lead cover flashings damaged and lifting
- Gaps where lead flashings overlap
- Standing water on flat roof
- Severe vegetation growth across flat roof
- No plinth, upstands, or flashing to plant footings, presumed fixed to loose laid slabs
- Standing water along the full length of the eaves gutter
- Debris, moss, and vegetation growth along the full length of the eaves gutter
- Splits in asphalt flat roof covering

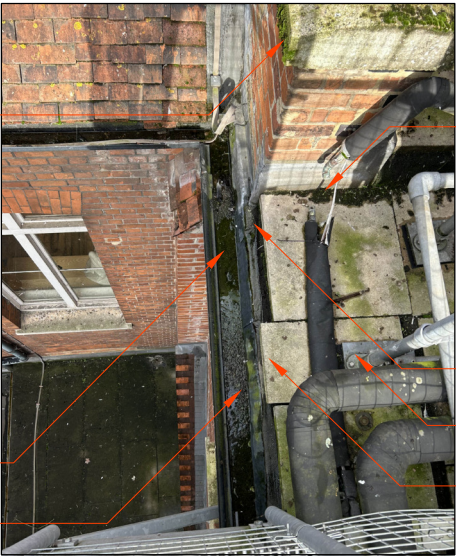
**05** GUTTER RF20-EGUT.01  
NTS - Date Taken: 17/10/24

- Moss and vegetation growth along coping stones and on brickwork of parapet wall
- Disconnected plant pipework with damaged waterproofing covers
- Detached mortar pointing from upstand to parapet wall
- Possible blocked outlet / outlet of insufficient diameter to enable drainage
- Standing water in parapet gutter
- Cracked/damaged cover flashing over eaves gutter with evident gaps
- No plinth, upstands, or flashing to plant footings
- Loose paving slab overhanging eaves gutter
- Isolated defective/open mortar joints and damaged/defective bricks in parapet wall

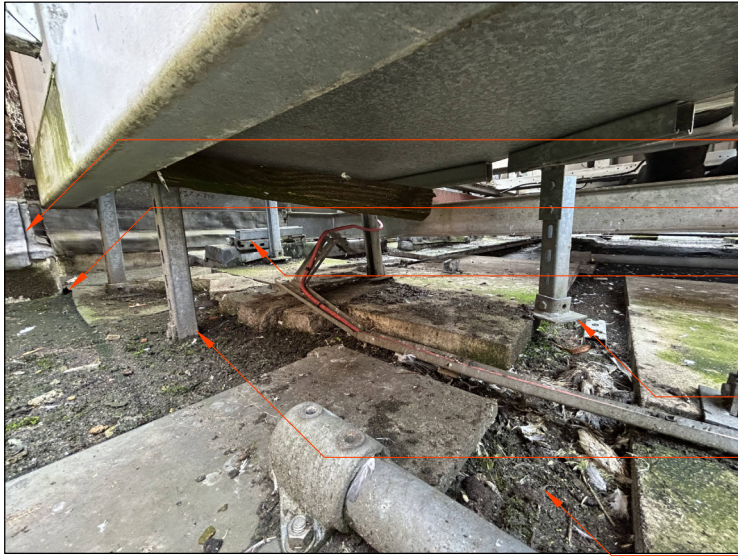
**07** FLAT ROOF COVERING AND PLANT RF20-PLANT.01  
NTS - Date Taken: 17/10/24

- Damaged waterproofing covers and corroded fixings to plant ducting
- Lead cover flashings damaged and lifting, with gaps in overlaps
- Lifting roof covering creating gaps around upstands
- Loose plant coverings and frames stored on roof
- Adhoc uPVC rainwater drainage laid across flat roof, held in place by paving slabs
- Walkway footing oversailing loose laid paving slab below
- No plinth, upstands, or flashing to plant footings
- Splits and gaps in flat roof covering, evidence of localised isolated repairs
- General dirt and debris below plant
