# ASBESTOS REFURBISHMENT SURVEY REPORT

J330513

FOR: Reading Borough Council (Corporate)  
AT: Reading Town Hall, Blagrove Street, Reading

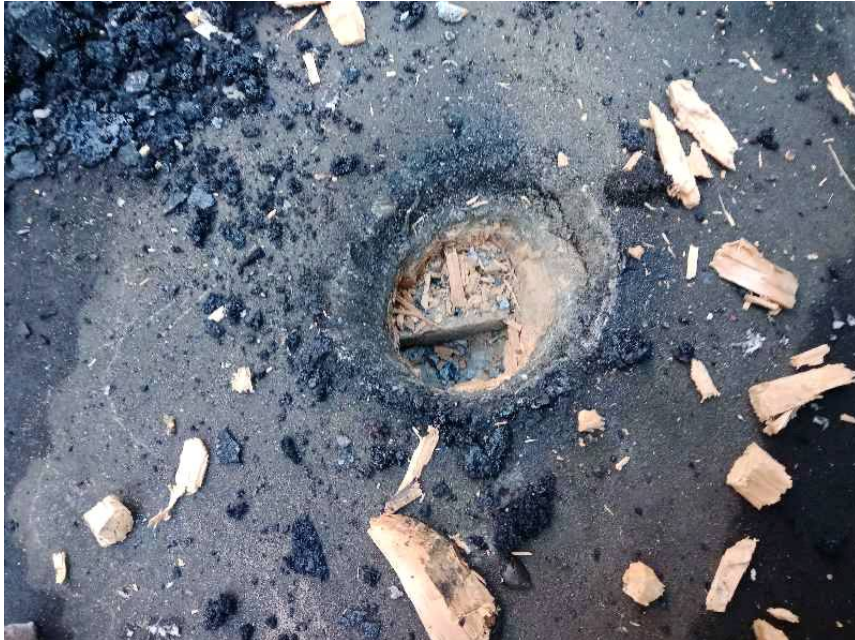
| Sample N° | TU000506 | | |

| Item: | Bottom layer to roof | Identification: | Identified |
| Extent of damage: | Low Damage | | 0 |
| Asbestos type: | No Asbestos Detected | | 0 |
| Comments:<br>Beyond the plywood. Sampled from various locations for reassurance purposes | | | |

| Action: | No Further Action Required | | |

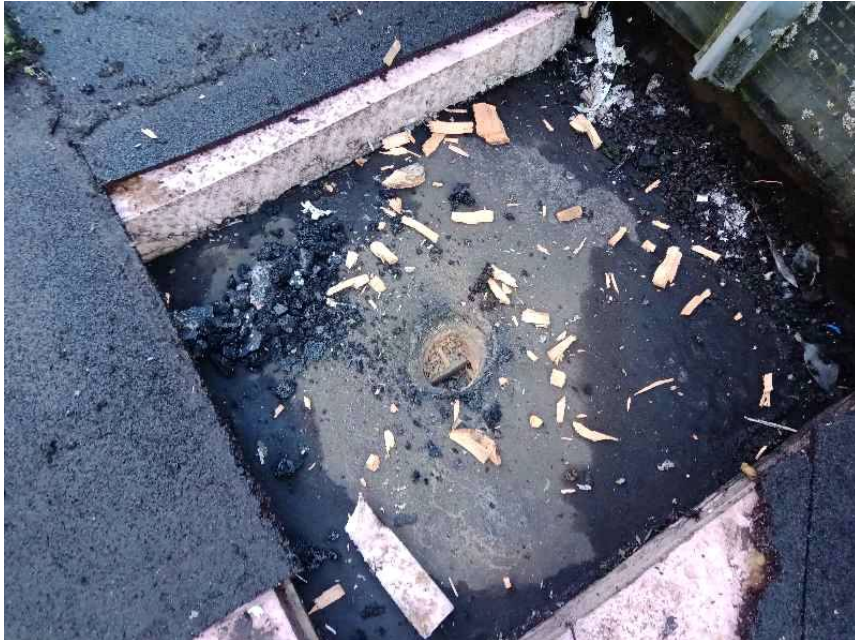
| Sample N° | Presumptive Sample 2 | | |

| Item: | Access point 1 | Identification: | Presumed |
| Extent of damage: | Good Condition | | 0 |
| Asbestos type: | No asbestos detected | | 0 |

| Action: | No Further Action Required | | |

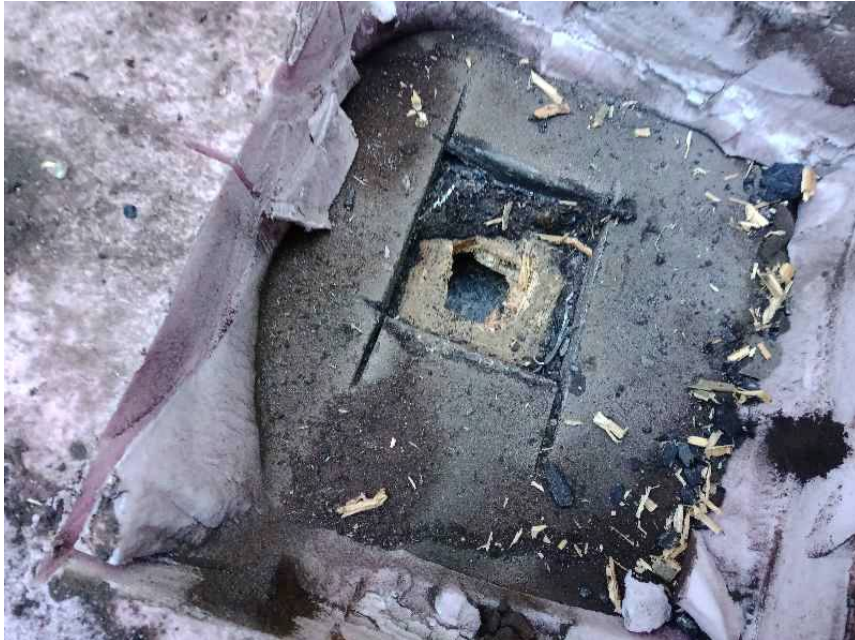
| Sample N <sup>o</sup> | Presumptive Sample 3 | | |

| Item: | Access point 2 | Identification: | Presumed |
| Extent of damage: | Good Condition | | 0 |
| Asbestos type: | No asbestos detected | | 0 |

| Action: | No Further Action Required | | |

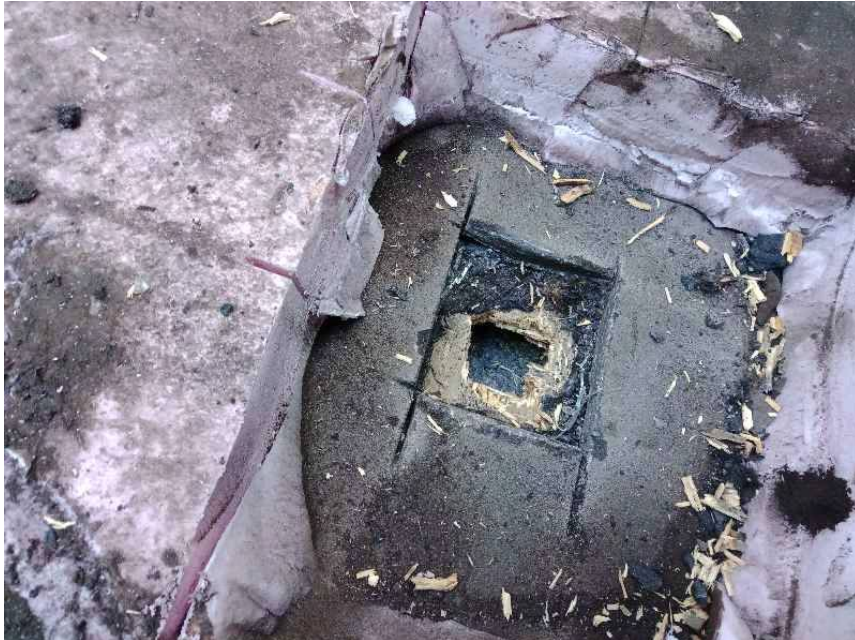
| Sample N° | TU000507 | | |

| Item: | Bituminous layer to roof | Identification: | Identified |
| Extent of damage: | Low Damage | | 0 |
| Asbestos type: | No Asbestos Detected | | 0 |
| Comments:<br>Sampled for reassurance purposes | | | |

| Action: | No Further Action Required | | |

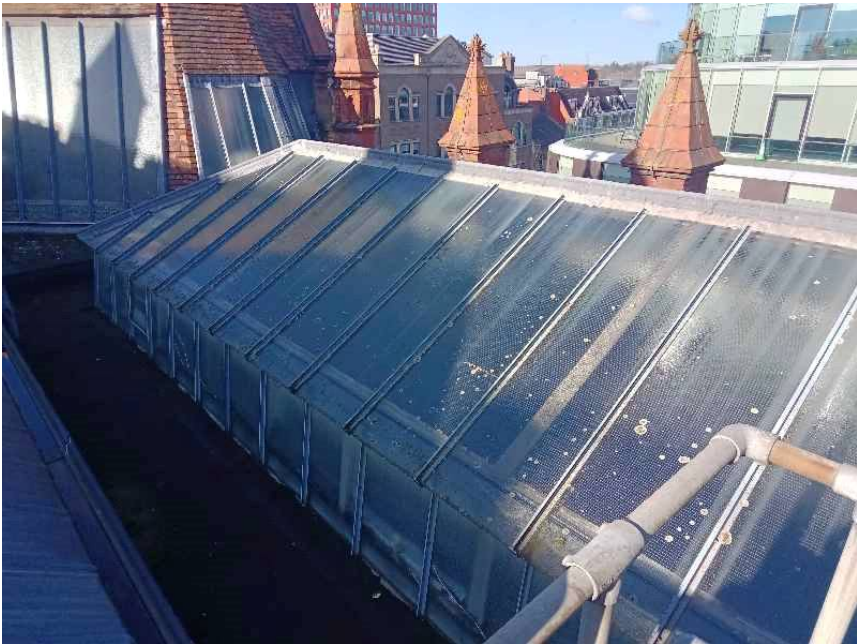
| Sample N <sup>o</sup> | Presumptive Sample 15 | | |

| Item: | Textiles to skylights | Identification: | Presumed |
| Product Type:<br><small>See Appendix VII: Glossary of terms</small> | Asbestos Textiles/Paper | | 2 |
| Asbestos type: | Chrysotile | | 1 |
| | | Material Assessment Score: | 5 |
| Comments:<br>Presumed, unable to access without causing irreparable damage. In close proximity to planned works | | | |

| Action: | Remove prior to demolition or refurbishment | | |

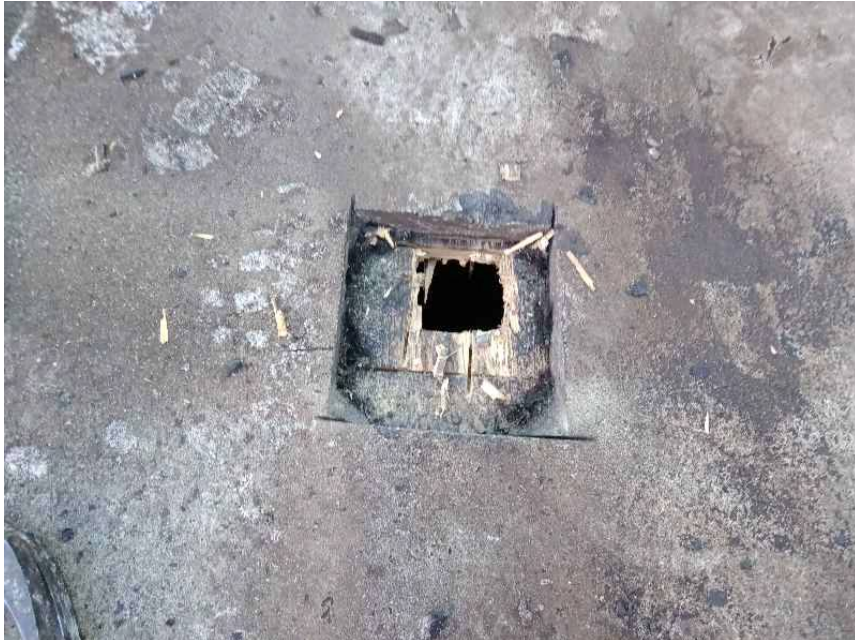
| Sample N° | Presumptive Sample 6 | | |

| Item: | Access point 3 | Identification: | Presumed |
| Extent of damage: | Good Condition | | 0 |
| Asbestos type: | No asbestos detected | | 0 |

| Action: | No Further Action Required | | |

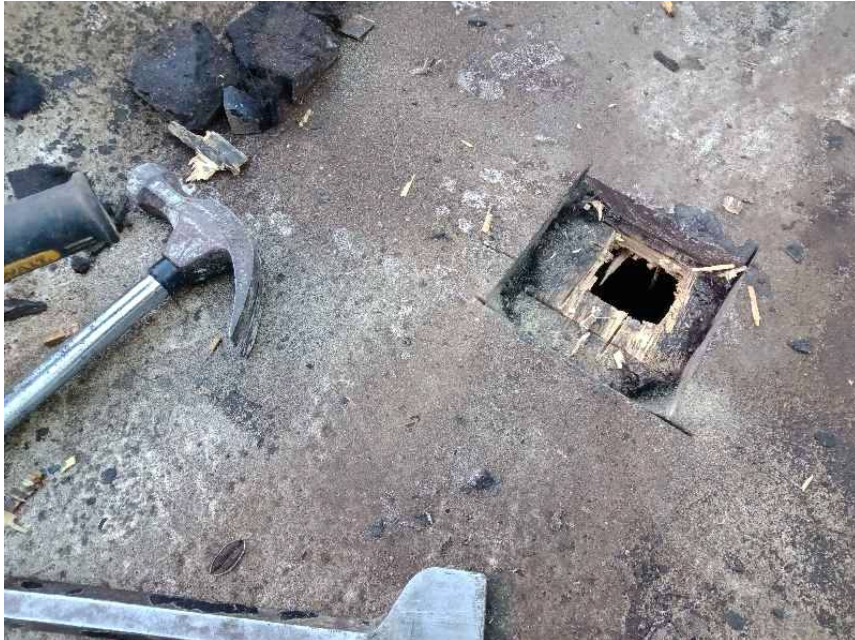
| Sample N° | TU000508 | | |

| Item: | Bituminous layer to roof | Identification: | Identified |
| Extent of damage: | Low Damage | | 0 |
| Asbestos type: | No Asbestos Detected | | 0 |
| Comments:<br>Sampled for reassurance purposes | | | |

| Action: | No Further Action Required | | |

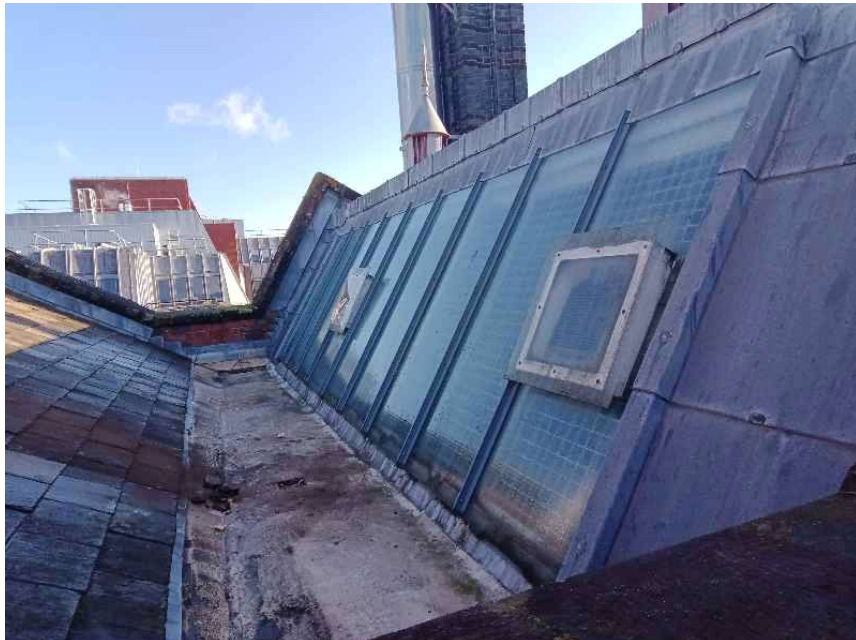
| Sample N <sup>o</sup> | Presumptive Sample 16 | | |

| Item: | Textiles to skylight | Identification: | Presumed |
| Product Type:<br><small>See Appendix VII: Glossary of terms</small> | Asbestos Textiles/Paper | | 2 |
| Asbestos type: | Chrysotile | | 1 |
| | | Material Assessment Score: | 5 |
| Comments:<br>Presumed, unable to access without causing irreparable damage. In close proximity to planned works | | | |

| Action: | Remove prior to demolition or refurbishment | | |

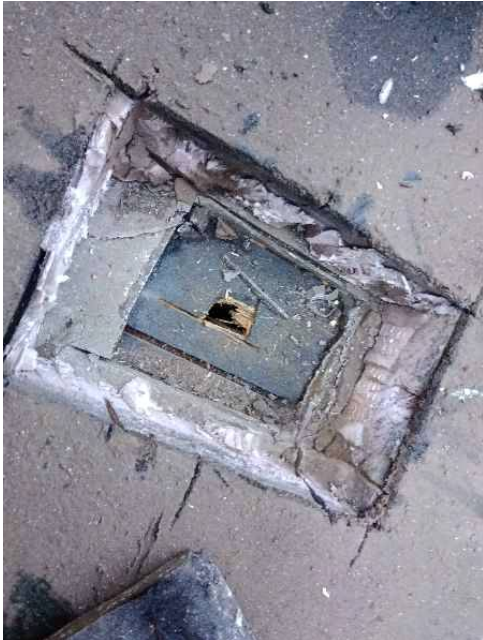
| Sample N <sup>o</sup> | Presumptive Sample 10 | | |

| Item: | Access point 4 | Identification: | Presumed |
| Extent of damage: | Good Condition | | 0 |
| Asbestos type: | No asbestos detected | | 0 |

| Action: | No Further Action Required | | |

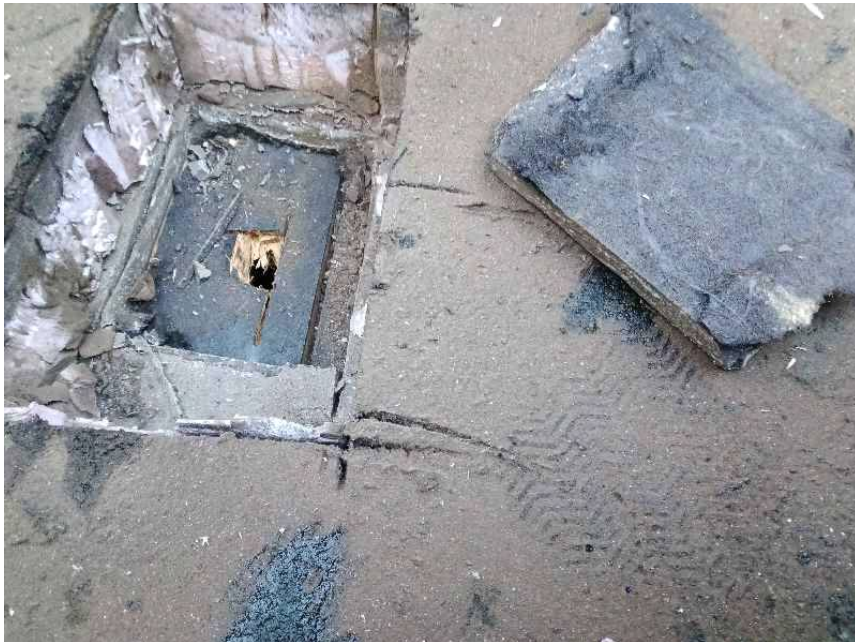
| Sample N° | TU000509 | | |

| Item: | Bituminous layer to roof | Identification: | Identified |
| Extent of damage: | Low Damage | | 0 |
| Asbestos type: | No Asbestos Detected | | 0 |
| Comments:<br>Sampled for reassurance purposes | | | |

| Action: | No Further Action Required | | |

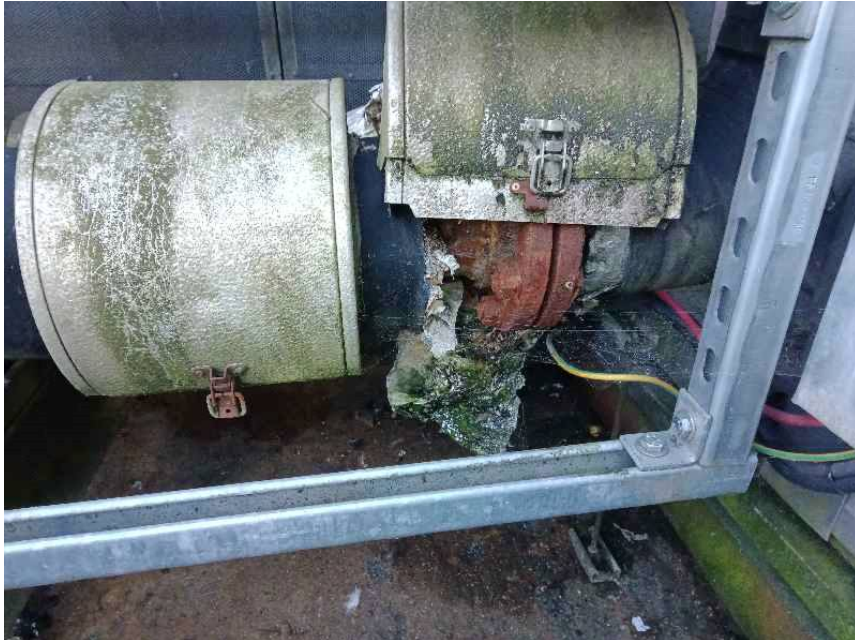
| Sample N° | Presumptive Sample 14 | | |

| Item: | Gaskets to pipework | Identification: | Presumed |
| Product Type:<br><small>See Appendix VII: Glossary of terms</small> | Asbestos Textiles/Paper | | 2 |
| Asbestos type: | Chrysotile | | 1 |
| | | Material Assessment Score: | 4 |
| <p>Comments:</p> <p>Present to foil faced MMMF insulated pipework. In close proximity to planned works</p> | | | |

| Action: | Remove prior to demolition or refurbishment | | |
