project  
**Reading Town Hall,  
Alterations & Improvements**

title  
**Photosheet Of Existing  
Roof RF7**

| job no.<br><b>997</b> | dwg no.<br><b>107</b> | status/revision<br><b>PL00</b> |

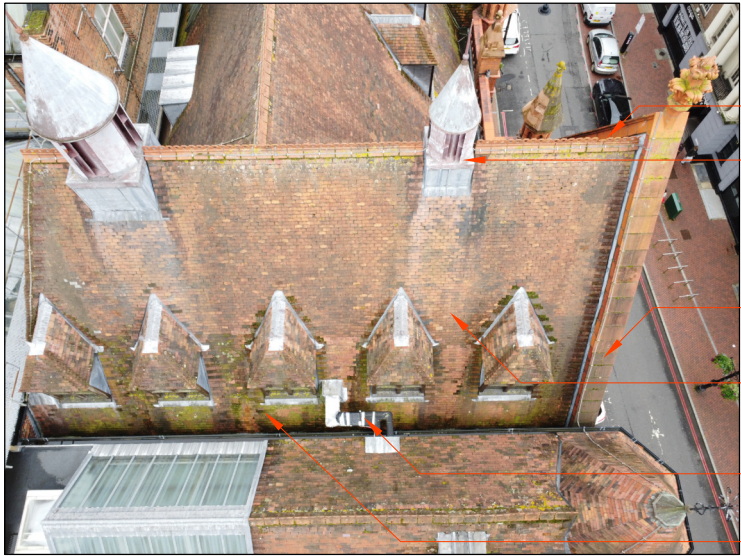
**01 NORTH SLOPE RF7A AND DORMERS**  
NTS - Date Taken: 09/10/24

- Recently repointed stepped flashing
- Damaged ridge tiles with open / missing mortar joints / moss
- Discolouration/weathering to vents
- Defective asphalt valley gutter covering
- Slipped / displaced roof tiles
- Cracked / damaged coping stones
- Minor roof sag between dormers / raised tiles around dormers
- Existing plant and ducting restricting access to remedial roof works
- Moss and algae present on tiles along eaves of northern roof slope

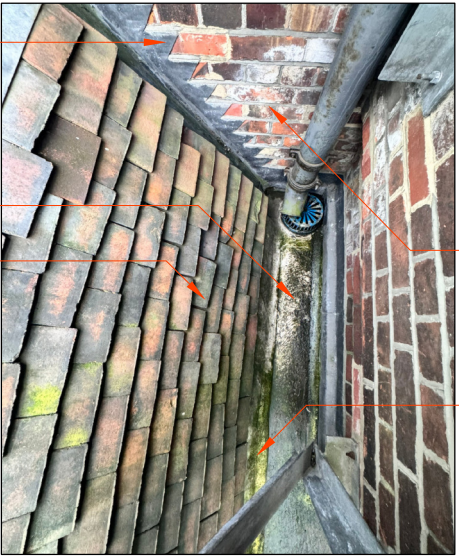
**02 VALLEY RF24-VGUT.14**  
NTS - Date Taken: 09/10/24

- Signs of wood rot in window frames
- Defective bubbling asphalt valley gutter covering, trapping water
- Peeling paint on timber window frames
- Lime bloom on bricks around rainwater downpipe
- Moss / algae growth showing signs of standing water
- Standing water in valley gutter

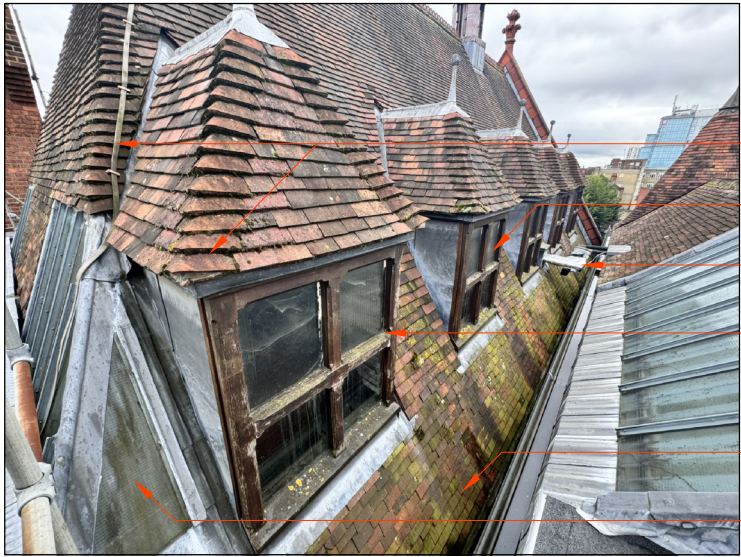
**04 DORMERS ON NORTH SLOPE RF7A**  
NTS - Date Taken: 09/10/24

- Single glazed Georgian wired glass patent glazing
- Uneven hip tiles on main roof and dormers
- Signs of wood rot in timber window frames
- Previous remedial waterproofing to ducting has become damaged
- Damaged finish to all timber window frames
- Slipped / displaced roof tiles
- Moss and algae present on tiles along eaves of northern roof slope
- Single glazed Georgian wired glass patent glazing

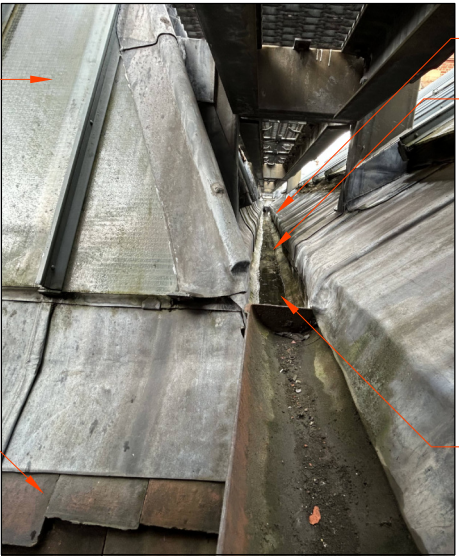
**05 VALLEY RF7-VGUT.02**  
NTS - Date Taken: 08/10/24

- Lifting lead flashings
- Defective asphalt valley gutter covering
- Lifting / warped lead flashings
- Moss, algae, and lichen present on surface of coping stones, moss in joints
- Delamination / spalling of terracotta stone on finials
- Open/defective mortar joints in terracotta
- Damaged/defective bricks
- Standing water in valley gutter
- Cracked / damaged coping stones
- Open/defective mortar joints in terracotta

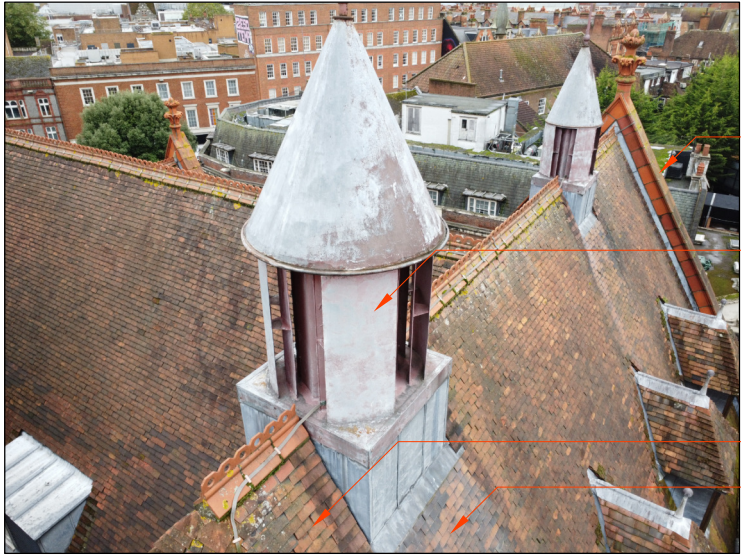
**07 RIDGE VENTS RF7-VENT.01 AND RF7-VENT.02**  
NTS - Date Taken: 09/10/24

- Service ducts for space below, vented through chimneys on ridge
- Cracked/damaged coping stones with open/defective mortar joints
- Discolouration/weathering to vents, potential water ingress from RF7-VENT.01
- Several lifted / displaced insulation rolls
- Existing plant and ducting restricting access to remedial roof works
- Slipped / displaced roof tiles
- Staining on tiles below vents
