project  
**Reading Town Hall,  
Alterations & Improvements**

title  
**Photosheet Of Existing  
Roof RF22**

| job no.<br><b>997</b> | dwg no.<br><b>122</b> | status/revision<br><b>PL00</b> |

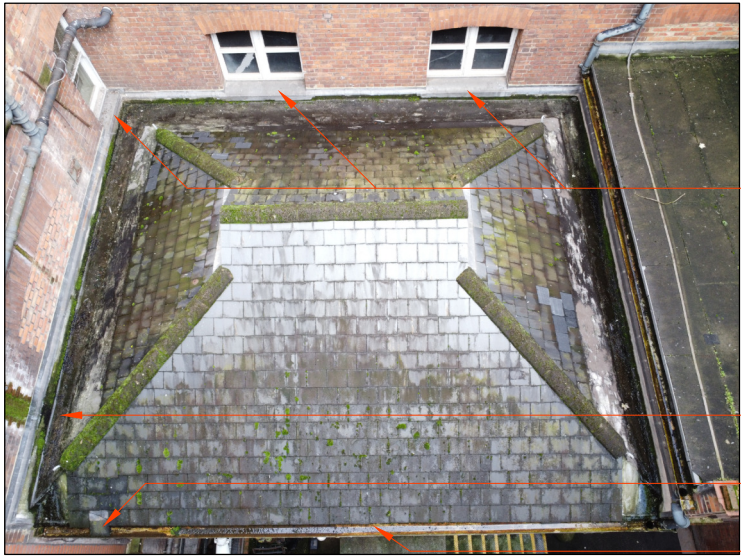
## 01 ROOF COVERING AND VALLEY GUTTERS RF22

Minimal upstand height between valley gutter and external window sill

Heavy moss growth around upstands to adjoining external brickwork wall

Minimal upstand heights between valley gutters and window sills

Isolated cracked / damaged slates across roof covering

Localised defective mortar bedding to some hip tiles, with moss over joints

Defective asphalt valley gutter covering, showing signs of cracking, slumping, and blistering

Isolated slipped/displaced slates where slate has cracked

Standing water along the full length of the eaves gutter

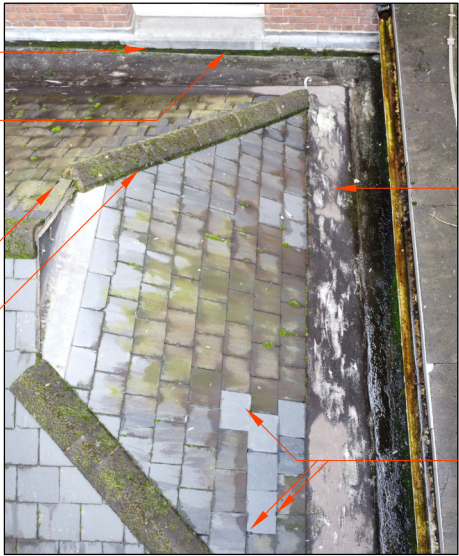
## 02 VALLEY GUTTERS RF22

Standing water in valley gutter

Defective asphalt valley gutter covering, showing signs of cracking, slumping, and blistering

Damaged surface finish of asphalt dressed up roof slope

Heavy moss growth around upstands to adjoining roof RF21

Hip tiles with localised defective open mortar joints, with moss between joints

Moss growth between and on the surface of slates

New replacement slates, previously refixed with tingles

No mortar verge to slates, possible location for water ingress

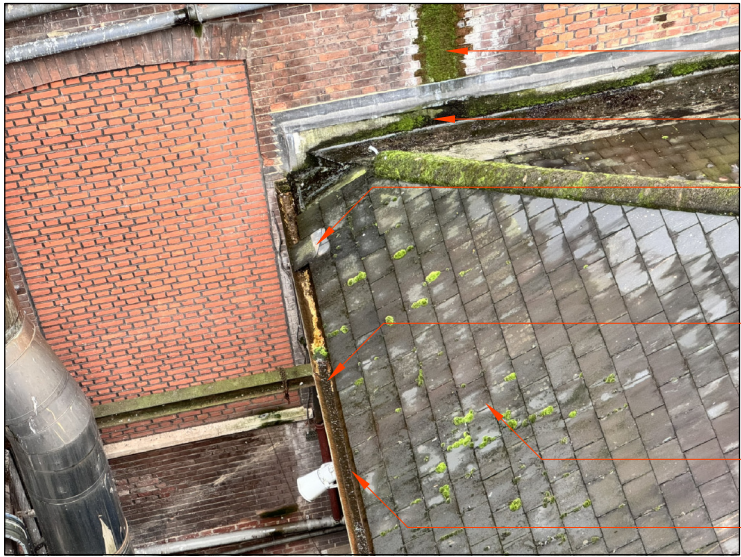
## 04 ROOF COVERING AND GUTTER RF22-EGUT.01

Algae growth and staining to brickwork due to downpipe leak

Algae /moss growth on upstands from high water level in gutters

Isolated slipped/displaced slates where slate has cracked

Hip tiles with localised defective open mortar joints, with moss between joints

Standing water along the full length of the eaves gutter

Moss growth between and on the surface of slates

Debris and moss growth along the full length of the eaves gutter

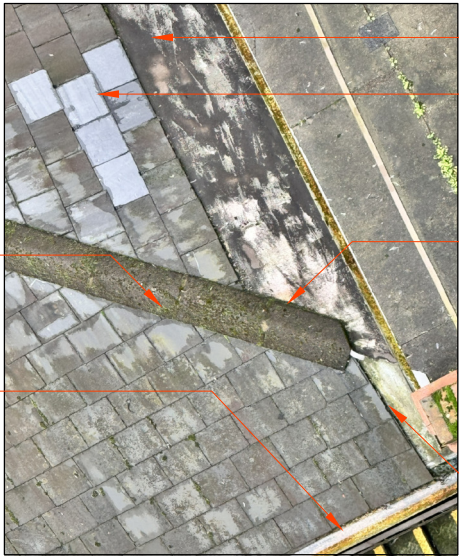
## 05 GUTTER RF22-VGUT.03

Damaged surface finish of asphalt dressed up roof slope

New replacement slates, previously refixed with tingles

Staining to brickwork indicating possible leaks in gutter

Localised defective mortar bedding to some hip tiles, with moss over joints

Minimal upstand height between valley gutter and external window sill

Heavy moss growth around upstands to adjoining external brickwork wall

Minimal distance between valley gutter and bottom of slate roof covering

No mortar verge to slates, possible location for water ingress

Isolated cracked / damaged slates across roof covering

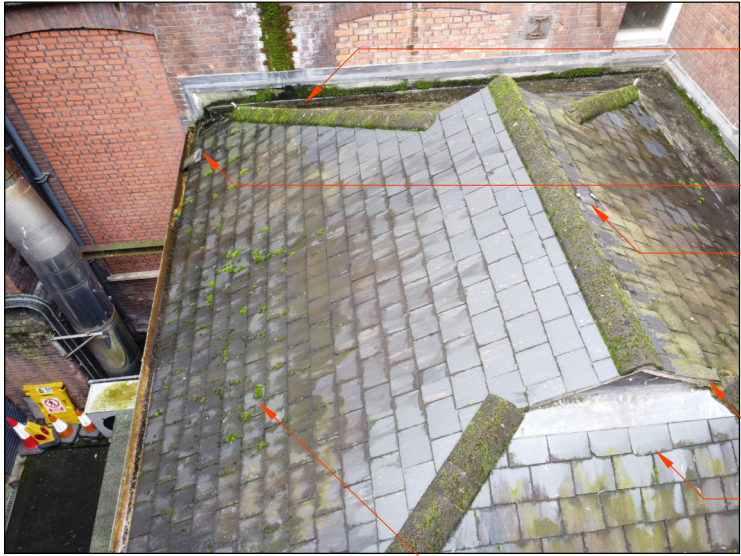
## 07 ROOF COVERING RF22

Defective asphalt valley gutter covering, showing signs of cracking, slumping, and blistering

Lead cover flashings damaged and lifting, failed mortar joint in wall above

Isolated slipped/displaced slates where slate has cracked

Isolated slipped/displaced slates, previously refixed with tingles

Heavy moss growth around upstands to adjoining roof RF21

Isolated cracked / damaged slates across roof covering

Isolated slipped/displaced slates

Moss growth between and on the surface of slates
