# RESULTS OF TREE PROTECTION INSPECTION

## Nos. 2-6 Water Road and 158 Dee Road, Reading RG30 2NN

| REPORT DATE: | 30 <sup>th</sup> March 2026 |

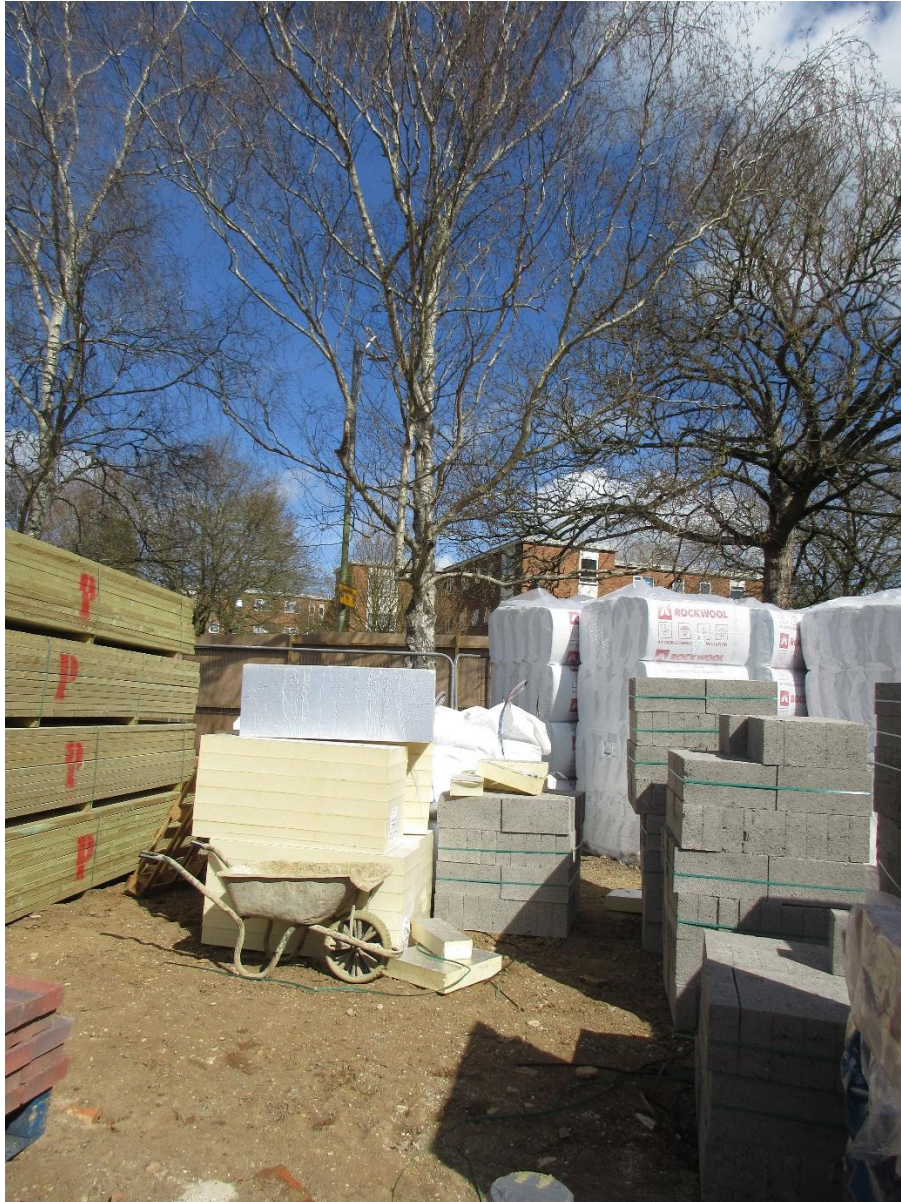
2.3.1 I saw a rack of plastic drainage goods beginning around 2 m from the northern end of the current tree protection barriers (see photograph 4, Appendix 1). At the opposite, southern end, there are packs of insulation (see photographs 1 & 2, Appendix 1).

**PHOTOGRAPH NO. 1 – Materials stored west and south of the trees**

5.1 Remove all stored building materials to enable establishment of the correct RPAs. De-compact the western side of the calculated RPAs by means of using a garden fork to insert the tines to their full length on a 300 mm by 300 mm grid pattern. If dry conditions prevail, thoroughly water the whole area before applying a 75-100 mm layer of **coarse** wood chip.

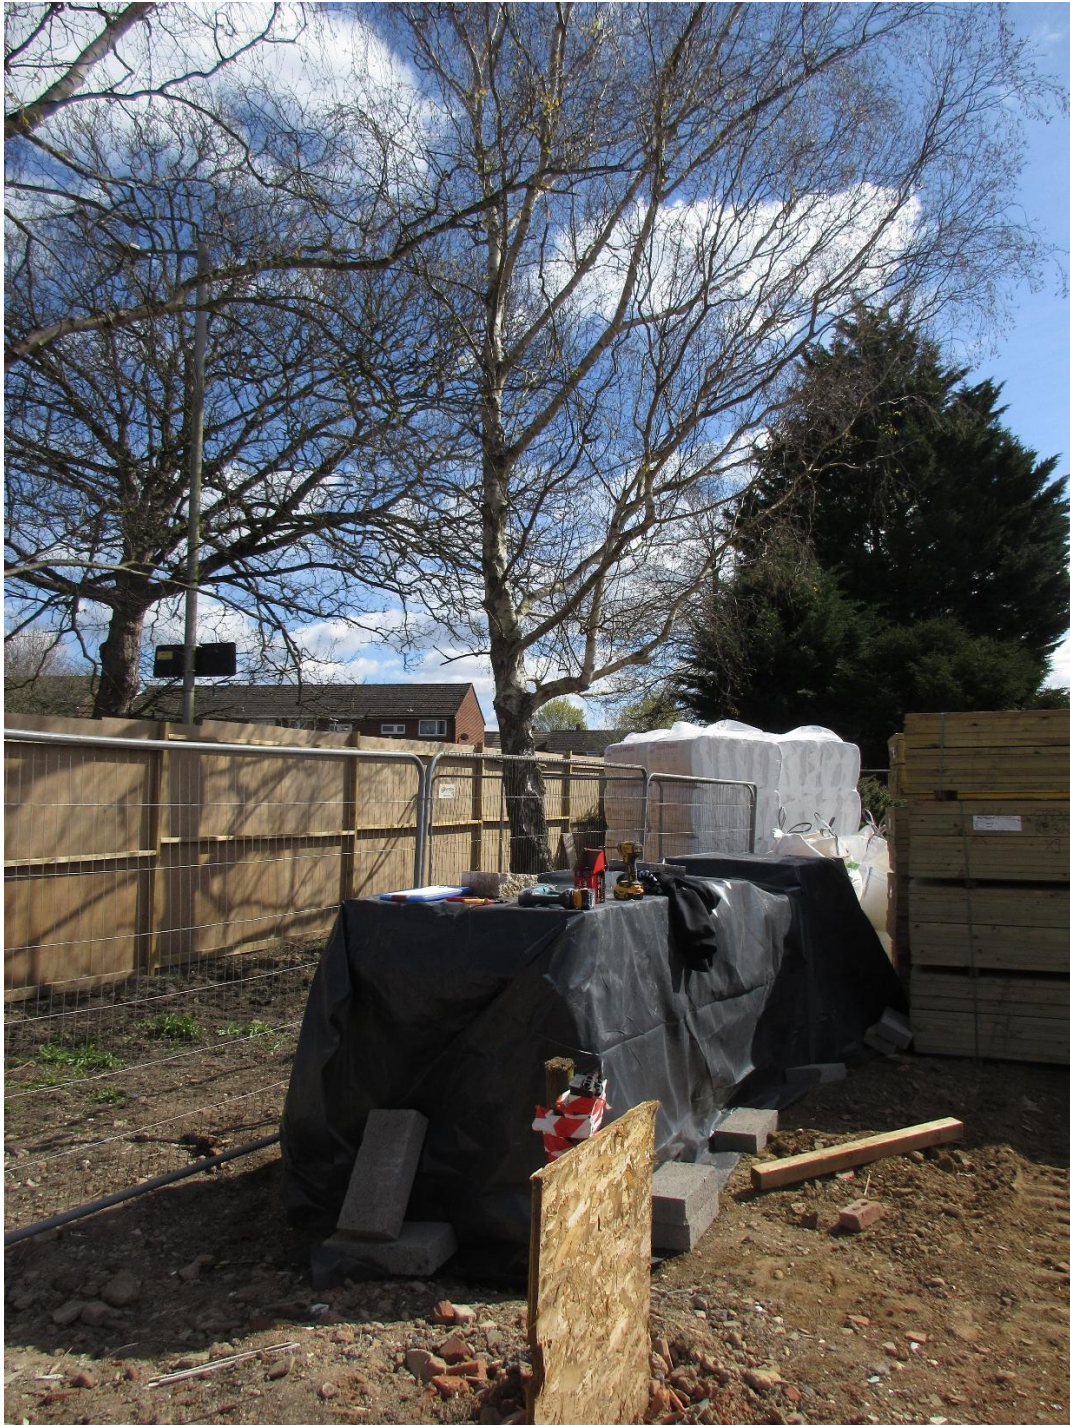
2.3 Building materials are stored within the distal sections of the calculated RPAs, in most instances around another 0.5 m outside the barriers. Heavy-side materials are stored to the west, inner side (see photograph 2, Appendix 1), while lighter goods are stored to the north and south see photograph 4, Appendix 1 – 1 & 2 respectively).

2.4 The ground surface around both trees within the existing tree protection barriers is relatively undisturbed and seems to be at its original level (see photograph 2, Appendix 1). Remains of historic garden infrastructure – notably a brick wall around the eastern side of T3 (TPO No. 1) are visible. I used the presence of this and emergent herb layer vegetation to conclude that the ground level is now as it was before the redevelopment works began.

- 3.2.2 Heavy side materials are stored west of both trees within the distal one-third of the calculated RPAs (see photographs 2 & 4, Appendix 1). These should be removed as soon as is practical.

**PHOTOGRAPH NO. 2 – Heavy-side materials stored west of the trees**

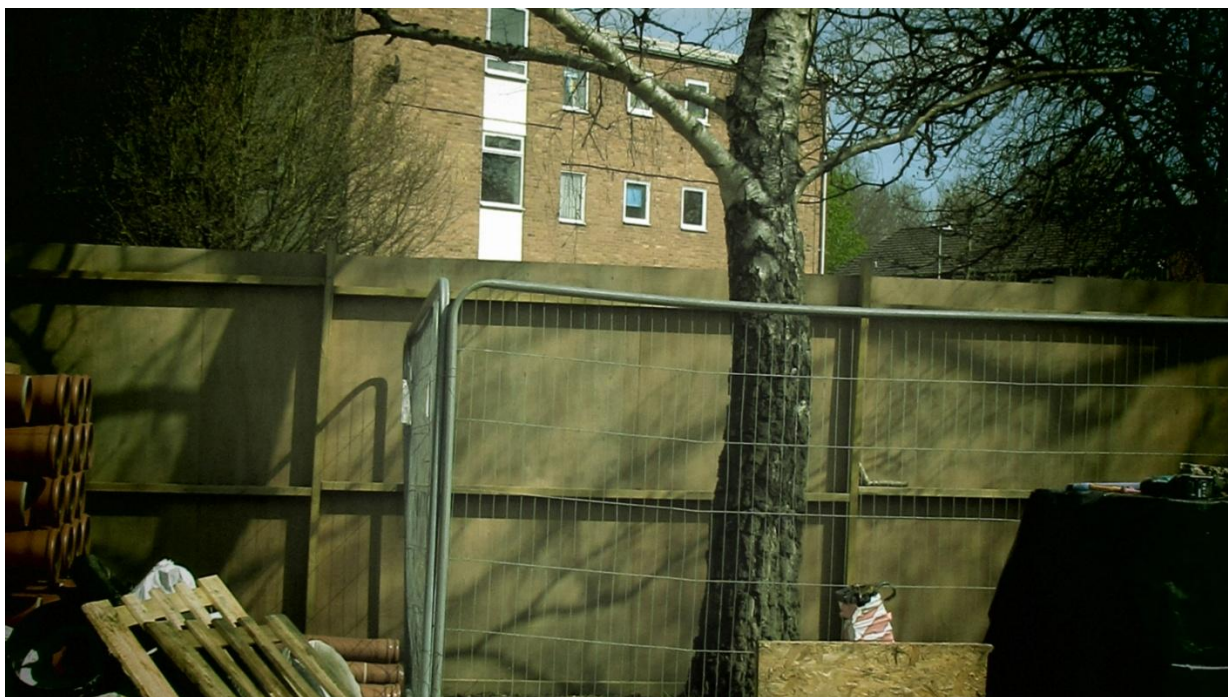
2.2 I saw that protective barriers had been installed, though not in the correct locations. Tree 2 (TPO No. 2) has a calculated RPA radius of 4.98 m, whilst that of T3 (TPO No. 1) is 4.56. With both trees I found the tree protection barriers (see photographs 2, 3, 4 & 5, Appendix 1) to be located as set out below:

**PHOTOGRAPH NO. 3 – Protective barriers around T3 – Silver birch  
(TPO No. 1 – 20/16)**

5.2 Install tree protection barriers in a hexagonal configuration around the outer extent of the calculated RPA of both trees. The RPA radii are as follows:

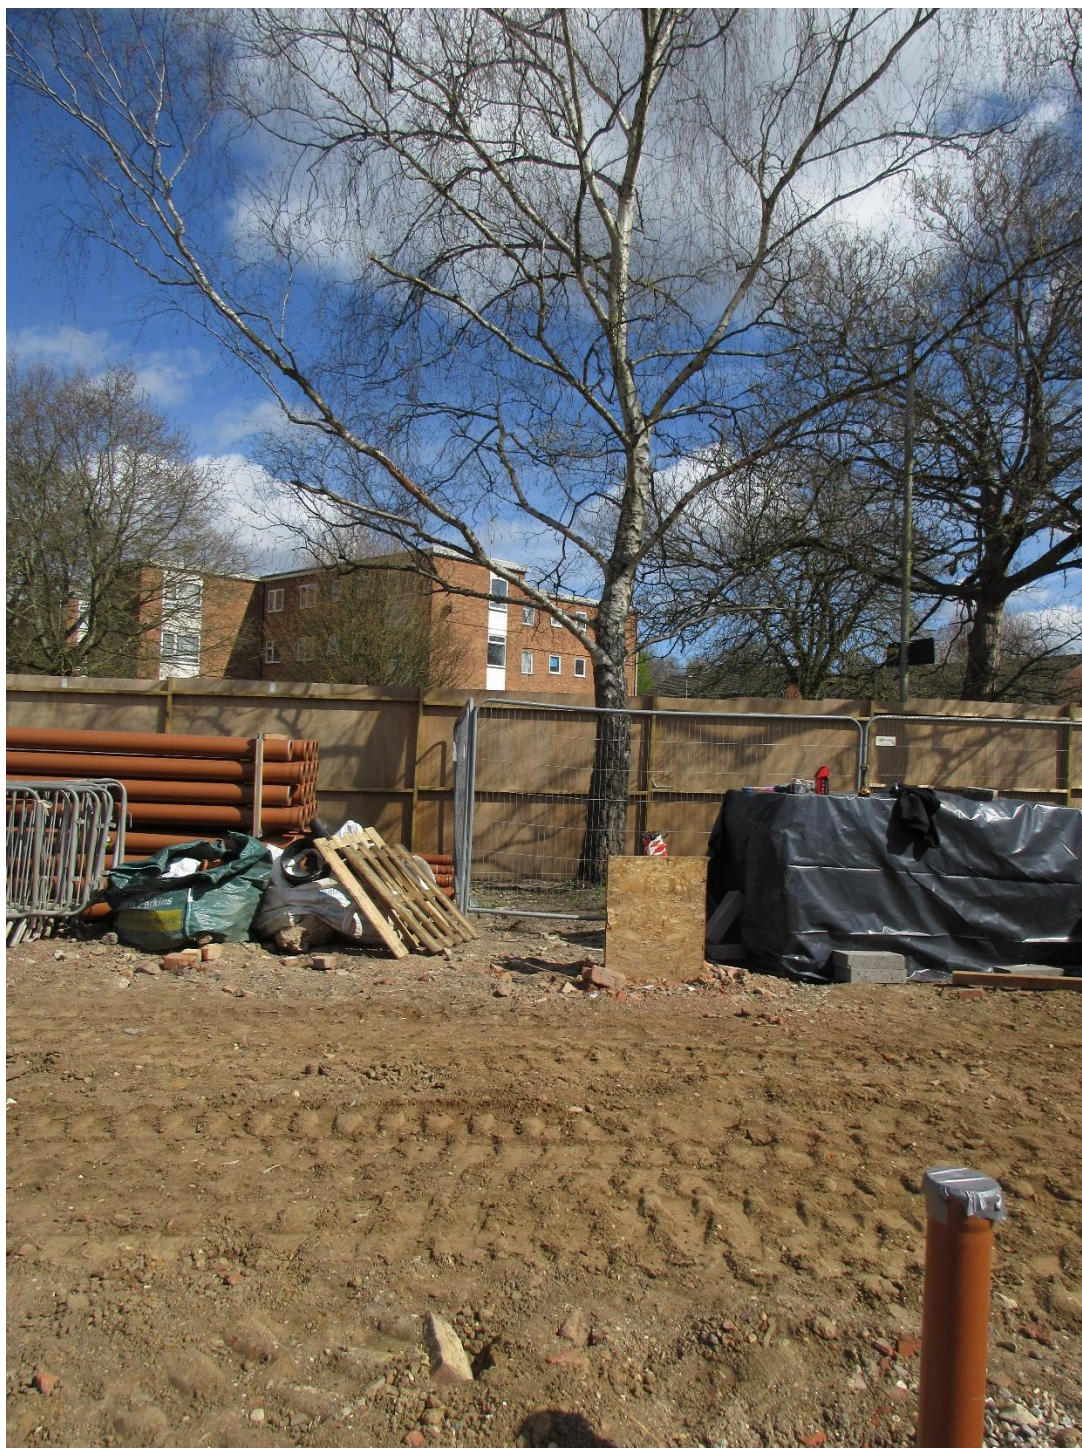
- 3.1 Although tree protection barriers have been installed, they are not in compliance with the specifications provided within the Arboricultural Method Statement prepared by SJA trees. The northern side barriers are around 1.5-2 m closer to the trees than is specified (see photographs 2, 4 & 5, Appendix 1). Those to the north and south are respectively 2.85 m and 3.68 m closer than they should be.

- 3.2.1 Similarly, the lightweight plastic drainage goods stored north of T3 (see photograph 4, Appendix 1) will have caused no ground compaction and minimal reduction of rainwater infiltration.

**PHOTOGRAPH NO. 4 – Protective barriers around T3 – Silver birch (TPO No. 1 – 20/16) showing the lightweight plastic drainage goods to the left (northern) end**

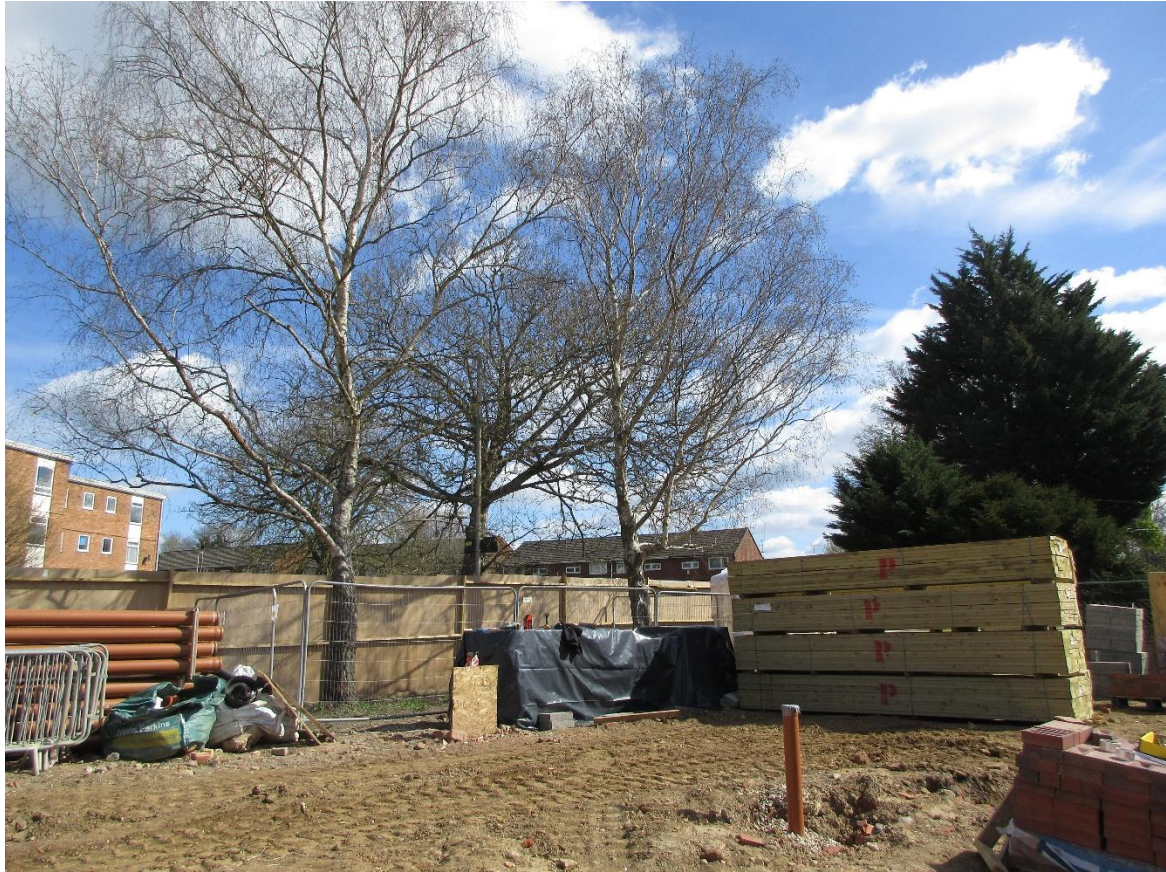
**PHOTOGRAPH NO. 5 – T3 – Silver birch (foreground) and T2 – Silver birch (background) viewed from the northwest**
