# Tree Condition Survey Report (VTA)

**Site:** Beacher Hall Care Home, 42 Bath Rd, Reading RG1 6PG

**Client:** Bupa

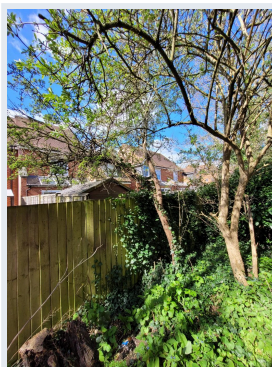
### Common hawthorn Tree ID #6

| Tree Survey Schedule | | | | | | | | | | | | | | | | | | |
|---|---|---|---|---|---|---|---|---|---|---|---|---|---|---|---|---|---|---|
| 6 | 2736 | Common hawthorn | Crataegus monogyna | 0-5m | 200 | Semi-mature | Fair | Fair | Overhanging shed in garden<br>2026- western branch resting on shed roof. | Root Severance | Leaning, Ivy Covered Stem | Crown Close to Building and/or Infrastructure | None Observed | None Observed | Building, Fence, Garden | Medium | Good | Client |

| Tree ID | Common Name | Work Task | Priority | Description | Tag No | Hours |
|---|---|---|---|---|---|---|
| 6 | Common hawthorn | Remove Specific Branch/Limb | Within 3 - 6 Months | Remove western limb resting on shed roof. | 2736 | 1 |

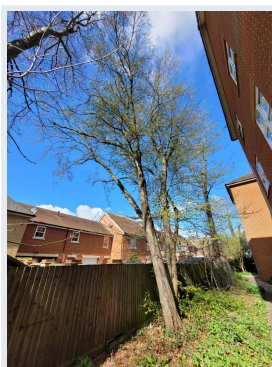
### Hornbeam Tree ID #9

| Tree Survey Schedule | | | | | | | | | | | | | | | | | | |
|---|---|---|---|---|---|---|---|---|---|---|---|---|---|---|---|---|---|---|
| 9 | 0426 | Hornbeam | Carpinus betulus | 16-20m | 450 | Early-mature | Fair | Fair | 1 Lateral limb has been reduced in length to reduce end weight loading- fungal fruiting bodies are visible on limb (suspected Phellinus or Stereum ,visibility restricted - both indicative of dysfunctional wood) - monitor and reassess limb vitality at next inspection - 2025 no obvious changes in vitality- extent of fungal fruiting bodies has not increased<br><br>2026 - 3 dysfunctional zones around the stem at the base on W, SE and N aspects to 40cm. Most recent on the western side. Bark peeling to expose necrotic area with Armillaria mellea rhizomorphs (aggressive pathogenetic fungi that affects decays roots) | None Significant | Bark Wounding/Damage, Co-dominant Stem, Fungal Fruiting Body, Ivy Covered Stem, Reactive Growth | Asymmetrical, Fungal Fruiting Body, Low Vigour, Branch - Lion Tailing, Poor Vitality | Fungus - Armillaria, Fungus - Other, Fungus - Phellinus | None Observed | Building, Fence, Footpath | High | Good | Client |

| Tree ID | Common Name | Work Task | Priority | Description | Tag No | Hours |
|---|---|---|---|---|---|---|
| 9 | Hornbeam | Dismantle to ground level | Within 3 - 6 Months | Dismantle to ground level. Fell recommended as Armillaria rhizomorphs visible in necrotic zones at the base. | 0426 | 4 |

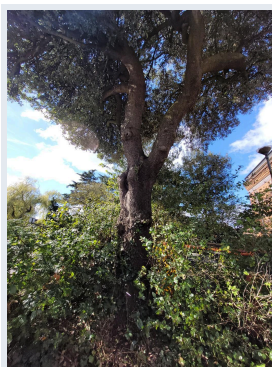
### Holm oak Tree ID #15

| Tree Survey Schedule | | | | | | | | | | | | | | | | | | |
|---|---|---|---|---|---|---|---|---|---|---|---|---|---|---|---|---|---|---|
| 15 | 0801 | Holm oak | Quercus ilex | 11-15m | 750 | Mature | Fair | Fair | Split in lateral limb in upper crown overhangingshrub area - appears stable<br><br>Major deadwood sections overhanging shrub area<br><br>Bark damage noted on lower lateral limbs<br><br>2026 - no access to base for through inspection. | Suckering/basal growth | Forked, Cavity in Stem | Fungal Fruiting Body, Crack/Split | None Observed | Potential Bird Habitat | Car park, Footpath, Road, Street light/furniture | High | No access to base/stem | Client |

| Tree ID | Common Name | Work Task | Priority | Description | Tag No | Hours |
|---|---|---|---|---|---|---|
| 15 | Holm oak | Clear vegetation to allow access to basal areas of trees for inspection purposes | Within 6 - 12 Months | Removal epicormic growth to 2m, Remove Ivy and Create 50cm clearance from stem. Works to facilitate proper inspection of the base. | 0801 | 0.5 |

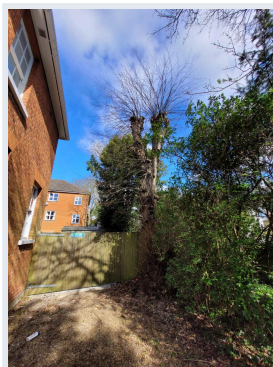
## Common lime Tree ID #18

| Tree Survey Schedule | | | | | | | | | | | | | | | | | | |
|---|---|---|---|---|---|---|---|---|---|---|---|---|---|---|---|---|---|---|
| 18 | 0803 | Common lime | Tilia x europea | 11-15m | 1000 | Mature | Poor | Poor | Unable to inspect base or trunk due to sucker growth<br><br>Forked at approximately 6m from ground level.<br><br>2026 - topped at 7m with 3m regrowth. Kretzschmaria deusta on N side of stem from ground level to 40m. Attributed to white/soft rot and brittle fracture of stems at the base. Acoustic testing suggests significant decay at the base. | Suckering/basal growth | Acoustically tested with rubber mallet - significant decay noted, Forked, Fungal Fruiting Body, Prolific Epicormic/Basal Growth, Pruning Wounds - Occluded | Previously Pollarded | Fungus - Kretzschmaria (Ustulina) | None Observed | Building, Fence, Footpath, Garden | High | No access to base/stem | Client |

| Tree ID | Common Name | Work Task | Priority | Description | Tag No | Hours |
|---|---|---|---|---|---|---|
| 18 | Common lime | Dismantle to ground level | Within 1 - 3 Months | Tree has Kretzschmaria deusta at the base and within falling distance of building. | 0803 | 3 |
