**CAVERSHAM COURT GARDENS, GAZEBO**

**STRUCTURAL REPORT**

| SFK Document No: | | 25143/R02 | | |

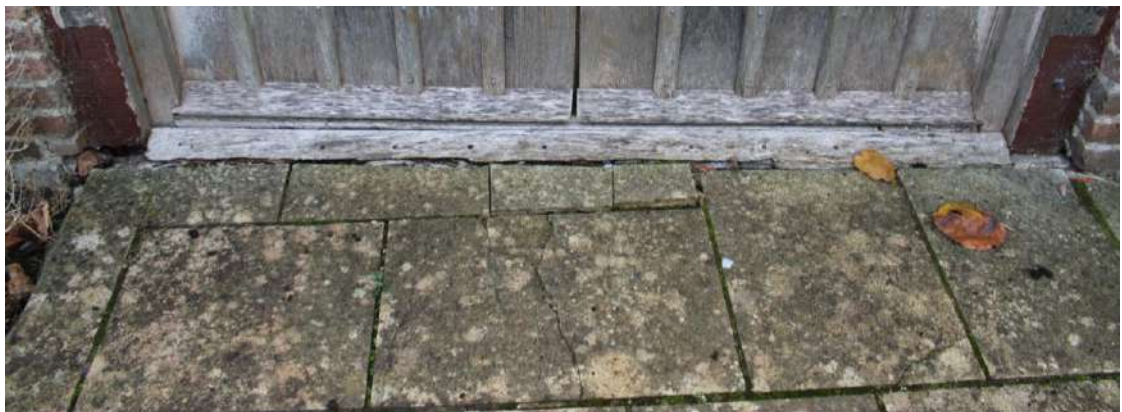
The north elevation was in overall reasonably good condition. The structural timber members had no significant decay. The timber sill to the entrance doors was noted to be decayed and loose at the east end. Paving in front of the sill was loose and cracked, Fig. 4.1.

*Fig. 4.1 North elevation – door sill decayed and paving defects*

Repairs required to the north elevation are typically non-structural such as the timber door sill replacement, paving repair and repointing below the wall plates.

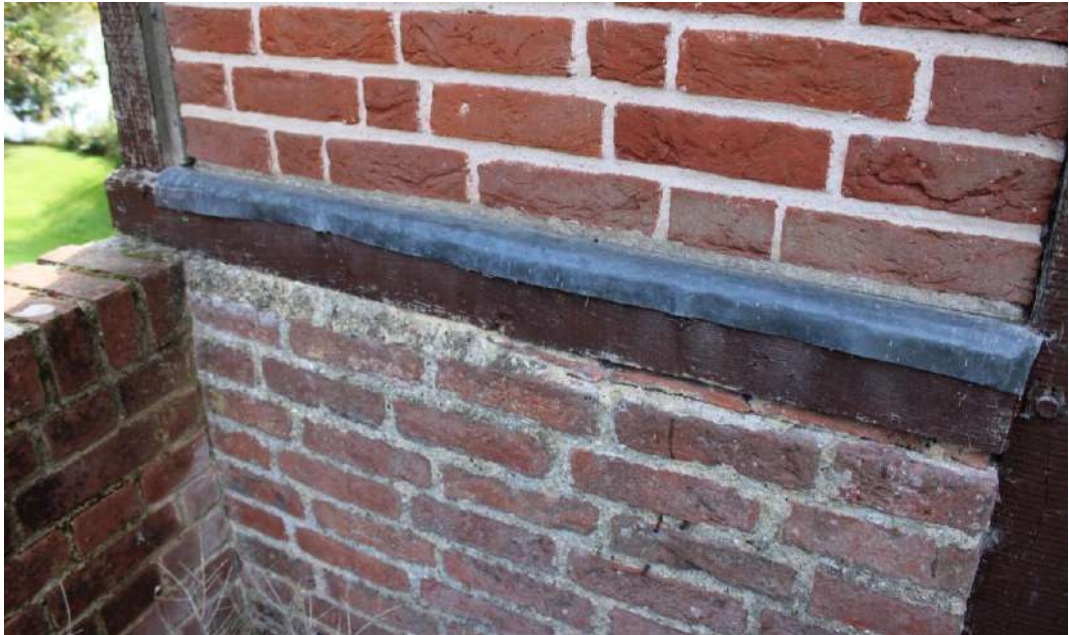
The wall plates measured approximately 170 w x 110 d. Below the east wall plate there was some loss of mortar below the plate, Fig. 4.2.

*Fig. 4.2 North elevation – east wall plate with mortar loss below*

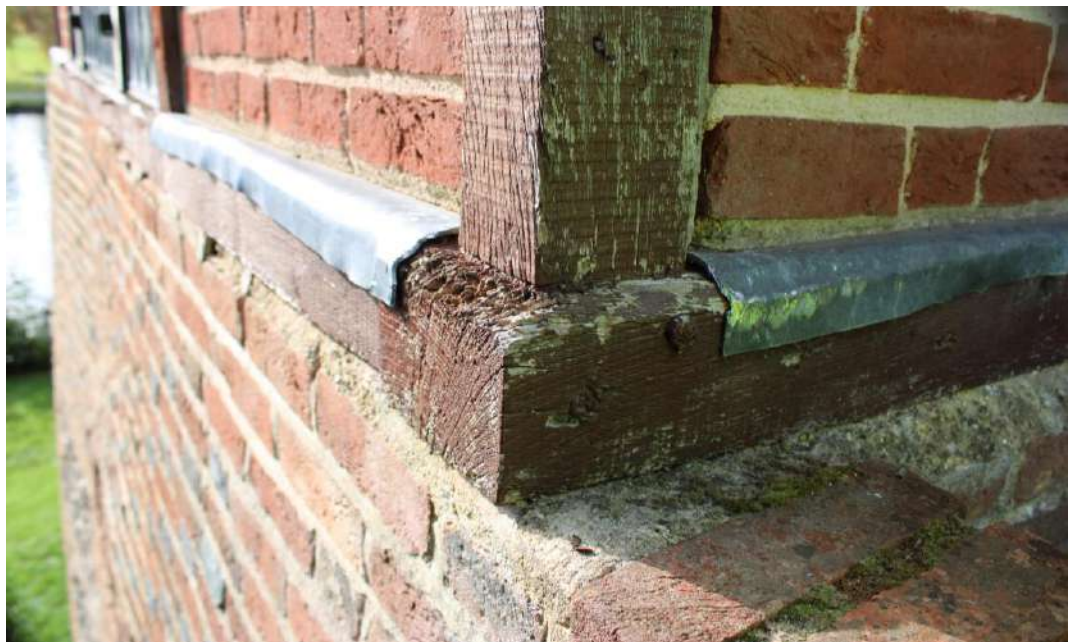
The lead flashing detail over the plates, stops at the corners leaving the plate exposed at the base of the 100mmx100mm corner posts, Fig. 4.3. The brown paint finish to the timber was noted to be typically flaking off. There was no significant decay of the plate at this northeast corner.

*Fig. 4.3 North elevation – northeast corner post and plate*

A detail that requires further conservation architectural review is at the bottom of all the corner posts. The current lack of flashing is creating an increased risk of decay. At the northeast corner allowance should be made for a small local patch/pack detail to the top of the lower wall plate. Similarly, the lack of sill plate flashing detail across the windows is also creating an increased risk of decay and requires architectural review. To the west elevation this has led to water ingress, beetle attack and decay. The plate here requires local replacement.

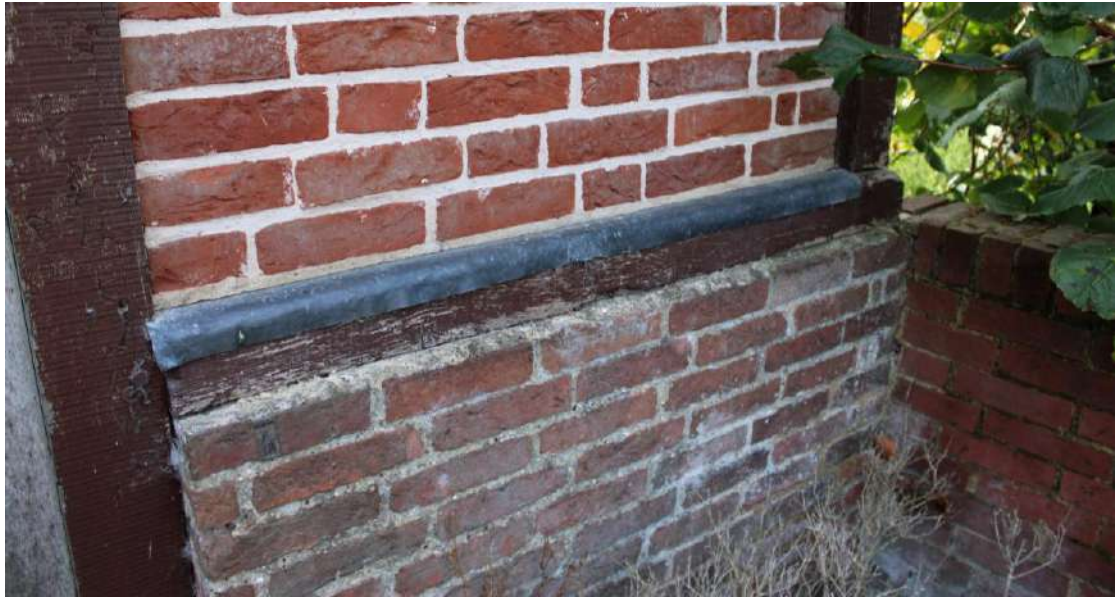
Below the west wall plate there was also some loss of mortar below the plate (although not as extensive as to the east), Fig. 4.4.

*Fig. 4.4 North elevation – west wall plate with mortar loss below*

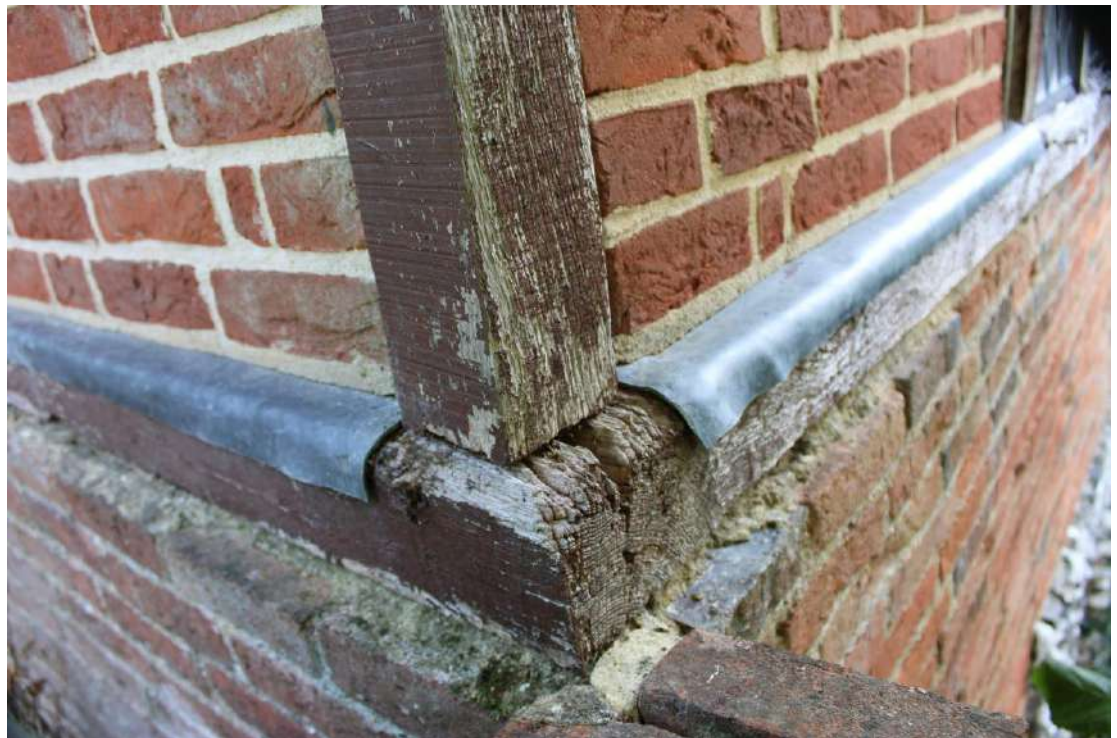
At the northwest corner, the plate had some minor decay with the formation of “V” split to the upper surface, Fig. 4.5. Paint was again flaking off.

*Fig. 4.5 North elevation – northwest corner post and plate*

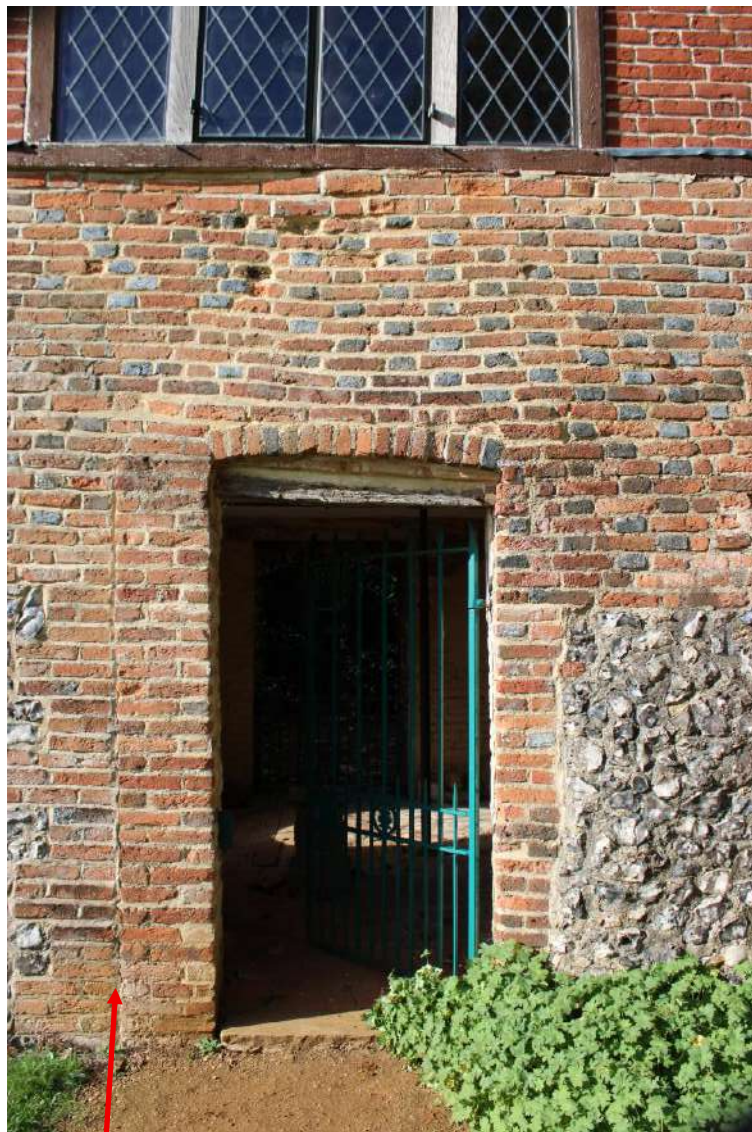
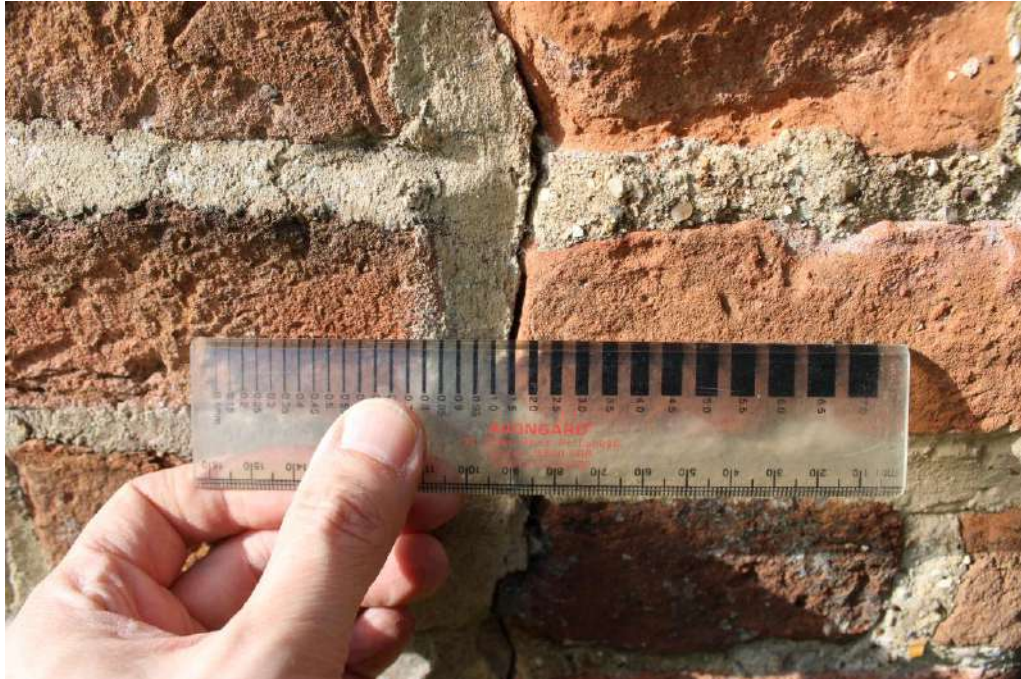
To the south of the gate, the bricks are not fully bonded in (effectively forming a pier), and a fine vertical crack is present. This measured 1.5mm wide at a height of 1270mm from ground. Above the gate there is some historic deformation of the brickwork, and two or three bricks are spalled, see Fig. 4.6 and 4.7. There is also some mortar loss under the wall plate.

Fine vertical  
crack

*Fig. 4.6 East elevation – gate area*

*Fig. 4.7 East elevation – vertical crack south of gate, 1.5mm wide at 1270mm high above ground.*

To the east elevation repointing is required under the upper wall plate. The spalled bricks should be considered for replacement. The vertical cracking to the south of the gate opening and cracking under the window are not considered structurally significant currently. The cracks should be repointed and monitored for future re-cracking.

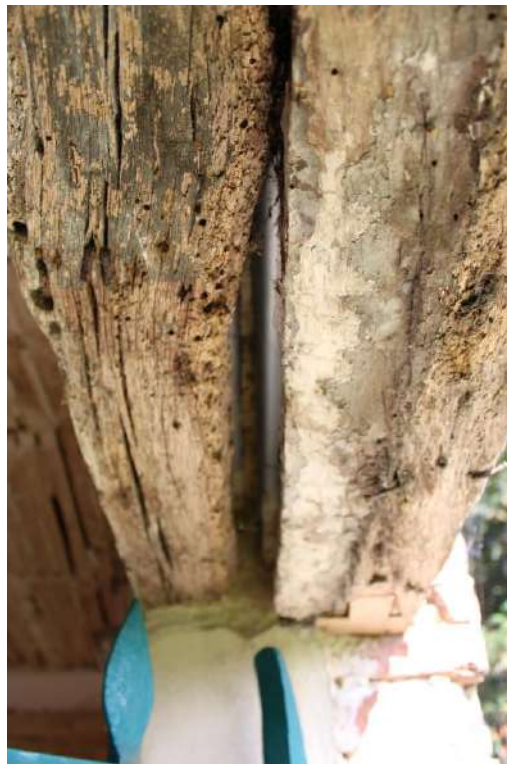
Above the gate the twin timber lintels have some decay but viewed from the underside it is apparent that two stainless steel angle lintels have previously been added above the timber lintels, Fig. 4.8. The outer timber lintel has had a previous timber repair at the north end.

*Fig. 4.8 East Elevation – lintels above gate*

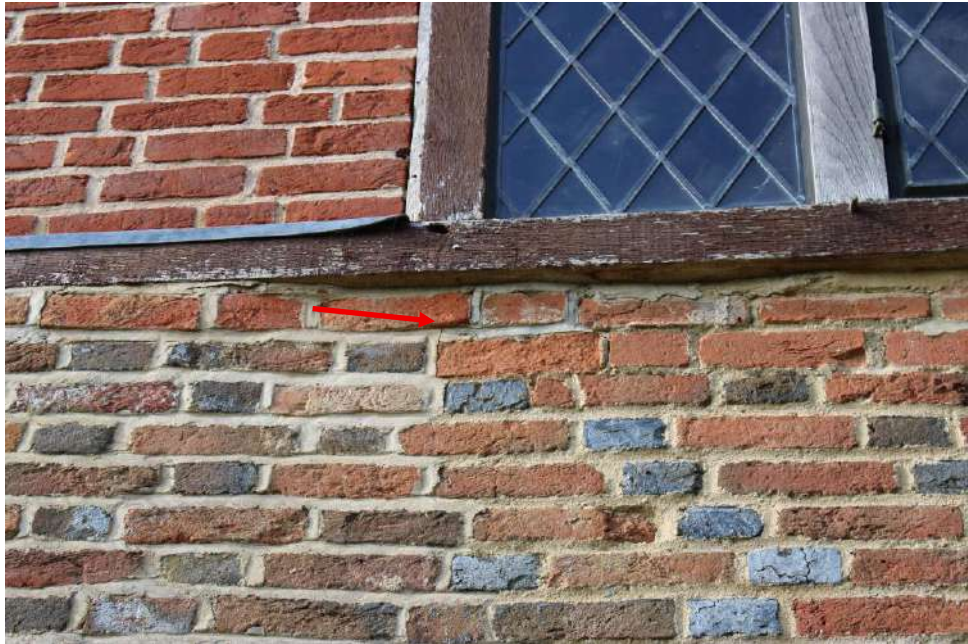
To the first floor below the south edge of the window, there was some minor fine cracking to the mortar joints, Fig. 4.9.

*Fig. 4.9 East elevation – brickwork below south edge of window*

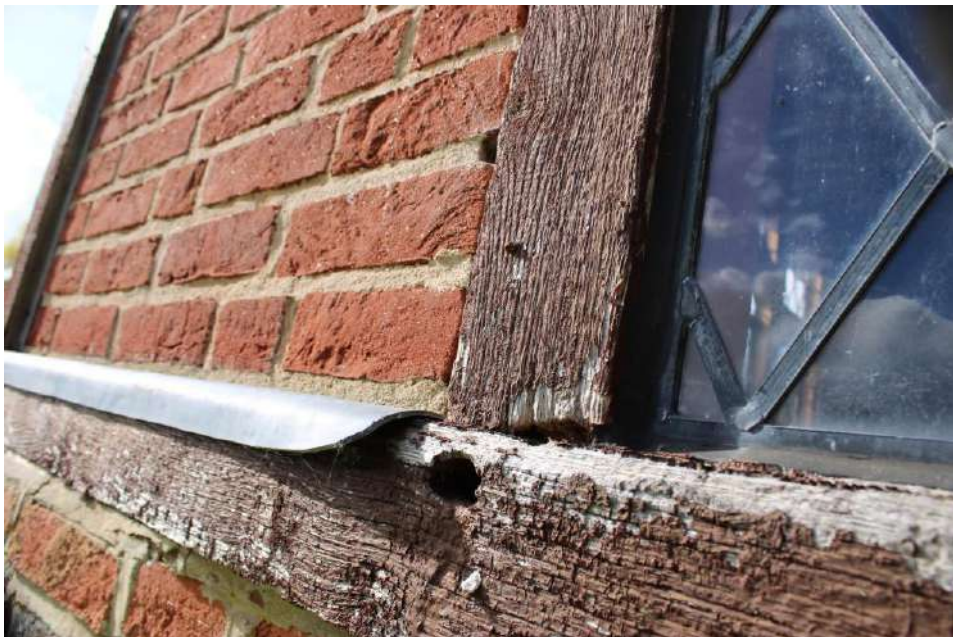
The lead flashing does not continue across the wall plate under the window, and the paint finish has broken down and flaked off. At the south window post, the peg is missing from the joint and the corner of the bottom of the post has some small local decay, Fig. 4.10.

*Fig. 4.10 East elevation – south window post*

To the east timber window, where there is a split at the top of a post, this should be further investigated and allowance made for a local face patch repair. At the bottom of the east window post where peg is missing this should be replaced and the bottom checked for extent of decay. A local face patch repair may be required.

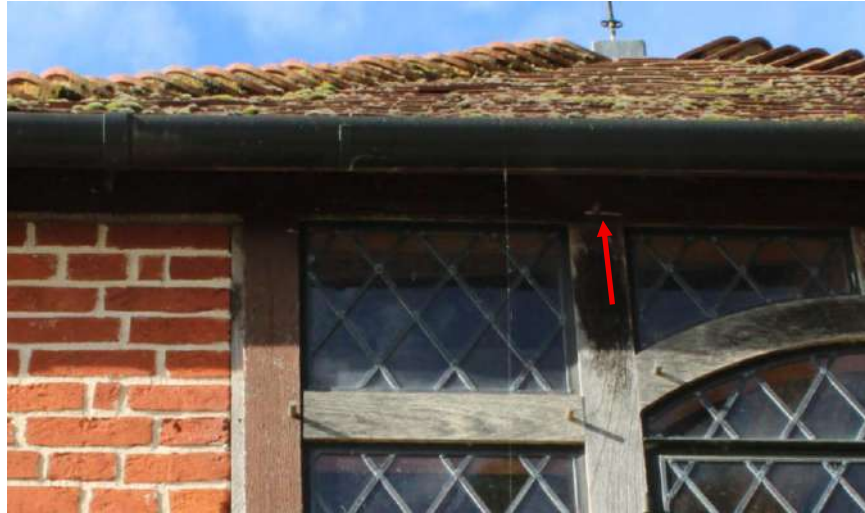
To the top of the first window post from the south edge, there appears to be a split in the upper wall plate at the peg joint, although this could not be reached for close inspection, Fig. 4.11.

*Fig. 4.11 East elevation – split above window post*

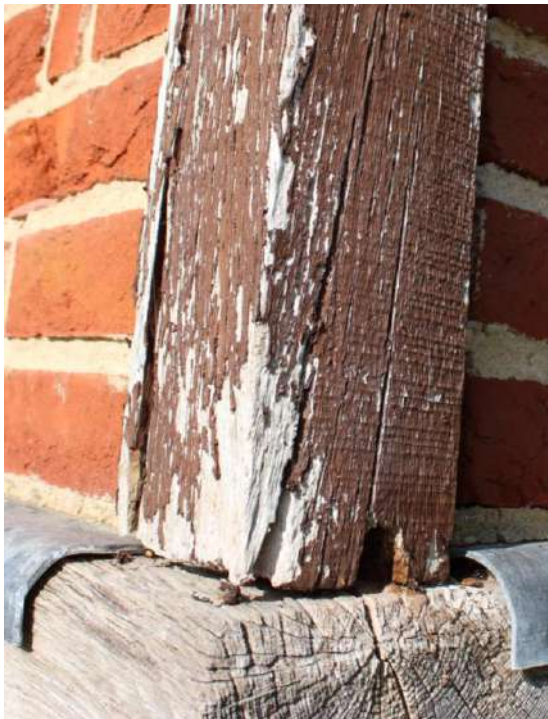
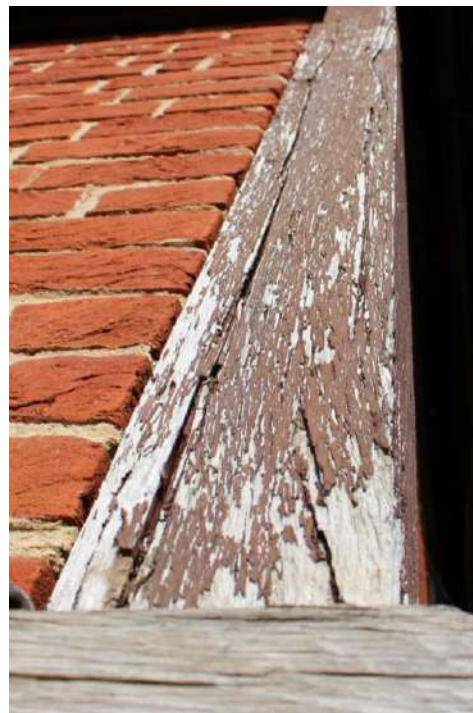
The southeast corner post has some minor decay to the bottom and a series of vertical splits, mainly at the corners, Fig. 4.12. To the south elevation, the split extends most of the height of the post, Fig. 4.13. The end of the plate was also noted to have local timber wedge packers with gaps around them.

*Fig. 4.12 East elevation – southeast post*

*Fig. 4.13 Southeast post – south elevation*

For the southeast corner some decay was noted at the bottom of the post. This did not appear extensive and ideally repair would be carried out without the need to remove any infill brickwork. Allowance should be made for a short scarf repair at the bottom of the post. The south face of the post had vertical spiting and an appropriate repair technique such as face repair will need to be agreed with conservation carpenter. The wall plate at the southeast corner also requires re-bedding/packing with lime mortar and slate/tiles.

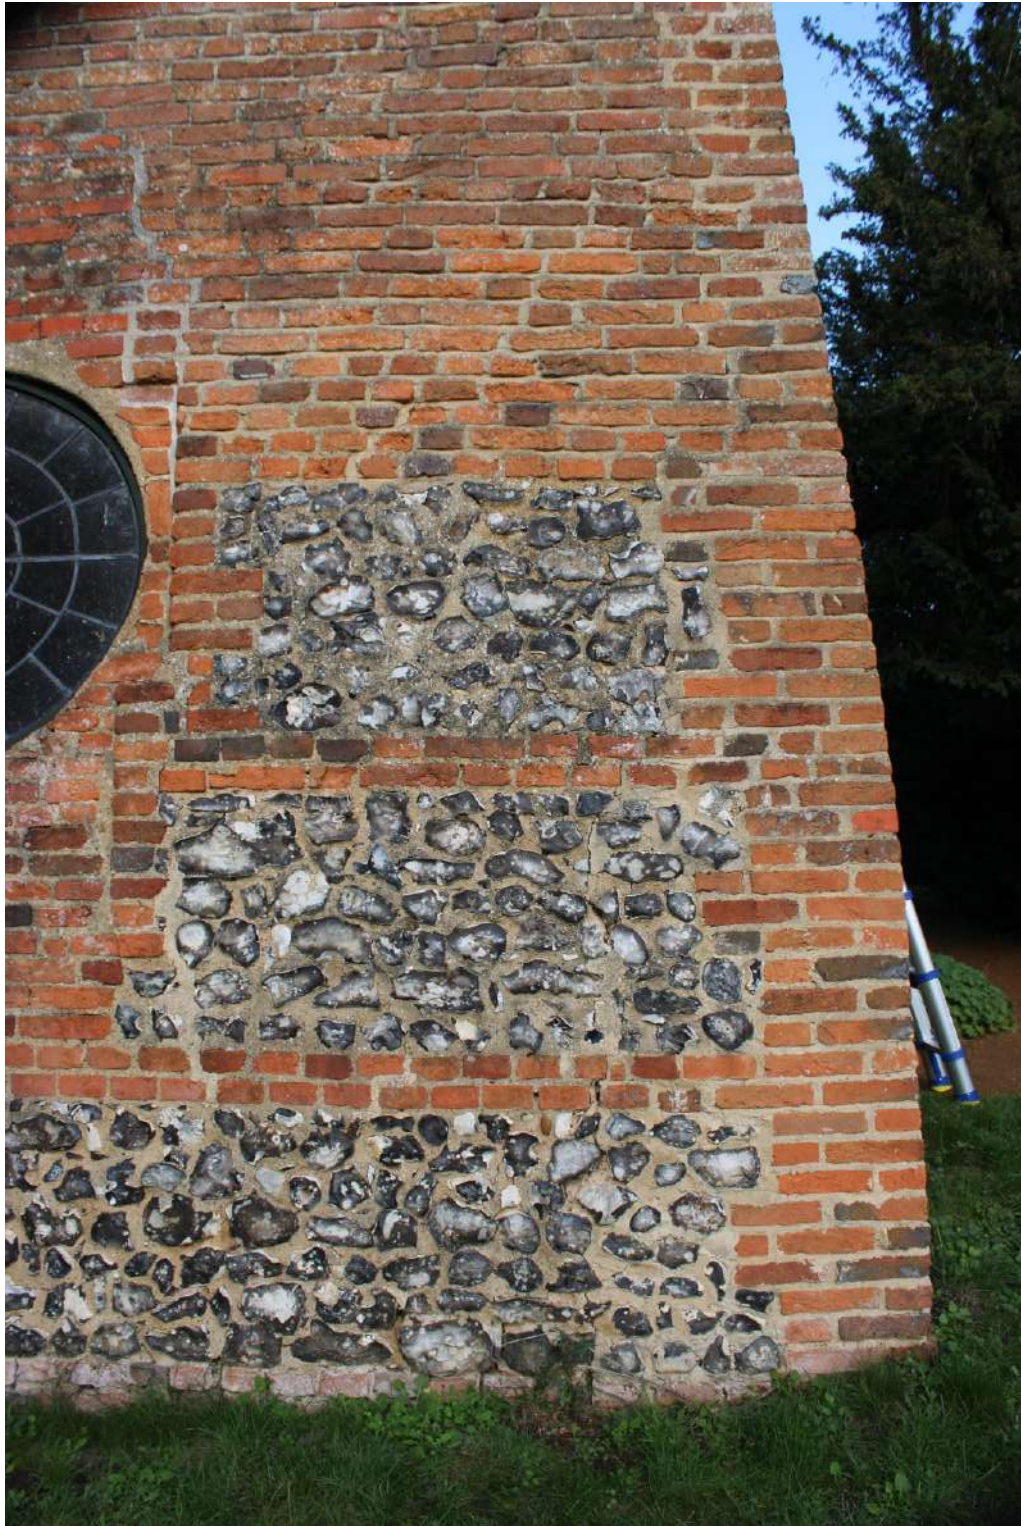
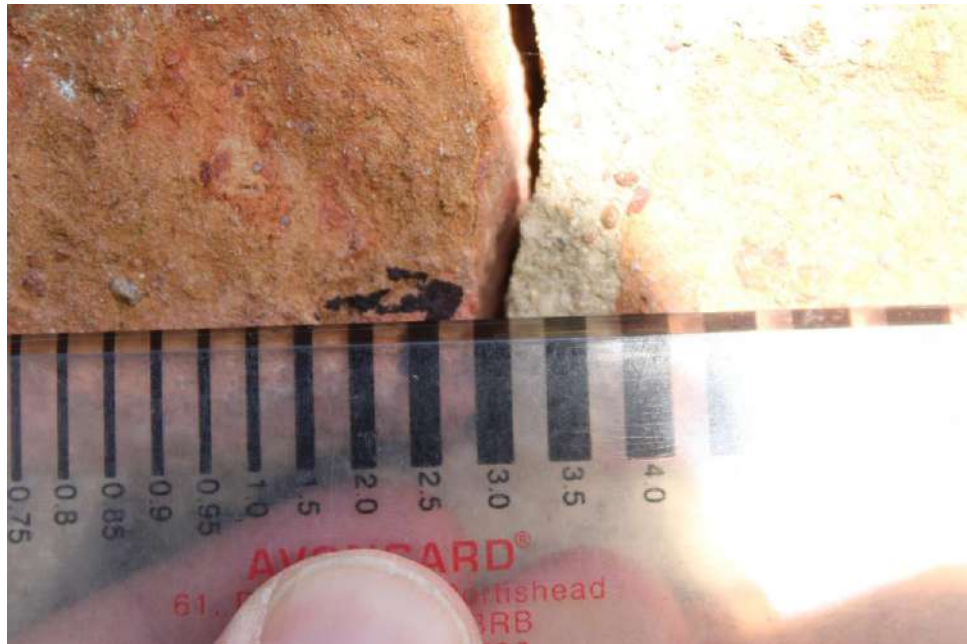
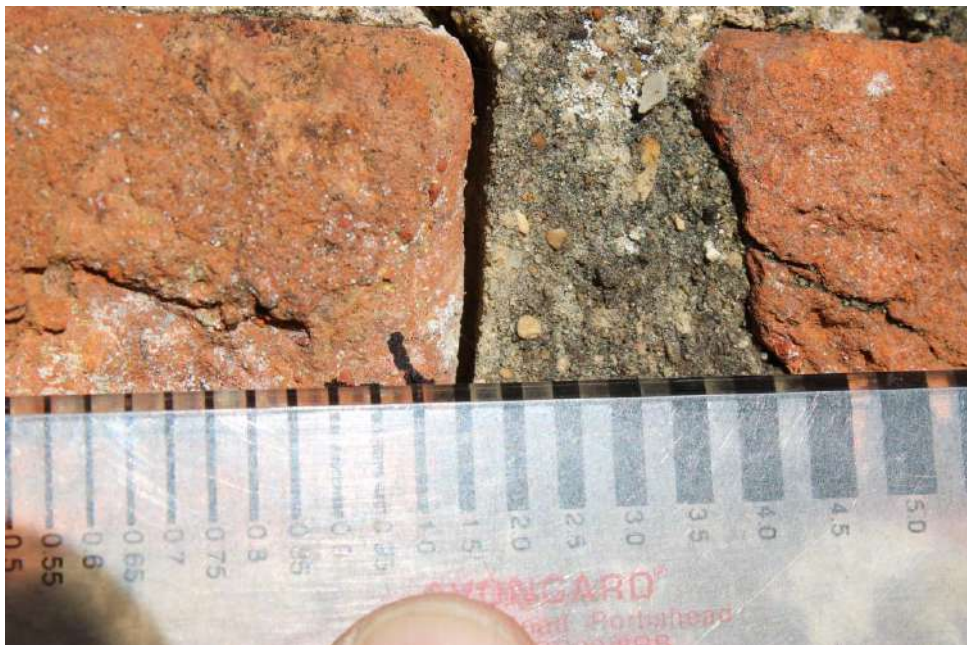
The south elevation was in overall reasonably good condition. To the east corner there is fine to slight vertical cracking through the flint panels and bricks, Fig. 4.14.

*Fig. 4.14 South elevation – cracking at east corner*

At 830mm height the cracking was measured as 3mm wide and at 1580mm height was measured as 1.5mm wide, Fig. 4.15 and 4.16.

*Fig. 4.15 South elevation – vertical crack, 3mm wide at 830mm high above ground*

*Fig. 4.16 South elevation – vertical crack, 1.5mm wide at 1580 mm high above ground.*

For the south elevation the trial pit investigation showed the wall continued to a reasonable depth below ground level (circa 800mm) and that the vertical cracking at the corner did not continue below ground level. The cracking does therefore not appear to be due to foundation movement and might be attributed to restraint/thermal movement of the wall. The cracking is not of structural concern, and it is therefore suggested the cracking is repointed and monitored for any future re-cracking.

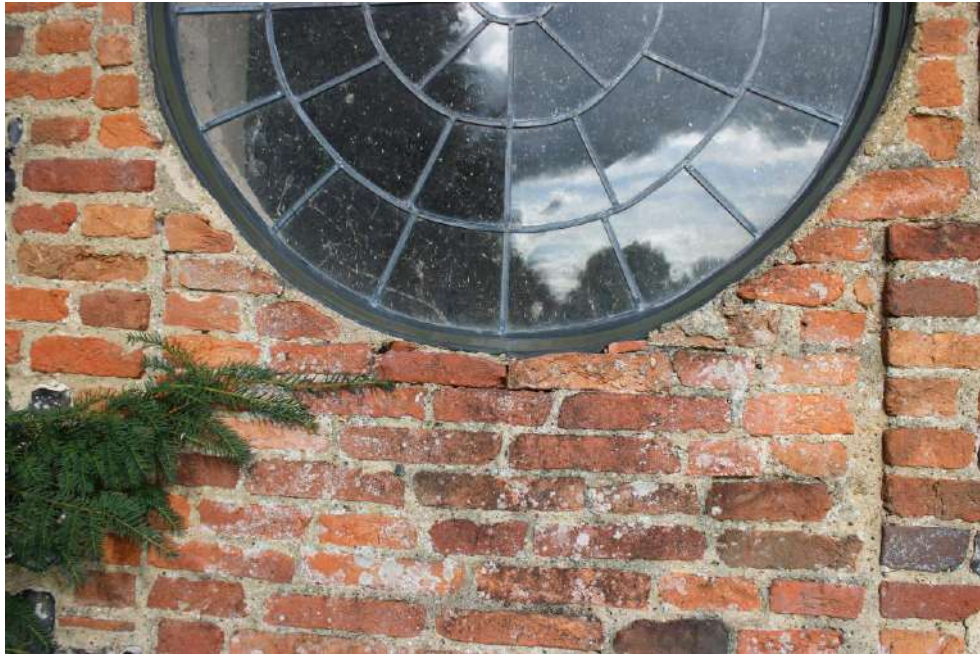
Below the circular window there was some mortar loss, Fig. 4.17.

*Fig. 4.17 South elevation – mortar loss below window*

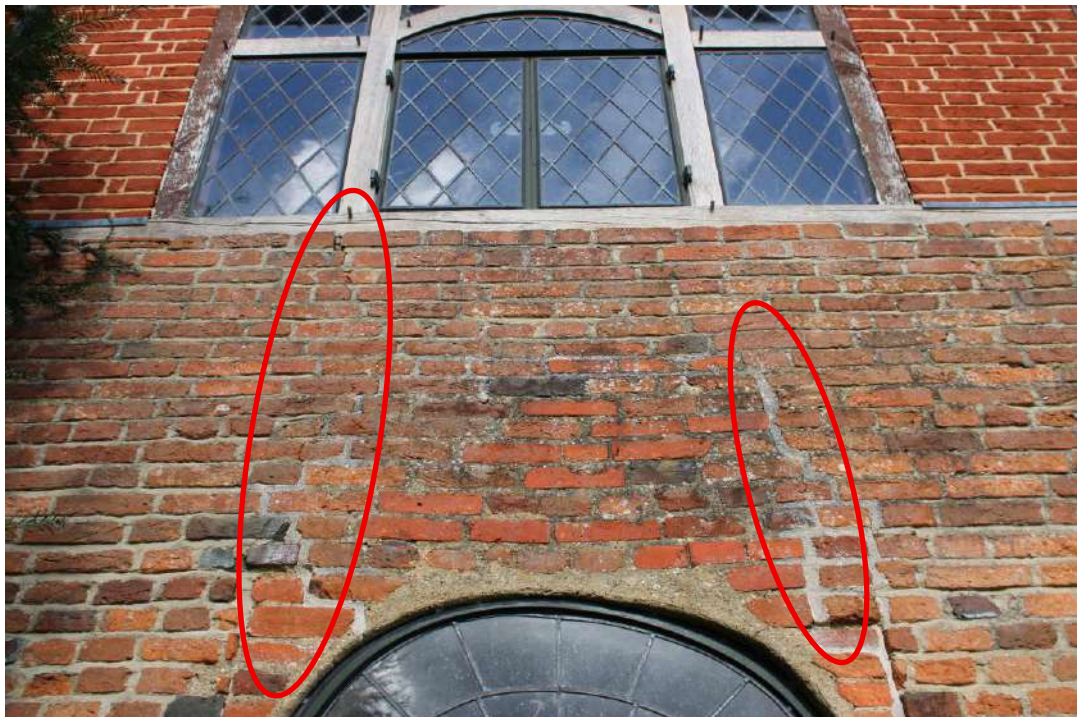
Above the circular window some fine diagonal cracking along areas that have previously been repointed, Fig. 4.18. The top of the circular window is a distorted shape, but this appears historic.

*Fig. 4.18 South elevation – cracking above window*

The deformation above the south circular window appears historic and may have occurred due to previous decay of internal timber lintels which were replaced as part of the 2008 repairs. However, the outer skin of brick is not directly supported by the timber lintels and may rely on the arching action over the window. This may explain the cracking over the windows as any small vertical movement of the arch is likely to result in the form of cracking noted. As this cracking has likely re-occurred since the 2008 repairs, it is recommended that the brickwork is strengthened over the circular window. This can be achieved with the addition of stainless steel Helifix Helibars that are inserted into the mortar joints over the window.

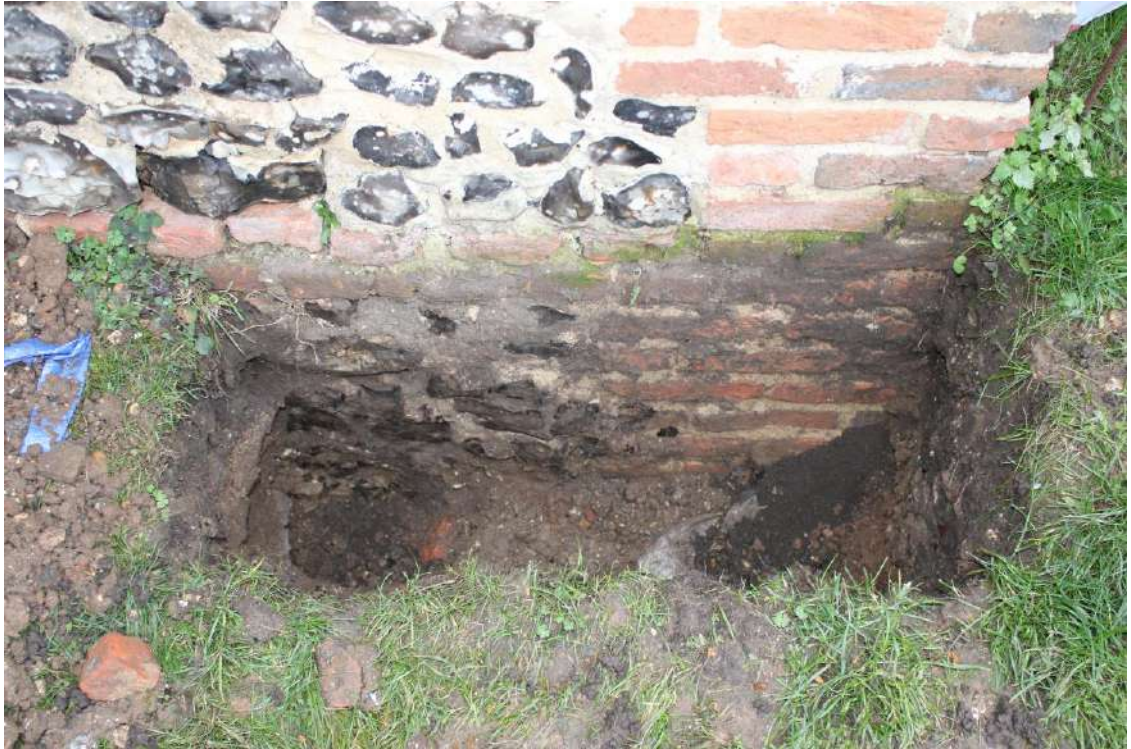
The findings are recorded below and on SFK sketch SK101 in Appendix A. The flint and brick wall continued below ground level at the same width and did not corbel out on the outside face, Fig. 4.20. The main pit was dug to a depth of 550mm below ground level and a smaller area at the west end was dug approximately 150-200mm deeper. By probing in the deeper hole, it was established that the bottom of the wall was founded approximately 800mm below the south elevation ground level. The cracking to the wall at the corner did not extend below ground level. The ground at the founding level was soft brown clay. See Fig.4.21.

*Fig. 4.21 Trial pit looking at south elevation*

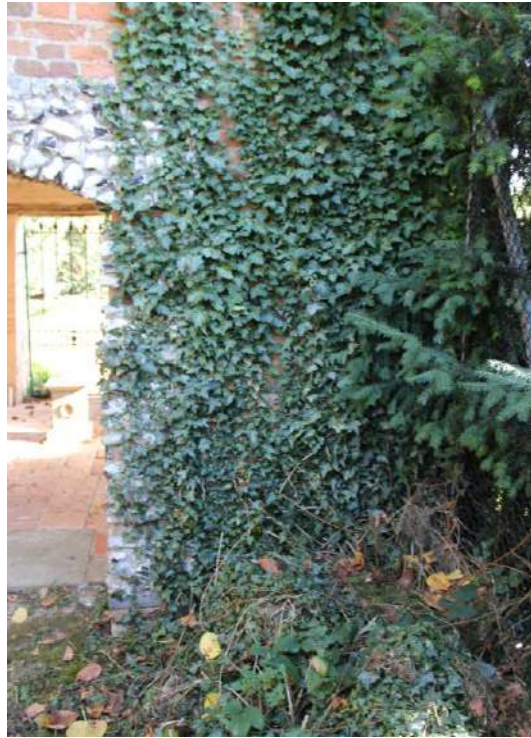
The west elevation was in overall reasonably good condition. The brick condition at the south side was largely obscured due to heavy growth of ivy, Fig. 4.22.

*Fig. 4.22  
West Elevation- ivy  
growth to south side*

For the west elevation the ivy growth to the south side should be carefully removed to allow further inspection of the wall condition. Repointing is required under the wall plate and to the lower part of the wall, north of the gate. At the bottom of the gate on the north side a small local area requires rebuilding in brick and flint. The spalled bricks to the north side (just above top of gate level) should be considered for replacement.

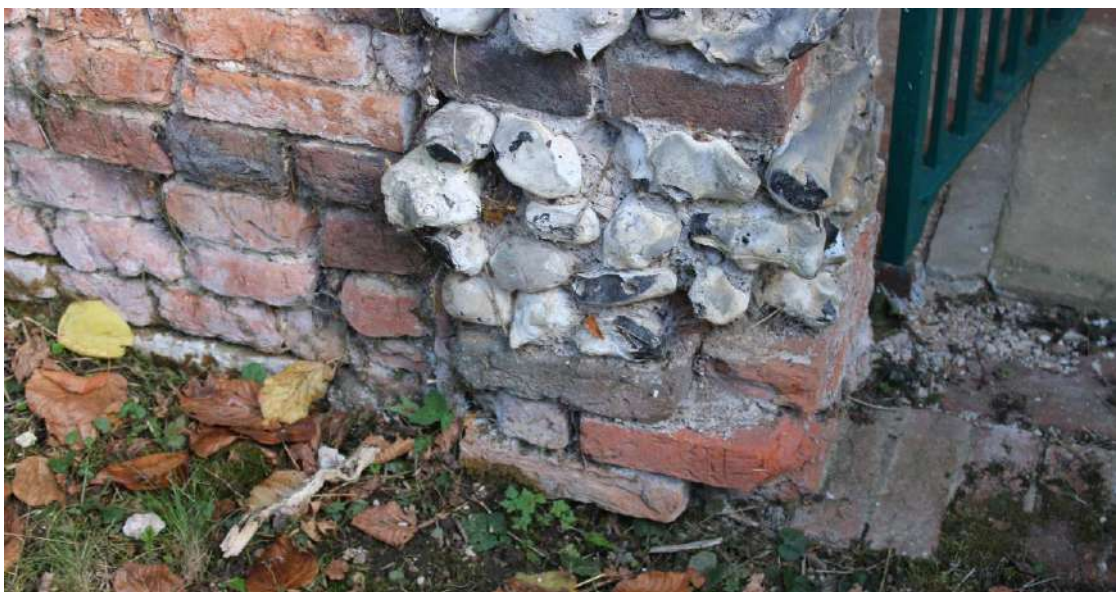
The flintwork and brick surround to the gate opening was in generally good condition except at the bottom on the north side where there were missing bricks and some missing flints, Fig. 4.23.

*Fig. 4.23 West elevation – local brick/loss*

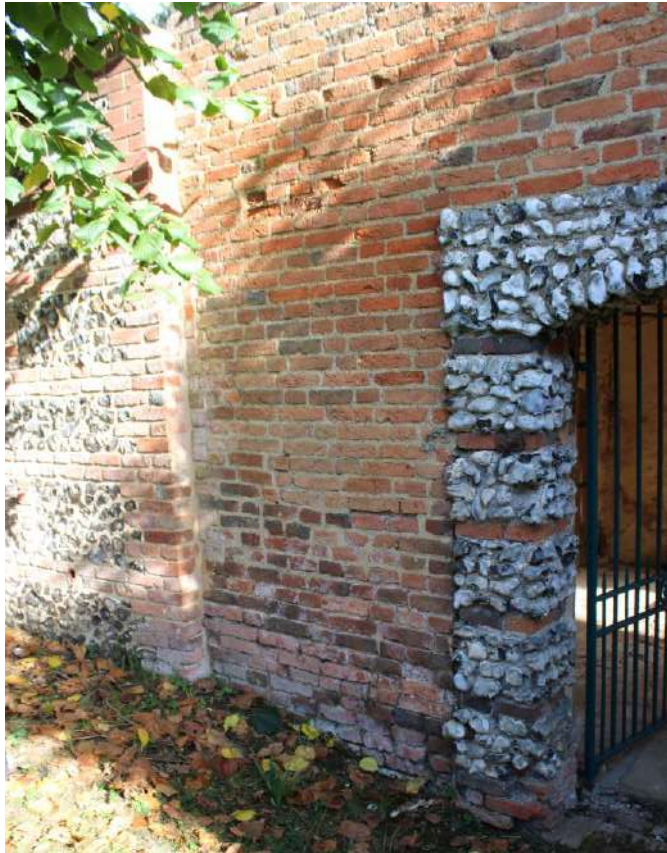
To the wall north of the gate there was general loss of mortar from the joints at the bottom of the wall and there were three or four spalled bricks at higher level, Fig. 4.24.

*Fig. 4.24  
West Elevation- mortar  
loss at bottom of wall  
and spalled bricks at  
higher level*

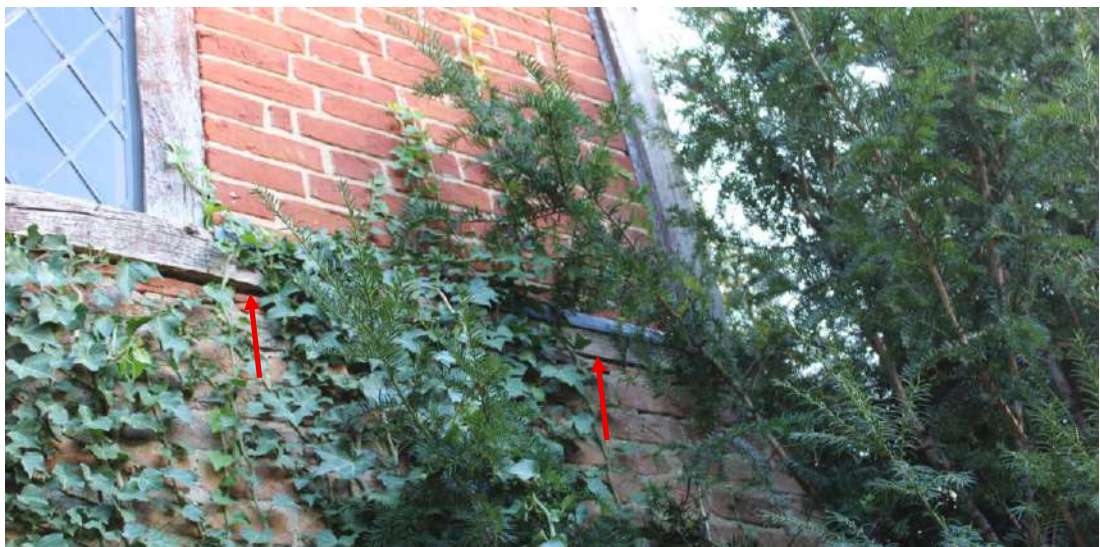
The wall plate had some loss of mortar under the south end, Fig. 4.25.

*Fig. 4.25 West elevation – mortar loss under wall plate*

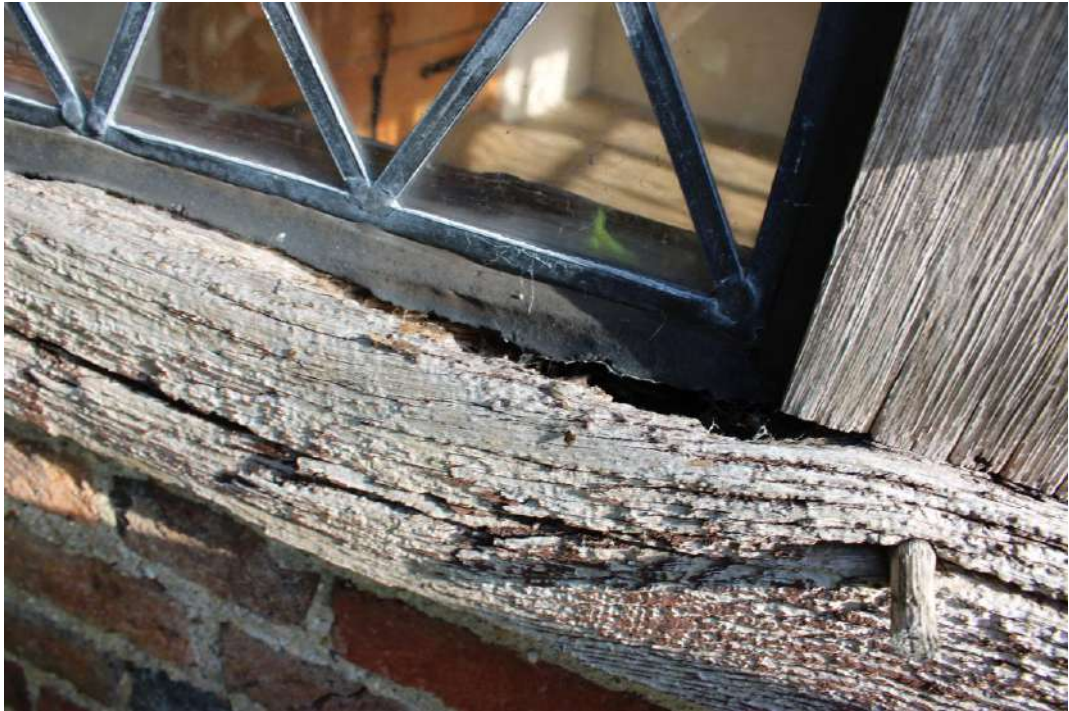
The lead flashing does not continue across the wall plate under the window, and the paint finish has broken down and flaked off. The face of the wall plate has a split along it over the width of the window. Under the north window post the top of the wall plate is significantly decayed (see also section 4.2.2. of the report), Fig. 4.26. The wall plate also appears bowed outwards to the west over the width of the window.

*Fig. 4.26 West elevation – decay and bowing of wall plate*

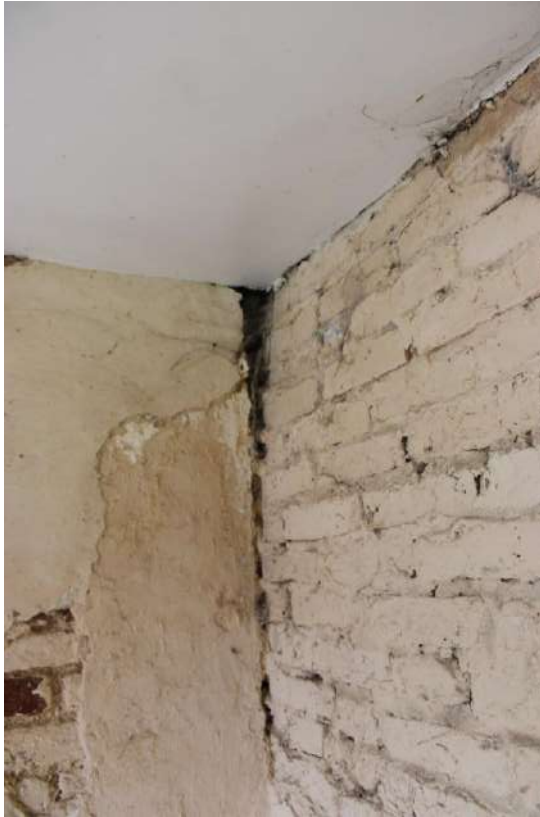
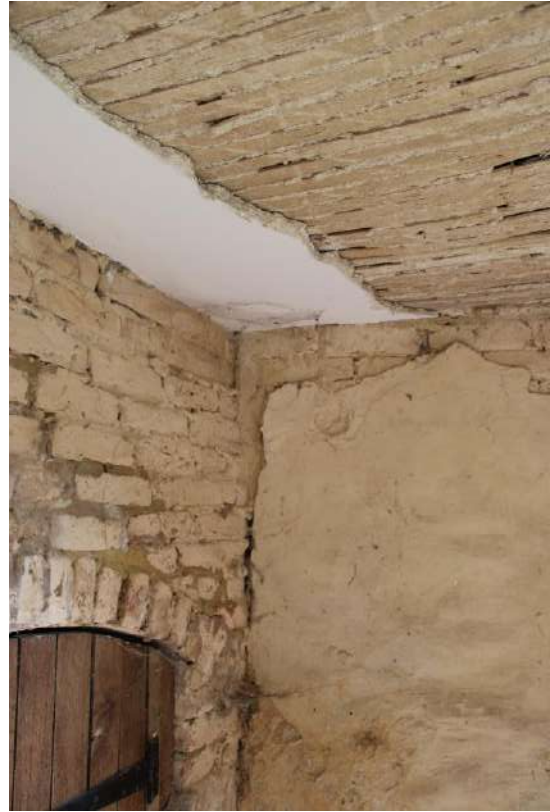
To the northwest corner there is a tapered crack that appears historic, Fig. 4.29. This does not extend through to the outside face. To the northeast corner there may have been a similar crack, but this appears to have been infilled with mortar, Fig. 4.30. Also, in the northeast corner an area of the ceiling plaster has failed, exposing the timber laths.

*Fig. 4.29*  
*Ground floor – northwest corner*  
*cracking*

*Fig. 4.30*  
*Ground floor - northeast corner infill*  
*crack and failed ceiling*

Based on photographs from repair work in 2008, the internal finishes to the ground floor (part plastered and part exposed brick) appear similar to the present condition. The cracking noted (northwest and northeast corners, south elevation below window seat, east elevation) typically appears historic and is not currently of structural concern. The cracks should be repointed with lime mortar and monitored for future movement.

The lath and plaster ceiling has failed in local areas. The ceiling should be checked in more detail by a conservation architect and repaired to their specification.

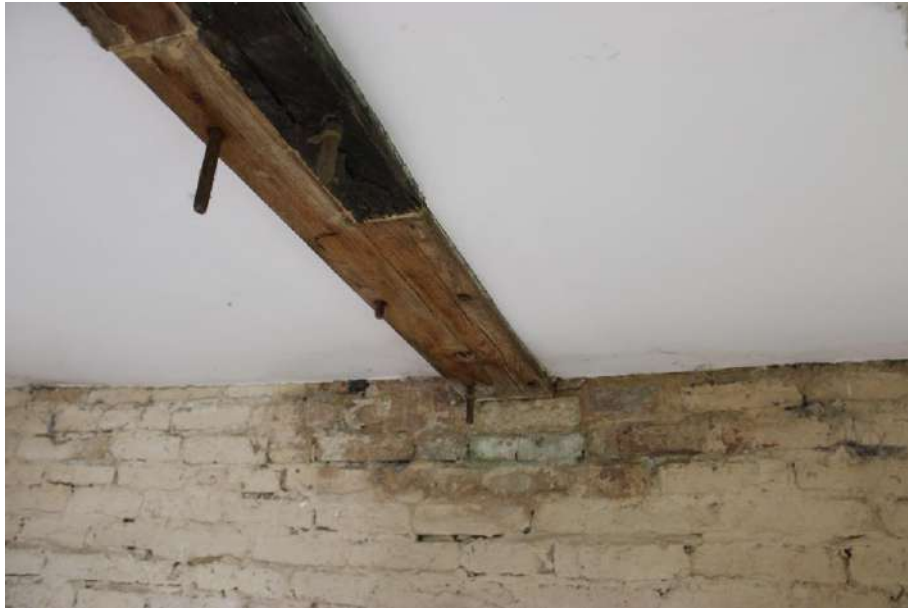
The north end of the main floor beam has clearly had a previous repair, Fig. 4.31.

*Fig. 4.31 Ground floor – previous repair to north end of main beam*

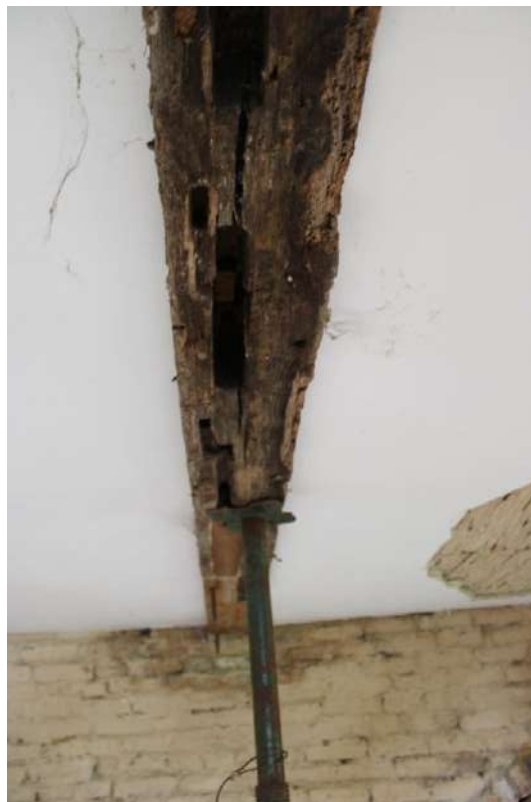
The beam has several deep mortice holes to the soffit, Fig. 4.32, and is likely to have been reused. The beam is currently propped with a single acro prop near midspan. The reason is unclear, but it is assumed there was some concern over the beam, perhaps through excess deflection when subject to public access.

*Fig. 4.32 Mortice holes and prop to main timber floor beam*

Drawing E1280-21 C1 suggests that the main beam is 195mm deep by 180mm wide. Based on this, preliminary calculations using a nominal imposed load of 2.0 kN/m<sup>2</sup> indicates that the bending stress is at its limit, but that deflection would exceed suggested current design code limits by over a factor of 2. It was also noted that the beam has been reused and has significant mortice holes to the soffit along its length. Making an appropriate reduction for this to the beam width leads to a failure in bending stress and deflection exceeding limits by a factor of 3. It is not known why temporary propping has been introduced but based on the preliminary calculations, it is suspected the beam is likely to deflect excessively under imposed load which may cause alarm to users.

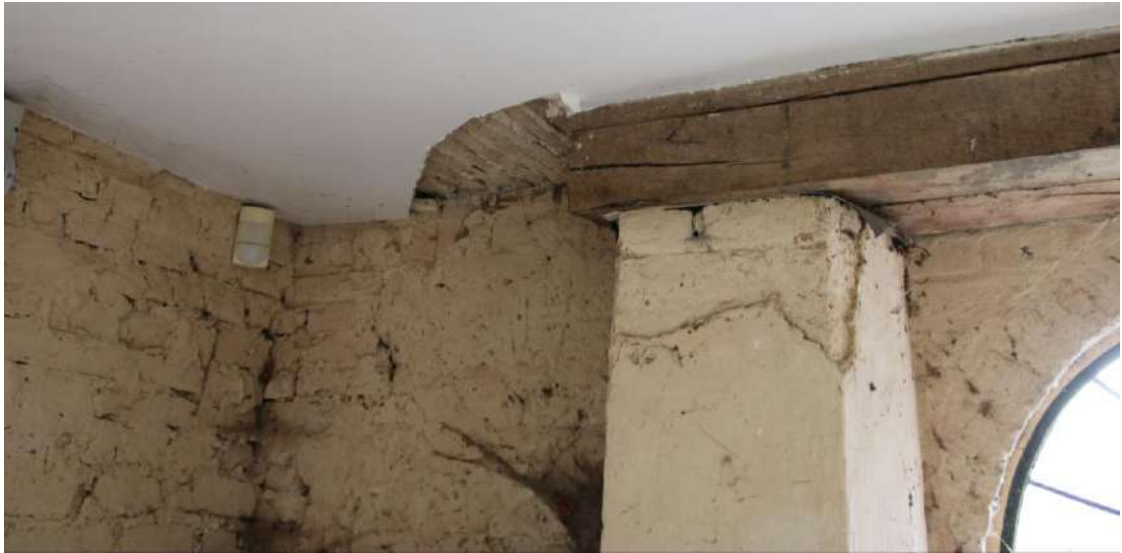
There is some diagonal cracking to the brickwork below the window seat, but this appears historic. The two timber lintels above the window are modern replacements and measured approximately 170mm wide x 120mm deep. The main beam appeared to bear onto both lintels. At the window (1300mm clear), the wall thickness was measured as  $220+360 = 580\text{mm}$  overall approximately. To the east end of the lintels a small area of plaster ceiling has failed, Fig. 4.35.

*Fig. 4.35 Ground floor – south elevation – ceiling loss at east end of lintels*

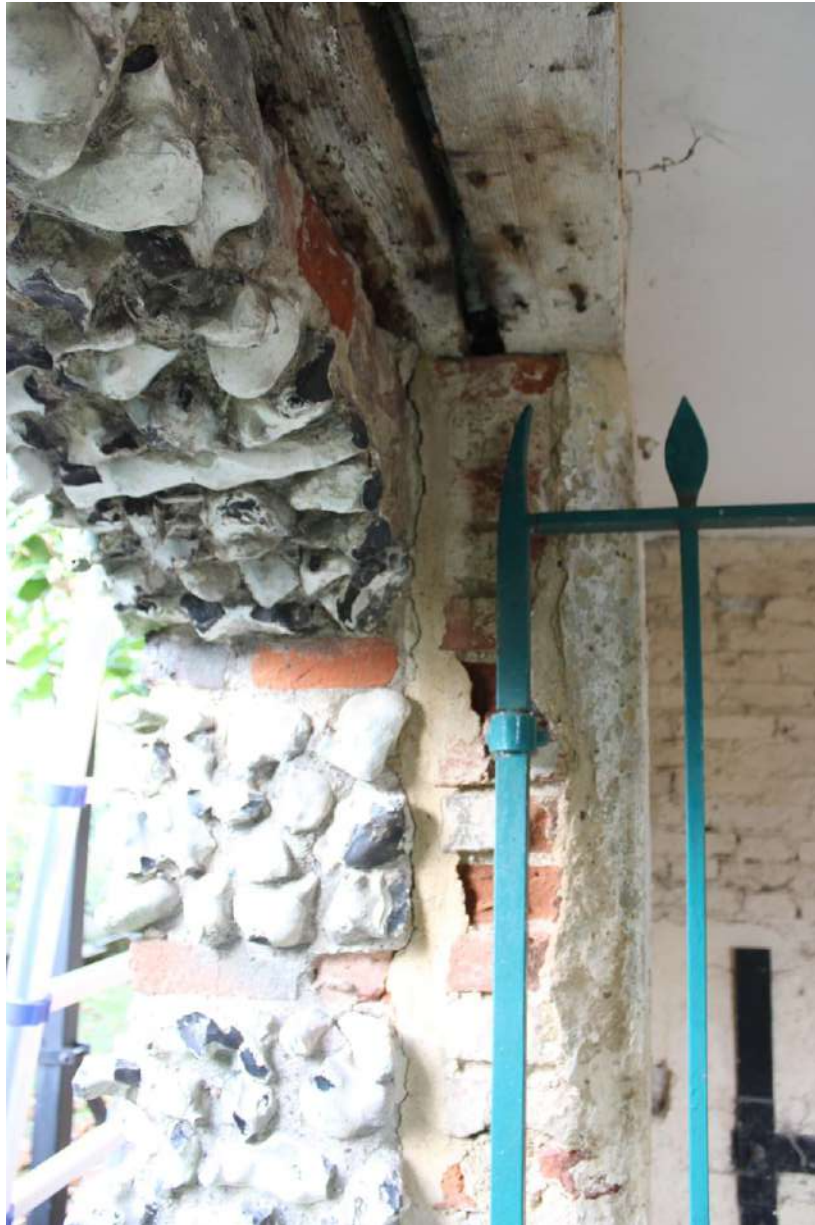
There is some diagonal cracking to the lower brickwork south of the gate, but this appears historic. At the gate, the wall comprises an outer leaf of 300mm flint and an inner leaf of 240mm brick work. At the north side there is some separation cracking between the materials, Fig.4.37. This measured 2mm wide at 1660mm height.

*Fig. 4.37 Ground floor – west elevation at north side of gate opening.*
