**CAVERSHAM COURT GARDENS, GAZEBO**

**STRUCTURAL REPORT**

| SFK Document No: | | 25143/R02 | | |

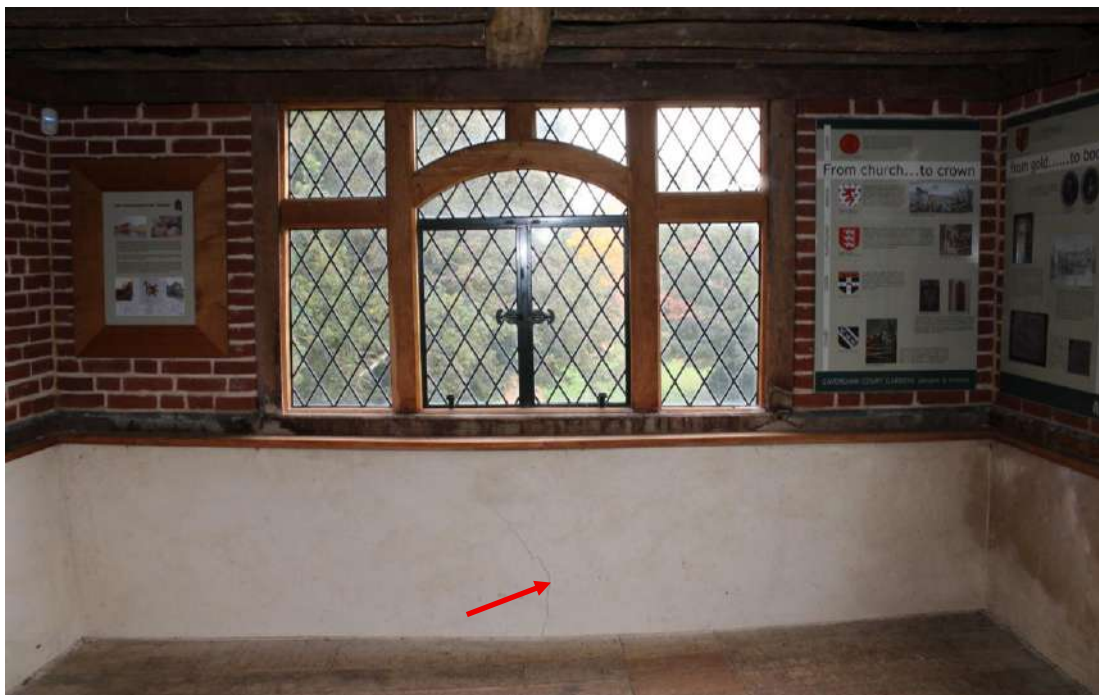
The east elevation is shown in Fig. 4.40. A vertical crack (2-3mm) was noted to the plaster under the middle of the window but otherwise no defects were noted.

*Fig. 4.40 First floor – east elevation*

The isolated cracks to the plaster under the east and south windows are not considered structural. A conservation architect should be consulted on possible repairs.

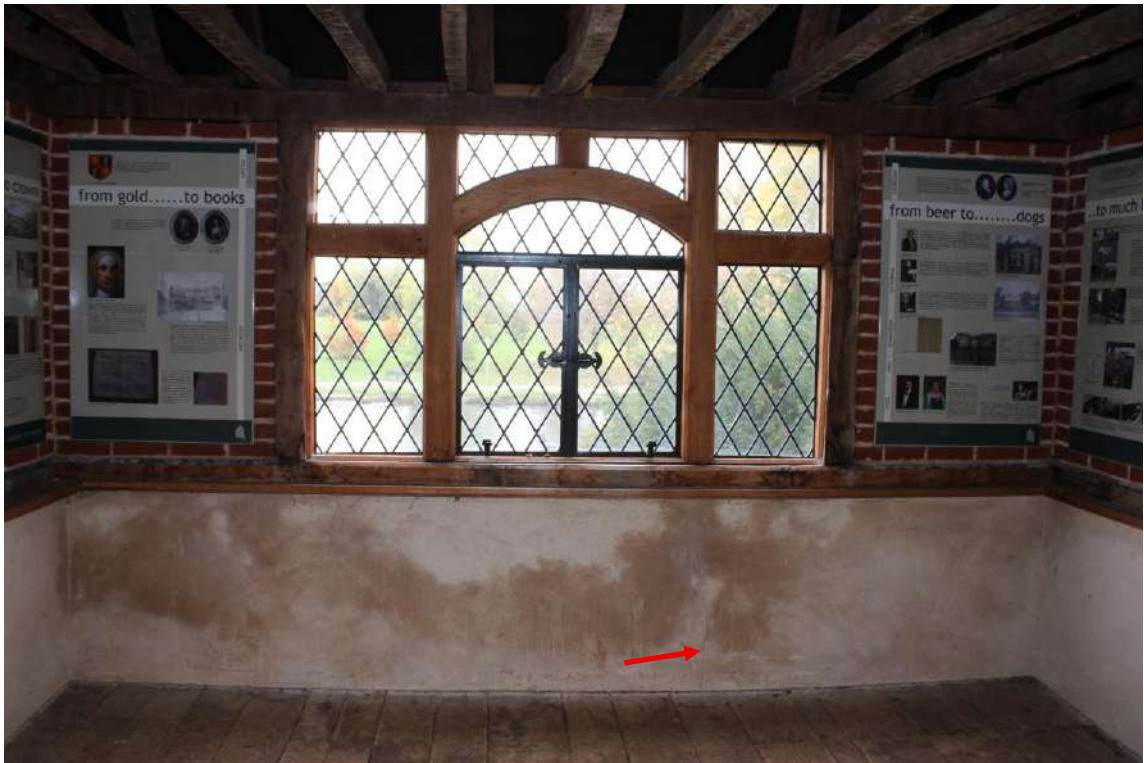
The south elevation is shown in Fig. 4.41. A vertical crack (2mm) was noted to the plaster under the window.

*Fig. 4.41 First floor – south elevation*

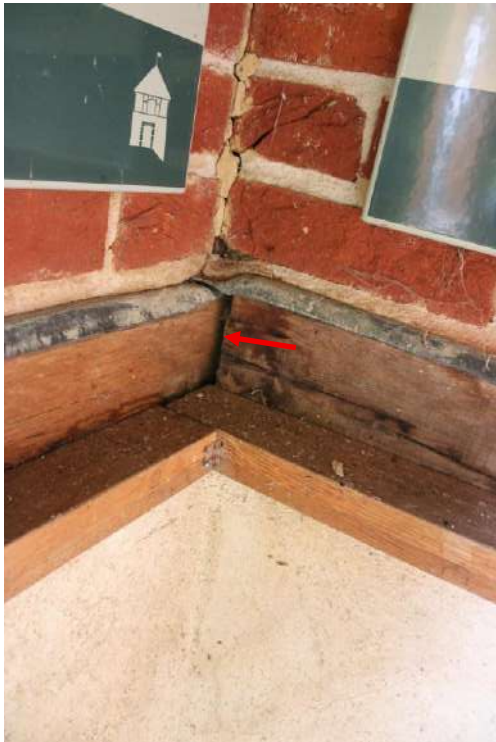
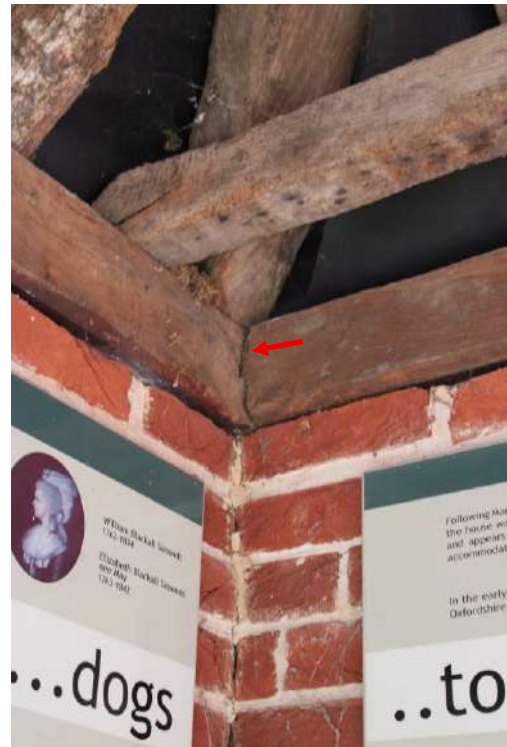
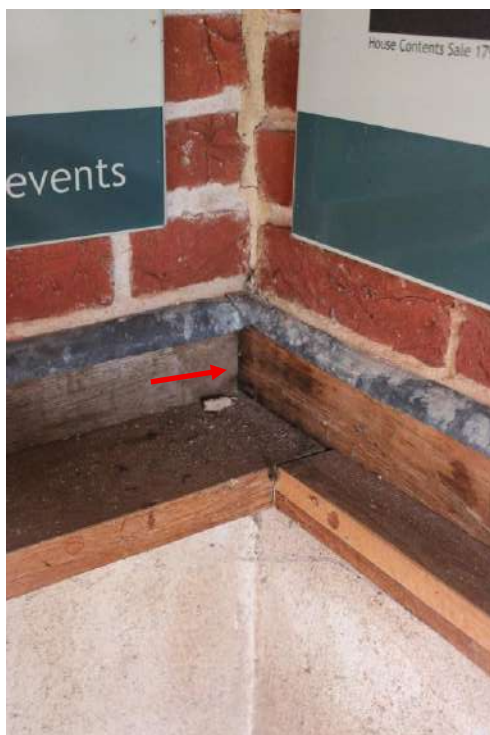
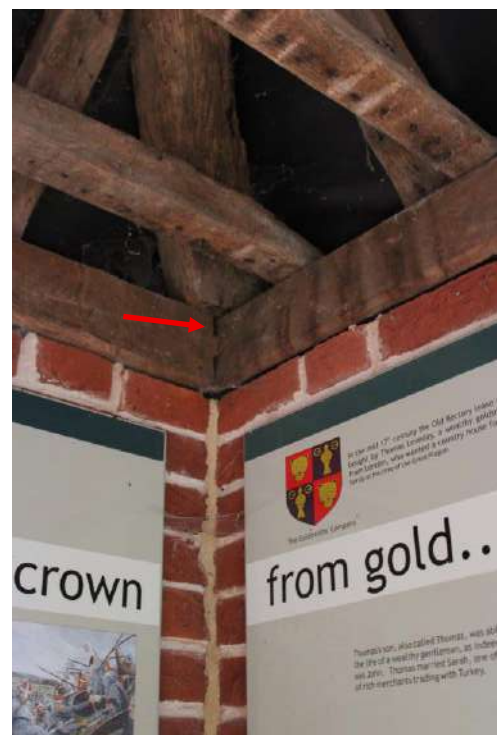
The west and east upper and lower wall plates were noted to have gaps at the ends to the south wall plates – see Fig. 4.42 to 4.45 and Table 4.1 below.

The gaps appear historic rather than recent movement and examining the ceiling joists to central beam joints, Fig. 4.46, did not suggest any recent movement either.

**Fig. 4.42**  
First floor – Southwest corner  
lower wall plate gap

**Fig. 4.43**  
First floor – Southwest corner  
upper wall plate gap

**Fig. 4.44**  
First floor – Southeast corner  
lower wall plate gap

**Fig. 4.45**  
First floor – Southeast corner  
upper wall plate gap

The gaps noted to the ends of the wall plates to the south elevation are likely to be historic and appear unlikely to be actively moving. These should be monitored for any future movement say every 5 years.

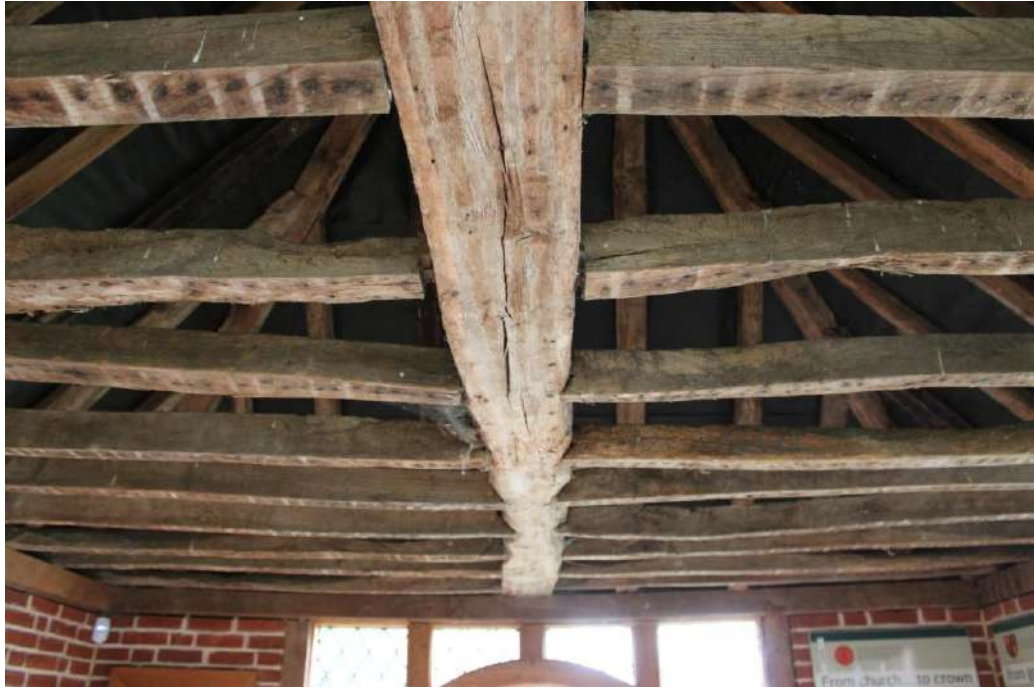
*Fig. 4.46 First floor – central roof beam looking east (south side on the right – joints with ceiling joist do not suggest recent movement)*

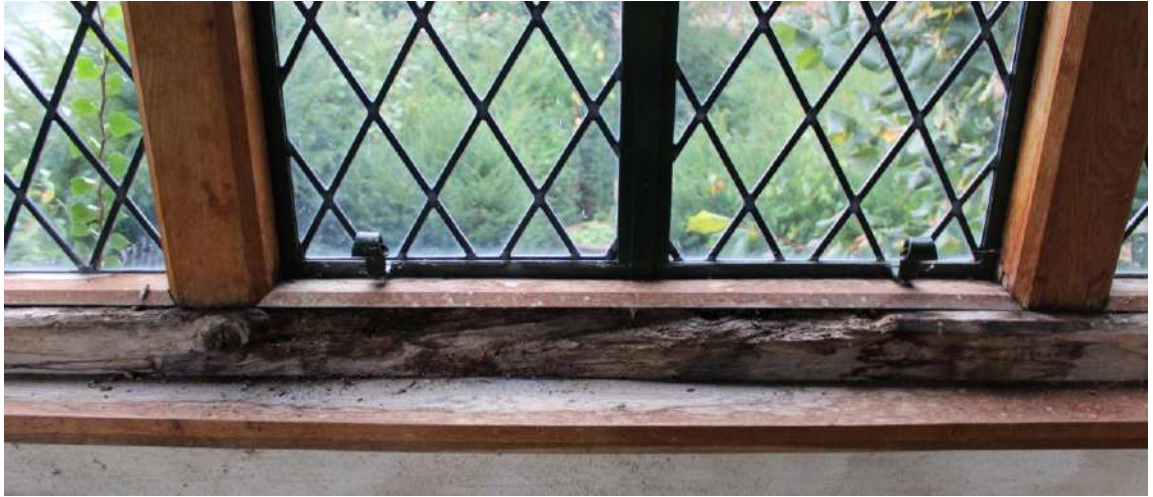
The west elevation is shown in Fig. 4.47. The main defect is extensive decay to the central part of the wall plate under the window, Fig. 4.48.

*Fig. 4.48 First floor – west elevation – decay to wall plate*

The decay to the west elevation wall plate is most likely to the lack of flashing detail across the window sill as previously discussed. The detail requires architectural review, and the decayed plate will require local replacement. Refer to typical repair details in Appendix B.

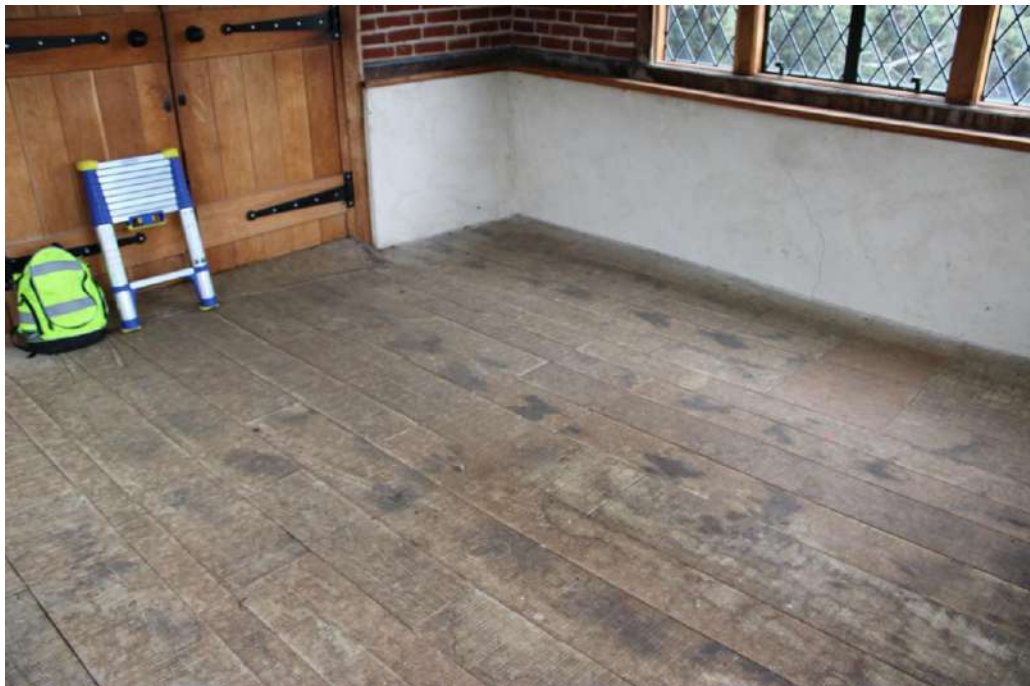
The first floor was noted to be uneven in level. There was a distinct fall to a lower level in the northeast corner, Fig. 4.49. The floor along the west elevation was also bowed, Fig. 4.46. To gauge and record the falls to the floor, measurements were taken with a 1.2m long digital spirit level, and these are recorded on sketch SK102 in Appendix A.

*Fig. 4.49 First floor – fall in level towards northeast corner*
