**CAVERSHAM COURT STABLES, COURTYARD WALL**

**STRUCTURAL REPORT**

| SFK Document No: | | 25143/R01A | | |

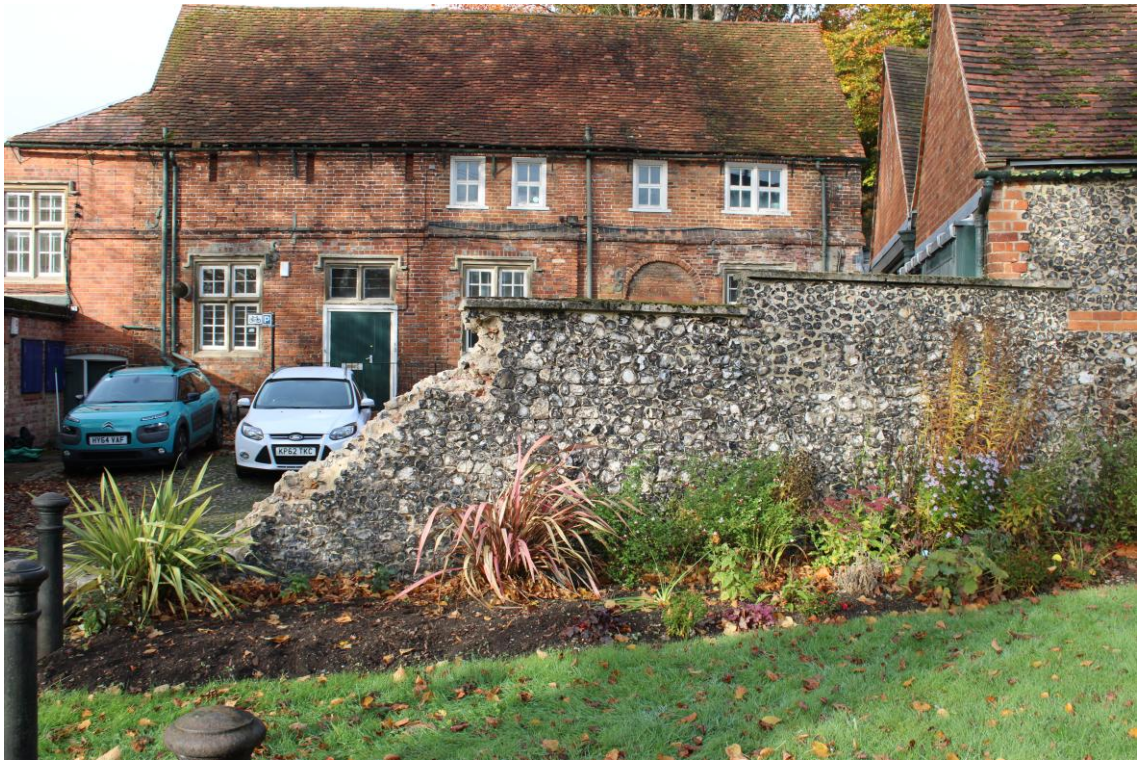
*Fig. 2.2 Courtyard Wall, East elevation, north section (damaged)*

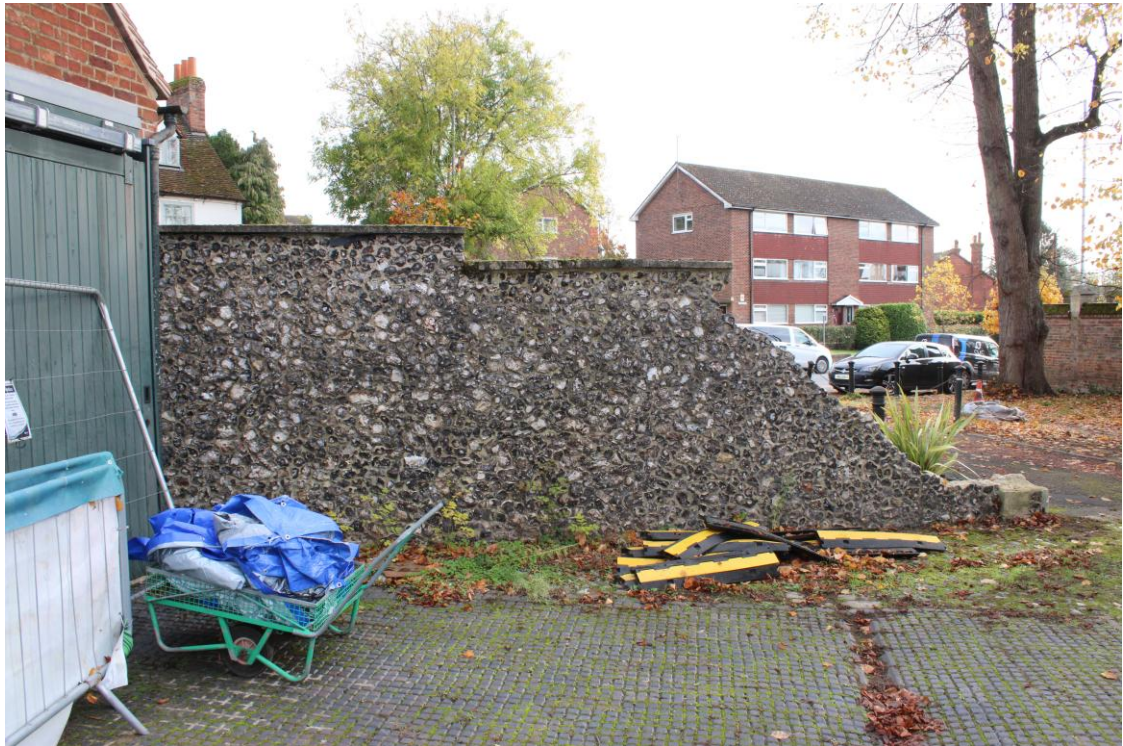
*Fig. 2.4 Courtyard Wall, West elevation, north section (damaged)*

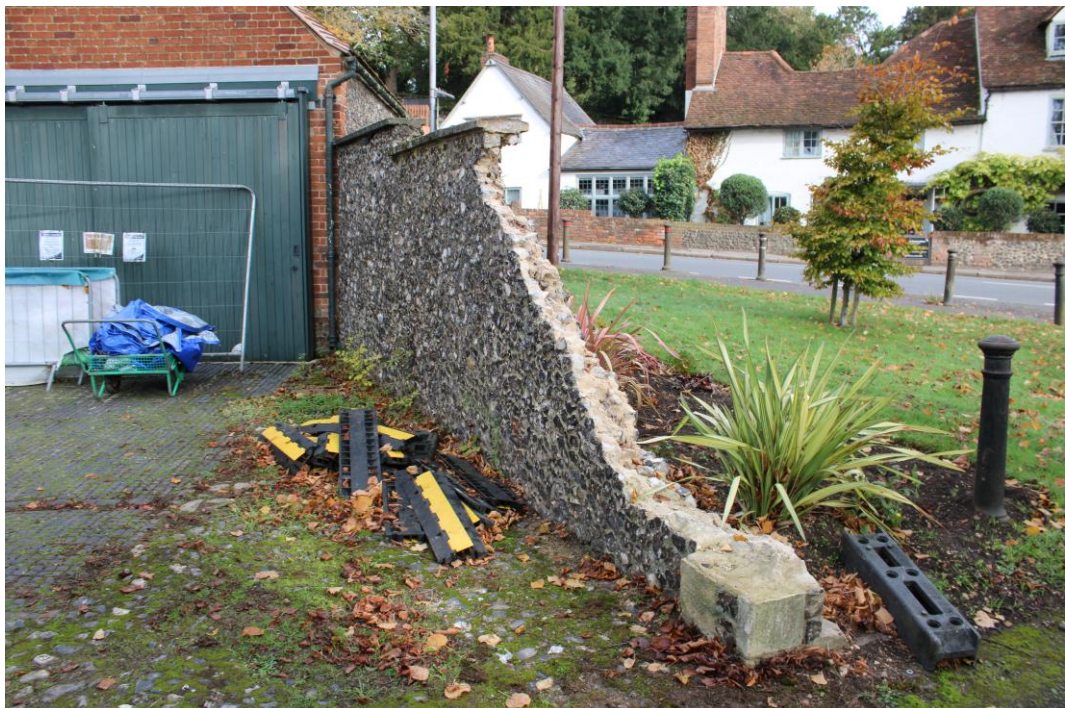
From the refuse lorry impact the north section pier and most of the lower-level length of wall collapsed, Fig. 3.1.

*Fig. 3.1 North wall section damage from vehicle impact*

The Heras fencing and tarpaulin should be reinstated to provide protection from the weather until repairs can be carried out.

The wall needs to be rebuilt to match the original geometry, and this is indicated in the Appendix A drawings based on measurements of the wall and also with reference to the south wall.

The wall needs to be rebuilt using the original flint and stone materials as stored in the courtyard. If any stone materials are found to be damaged, they may require local repair or may need to be replaced with matching stone. If any stone items are found to be missing, then these will need to be replaced in matching stone. The flints and

stone need to be set in a lime mortar to match existing. The advice of a conservation architect should be sought for further details of the mortar specification.

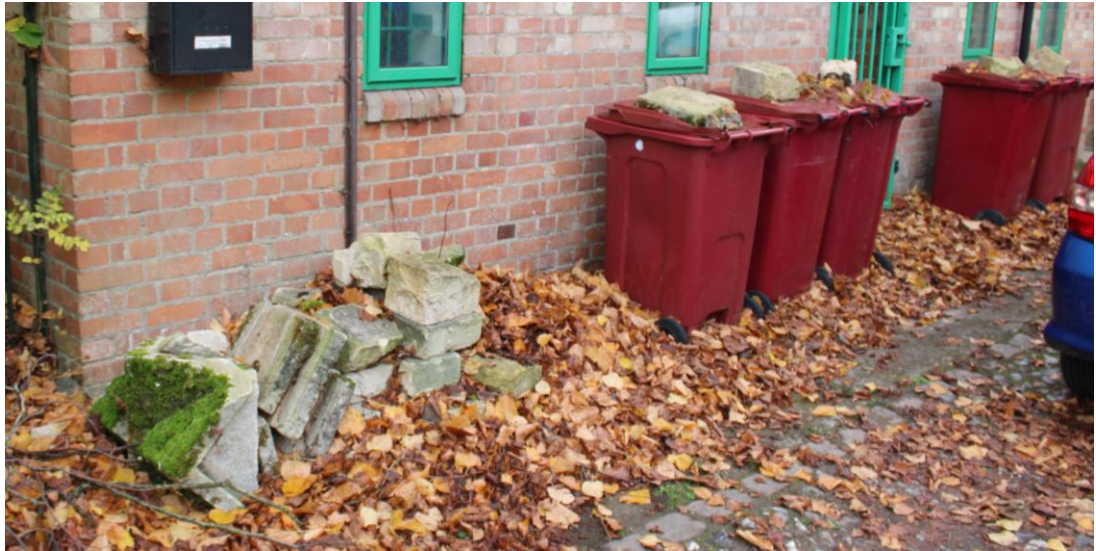
The materials from the collapse have been cleared up and safely stored at the side of the courtyard, Fig. 3.2. This includes flints, stone copings, pier stones and the pier coping. Most of the materials appeared undamaged and should be able to be reused but full inspection was not possible, and it is not known if any original materials are missing. Flints are stored in wheelie bins.

*Fig. 3.2 Storage of materials from damaged wall*

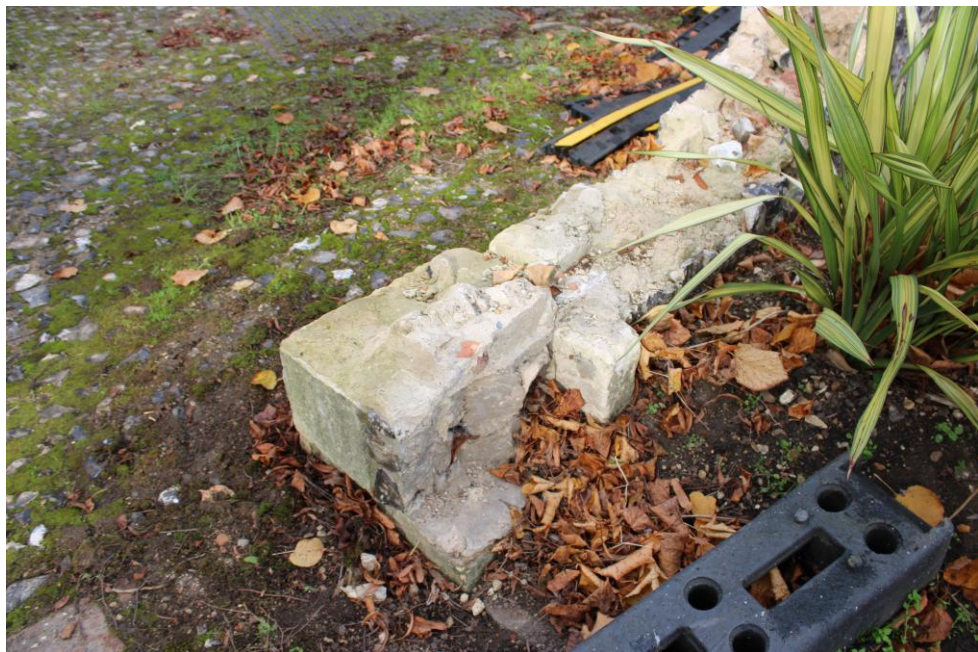
The foundations to the wall appear undisturbed with about 300mm height of pier/wall remaining at the lowest point, Fig. 3.3.

*Fig. 3.3 Remaining pier and wall at lowest point*

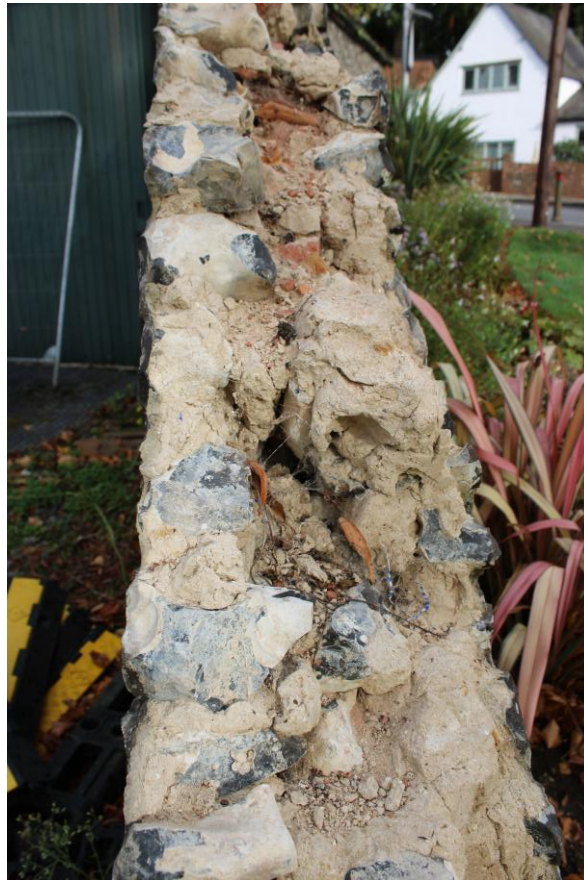
The wall varies in width from 320mm at the bottom to 250mm at the top. The wall is flint through its full thickness, but occasional pieces of brick were noted in the centre of the cross section, Fig. 3.4.

*Fig. 3.4 Close up of wall construction through width*

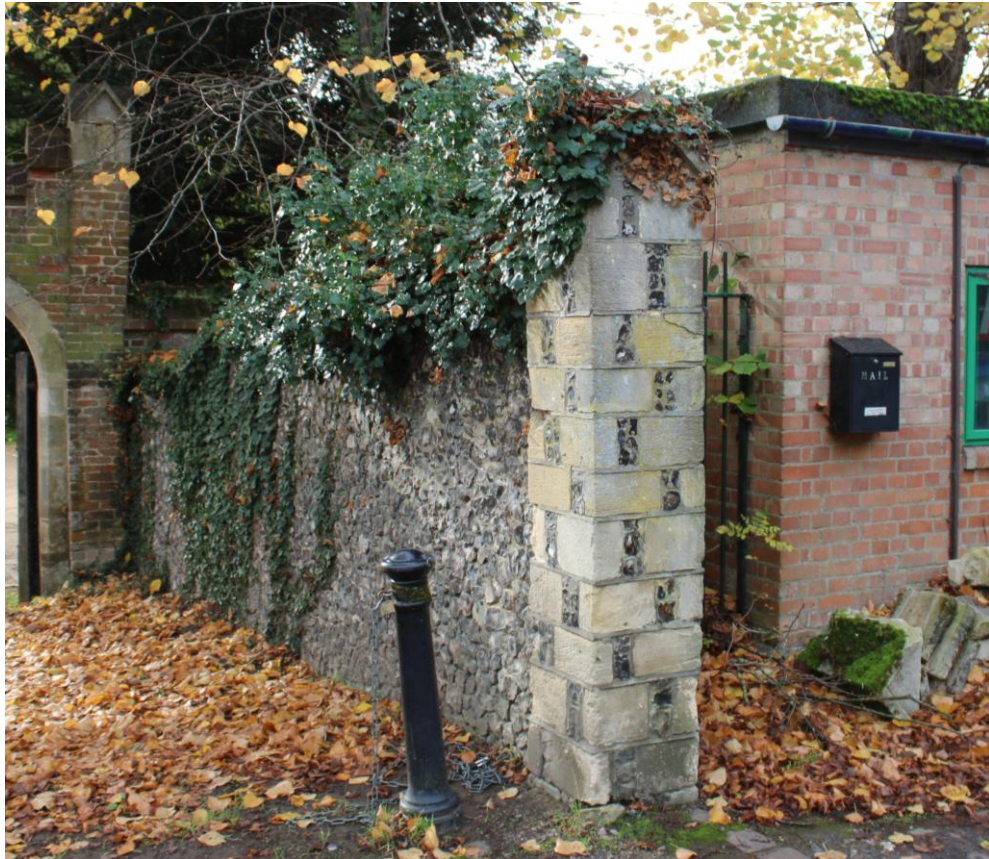
The south section of wall (Fig. 3.6) is in generally reasonable condition, but some mortar loss was noted to the east face. The west face was not inspected. There is significant ivy growth to the top and part of the east face.

*Fig. 3.6 South section of wall showing general condition of east elevation*

For the south wall the ivy should be carefully removed as it has the potential to damage the wall. The west elevation should be inspected for any defects. The wall should be considered for repointing with a lime-based mortar to match the mortar used for the north wall repairs.

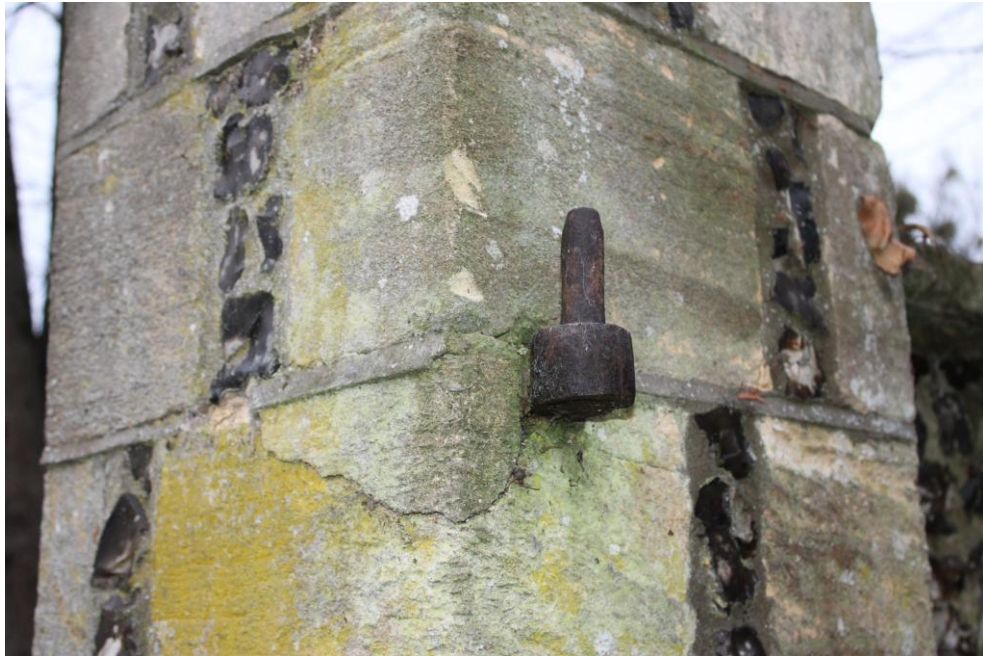
It was noted that the south pier has metal upper and lower gate pins built into the stonework, Fig. 3.7, 3.8. The upper gate pin has some cracking to the stonework around the pin.

*Fig. 3.7 South wall pier – upper gate pin*

To the south pier there was some cracking around the upper gate pin. This could be because of expansive corrosion of the fixing or the heavy weight of a previous gate acting on the fixing, or a combination of both. To the north pier the upper gate pin should be reinstated as part of the rebuilding of the pier. It is not known if the original pin was salvaged from the rubble, but if so then it can be reused. If not, then a new gate pin to match the south pin would need to be fabricated and installed.

It is understood there are no current proposals to introduce new gates. On this basis no repairs are proposed to the south pier upper hinge stonework. If new gates are proposed in the future, then it is essential that the gate pin fixings are reviewed for their capacity and condition as repairs may be required. Further, as the south pier upper gate pin has some cracking that could indicate the fixing may not have been adequate for the gate weight, then either lighter gates or gates supported by ground wheels may need to be considered.

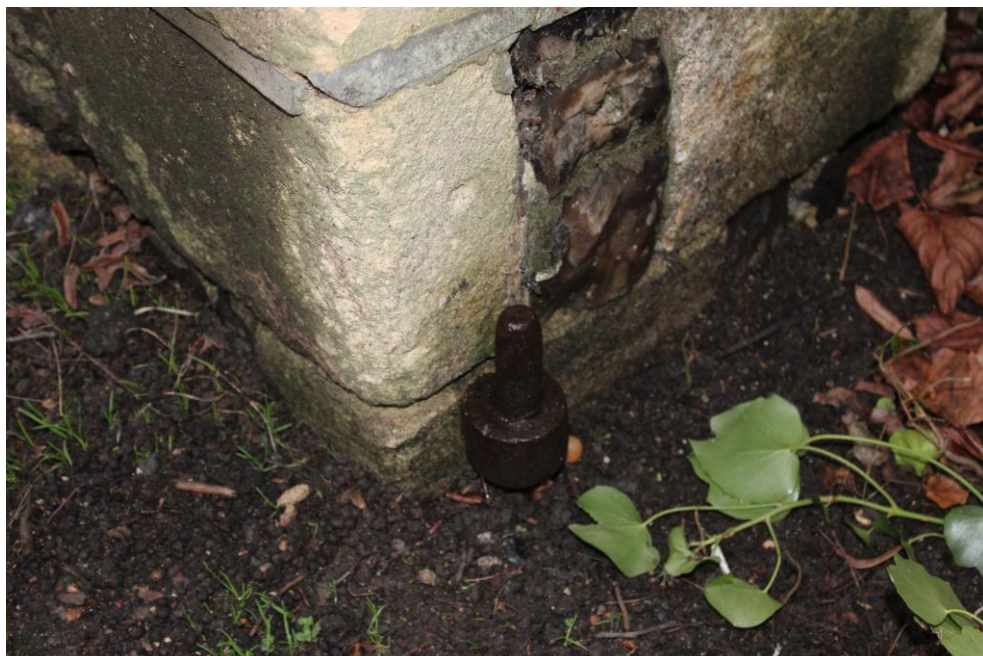
*Fig. 3.8 South wall pier – lower gate pin*

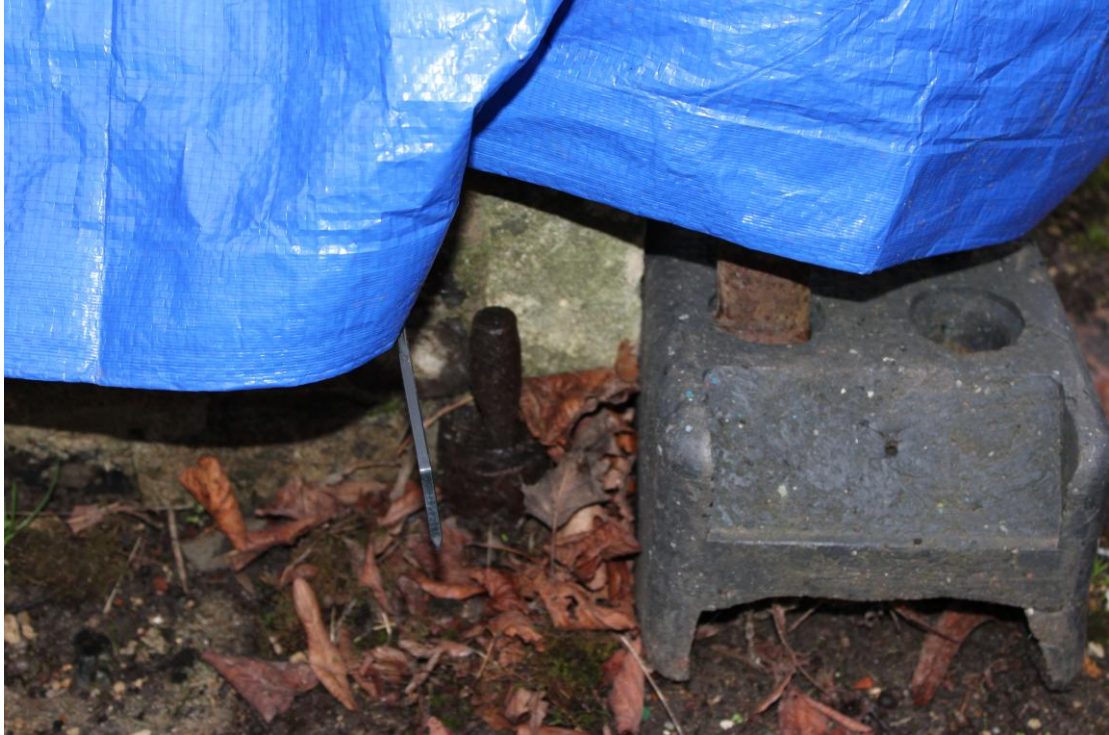
The bottom of the north pier remains after the vehicle impact, and the lower built-in gate pin also remains, Fig. 3.9. The upper part of the north wall pier collapsed and so the gate pin is not currently in place.

*Fig. 3.8 North wall pier – lower gate pin*
