## CAVERSHAM COURT GARDENS, CAUSEWAY

### STRUCTURAL REPORT

| SFK Document No: | | 25143/R03 | | |

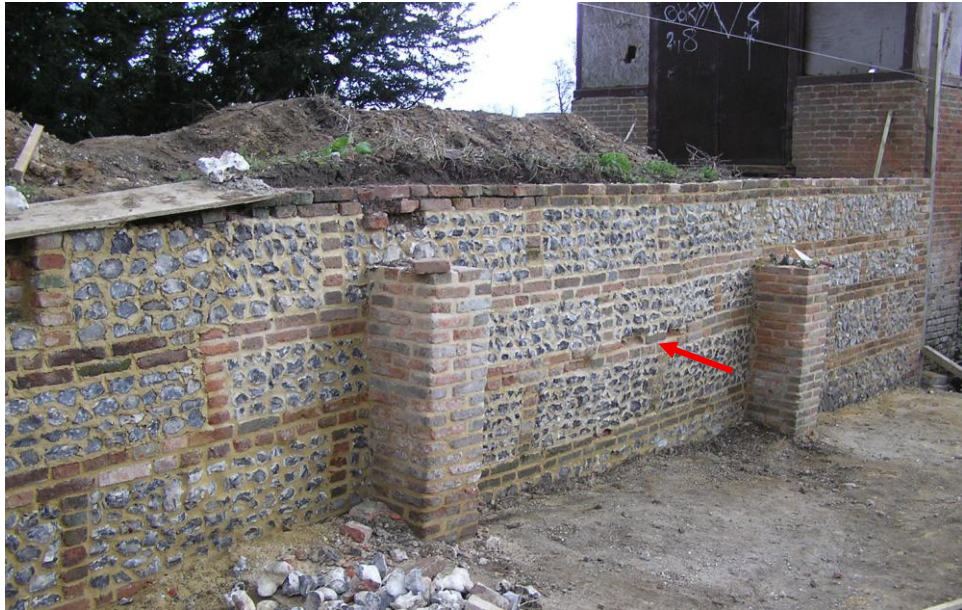
From the photos it is noted that the repaired west wall was left with an existing bulge in Bay 2 as shown in Fig. 3.11 and 3.12.

*Fig. 3.11 Causeway, west wall at south end, bulge in repaired Bay 2 in 2008*

For Bay 2 the 2008 photographs show that at the time of repairs the wall was left with a large bulge. It is assumed this was left to retain original materials and minimise intervention. With the additional strengthening and tying of the piers and the possible introduction of Helifix Helibars to the brick bands, it is assumed this was considered to provide sufficient strength to the wall to prevent any further movement.

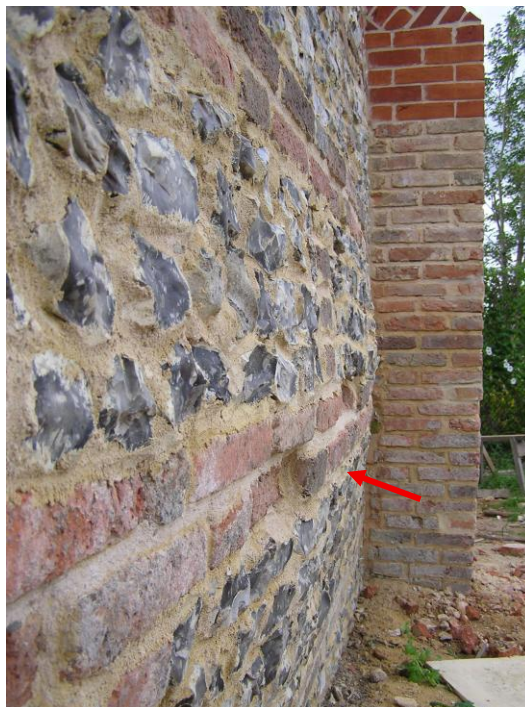
*Fig. 3.12 Causeway, west wall at south end, bulge in repaired Bay 2 in 2008*

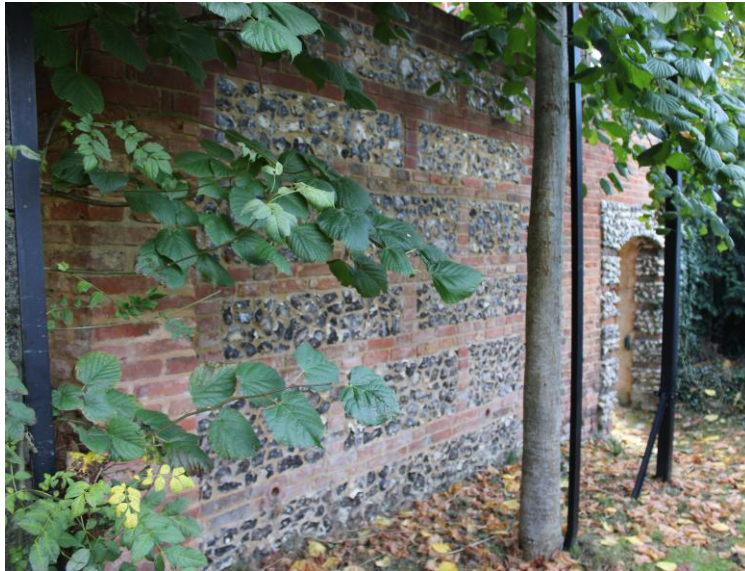
Bay 1 abuts the Gazebo at the south end and has a brick pier at the north end, Fig. 4.1. It comprises horizontal and vertical brick bands with flint infill panels. The bay is in good condition with no signs of movement or cracking.

*Fig. 4.1 West wall Bay 1*

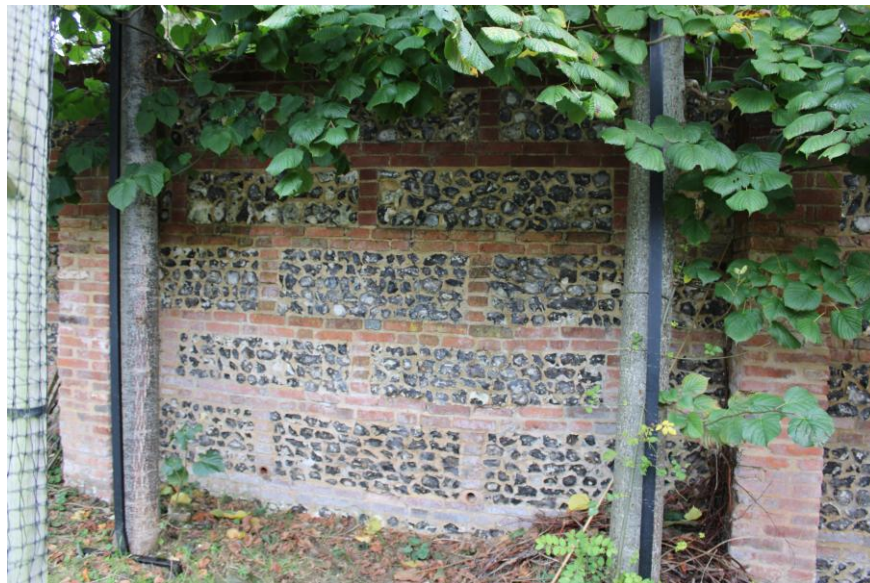
Bay 2 sits between two brick piers and comprises horizontal and vertical brick bands with flint infill panels, Fig. 4.2.

*Fig. 4.2 West wall Bay 2*

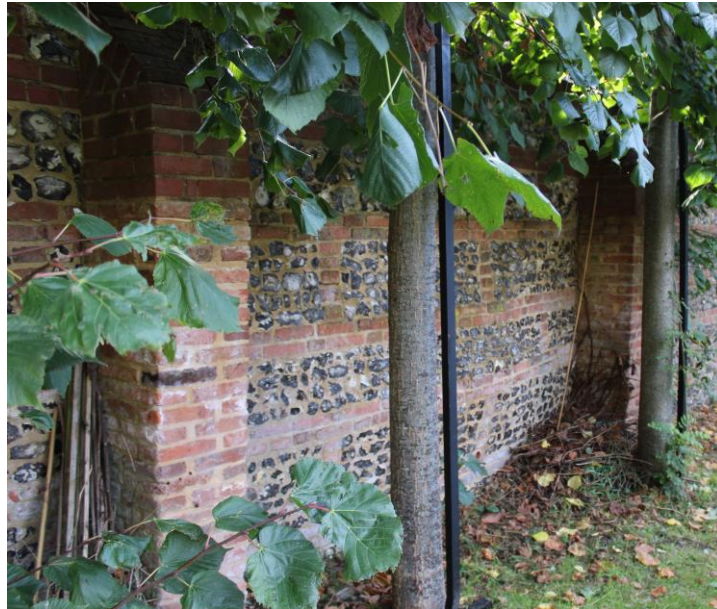
The panel has a significant bulge over an approximate area of 2m wide and 1.5m high, Fig. 4.3 & 4.4. The peak of the bulge is around 900mm above ground level and projects approximately 150mm from the general wall face, Fig. 4.5. Although bulged the flint and brickwork has not spalled. There is some local cracking to the mortar around the flintwork around the peak area of the bulge, Fig. 4.6. The mortar may appear slightly darker in this area which could indicate a degree of dampness.

*Fig. 4.3 West wall Bay 2*

Comparing Fig. 3.11 to Fig.4.3 and Fig. 3.12 to Fig. 4.4 the extent and projection of bulge do appear very similar. However, this is subjective and no measurements are available of the original bulge. The current peak bulge is around 150mm. If the bulge had significantly worsened since 2008, then it would be expected that the flints would have loosened and fallen out. This has not occurred but some cracking around the flints has occurred. This may be due to water ingress through the wall.

It is considered that the west Bay 2 is not at immediate risk of collapse as the bulge has been present since 2008 and has only marginally worsened since then over 18 years. However, it is important that local investigation is carried out together with repairs. The investigations should aim to establish the following.

To carry out this investigation in a practical and safe way it is proposed that the first step would be to add temporary propping in front of the bulged section. This would help stabilise the wall and prevent further loosening of any materials during investigations and repairs. The second step would be to locally excavate by hand to the rear of the wall behind the bulge. This will enable items 1 and 2 above to be established. This also locally relieves the wall of the ground pressure from behind and enables the next step to be carry out more safely. Step 3 would be to carefully remove local flints from the front in the areas of cracked mortar and set them aside for reuse. This will establish the depth of the flintwork (item 3 above) and allow the condition of the brickwork behind to be checked. It is hoped that the extent of repairs required will be limited to locally replacing the original flints in new lime mortar and repointing around the flint and brickwork. However, this can only be confirmed once the investigation work is undertaken. To help improve the bond of the flint with the brick wall, short lengths of Helifix Helibar can, if necessary, be fixed into the brick and bent at 90 degrees to sit within the joints between the flints. A conservation architect's advice should be sought for details of the lime mortar for repairs.

Step 1. Add temporary propping to front of wall at bulge position.

Step 2. Hand excavate behind the wall at the bulge position. Inspect rear condition of wall and determine if additional repairs are required.

Step 3. Carefully remove local flints from the front in the areas of cracked mortar and set them aside for reuse. Inspect and repair.

Step 4. Backfill the excavated material at the rear of the wall.

Step 5. Remove temporary propping to front of wall.

The above repairs should be carried out as soon as possible and within one year. Following repair, the wall should be inspected for its condition at regular intervals not exceeding five years.

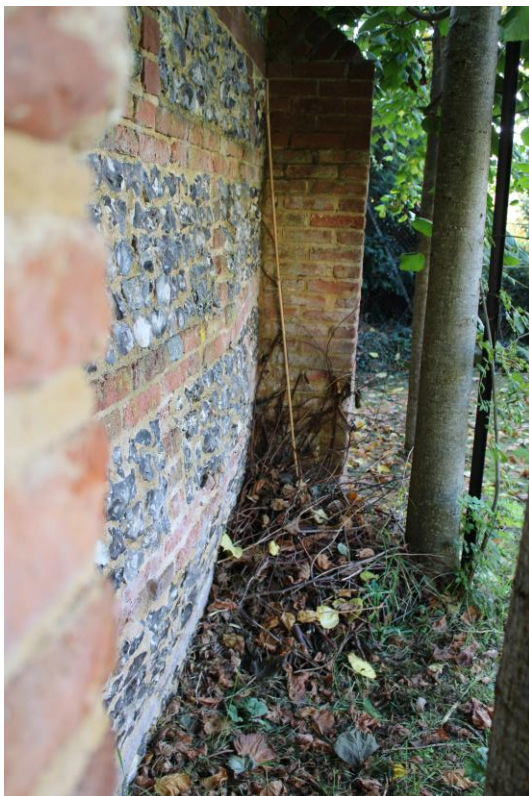
*Fig. 4.4 West wall Bay 2  
looking south along wall to  
highlight bulge*

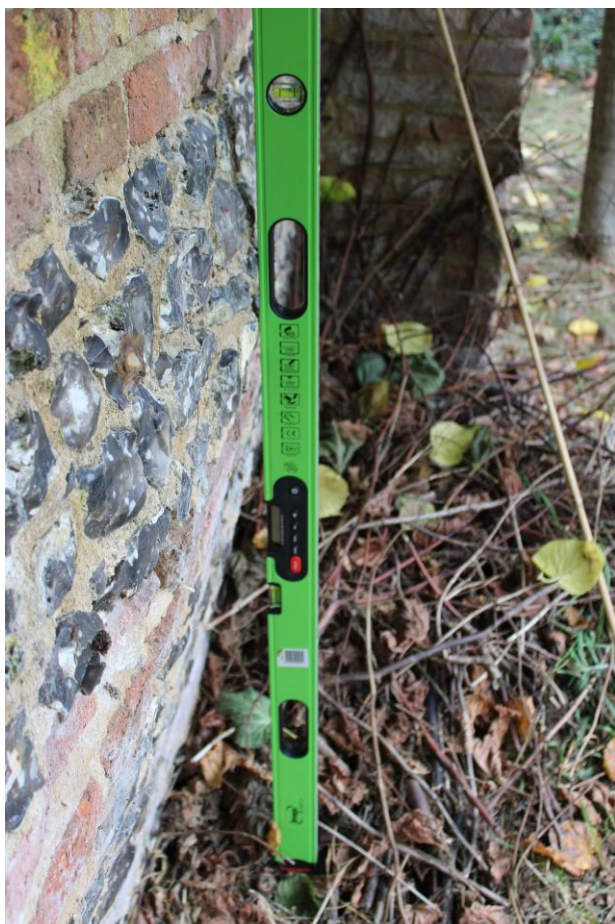
*Fig. 4.5 West wall Bay 2  
bulge projects approx.  
150mm at peak*

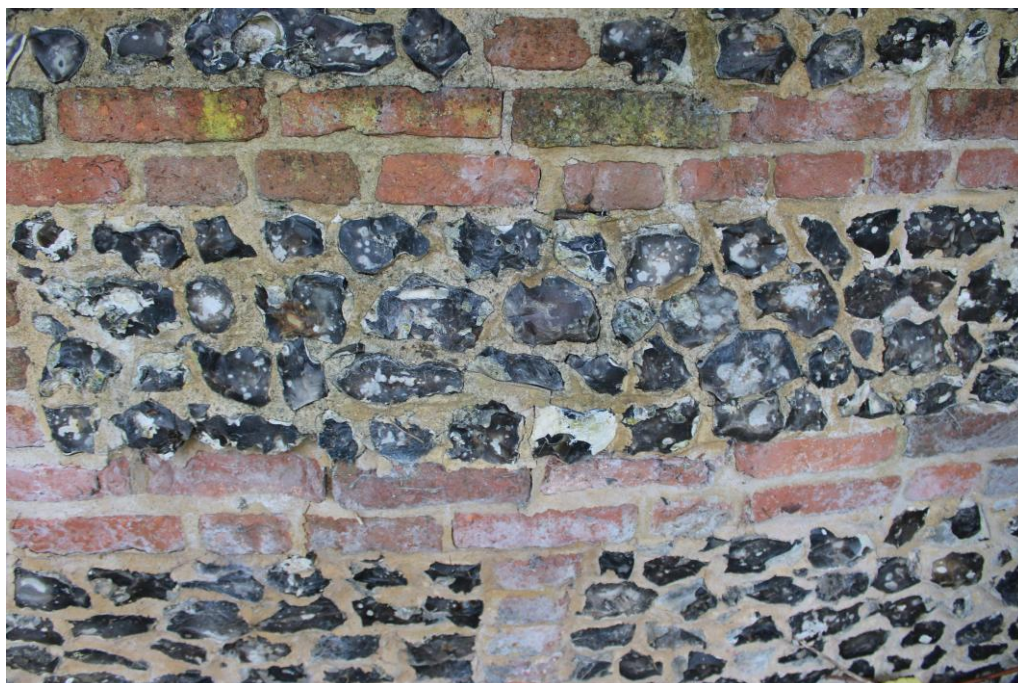
*Fig. 4.6 West wall Bay 2 – local mortar cracking at peak of bulge*

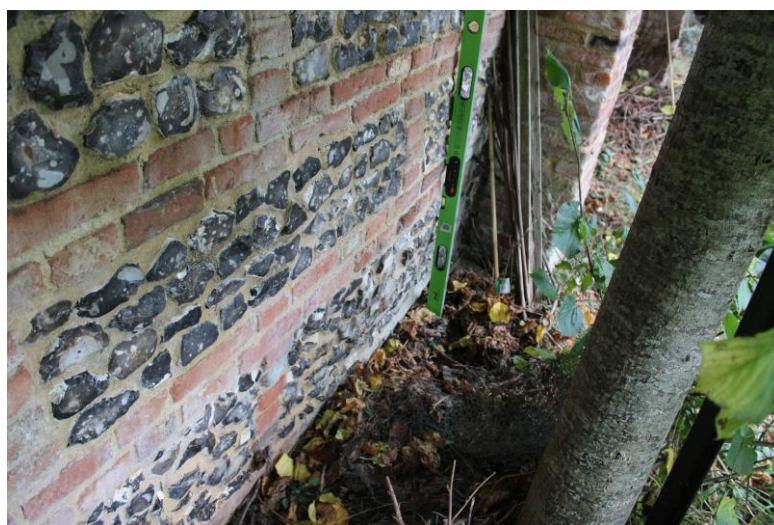
The panel has a small area of bulging in the bottom right-hand corner. There is no cracking to the mortar and no loose material. The projection of the bulge is approximately 50mm, Fig. 4.8. Other than this defect the panel is in generally good condition.

*Fig. 4.8 West wall Bay 3 – small local bulge at bottom right hand corner*

Two further bulges were noted but these were much smaller, near the bottom of the wall and adjacent to the brick piers. Studying the 2008 photo suggests these were

probably present at that time. There is no cracking of the mortar at these locations. No action is recommended to these areas, other than regular inspection as noted above.

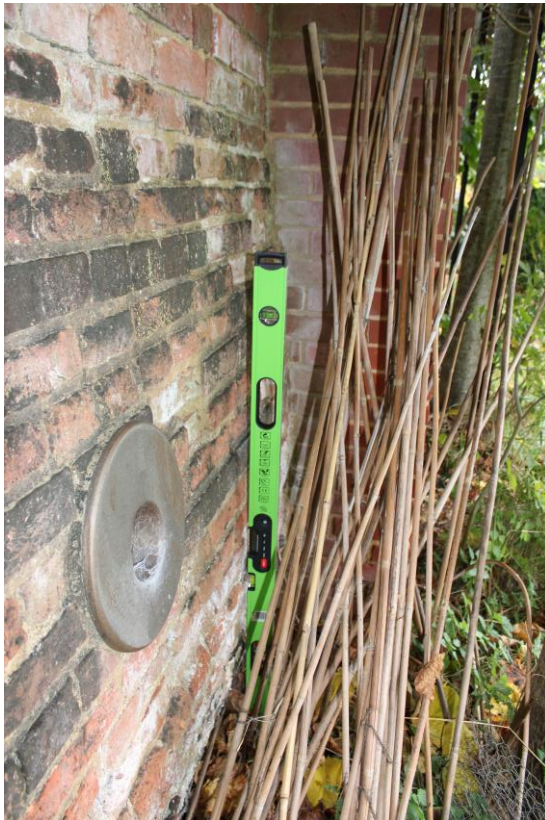
The wall north of Bay 3 was generally in good condition. Just north of pier 3 to Bay 3 is a series of four ground anchors through the wall which is mainly brick with flint banding at the bottom, Fig. 4.9. Adjacent to the first anchor there was a very small area of local bulge projecting approximately 50mm, Fig. 4.10.

*Fig. 4.10 West wall just north of pier 3 (to Bay 3) – small local bulge*

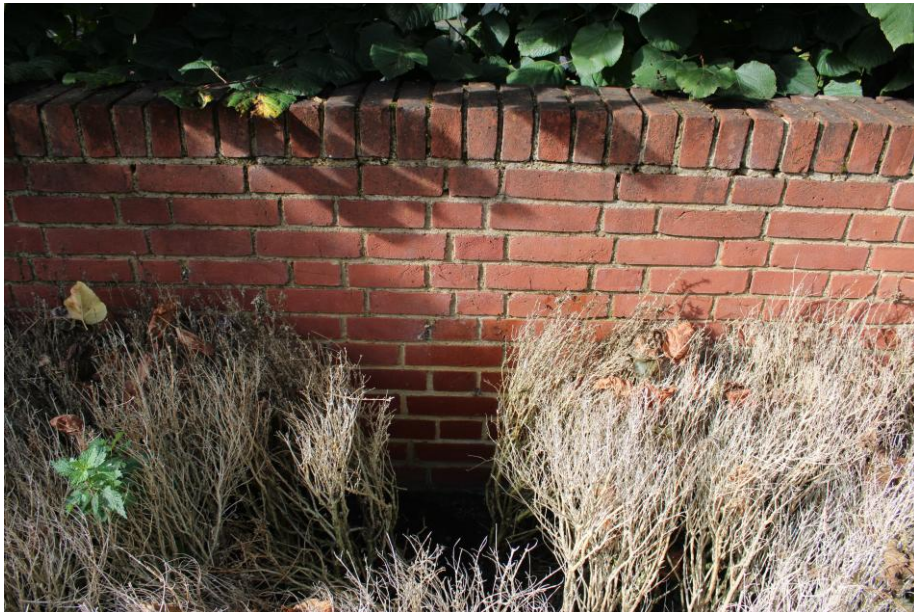
On the west side to Bay 2 (with the large bulge) the parapet, planting bed and path were inspected, Fig. 4.11. There was no indication of movement to the parapet and no sign of movement or depression in the soil or path surface.

*Fig. 4.11 West wall parapet and planting bed at Bay 2 from walkway level*
