01 SOUTH ELEVATION: Repairs  
1:50

| Caversham Court | | |
| North Boundary Wall<br>Buttress as Proposed | | |

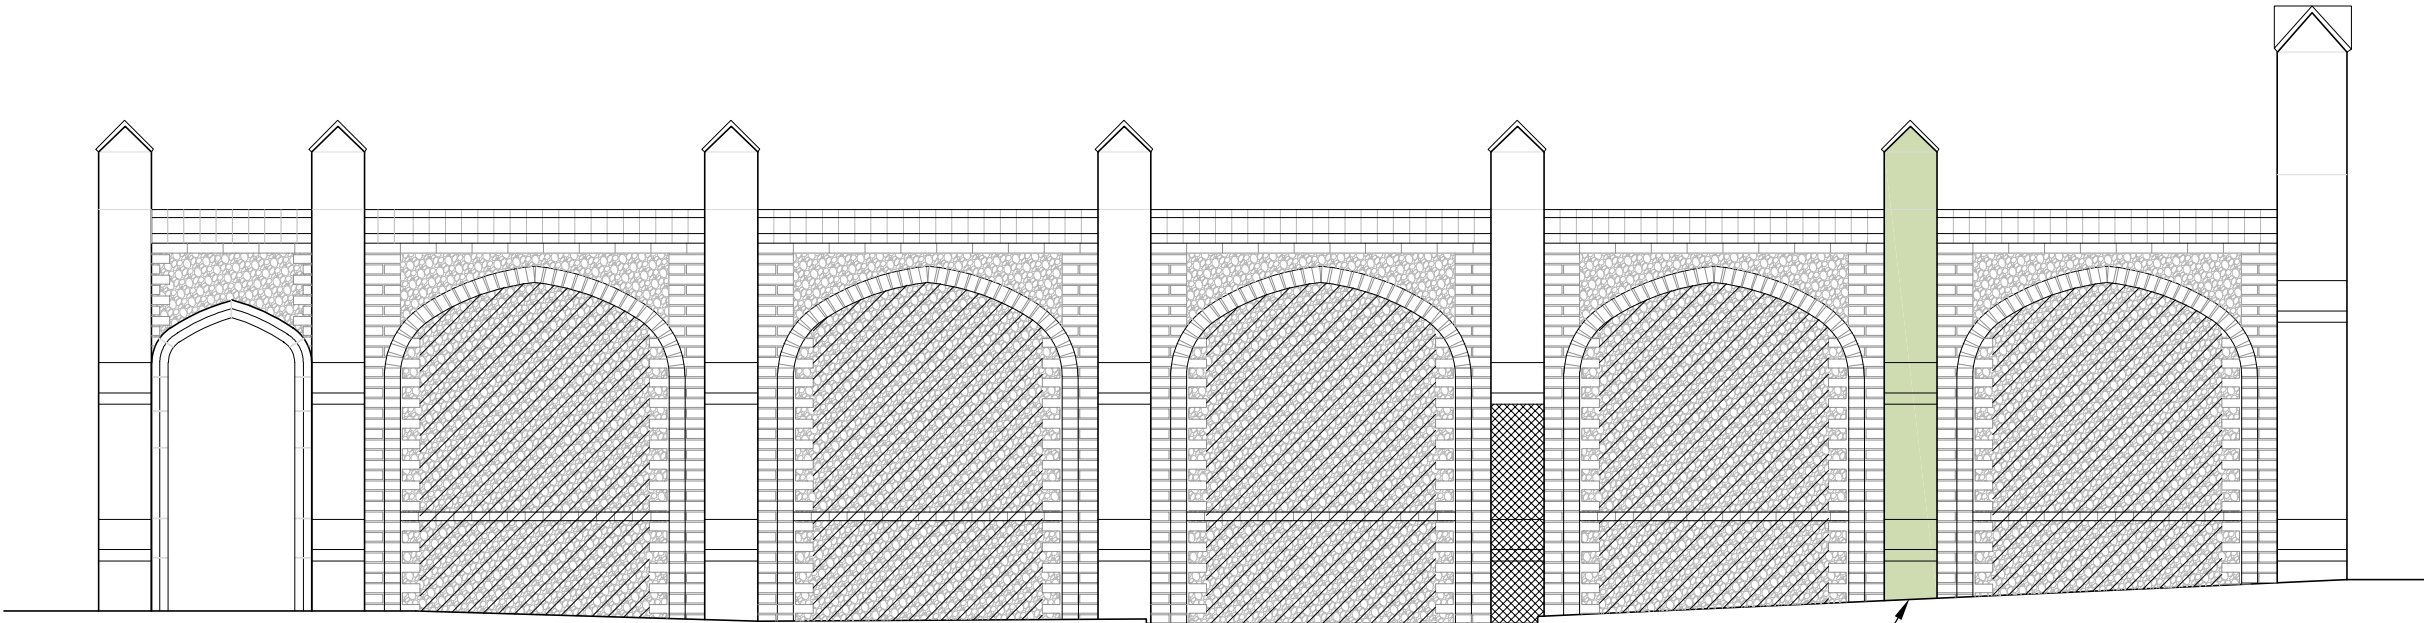
Damaged buttress: vehicle impact damage has displaced individual stones, including the lower plinth and offset: Allow for dismantling the whole of the buttress 100% and rebuilding to match existing on a 'like for like' basis. Existing salvaged stones to be bedded and pointed in lime mortar in their former positions

- Existing random flintwork to arched panels between buttresses: localised/isolated defective mortar pointing and individual loose/detached and/or dropped flints. Rake out and repoint defective mortar pointing to flintwork. Remove loose/detached individual flints. Reinstall removed/dropped flints in former positions bedded and pointed in lime mortar.
- Rake and repoint defective/open mortar joints to stonework to buttress. Point with lime mortar
