# Connick Tree Consultants

## ARBORICULTURAL REPORT Individual Tree Assessments

| OUR REFERENCE | 225974/RT |
| SITE | 23 Mandeville Close, Tilehurst, Reading, Berkshire. RG30 4JT |

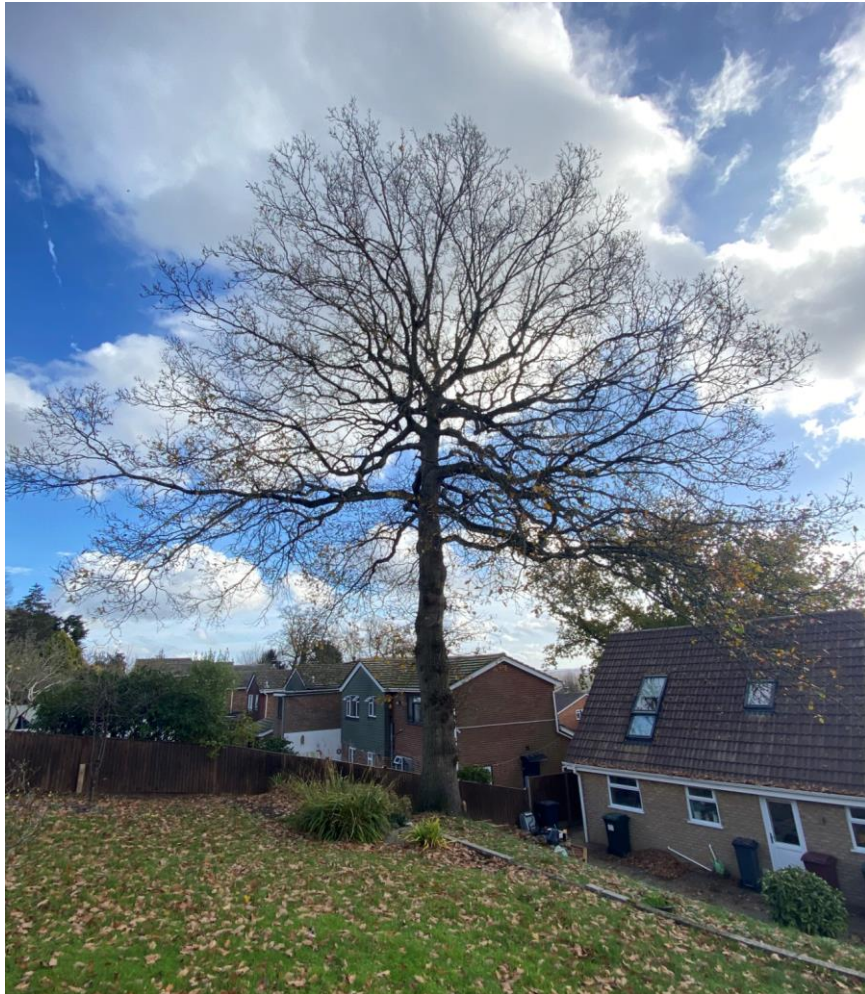
Photograph 1: Showing subject Oak T1 to centre of image

The Oak tree grows in the rear garden of the property on sloping ground formed into terraced levels. The stem of the tree lies approximately 6 metres from the rear of the property.

A low retaining wooden wall lies to the south within 4 metres of the stem; a low brick and concrete retaining wall lies to the north within 2 metres from the stem. A concrete footpath and steps lie to the east. The remaining garden is laid to grass.

The base of the tree is visible to the north, east, south and west and fully accessible which allowed a detailed inspection to take place around the soil/stem interface of the tree. The Oak has buttress growth dominant to the south and east with no sign of fungal fruiting bodies.

There was no low resonance picked up in the stem from ground level to 3 metres in height. The stem appeared sound with no visible cavities. Although a number of occluded stem wounds are present to approximately 7 metres above ground level.

The lower stem has epicormic growth to a height of 6 metres, formed of multiple 'frithy' whiskers and small sub 1 cm diameter growth of up to 1 metre in length. The historic removal of lower limbs has

altered the form of the Oak from an open grown, low, wide canopy to a more drawn up, woodland tree form.

The crown of the subject Oak tree was viewed from the north, east, south and west. The crown could be assessed due to multiple viewing angles. The overall appearance is of a symmetrical canopy with the extended lower limbs dropping to around 3.5 metres above ground level on the western side ( due to topography of the site). The crown over sails the adjacent property (No.25) and that of number 23.

Overall, the crown appears healthy with leaf and buds to the branch tips and of a normal colour and crown density. No apical dieback was evident in the upper crown but there is sporadic deadwood throughout the inner crown.

There is some evidence to suggest that the crown has been 'topped' in it's history. Although this cannot be confirmed.

The historic pruning and encroachment of development has increased targets and reduced storm resilience for T1.

It is recommended that the entire vertical crown structure is reduced by up to 3 metres, removing branches back to established secondary growth. Lateral extended limbs are to be reduced by the 'drop crotch' pruning technique by up to 4 metres with a view to reduce the overall crown weight, develop a manageable compact crown whilst reducing the sail over the adjacent properties without loss of shape.

All lower stem epicormic growth and 'frithy' epicormic whiskers are to be retained and allowed to develop into a secondary crown over time.

T1 should be pruned within 12 months from the date of this report.

Tree T1 should be re-inspected in 4 years from the date of this report if the prescribed work is undertaken or 2 years from the date of this report if the work is not undertaken.

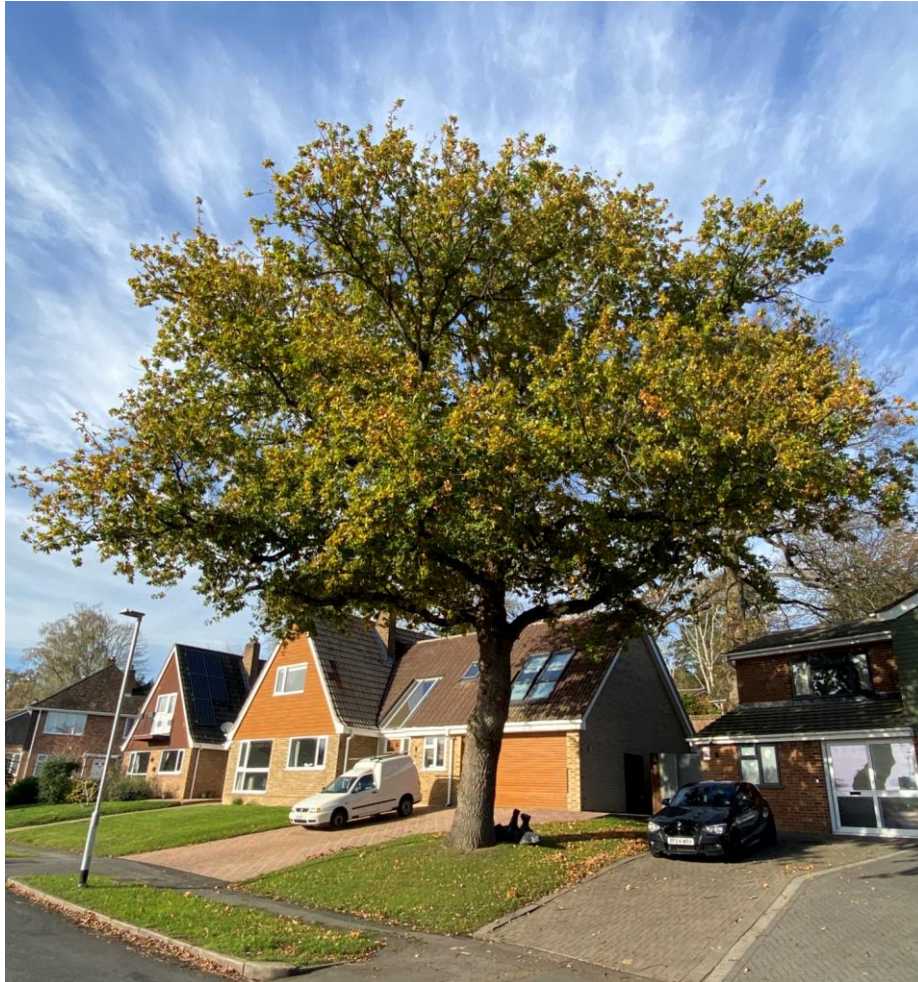
Photograph 2: Showing subject Oak T2 to centre of image

The Oak tree grows in the front garden of the property adjacent to 2 block paved driveways. The ground gently slopes from the property to the highway. The stem of the tree lies approximately 4 metres from the frontage of number 23 Mandeville Close and the neighbouring property at number 25.

The Oak tree is growing in a small grass area. The base of the tree is visible to the north, east, south and west and fully accessible which allowed a detailed inspection to take place around the soil/stem interface of the tree. The Oak has a lower stem flare but no significant buttress growth. There were no signs of fungal fruiting bodies on the lower stem.

The trunk was sounded with a light weight nylon tipped mallet. There was no low resonance picked up in the stem from ground level to 3 metres in height. The stem appeared sound with no visible cavities. An occluded stem wound is present at 3 metres above ground level to the north west.

The stem exhibits an eastern bias at 3 metres around the site of the stem wound, possibly a site of an historic limb loss.

The crown breaks from 5 metres above ground level, lower limbs have been recently pruned back on the north, east and west lateral branches and around the street light to the south west.

Overall, the canopy is dense with epicormic growth on the upper limb surfaces. There is minor apical die back throughout the upper crown. The central upper crown exhibits signs of historic 'topping' or storm damage.

The crown form is natural with a domed shape with a slightly foreshortened appearance due to pruning.

It is recommended that the top height of the Oak crown is retained and individual branches outside of the crown silhouette are pruned into the silhouette, removing only tertiary branches.

The lateral branches forming the crown are to be reduced by 'drop crotch' pruning removing between 1 and 2 metres to re-establish the natural flowing crown form whilst clearing the properties and street lighting.

T2 should be pruned within 24 months from the date of this report.

Tree T2 should be re-inspected in 4 years from the date of this report.

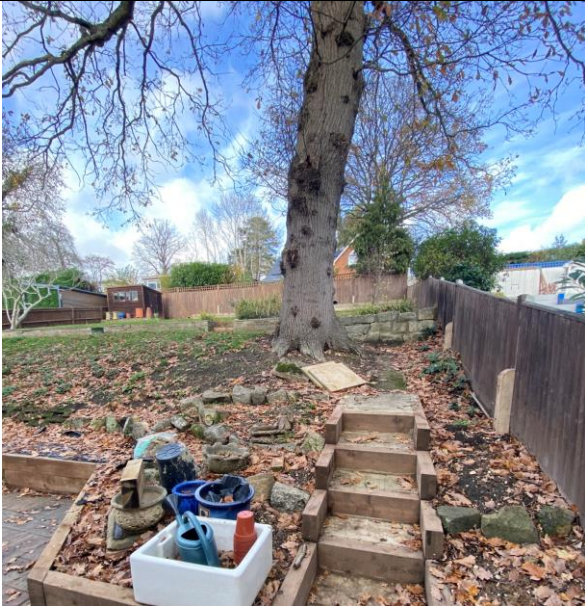
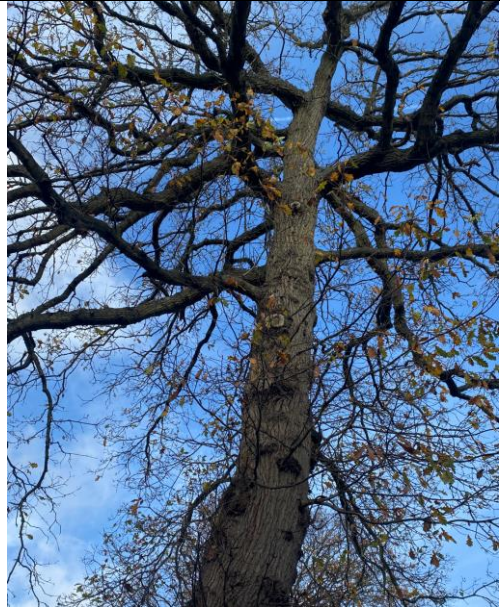
The proximity of the trees to the properties can be seen in **Images 1 & 2** for T1 and **Images 5,6,7 & 8** for T2. Further disturbance has occurred for the trees where steps and terracing have been formed by T1 in the rear (**Images 1 & 3**) and by the extension of block paving to the frontage (**Images 7 & 8**) for T2.

The permitted historic pruning of Oak tree 1 has allowed an unnatural form to develop through pruning with an exposed, over extended upper crown with a clear lower stem which has reduced the trees ability to reduce wind loading through mass dampening.

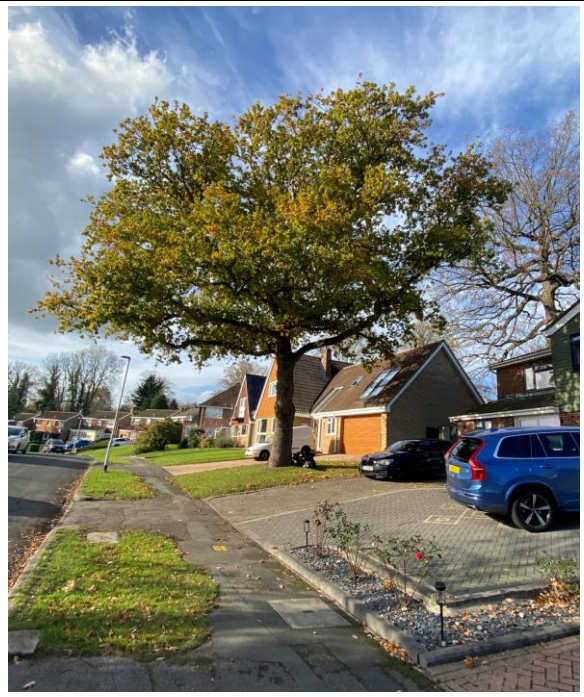
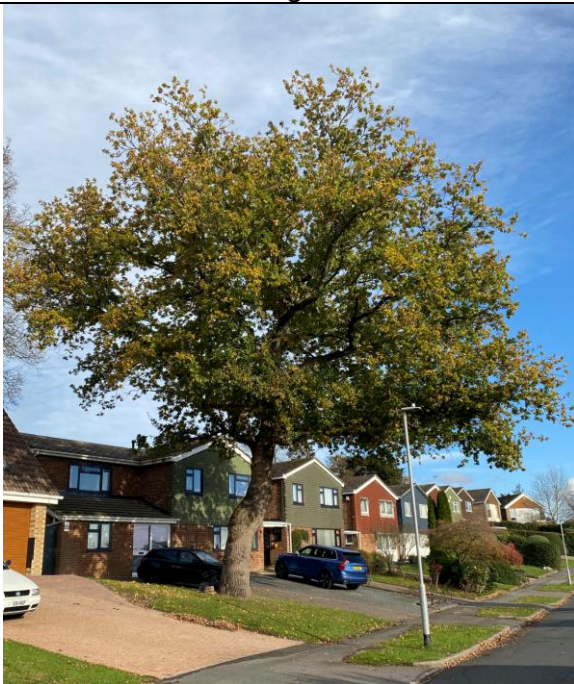
The permitted historic pruning of Oak tree 2 has allowed a poor crown form to develop with foreshortened lower branches disrupting the natural flow of the crown, the random nature of the permitted pruning means that a high value amenity tree looks aesthetically displeasing from a number of directions when viewed from the highway. (**Images 6 & 7**).
