## Heritage Statement for 8&10 Church St roof essential repairs

8&10 Church St are two Grade II listed interjoined properties under one single ownership title.

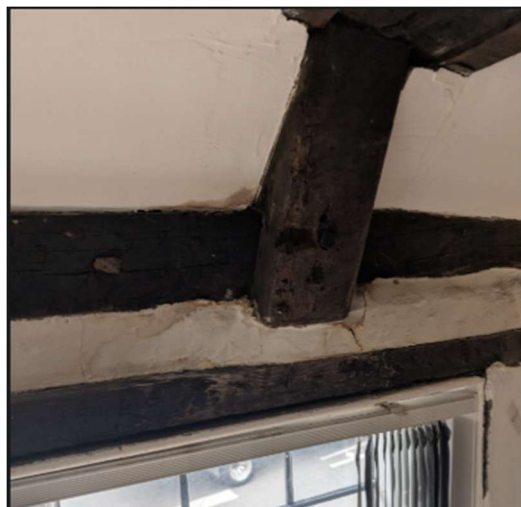
Internally above the window on the right above, as shown in the photograph below we can see some water damage likely from a slipped or damaged tile.

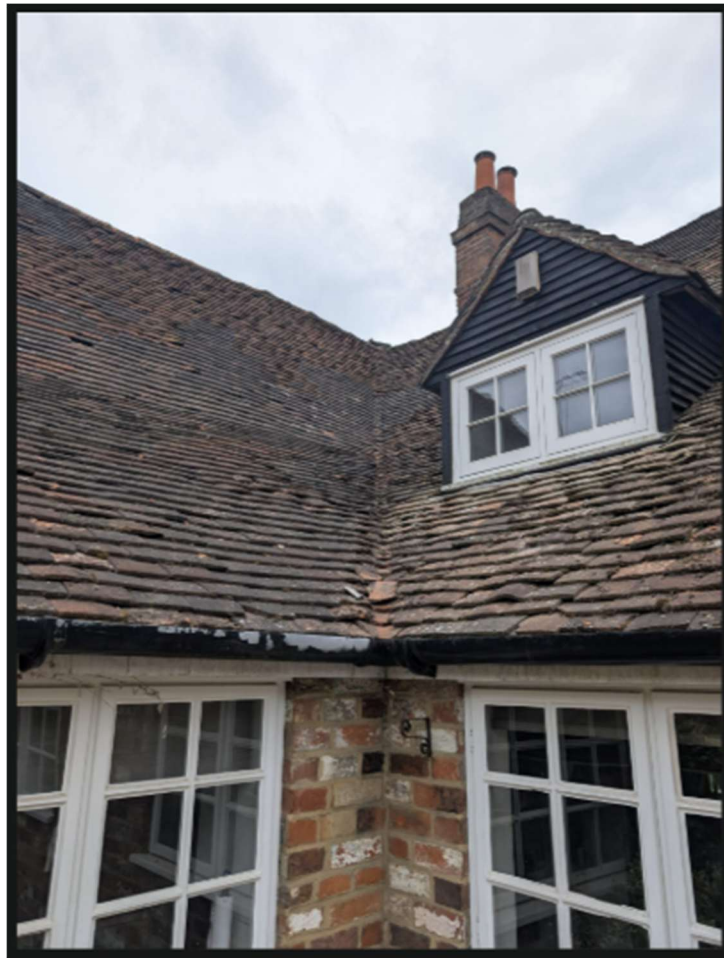
This photograph shows the roof from the rear courtyard. A loose tile can be seen in the gully.

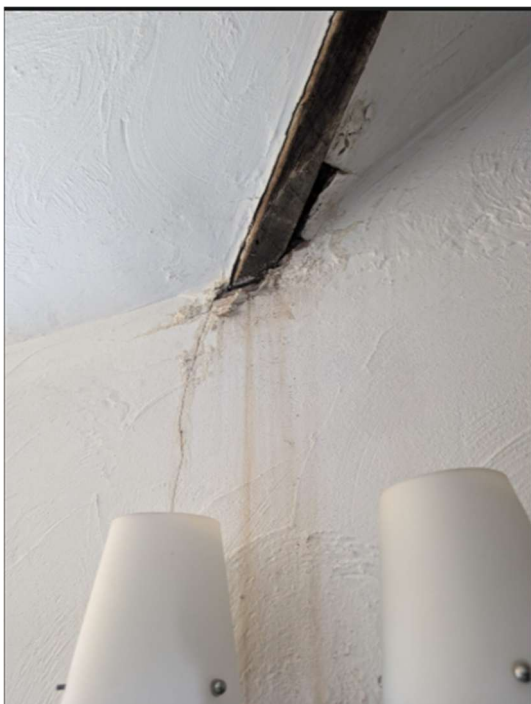
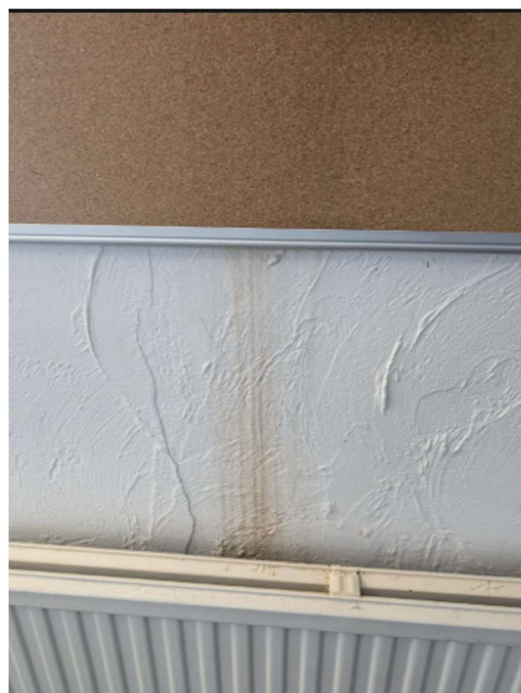
Internally, below the gully, the evidence of water entering during heavy rain can be seen:

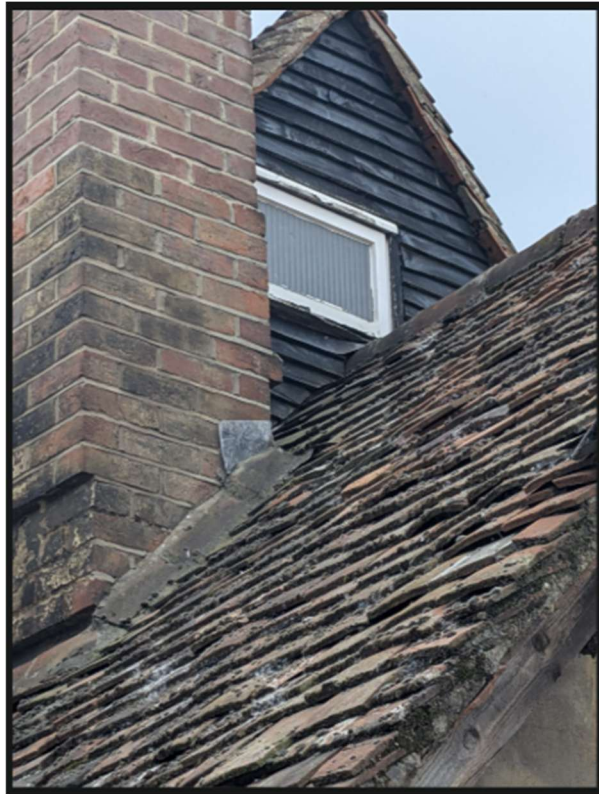
This photograph shows the location of the final identified problem area. The lower roof is a more modern addition to the building and water appears to be leaking through the lead flashing at the base of the upper section of the chimney.

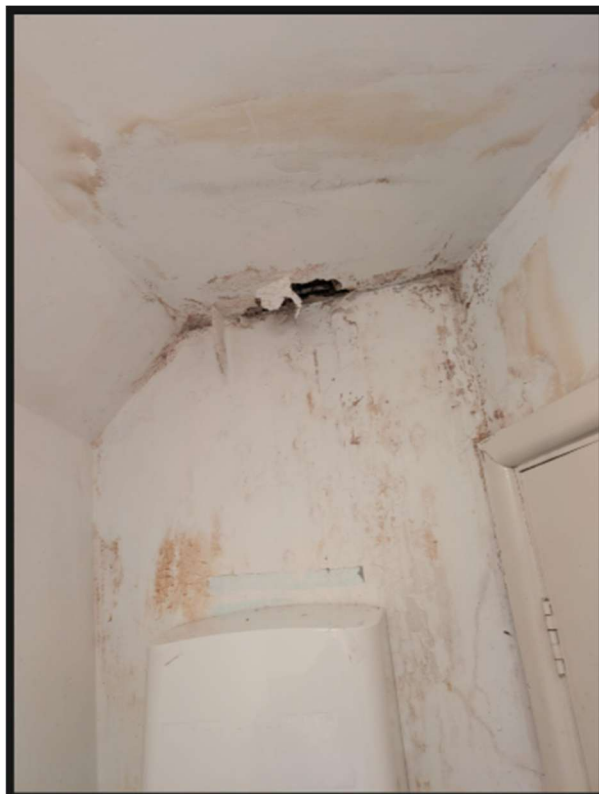
And here is the internal view showing the issue that needs to be resolved by roof repairs.
