## ARBORICULTURAL REPORT

TREE CONDITION SURVEY

ENGLISH MARTYRS CATHOLIC CHURCH  
64 LIEBENROOD ROAD  
READING  
BERKSHIRE  
RG30 2EB

Ref: 07023 / 2026

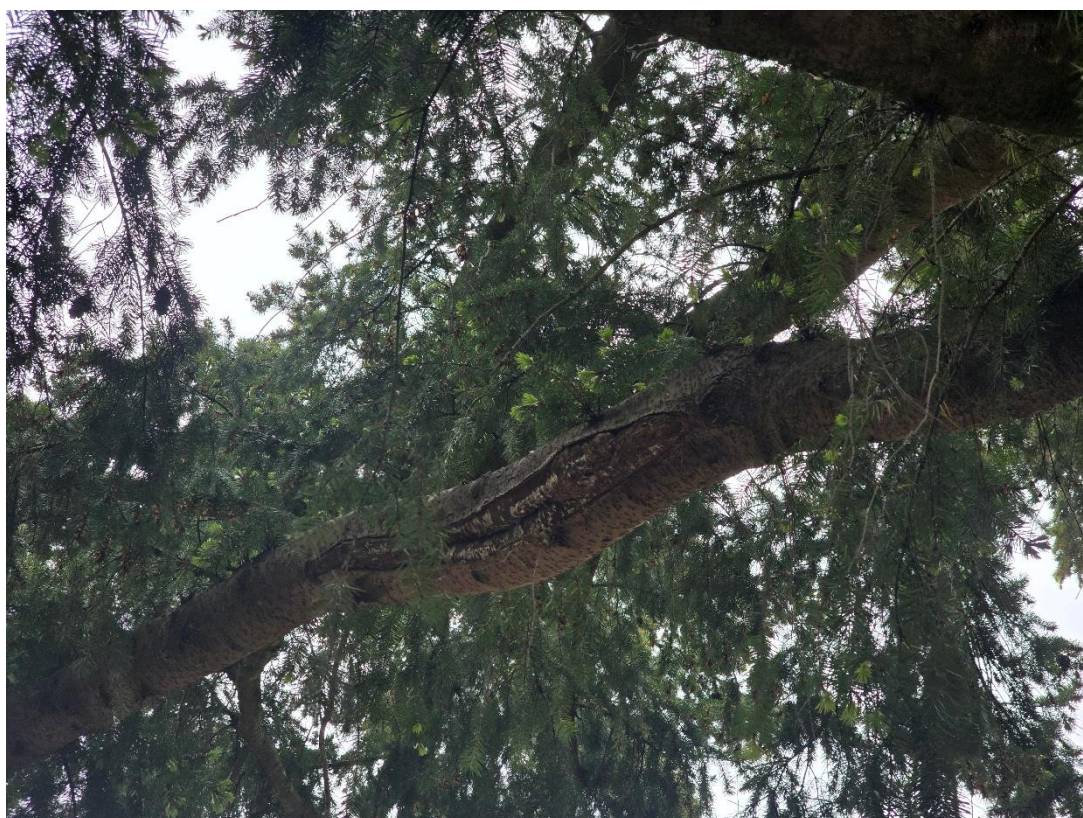
Of the lowest whorl of branches 3m above ground level, one of the branches has split at the base and is resting on ground. Two others on south and southwest side have horizontal cracks along their bases which pre-empt failure. There are other split broken branches in upper crown resting on branches below.

T1 is predisposed to branch failure caused by sheering fibres at the base of many branches. Two branches have failed and at least three more in the lower canopy have visible cracks / bark scars suggesting cracks which will grow and potentially undermined the affected branch(es). Works are required to remove the defective and broken lower branches and to create reasonable clearance to the church building and above ground level. The tree should be monitored for any signs of splits forming on branches in the canopy where they may impact visitors / staff at the church.

Photo 2 – Linear splits in lower whorl of branches.

| <b>Recommended Tree Works:</b> <ol style="list-style-type: none"> <li>1) Remove lower whorl of branches which includes of 1x broken branch, 2x split branches and 1x branch with tips low over building / parking back to trunk. Branch diameters are approximately 100mm diameter.</li> <li>2) Crown clean pruning out other dead/split broken branches higher in crown.</li> <li>3) Reduce tips of single branch on west side of crown low over building by 2m to reduce weight &amp; create reasonable clearance to building. Branch has a split forming at its base which indicates a point of future branch failure.</li> <li>4) Crown lift to create 3-3.5m crown clearance over courtyard and 2.5m crown clearance over raised soft landscaped area for access / grounds maintenance.</li> <li>5) Reduce tips of 2x branches on northwest and northeast side of crown by 1.5m to reduce weight &amp; exposure following removal of lower whorl of branches &amp; create reasonable clearance to church building.</li> </ol> | <b>Priority</b> | Within 6 months |

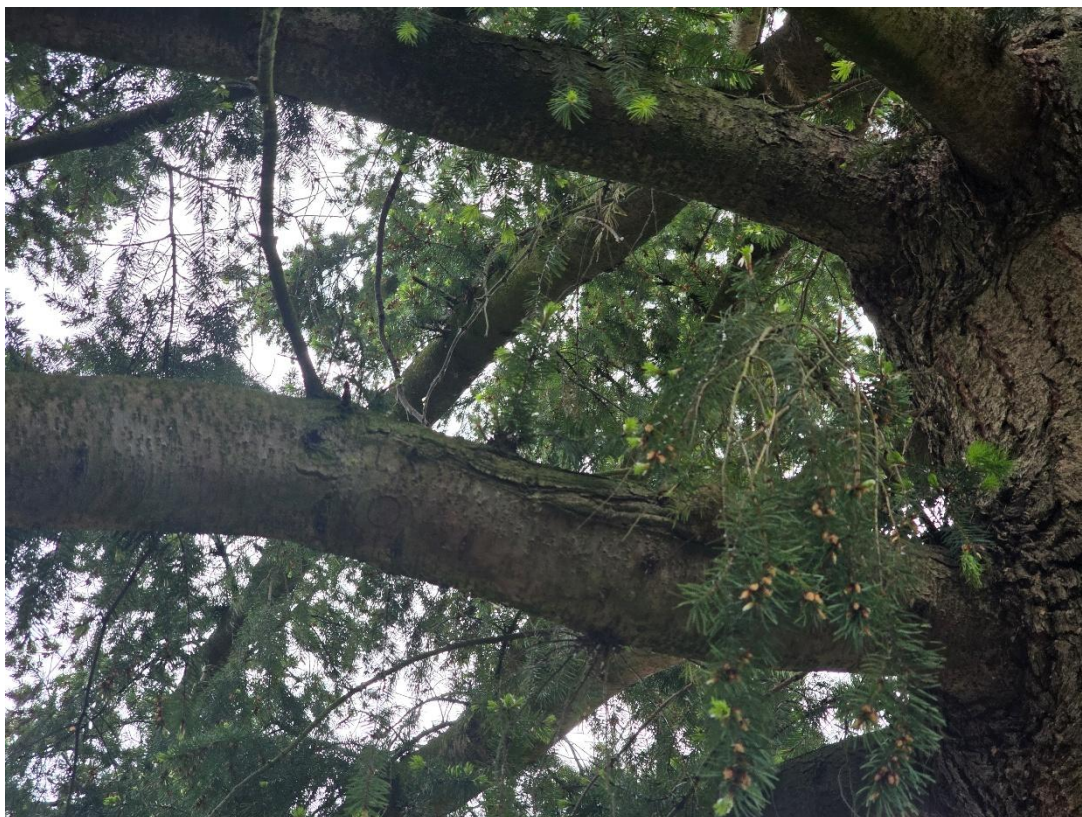
Photo 3 – Linear splits in lower whorl of branches.

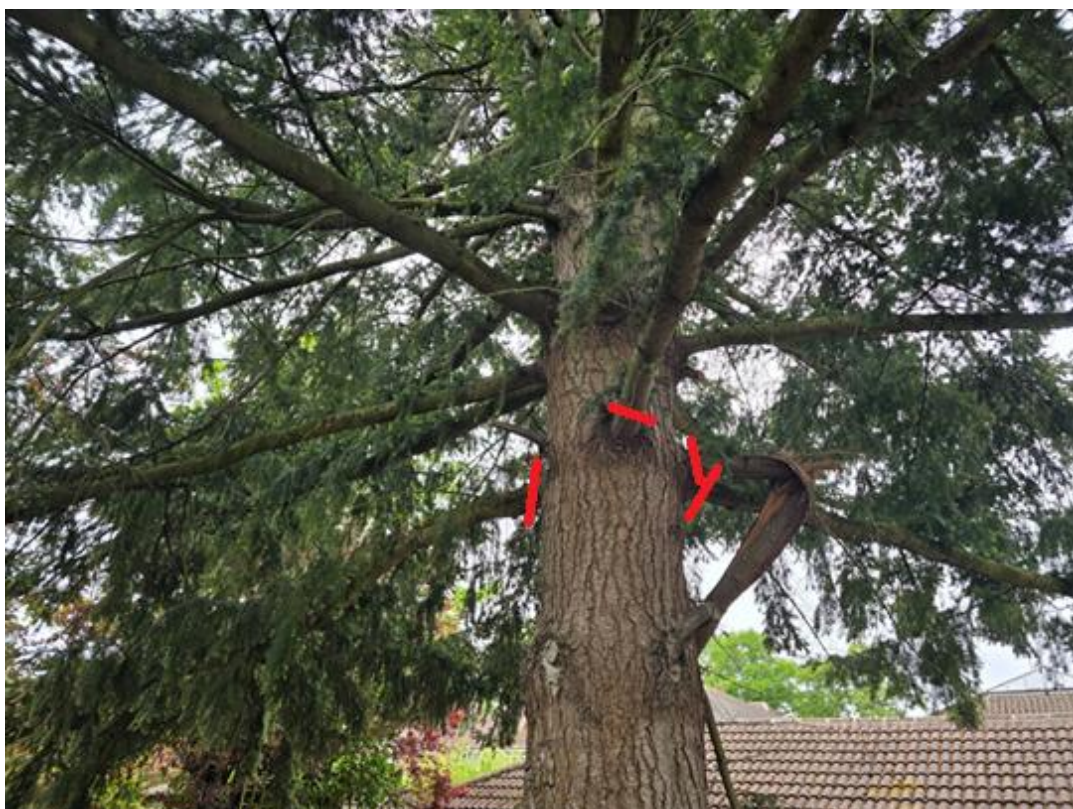
Photo 4 – Lower whorl of branches to be removed.

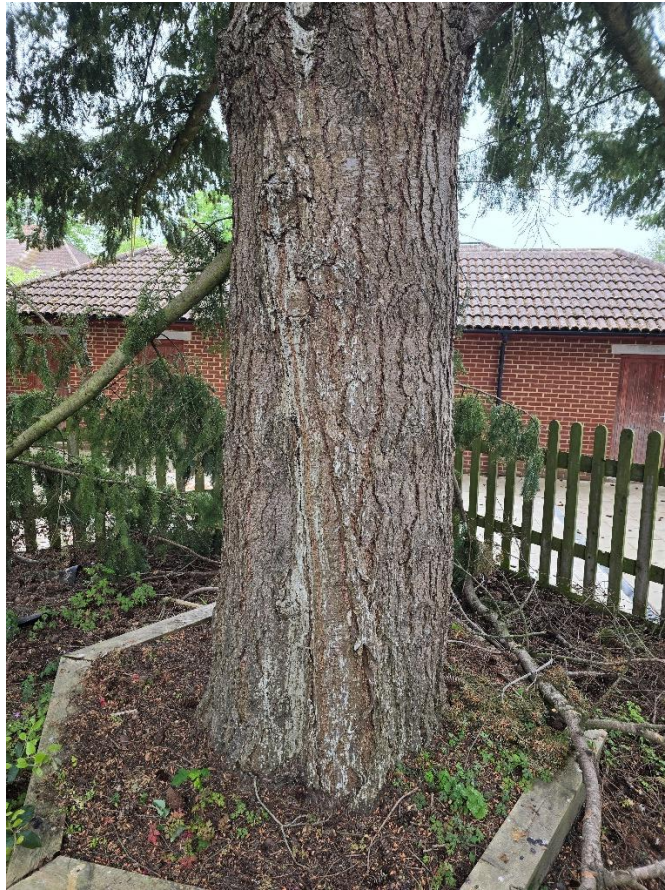
I have been advised that the tree was struck by lightning 10+ years ago. The tree has linear vertical scars on the east and west side of the lower trunk up to approximately 2m above ground level. Scars are 200mm wide at the base. Such scars can indicate a split / sheer of the internal wood fibres, however on this occasion, these vertical wounds are likely to have been caused by the lightning strike.

Photo 5 – Lightning strike scars on lower trunk.

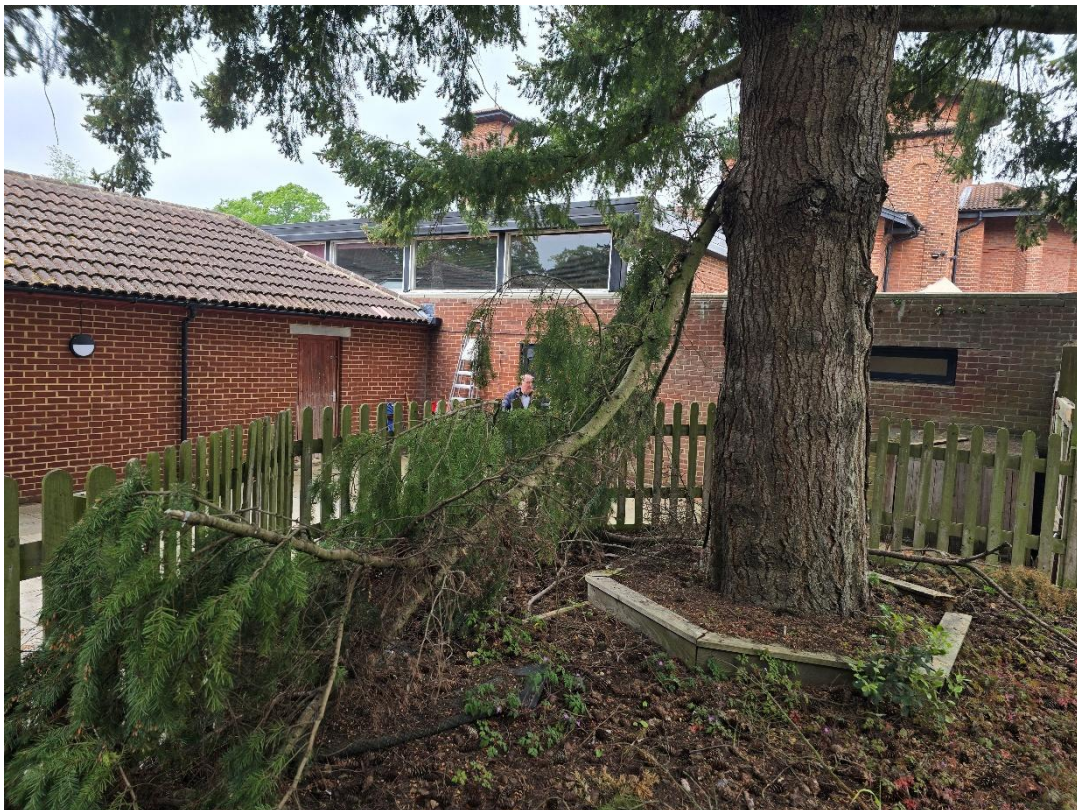
Photo 6 – Broken, hanging branch.

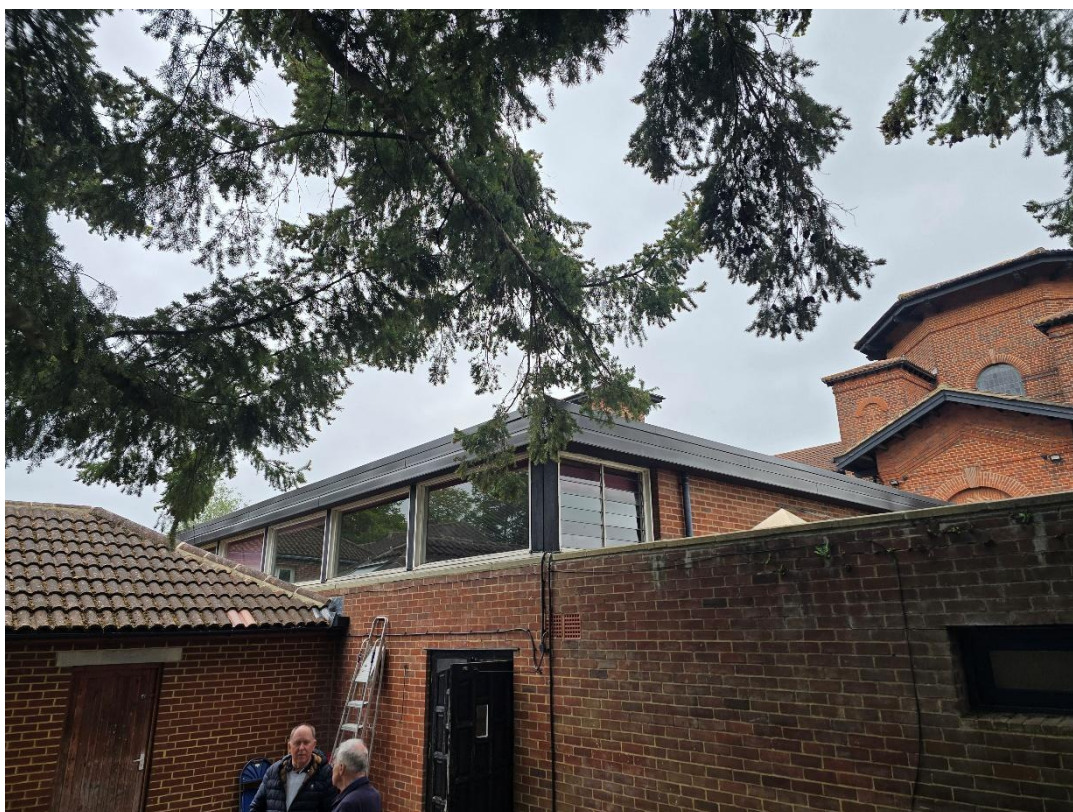
Needles dense and even. Low pendulous branches drooping to 1m above ground level over soft landscaped area and 2m over courtyard. Branch tips in direct contact with church building.

Photo 7 – Branches touching roof.

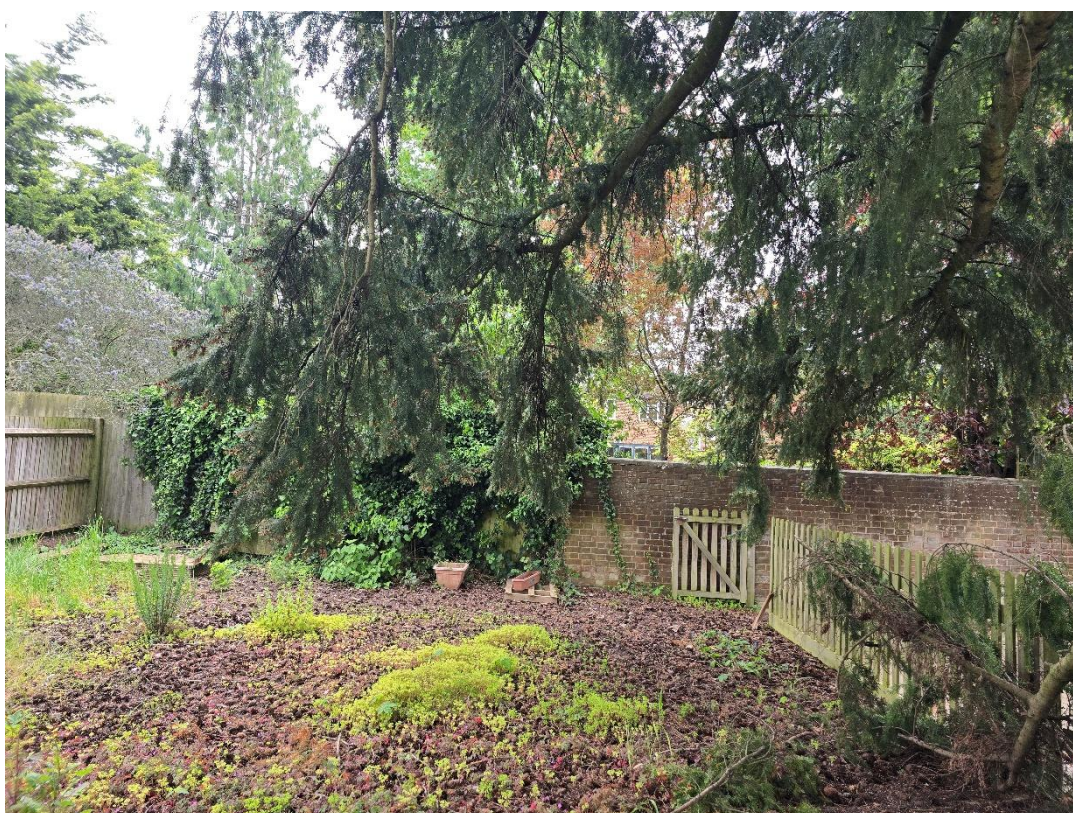
Photo 8 – Low crown over garden area
