**Client:** Annamaria Fox

**Site Address:** 21 Lowfield Road  
RG46NL

**Date:** 20/02/26

## TREE REPORT

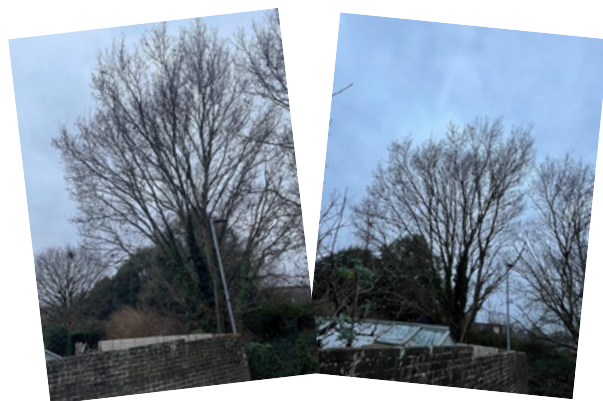
**a. Oak tree from road**

The Oak tree (*Quercus robur*) is located to the rear of No. 21 Lowfield Road (a), approximately 2 metres from the boundary wall on a council-owned public footpath (b). This footpath reportedly has a high footfall including children from the nearby school. It is a multi-stemmed tree (g) measuring approximately 12–15 metres in height. The crown is typical for a multi-stem of this species but is asymmetric due to heavy historic pruning on the eastern side, resulting in greater spread to the west (a).

As the root system has already caused damage to the wall and footpath, I recommend carrying out a crown reduction by approximately 2-3 metres to suppress the expansion of the root system to reduce the likelihood of future damage. This can also be done alongside the deadwooding, however is not as high of a priority. This should be done within the next 12-24 months.

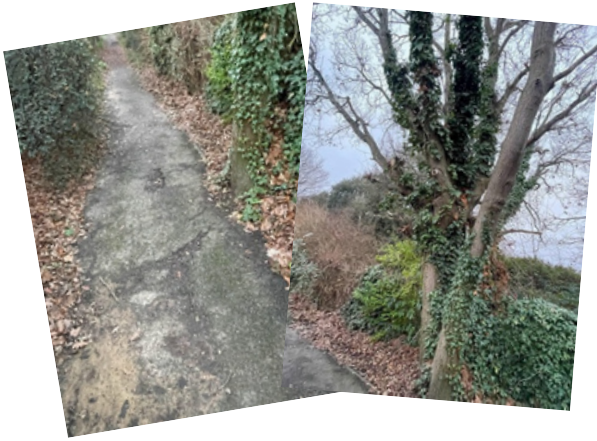
**b. Damaged footpath**

The root system is lifting the footpath causing multiple cracks to appear which has resulted in a trip hazard (b). The root system is also lifting and causing cracks in the rear garden wall (f).

I only suggest this to prevent further damage to the foot path and brick wall, but it's up to the council to decide what, if any, remedial action is to be taken and on what timeframe.

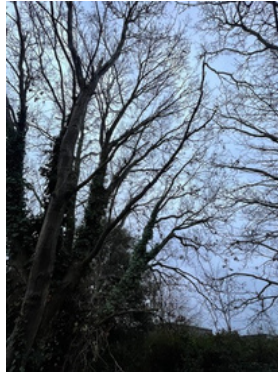
**d. Dead wood throughout crown**

A metal fence is ingrown into the rear of the trunk (c). Deadwood is present throughout the canopy, some overhanging the foot path putting the general public at risk (d).

**Conclusion and recommendations:** The vitality for this Oak tree is normal however the risk to the general public from falling dead wood should be remediated. This should be done within the next 6-12 months.

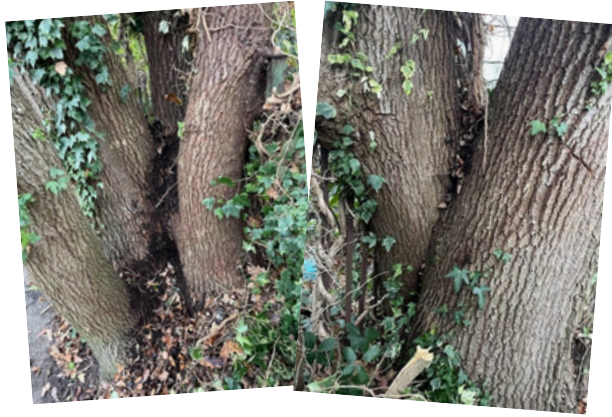
**g. Multi stemmed trunk with Ivy removed**

No fungal fruiting bodies were observed at the time of inspection. Ivy covers the trunk to a height of approximately 5 metres (b), and several historic pruning wounds are present up to approx 5 metres (e).

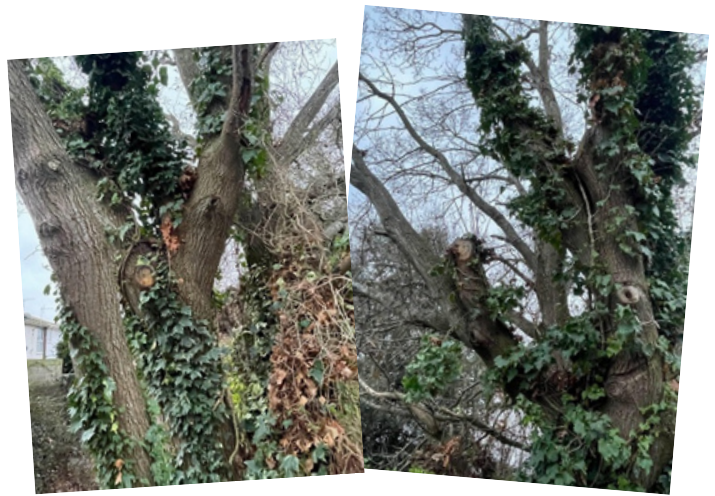
**e. Historic pruning wounds**

This tree has a number of historic pruning with some occluding well but others not, these are unlikely to significantly affect the longevity of the tree (e).

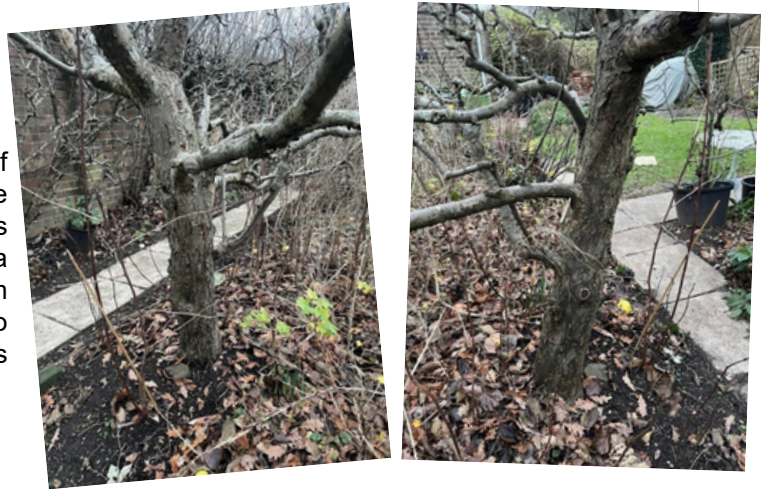
**a. T02 Trunk**

Apple Tree 1 is located on the north side of the garden alongside the footpath (see photographs for reference). The tree is approximately 4 metres in height with a trunk circumference of approximately 50 cm (a). The trunk is in good condition, with no visible decay and no fungal fruiting bodies observed at the time of inspection.

**Recommendation:** No arboricultural works are required at this time, other than routine annual maintenance pruning. The tree is relatively small and fair enough away from the proposed extension that damage to the root system would be minimal. However steps should be taken to prevent soil compaction from machinery or stacked materials within the RPA.

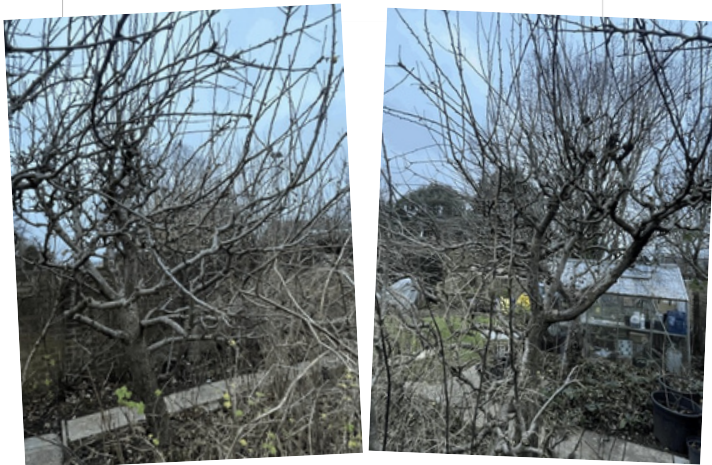
**b. T02 Crown**

The tree has been annually pruned for many years and managed as a productive fruit tree by the previous and current owners (b).

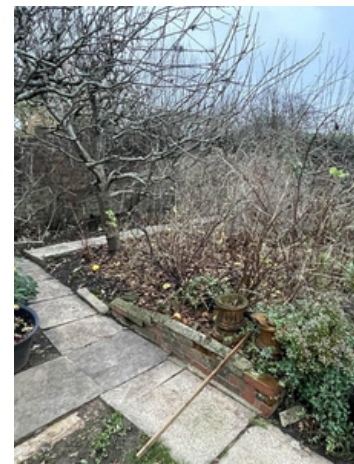
**C. T02**

It is located approximately 3 metres from the proposed house extension (c).

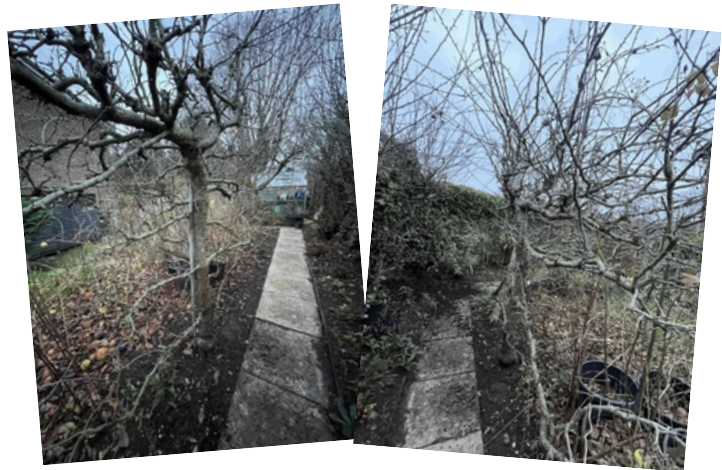
a. T03

Apple Tree 2 is located on the north side of the garden, approximately 4 metres from Apple Tree 1 and adjacent to the footpath (see photographs for reference). The tree is approximately 4 metres in height with a trunk circumference of approximately 40cm(a).

The tree has been regularly pruned and maintained as a production tree by the previous and current owners. A metal support stake is present adjacent to the trunk; however, this is not considered significant to the assessment (a). The tree is located approximately 3 metres from the proposed house extension.

**Recommendation:** No arboricultural works are required at this time, other than routine annual maintenance pruning. The tree is relatively small and fair enough away from the proposed extension that damage to the root system would be minimal. However steps should be taken to prevent soil compaction from machinery or stacked materials within the RPA.

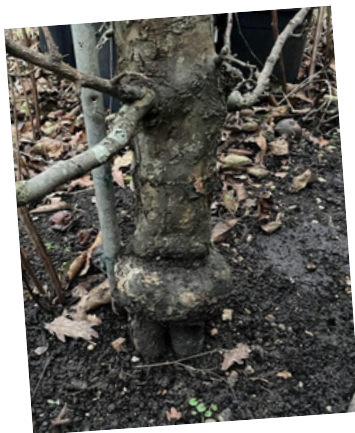
### b. T03 Trunk

The trunk is in good condition, however with a noticeable basal swelling at ground level consistent with grafting at the sapling stage (b). No decay or fungal fruiting bodies were observed at the time of inspection.

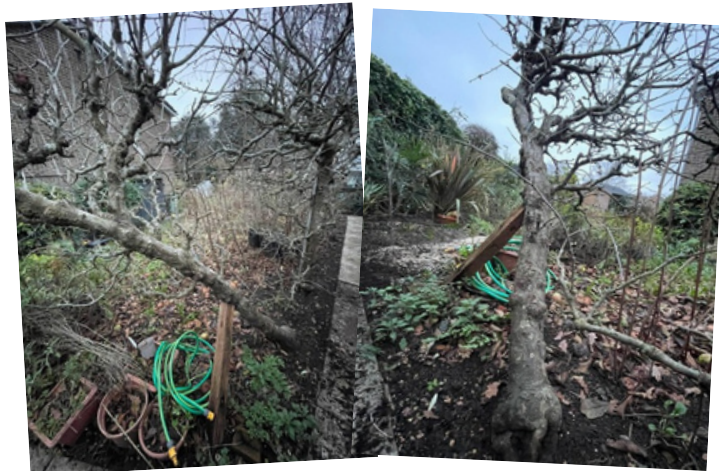
**a. T04 Trunk**

Apple Tree 3 is located on the north-west side of the garden, approximately 1 metre from Apple Tree 2 and adjacent to the footpath (see photographs for reference). The tree is approximately 3.5 metres in height and is leaning at an angle of approximately 45 degrees.

The cause of the lean is unknown; however, the tree appears to have partially fallen previously and is currently supported by a wooden stake (a). A basic stability check was undertaken, and no visible root movement was observed at ground level.

**Recommendation:** Heavily prune extended branches to reduce loading and minimise the risk of structural failure. The tree is relatively small and far enough away from the proposed extension that damage to the root system would be minimal. However steps should be taken to prevent soil compaction from machinery or stacked materials within the RPA.

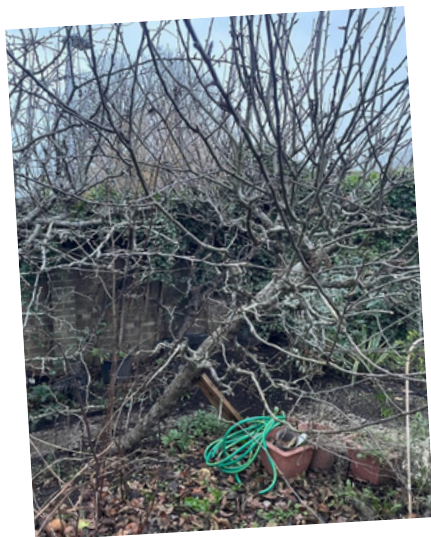
The trunk has an approximate circumference of 40 cm and is in good condition, with basal swelling consistent with grafting and some exposed root structure. No decay or fungal fruiting bodies were observed at the time of inspection. The tree has been regularly pruned and managed as a production fruit tree. It is located approximately 3 metres from the proposed house extension.
