# **Inspection of timber species and condition 19-21 Castle Street, Reading**

**A Report To:**  
**Trident**

**Report Reference:**  
FTC 26128

**Date:** 22/06/2026

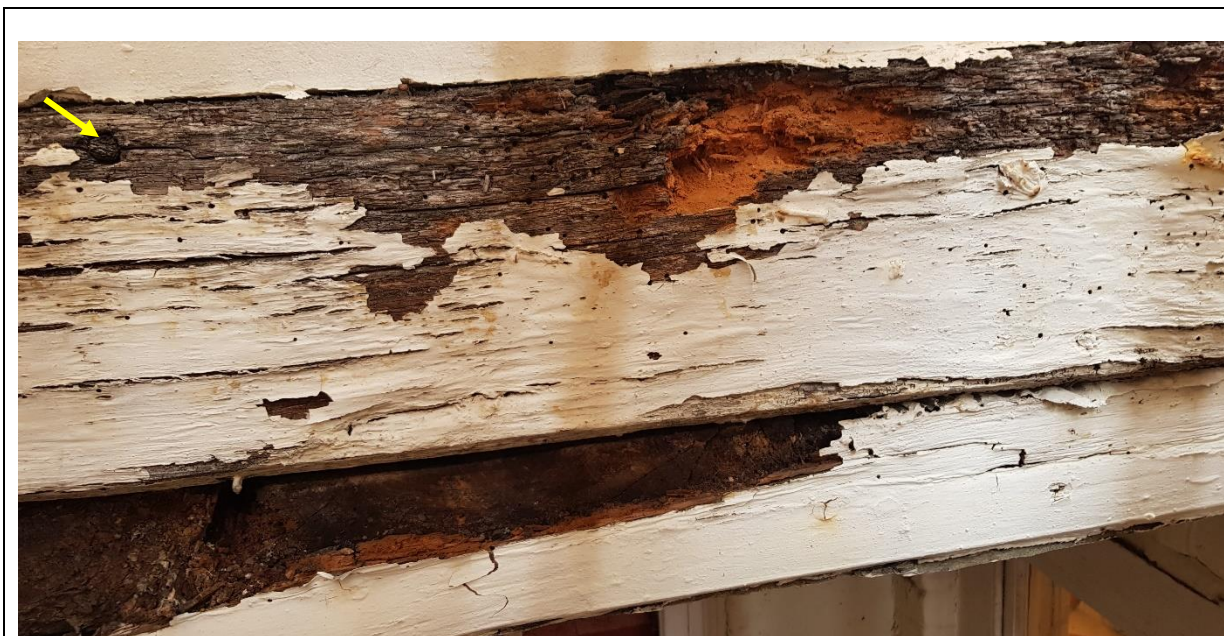
The lintel measured 1360mm in length (excluding the bearing ends) by 240mm (width) and 210mm (height). It was manufactured from oak. The front face was coated, with this coating flaking away over large areas. The coating contains emergence holes produced by wood boring insects. This lintel shows extensive brown decay and wood boring insect attack extending across its full width (i.e. front to rear) in several locations which will have resulted in a significant reduction in its strength. Two bore holes for pegs suggests this timber was previously joined to vertical members through mortices cut into this timbers' top edge (refer to Photograph 1). These mortices will have already reduced the cross section in these locations prior to decay/insect attack.

The 'bun-shaped' frass, round shape and 3-4mm diameter emergence holes are consistent with attack of the lintel by deathwatch beetle *Xestobium rufovillosum*.

**Photograph 1** Lintel (top) and associated timbers beneath it . Note wood boring insect emergence holes through white coating and coating flaking away from timbers. Surface of lintel 'picked away' revealing wood boring insect tunnels. Note peg in hole (arrowed)

The extent of decay to the lintel and associated timbers spanning the passageway is significant and these elements require replacement. The extent of decay/damage in the lower timber and board fixed to it means there is currently a significant risk that these may fall into the passageway below injuring pedestrians.

In terms of replacement, then were this to be like for like, it should be undertaken using European oak heartwood that has been air-dried, rather than with green oak (that which has not been dried) to reduce shrinkage of the timber/s used for the replacement. The lintel performs a structural function and likely to require visual strength grading according to BS5756<sup>3</sup> and to meet the requirements for THA or THB depending on the requirements of the structural engineer.

- (ii) Since the lintel is structural, it should be replaced using strength graded European oak heartwood following consultation with a structural engineer.

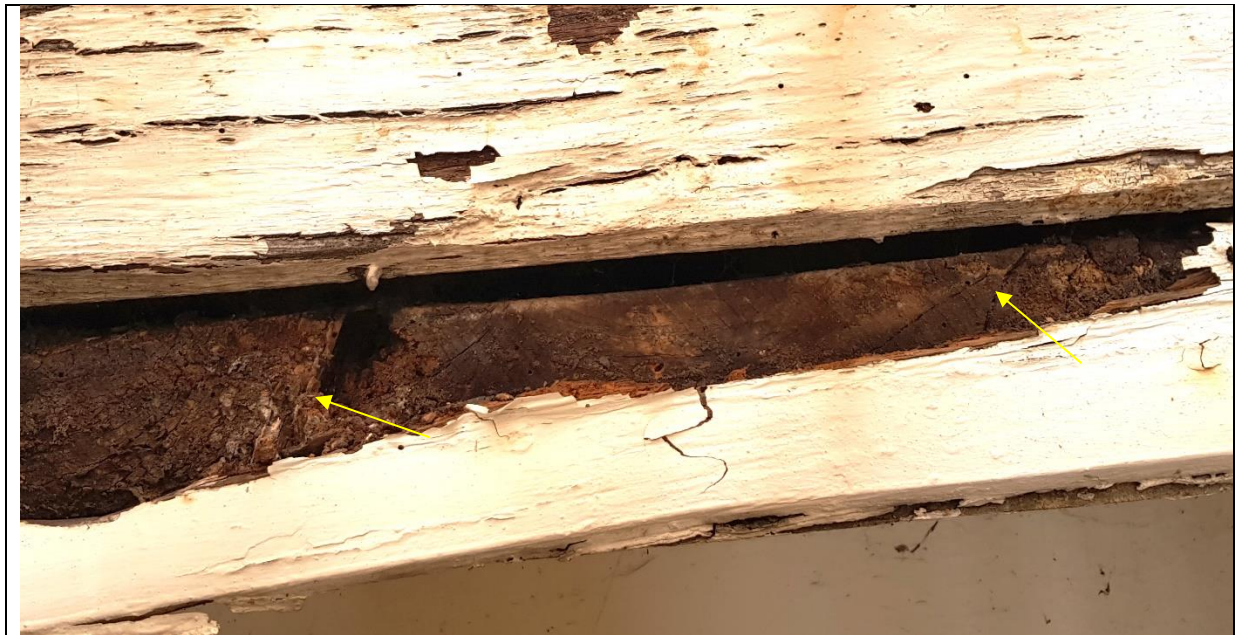
A second timber spanned the passageway beneath the lintel measuring 120 x 120mm in cross section. This timber was also manufactured from oak and had a large crack running top to bottom through the section at approximately mid span adjacent to a large knot. This timber had been extensively decayed by brown rot (refer to Photograph 2) resulting in significant loss in strength. The front of this timber had been overlaid with a softwood board which also exhibited extensive brown rot decay.

**Photograph 2** Timbers beneath lintel showing fractures associated with slope of grain (arrowed) with extensive decay/failure of overlying timber fixed to its face

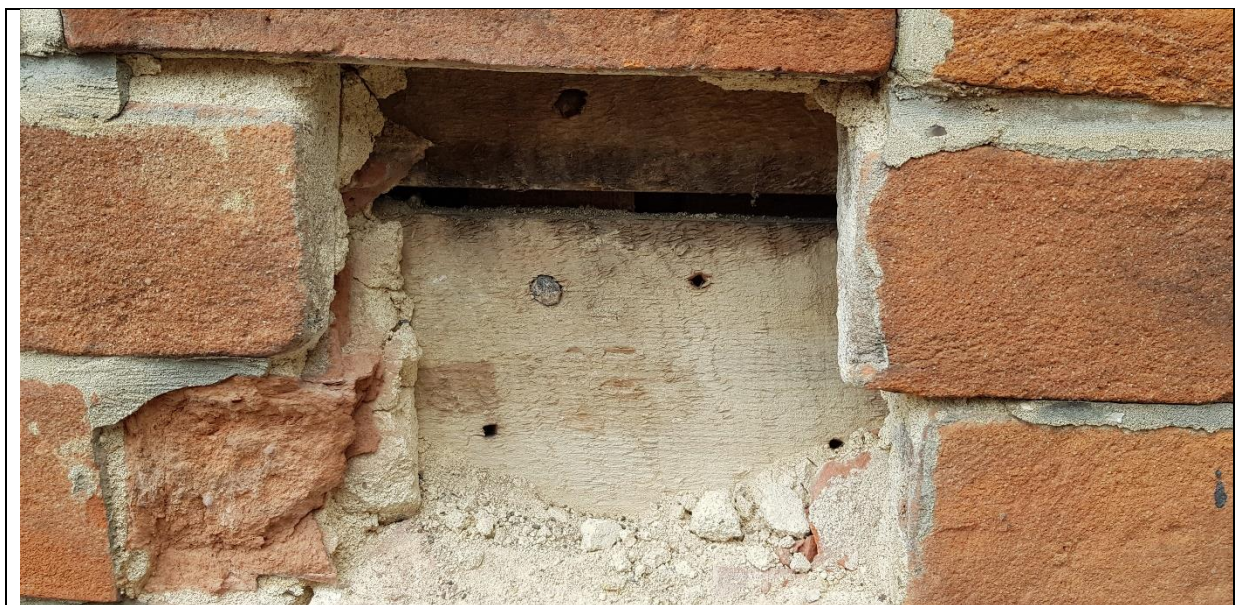
The boards to which the engineered tiles were fixed were manufactured from pine. These boards were fixed to 50 x 100mm softwood battens to the rear (refer to Photograph 3). Opening work had been undertaken in nine separate locations across the elevation. In three locations there was extensive brown rot decay of the boards which had reduced their strength and fixing holding capabilities (refer to photographs 4, 5 and 7). Boards in other locations were dry and free from evidence of decay and wood boring insect attack. Tile fixings were corroded where boards were decayed indicating board moisture content was elevated at these locations (Photograph 6). Moisture contents of all boards were below 20%.

**Photograph 3** Boards to which engineered tiles are fixed in good condition in this location. <20% moisture content and free from decay. Fixings show location of batten to rear.

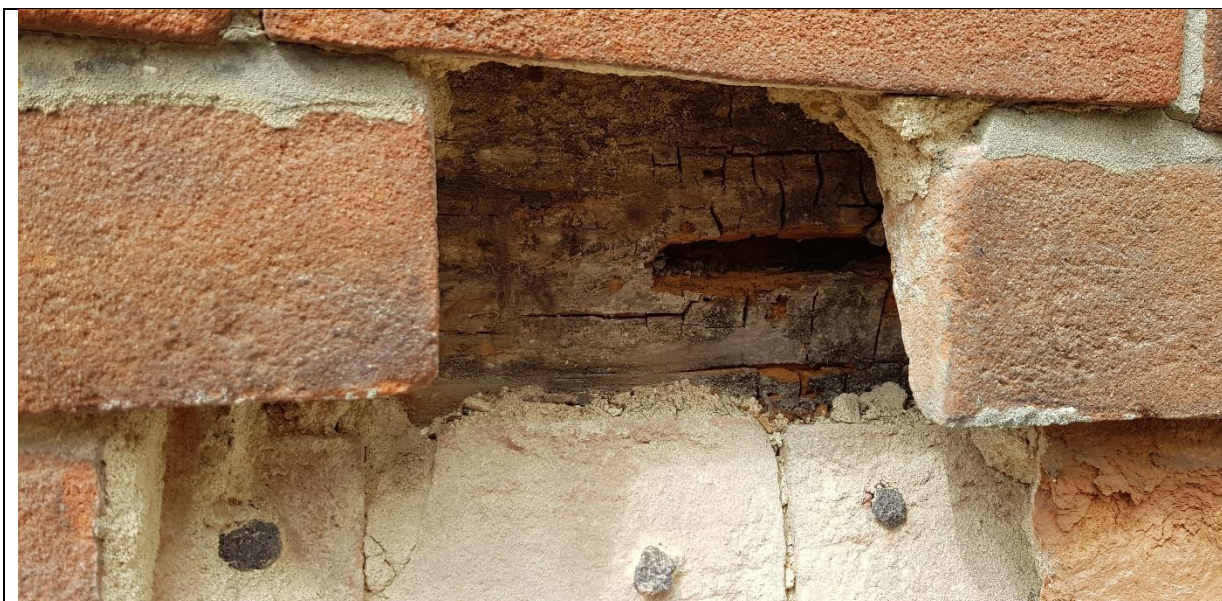
**Photograph 4** Board showing extensive but historic brown rot attack (cuboidal cracking and red brown colouration of wood)

With respect to the boards to which the engineered tiles are fixed, then Filros recommends their condition be assessed following removal of the tiles. The same would apply to the battens to their rear to which these are fixed. Where decay is localised then Filros would recommend sections of board/batten could be replaced. Replacement should be with softwood, preservative-treated for Use Class 3<sup>5</sup>. Where any cutting is undertaken on site it is important cut ends are treated using end grain wood preserver. A treatment certificate should be sought from the timber supplier to ensure timbers have been treated to meet the requirements of Use Class 3. Preservative treated European redwood is readily available.

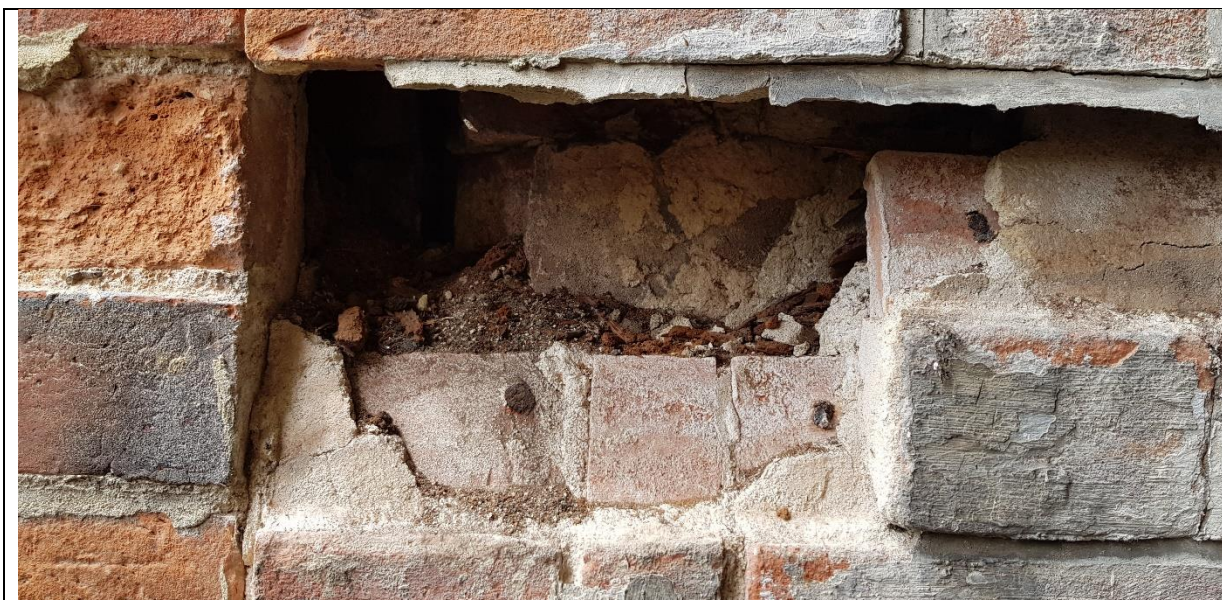
**Photograph 5** Board showing extensive but historic brown rot attack (cuboidal cracking and red brown colouration of wood)

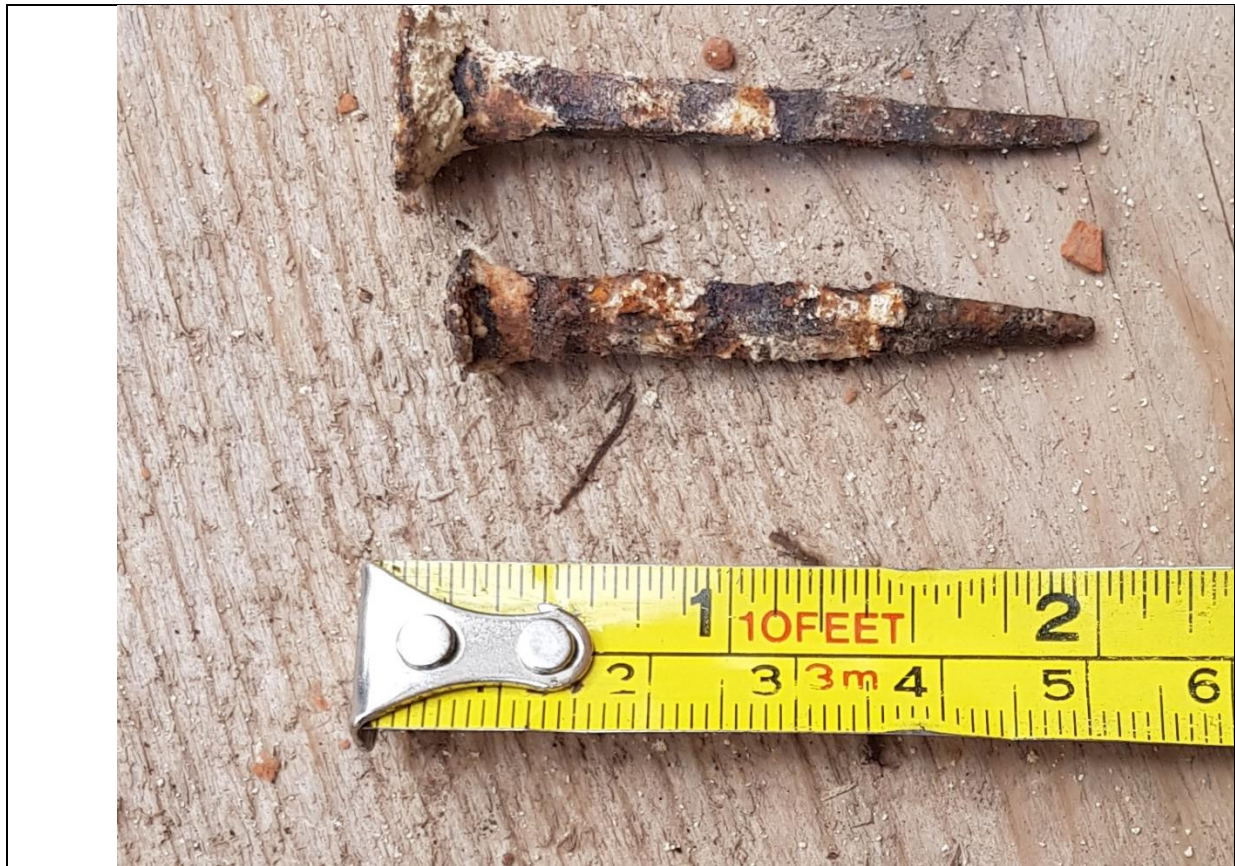
**Photograph 6** Corroded fixings for engineered tiles indicating boards through which they were fixed were of high moisture content

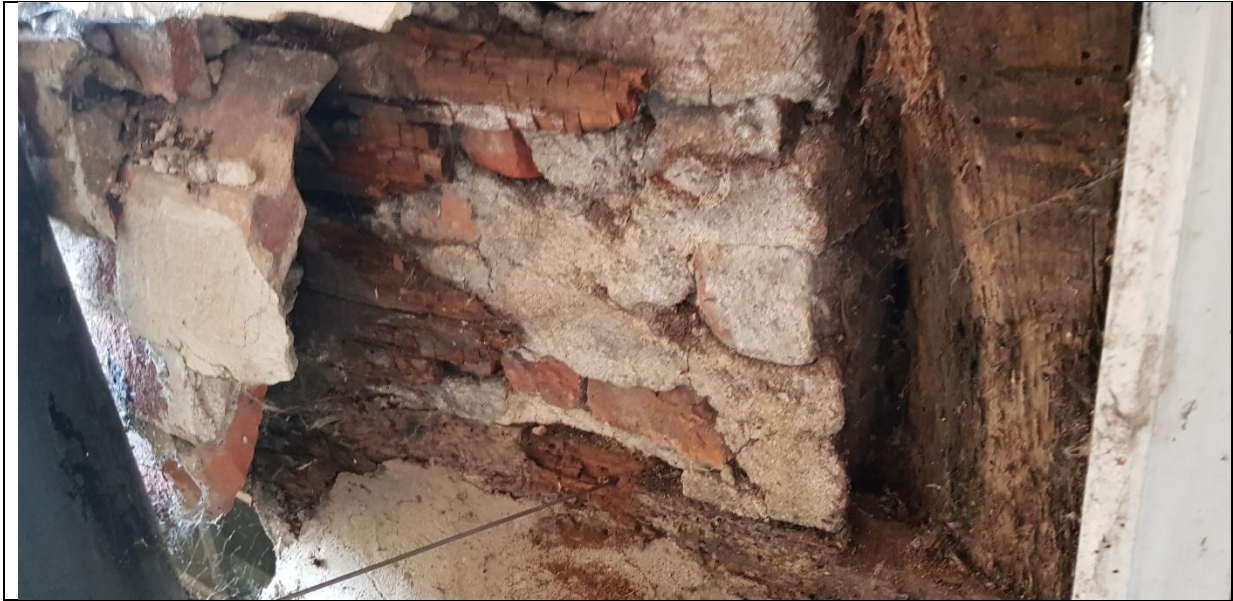
The cill (horizontal timber running parallel with passageway beneath the brickwork) exhibited significant brown rot decay resulting in up to 50% loss in its cross section which was 200 x 200mm. The post/stud adjacent to the door (150 x 150mm in section) was pine and showed extensive brown rot decay resulting in 50% loss in cross section at its base extending to 350mm in height (Photograph 7). Moisture contents of these timbers were below 20%.

**Photograph 7** Decayed cill with probe in place and decayed stud/door framing to right. Note cementitious render to face of cill

With respect to the cill and post then these will require localised repair or replacement using European redwood treated to Use Class 4. The higher level of treatment (preservative retention and depth of penetration) reflects the greater risk of these timbers 'wetting up' in service due to their location at the base of the wall.
