# External Wall Investigation

## Addendum Photographic Report

### 19-21 Castle Street

### Reading

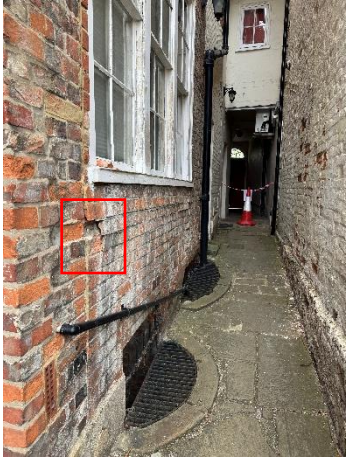
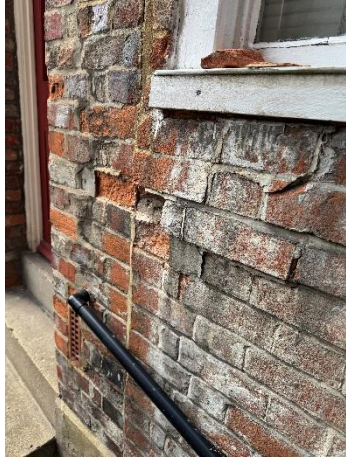
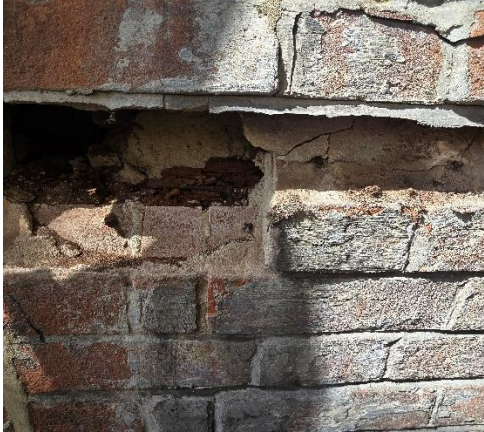
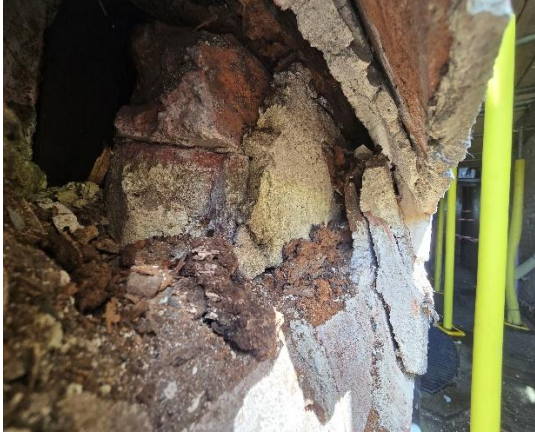
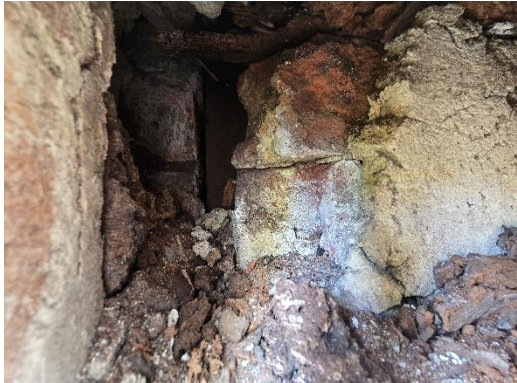
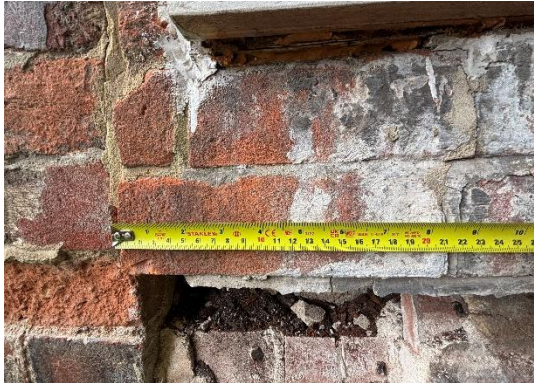
| Element | Material(s) | Comment |
|---|---|---|
| Outer Leaf finish | Clay tile | Tile came off easily during investigation works |
| Timber backing board / battens | Timber | No timber backing board / battens in place. Evidence of rot due to decay to timber |
| Nails | Assumed iron. | Evidence of corrosion to nails |

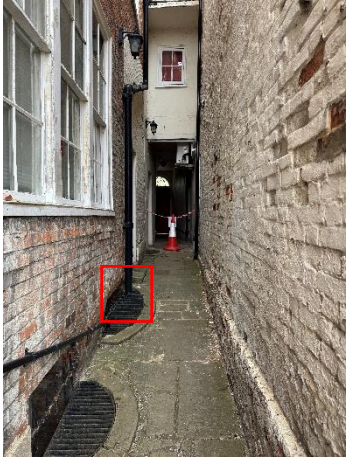
| Element | Material(s) | Comment |
|---|---|---|
| Outer Leaf finish | Clay tile | No clay tile present when undertaking inspection |
| Timber backing board / battens | Timber | Evidence of rot to timber in situ.<br>Extent of rot to timber unknown. |
| Other comments | | Rot to timber at vertical and horizontal joints.<br><br>Previous concrete repair undertaken adjacent to horizontal timber joint. |

| W02-01 | Survey location on elevation photo | W02-02 | Close up view of existing opening. |

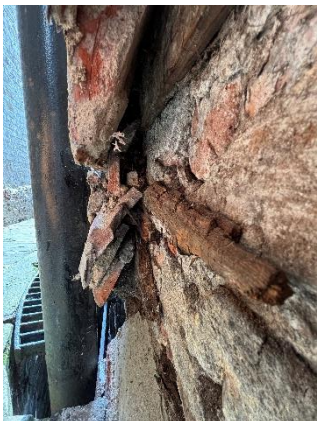
| W02-05 | View within structure, no timber batten evident. | W02-06 | Check measurement of |

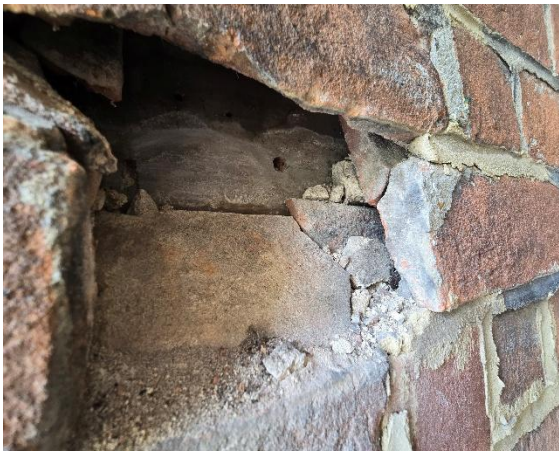
| Element | Material(s) | Comment |
|---|---|---|
| Outer Leaf finish | Clay tile | Tile came off easily during investigation works |
| Timber backing board / battens | Timber | Backing board appeared dry at time of inspection. |
| Nails | Assumed iron. | Evidence of corrosion to nails |

| W03-03 | Close up view of opening formed by removing clay tiles | | |

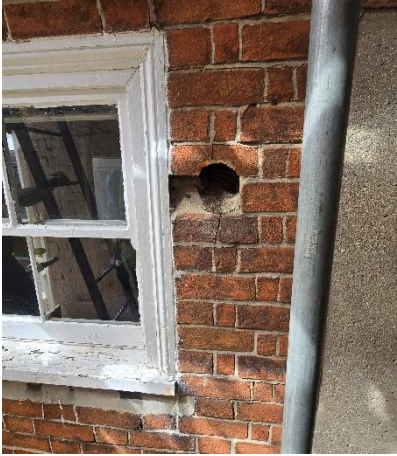
| Element | Material(s) | Comment |
|---|---|---|
| Timber backing board / battens | Timber | Area of timber backing board previously removed (assume from a boiler flu).<br><br>Timber board appeared dry at time of inspection. |

| <p>W04-03</p> <p>Close up view of opening formed by removing concrete mortar.</p> | <p>W04-04</p> <p>Close up view behind concrete mortar.</p> |

| Element | Material(s) | Comment |
|---|---|---|
| Other comments | | Remove insulation to cavity / backing board. |

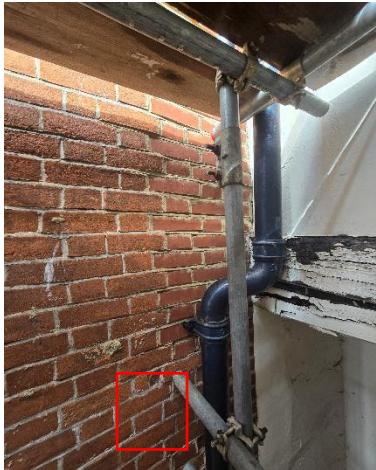
| Element | Material(s) | Comment |
|---|---|---|
| Other comments | | Mortar joints to the newer addition clay tile are showing early signs of cracking and deterioration. |

| W05-01 | Survey location on elevation photo | W05-02 | Close up view of location. |

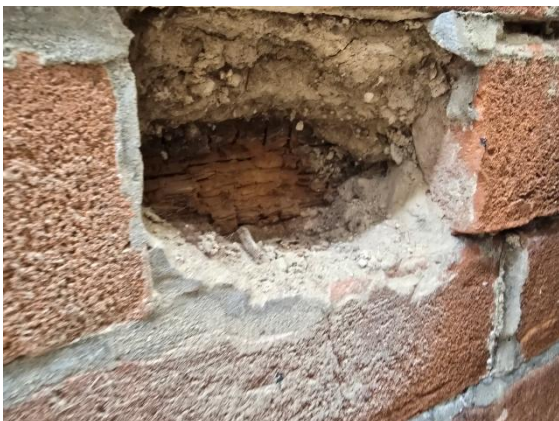
| Element | Material(s) | Comment |
|---|---|---|
| Timber backing board / battens | Timber | Backing board appeared dry at time of inspection, evidence of rot to timber. |

| W05-05 | Rot evident to timber backing board. | | |

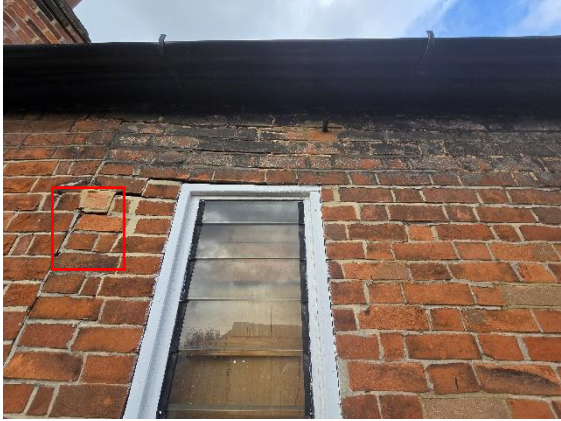
| Element | Material(s) | Comment |
|---|---|---|
| Other comments | | Mortar joints surrounding clay tile showing signs of cracking. |

| W06-01 | Survey location on elevation photo | W06-02 | Close up view of location. |

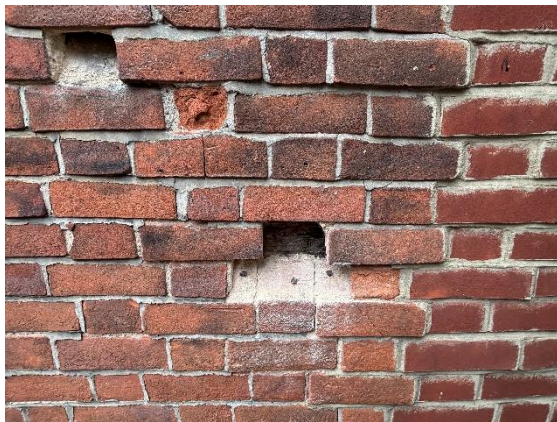
| Element | Material(s) | Comment |
|---|---|---|
| Timber backing board / battens | Timber | Backing board appeared dry at time of inspection. Evidence of rot |
| Nails | Assumed iron. | Evidence of corrosion to nails to backing board |
| Other comments | | Extent of rot to timber unknown |

| W10-03 | Close up view of opening formed by removing clay tile | W10-04 | Close up looking towards the left of the opening up |

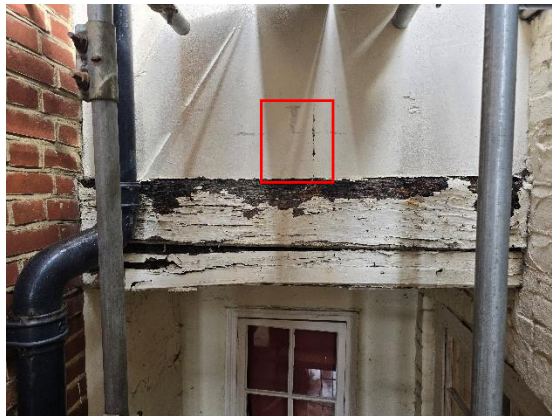
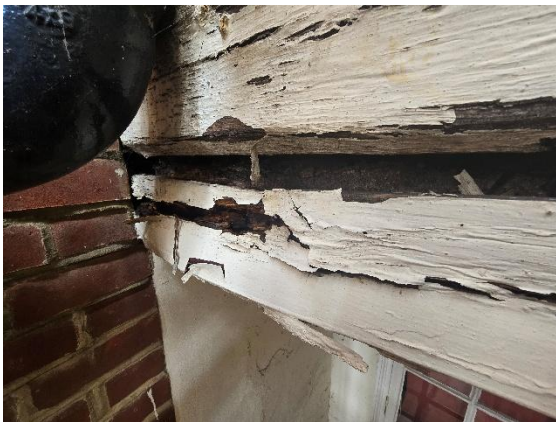
| Element | Material(s) | Comment |
|---|---|---|
| Timber ‘structural’ beam | Timber – Assume Oak | The timber beam shows evidence of rot, which will have implications for its structural integrity |

| W08-01 | Survey location on elevation photo | W08-02 | Close up view of timber beam |

| Element | Material(s) | Comment |
|---|---|---|
| Other comment | | Refer to Timber Specialist Report |

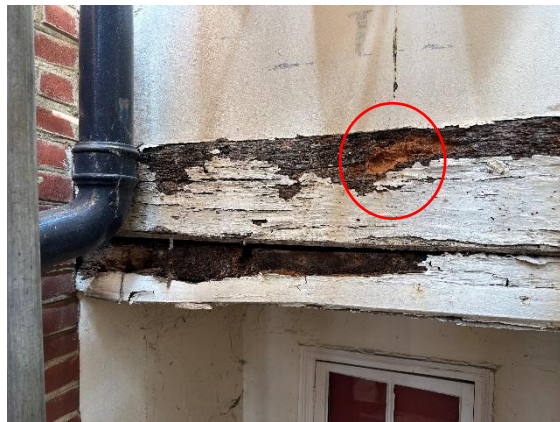
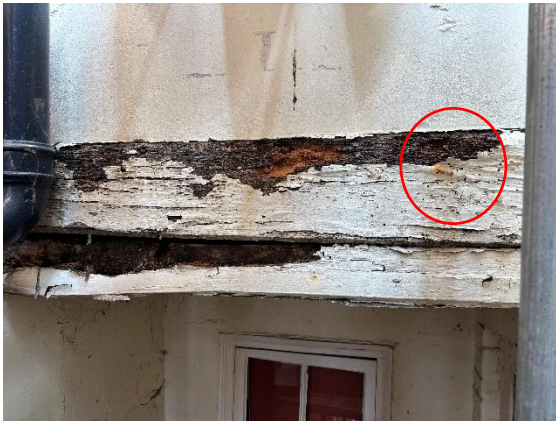
| Element | Material(s) | Comment |
|---|---|---|
| Timber board | Timber – Assume Softwood | The timber board shows evidence of rot.<br><br>Note: while undertaken the bore drill test through to the beam behind, a large piece had broken away from the structure |

| W08-03 | Close up view of timber beam | W08-04 | Location of core drill testing to timber beam. |

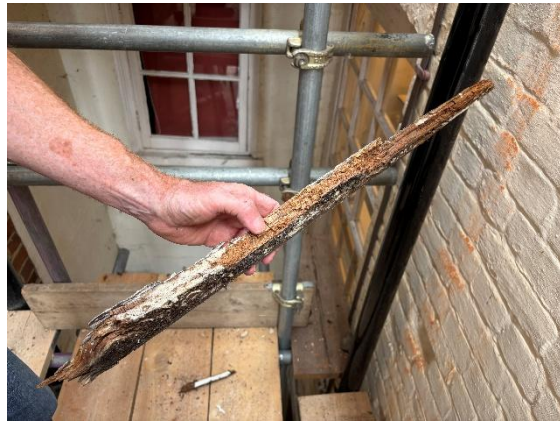
| W08-03 | Location of core drill testing to timber beam. | W08-04 | Close up of rot to front board to timber beam. |
