**19-21 Castle Street**

**Structural Inspection of  
mathematical Tiles**

226223 - MNP - XX - XX - RP - S - 0001

June 2026

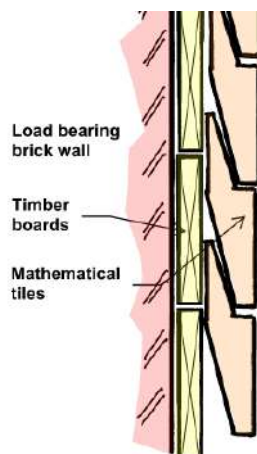
Figure 2. Indicative Section

The investigations found that in this case the tiles are fixed back to wide timber boards, which are in turn attached to an internal loadbearing masonry wall. Other than at ground floor level, adjacent to the doorway, there was no indication of a structural timber within the wall. At the south end of the wall (where it meets a later addition) there was no indication of a timber post. These observations suggest that the wall is entirely masonry and not a timber frame with brick infill.

In all locations the buildup was found to be consistent and as indicated in figure 2. In several locations the timber boards onto which the tiles are fixed, were found to be in poor or very poor condition. This generally correlated with areas of visible distortion or damage.

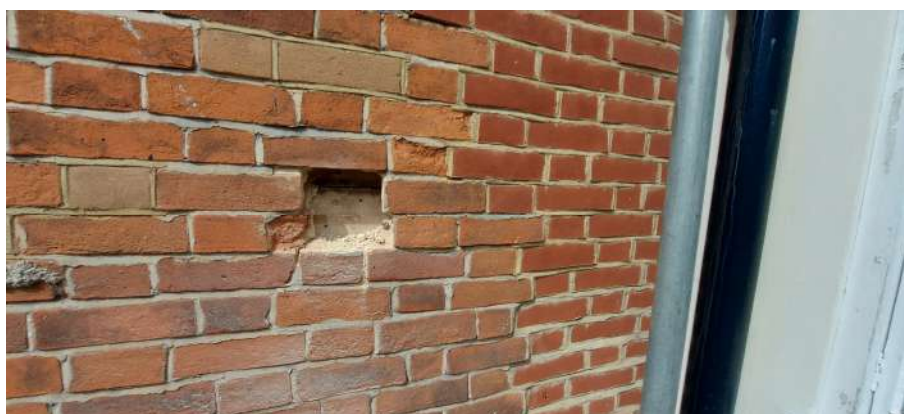
Figure 3. Top of wall – note previous rebuild on right

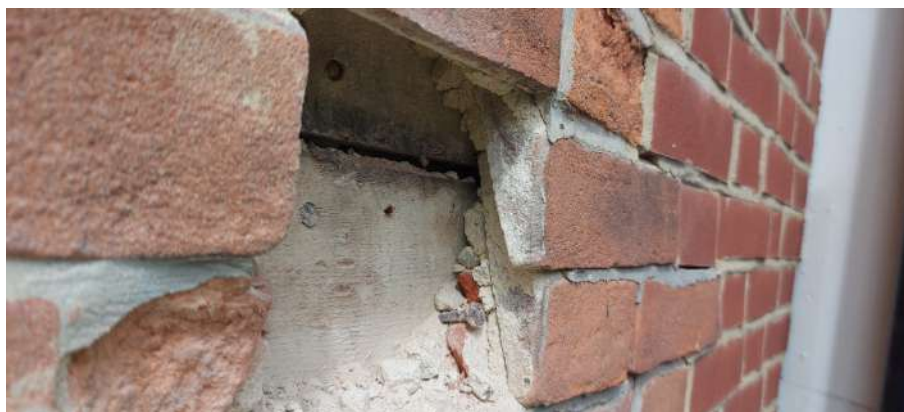
Figure 4. Detail at position in figure 3

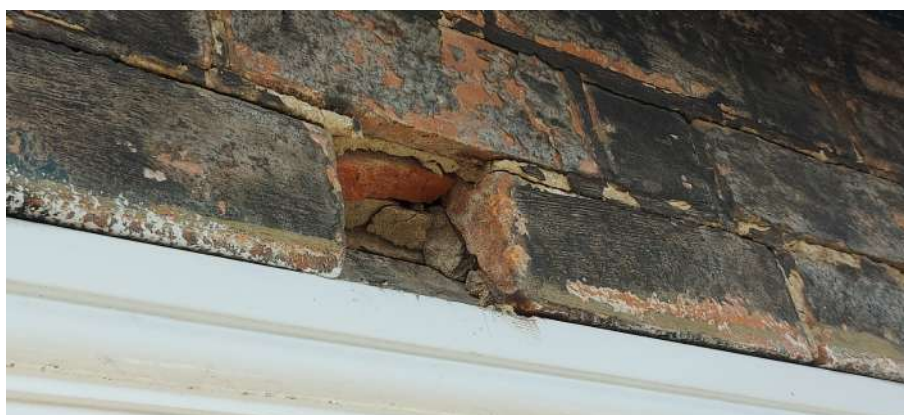
Figure 5. Top of wall – over window

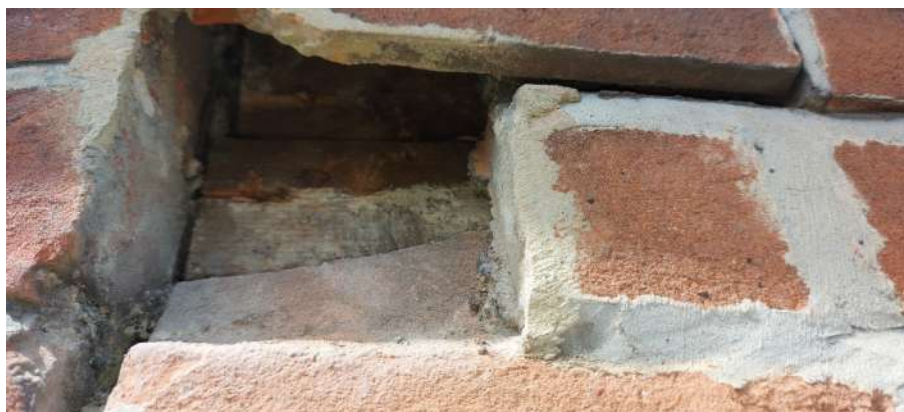
Figure 6. At south end junction with later solid wall. Timber poor

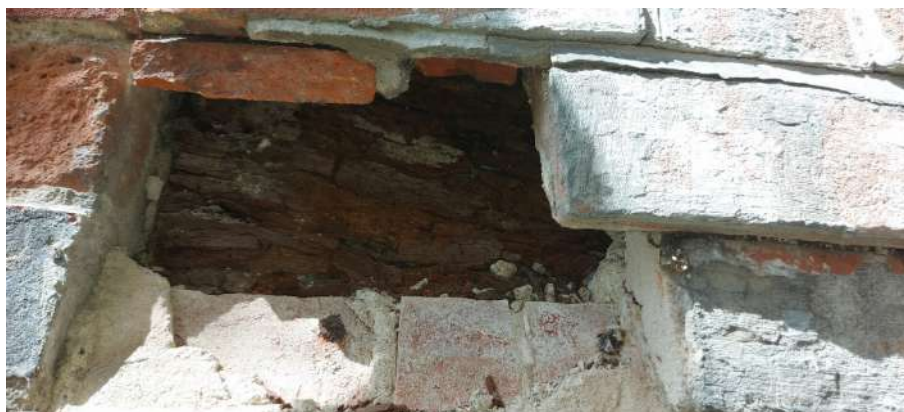
Figure 7. Ground floor – timber board very poor

In general, the pointing to the whole elevation was poor, with various phases of repair and making good. At ground floor level, below the window the timber boards were in very poor conditions, leaving many of the tiles insecure.

- The whole of the tiled elevation should be repointed with all cementitious material removed. A relatively soft lime based mortar should be used. This will help prevent the boards behind becoming saturated. It should be noted that the work to cut out the old mortar may cause some damage to the tiles requiring local replacement, this is particularly the case in areas of cement based pointing.
- The areas of distorted or damaged tiles should be removed and refixed, with the boarding behind checked and replaced as necessary – the extent of this will only become apparent as the pointing is cut out and repairs are made. While some tiles that are not damaged may be salvaged and reused; a significant number of new units will be required. In particular it is recommended that the bottom 1.5m of the façade is fully removed and refixed over the full length of the elevation.

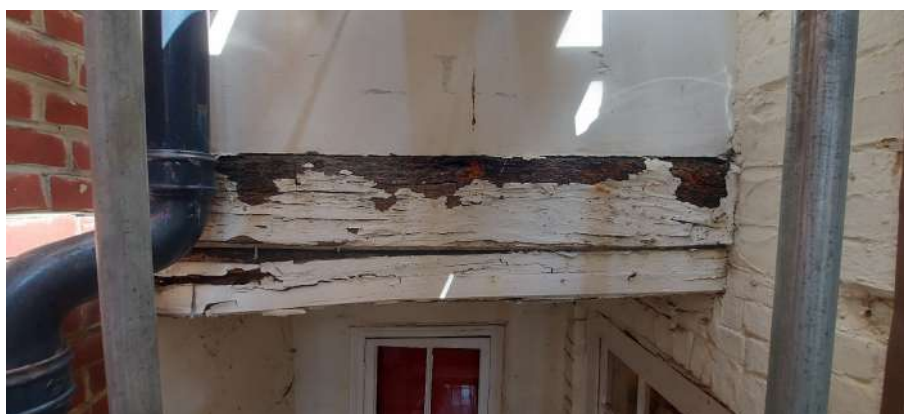
Figure 8. Timber Lintel

An existing timber lintel at high level over the passageway was visually inspected. The face of the timber appears to be in poor condition, with the paint peeling away and numerous flight holes from insect infestation. It is not possible to confirm an active beetle infestation, but the exposed nature of the timber suggests that the moisture levels will be sufficiently high to allow insects to burrow in the timber.

The timber lintel condition is of concern, if the whole cross section of the timber is decayed the structure will be unstable and the support to the wall and floor above compromised.

With regard to the timber lintel a timber specialist should be engaged to test drill the timber lintel to determine the extent of the decay, if it is more than superficial a new lintel is required. The type of replacement will require discussion with the conservation officer. In this situation a new concrete lintel may be more appropriate than timber. It should be noted that although the lintel supports the rear of Number 21 (Listed Grade II), it bears onto the wall of Number 19, which is listed at the higher level of Grade II\*.

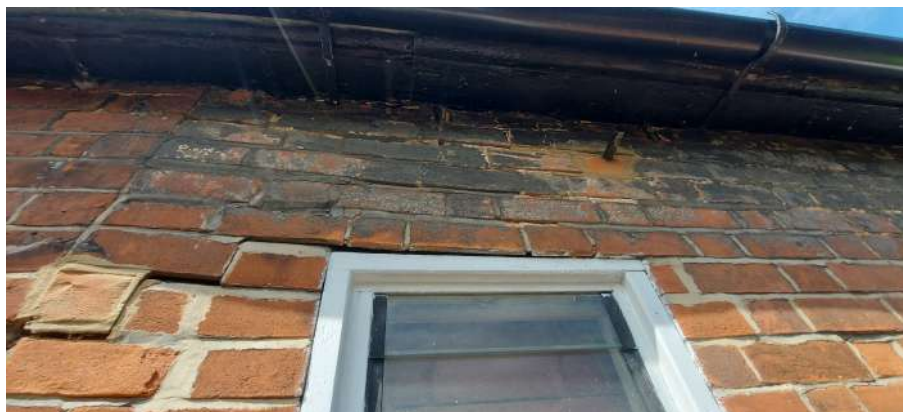
A separate section of timber below the main lintel is significantly distorted and not robustly fixed (as seen in figure 9). Despite the apparently poor condition of the timber, no significant distress or distortion was noted in the wall above.

The condition of the timber boards behind the mathematical tiles is of concern as the fixing of the clay units is compromised. Particular areas of concern are above windows and at the base of the wall where significant distortion was observed.

Figure 9. Distortion over window

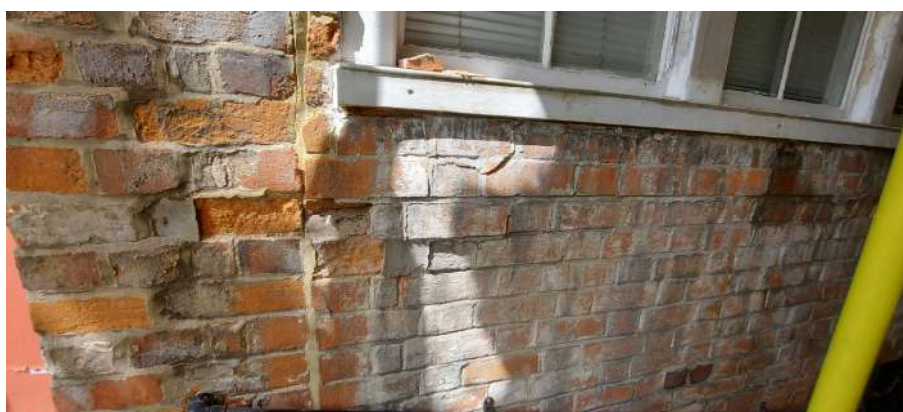
Figure 10. Ground floor – significant distortion

The variable (and often poor) condition of the pointing is allowing water to penetrate the wall, allowing the timber boards to decay locally. Where distortion occurs the mortar joints are opened up, allowing more water to penetrate and cause damage.
