**RE: PROPOSED WORKS TO 1NO. NORWAY SPRUCE AT ROMAN CATHOLIC CHURCH OF THE ENGLISH MARTYRS, LIEBENROOD ROAD, READING - T1 OF TREE PRESERVATION ORDER NUMBER 51/06.**

Further to mine and my colleague Sarah Hanson's visit of 1<sup>st</sup> July 2026, and with reference to the Tree Condition Survey, May 2026, Ref: 07023/2026, I have the following comments:

#### T1 Norway Spruce of TPO; T1 Douglas Fir of Survey

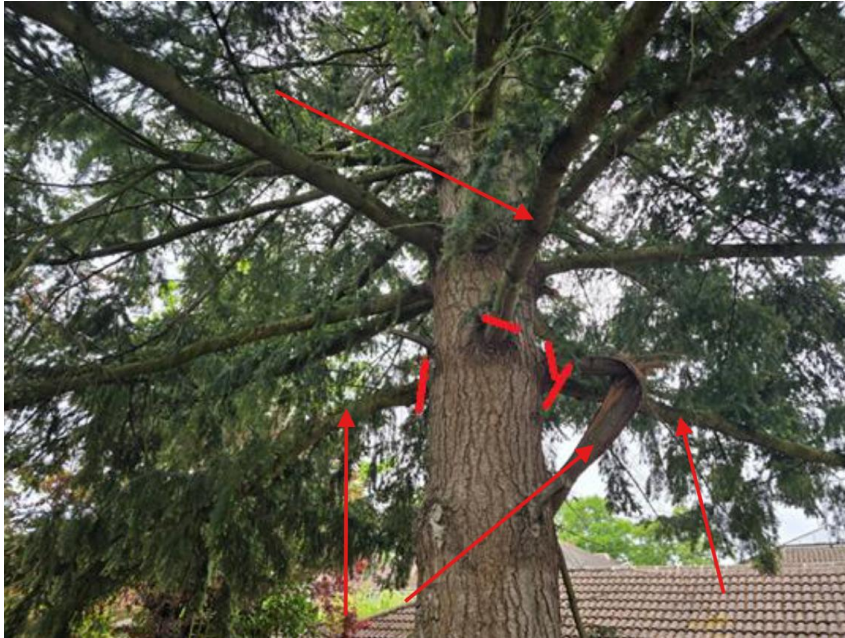
The four branches of the first whorl are proposed to be removed back to their source (main stem). Given the defects mentioned in your Tree Condition Survey, including the failed/broken branch and the splitting of timber in two others, this is considered reasonable. Removing these branches, along with the reductions discussed below, will hopefully reduce the likelihood of failure, similar to that experienced by one of the branches already. The other branch without any defects is growing low and close to the building, hence it's removal to create clearance is considered appropriate. It is best these

Figure 1: 4no. branches within the first whorl to be removed back to source

- Remove lower whorl of branches which includes of 1no. broken branch, 2no. split branches and 1no. branch with branch tips overhanging the building/parking area back to source, as shown in Figure 1 below;

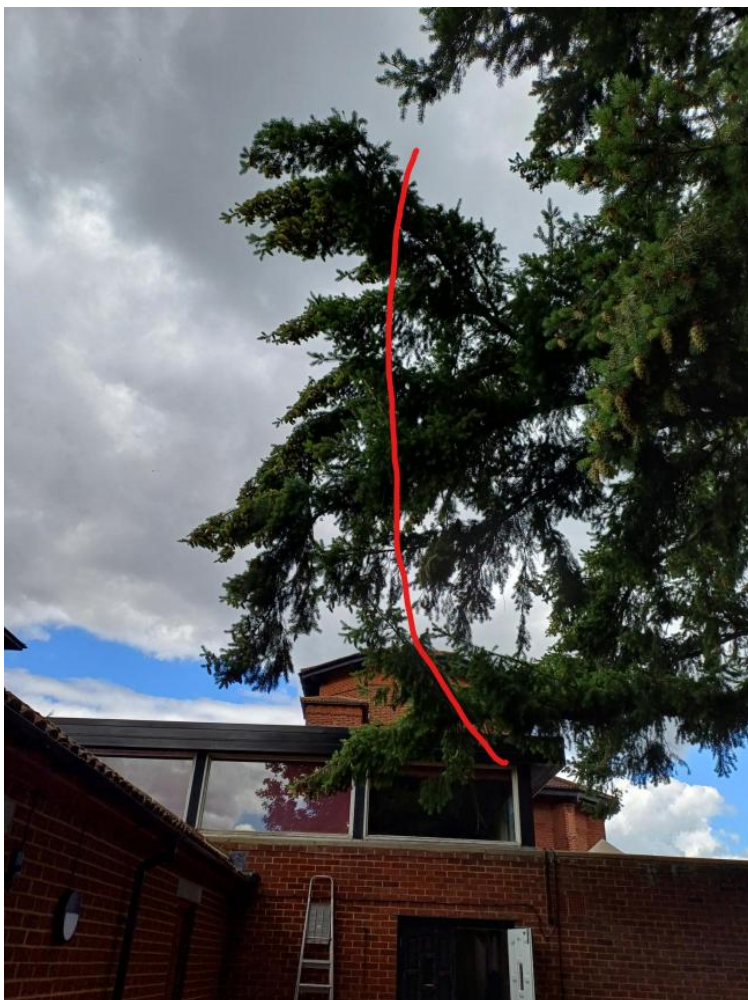
Figure 2: tip reduction of the lower branch on the west aspect by approximately 2m

- Tip reduce the lowest branch on the west aspect by approximately 2m (see Figure 2), ensuring no more than one third of the foliage is removed from the branch, leaving suitable growth points;

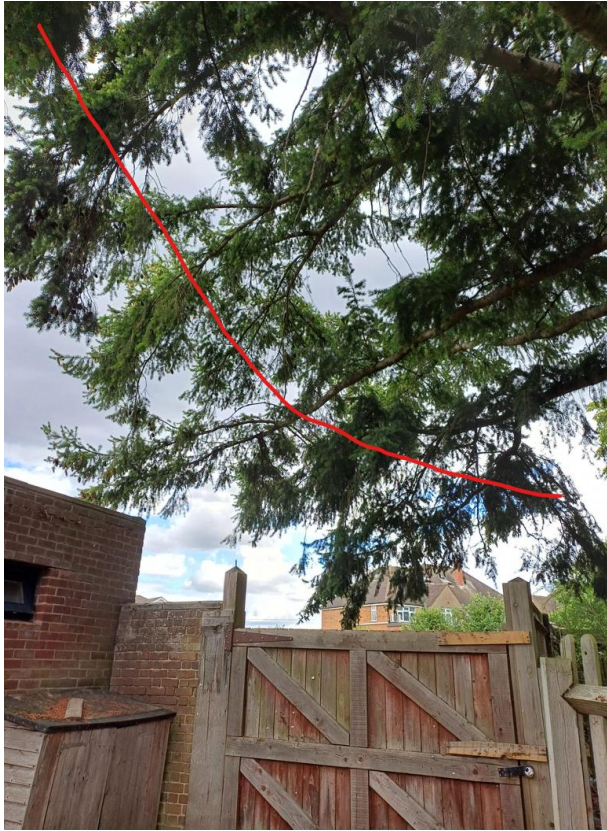
Figure 3: tip reduction of lower branches on the northeast aspect by approximately 1.5m

- Tip reduce lower branches on the northeast (see Figure 3 & 4) and northwest aspects (see Figure 4) by approximately 1.5m, ensuring no more than one third of the foliage is removed from each branch, leaving suitable growth points;

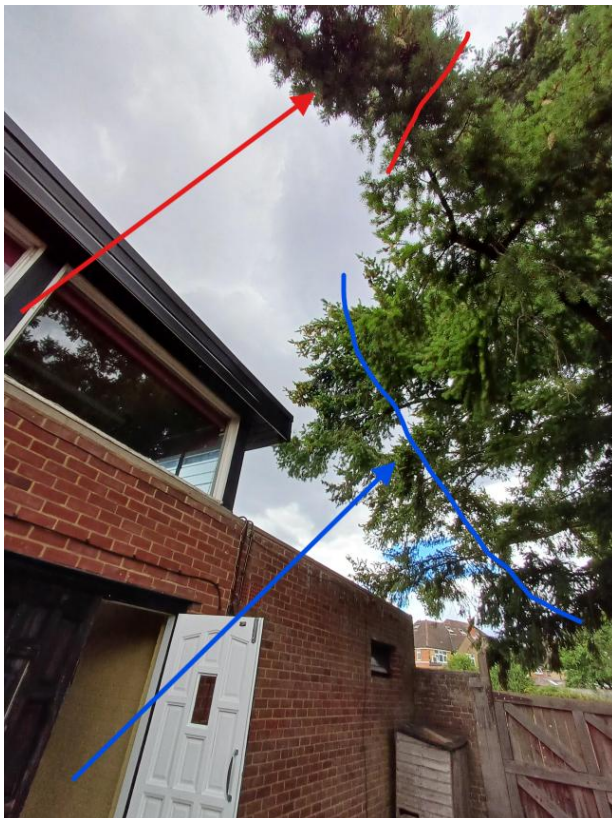
Figure 4: tip reduction of lower branches on the northeast (blue) and northwest aspects (red) by approximately 1.5m

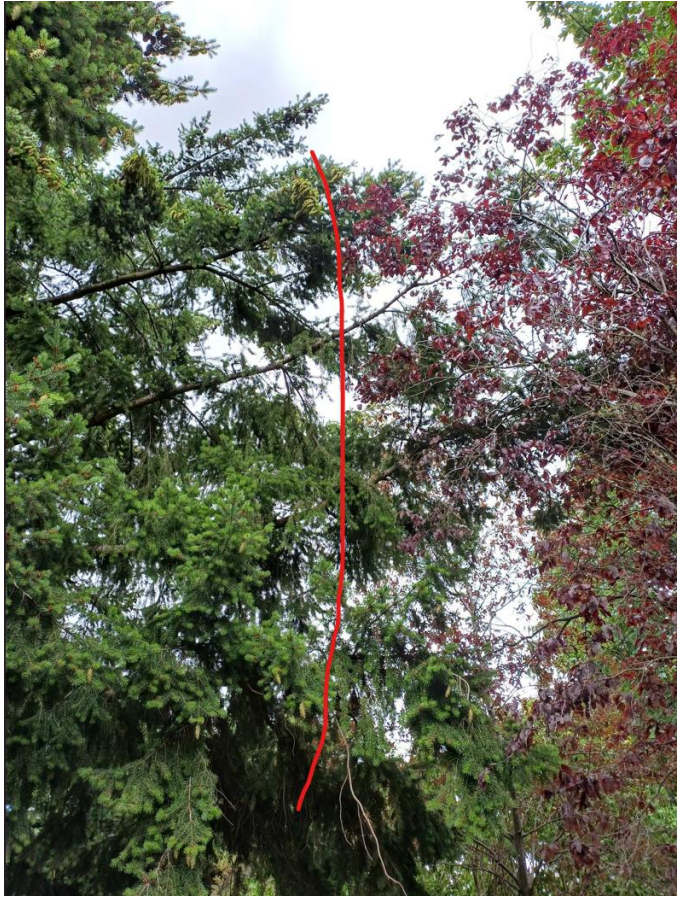
Figure 5: tip reduce branches growing towards the adjacent Plum tree on the south aspect to create approximately 1m clearance

- Tip reduce the branches on the southern aspect (see Figure 5), growing towards the adjacent Plum tree to create approximately 1m clearance, leaving suitable growth points.
