86 London Street  
Reading  
Berkshire  
RG1 4SJ

Structural Inspection & Recommendations  
of Timber Ground Floor

July 2026  
Project Ref: 267052

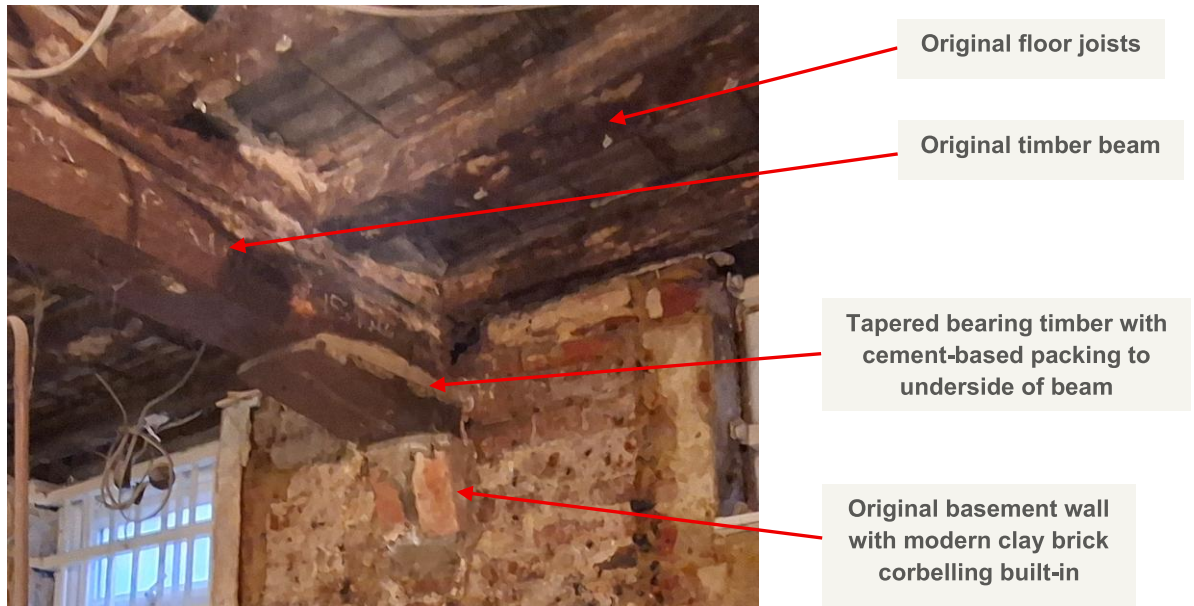
- f) The timber beam built into the front elevation recorded low to moderate levels of moisture, with no signs of timber decay recorded.
  - g) The timber beam built into the rear has extensive timber wet rot (see iii below), with a very high moisture level recorded.

Figure 8. Remedial works to the enhance rotten end bearing

The worst affected historic timber is the primary timber beam built into the rear elevation, which has suffered significant wet rot / decay leading to loss of structural integrity and material. Interventions have been made to enhance the bearing via brick corbelling and tapered bearing timbers, with cement-based packing and void filling. The remedial works have proven to be successful to date, however, due to continued dampness and decay we consider the remedial detail to no longer be fit for purpose. We recommend that the existing brick corbel bearing is replaced with a new stainless steel fabricated angle, connected to a new concrete padstone replacing the brick corbel. Alternative solutions considered include:

Based on the above, we recommend the stainless-steel shelf angle solution, as this has the least impact on the existing historic structural elements.

- 2) The timber beam built into the rear wall is supported by a new stainless-steel angle, affixed to a new concrete padstone, replacing the existing brick corbel. This will have the least impact on the original structure and only replace the newer brick corbel elements that have previously been installed.

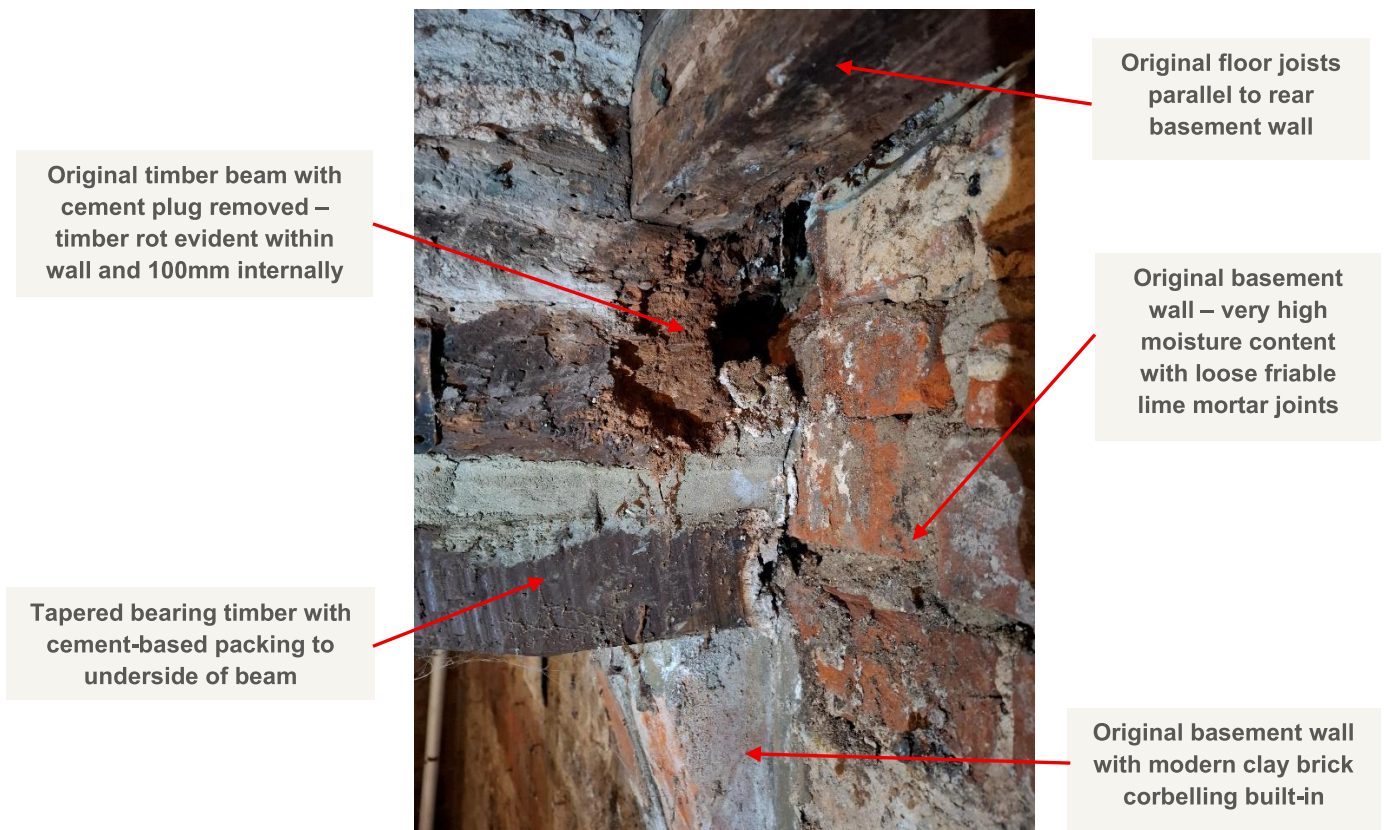
- iii. The timber beam built into the rear elevation, as previously mentioned, has a history of timber wet rot, as evidenced by the remedial works undertaken to the bearing, that have been carried out at some stage in the property's history (Fig. 8). The remedial works consist of the insertion of a new clay brick corbel into the original wall, with a tapered bearing timber installed over, between the new brick corbel and the original beam. The gap appears to have been packed out with a cementitious mortar / dry pack. The voids within the beam due to wet rot had been infilled with a cementitious mortar, which was extracted during the investigation (Fig. 9).

Figure 9. Close-up of remedial bearing

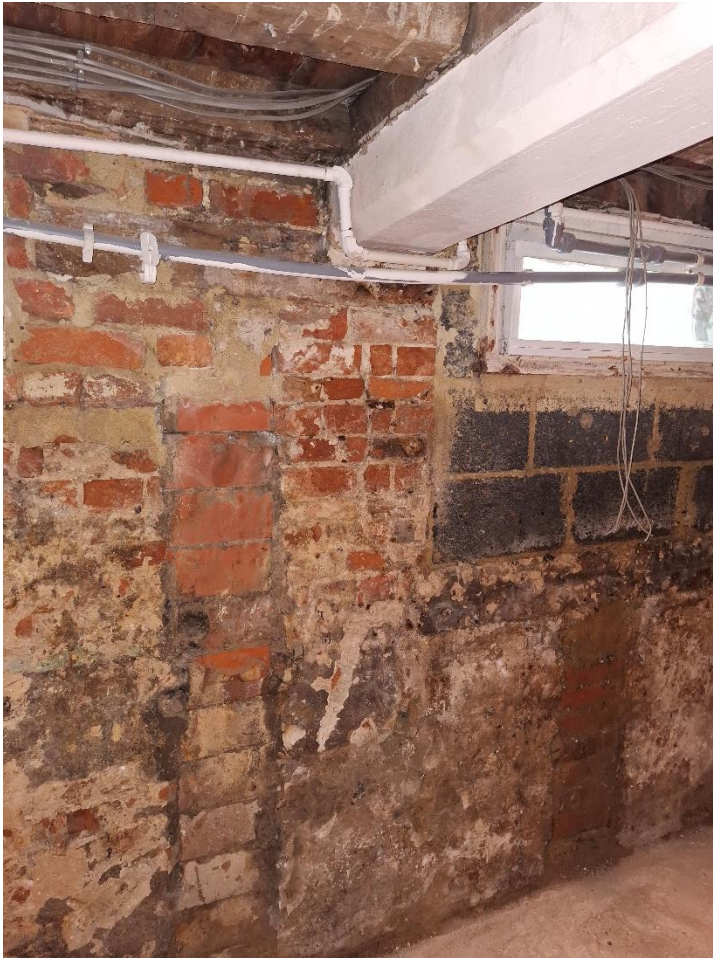
- iv. The timber floor beam built into the front elevation shows no signs of decay and the timber offered sufficient resistance when probed with a small flat-headed screwdriver. It was noted that the front elevation basement wall has been remodelled historically, with new brick / block inserts evident, all with extensive repointing (Fig. 10). No remedial works are deemed necessary at this location.

Figure 10. Timber beam supported by remodelled basement wall to the front elevation

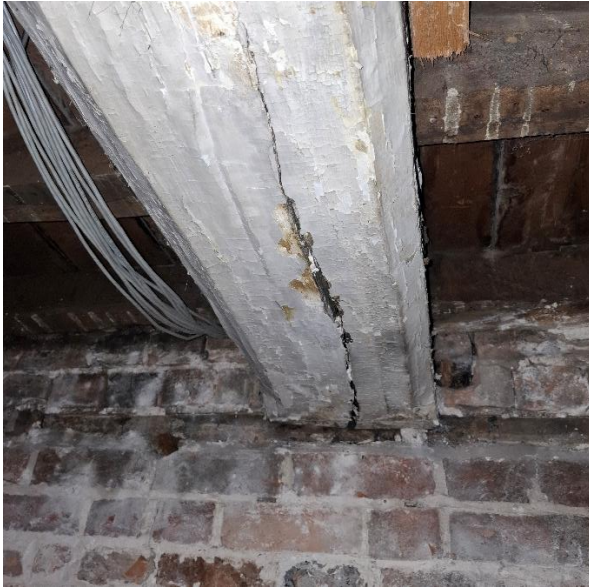
- v. The timber beam from the front elevation is supported by an original internal load-bearing wall via an embedded timber wall plate. The timber beam exhibited a longitudinal split near the bearing (Fig. 11). However, this is considered an inherent defect of the timber section and not related to loading or moisture defects. Both the timber beam and internal wall had low moisture readings when tested. The supporting wall appears to be fully repointed in a cementitious mortar. No remedial works are deemed necessary at this location.

Figure 11. Timber beam supported by internal brick wall via embedded timber wall plate

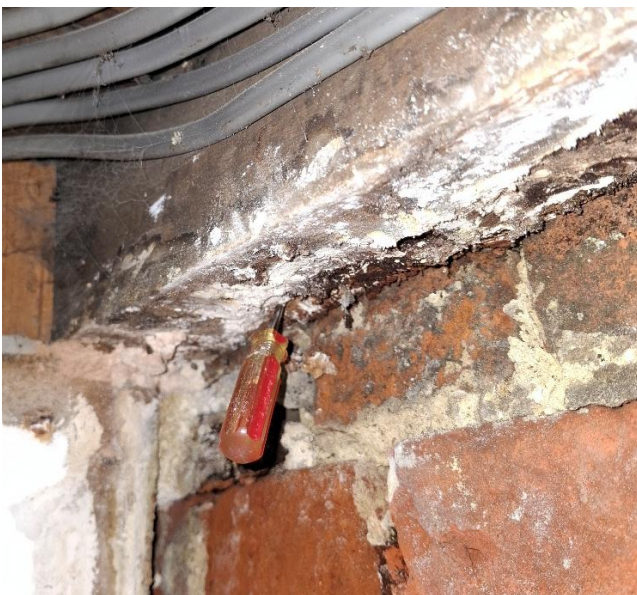
- vi. As previously noted, the timber joists that run adjacent and parallel to the front and rear basement walls recorded high levels of moisture due to the proximity of the timber to the saturated walls. Several of these joists presented little resistance when probed with a small flat-headed screwdriver (Fig. 12).

Figure 12. View of timber joist parallel to front elevation basement wall with screwdriver probe

Existing joists adjacent and parallel to the damp front and rear basement walls recorded high moisture levels, with signs of wet rot and loss of integrity as identified by probing with a small flat-headed screwdriver. We recommend that the existing timbers are retained and supplemental joists are installed adjacent to them to support the floorboarding to the ground floor.

- 3) New supplemental joists are installed parallel to the outer joists adjacent to the damp walls.
- 4) New timber wall plates are to be installed to provide additional bearing to the embedded floor joists that show signs of damp and whose integrity has been compromised in several locations.

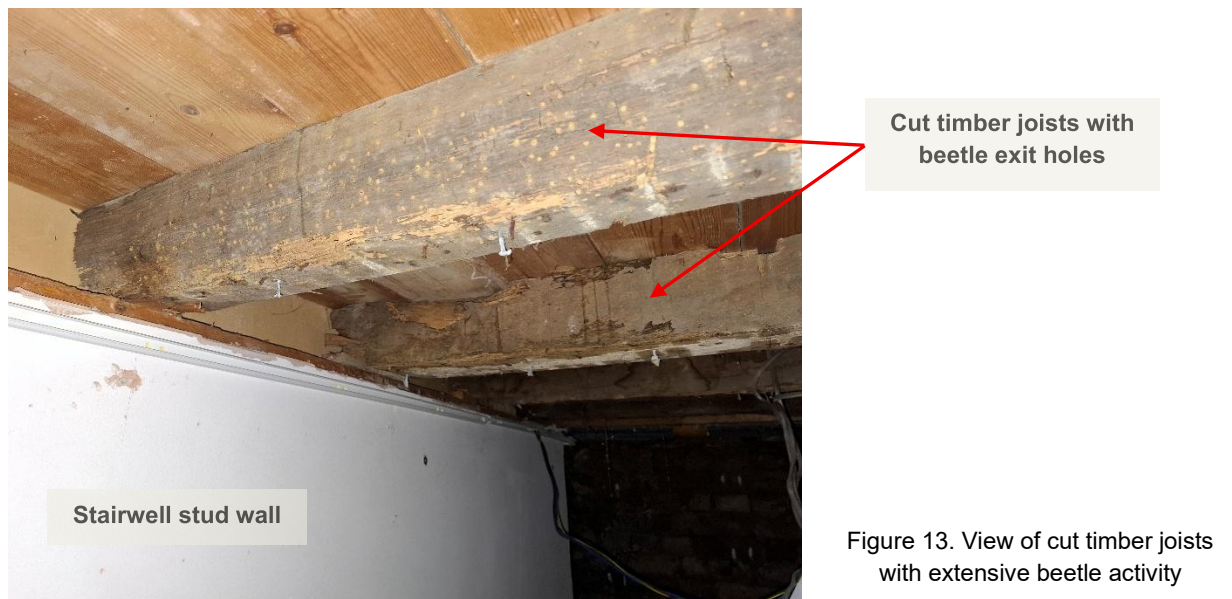
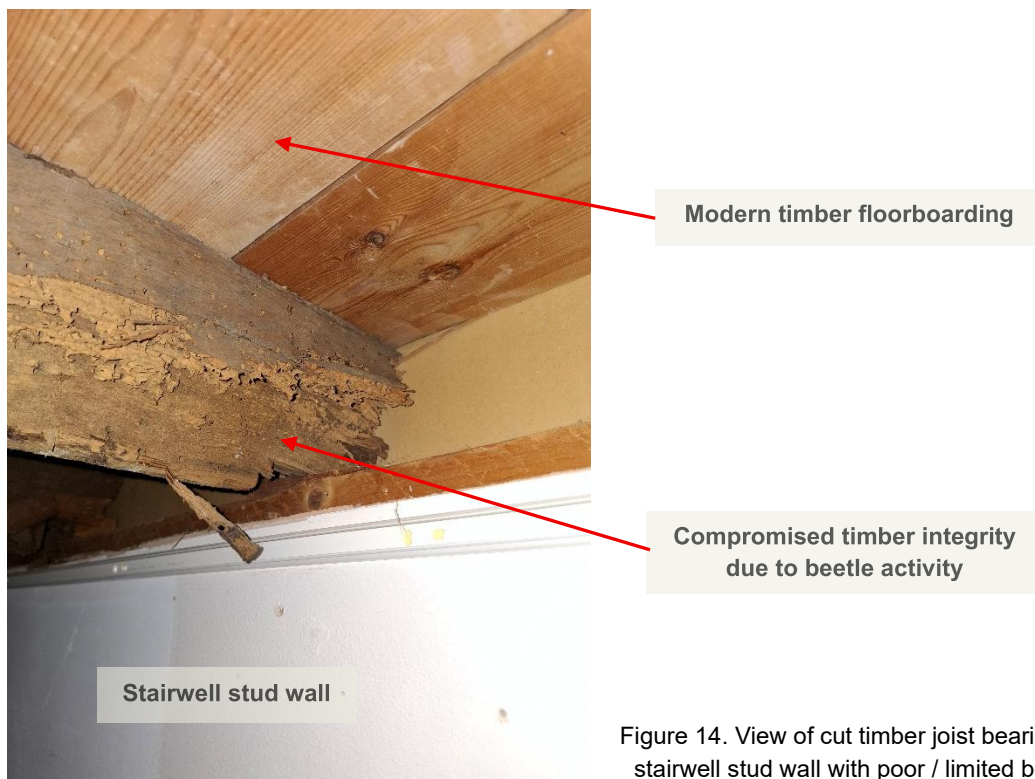
- vii. The floor timbers adjacent to the stair appear to be newer, repurposed timbers that have been modified / cut to form a new opening for basement access at some time during the history of the property. The timbers are in poor condition, with extensive beetle holes and loss of structural integrity due to beetle activity. In addition, the bearing for the cut timbers is very poor, with minimal / limited bearing, likely attributable to the poor timber quality (Fig. 13 & Fig. 14).

Newer or repurposed timbers used to form the stairwell to the basement have been significantly affected by beetle activity, such that their structural integrity has been compromised. These timbers should either be replaced or supplemented with new floor joists if the existing timbers need to be retained for conservation purposes.

- 5) Provide supplemental floor joists adjacent to the stairwell joists due to the structural integrity being compromised by beetle activity.
