## **Arboricultural Report**

**9 Chalgrove Way, Emmer Green,  
RG4 8SJ**

July 2026

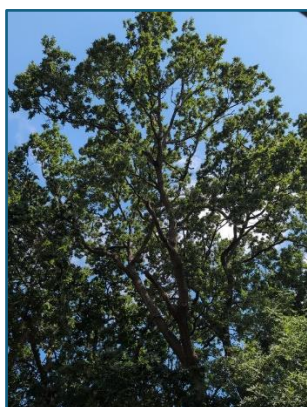
The oak is a mature tree of significant proportions, approximately 14 m in height with an average crown radius of 8 m and a stem diameter of approximately 109 cm. At the time of inspection, the tree was in good overall physiological condition and displaying good crown vitality.

*Photo from SW*

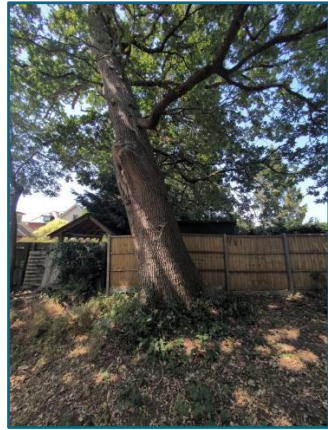
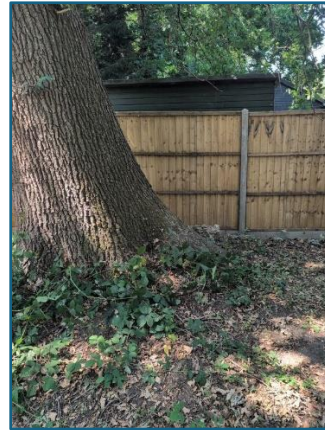
The tree has a pronounced lean of approximately 25° in a southerly direction. Pronounced basal buttressing and adaptive growth are present and are considered indicative of a long-standing physiological response to the tree's lean. No obvious recent movement, soil cracking, lifting of the root plate or other observable indicators of basal or root instability were identified at the time of inspection.

*Photo from east – tree lean, increased buttressing on northern aspect to compensate lean*

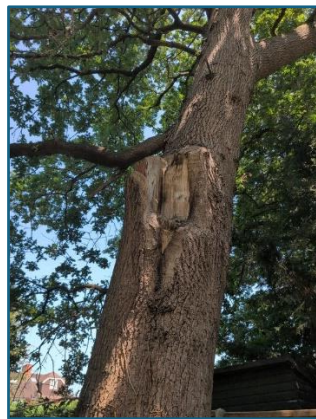
Historic branch tears are present on the south-eastern aspect at approximately 3m and on the southern aspect at approximately 7-8m. Heartwood is exposed at both locations; however, there is evidence of progressive occlusion around the wound margins. At the time of inspection, no obvious external indicators of significant decay or dysfunction associated with these wounds were observed.

*Branch tears; South eastern aspect 3m*

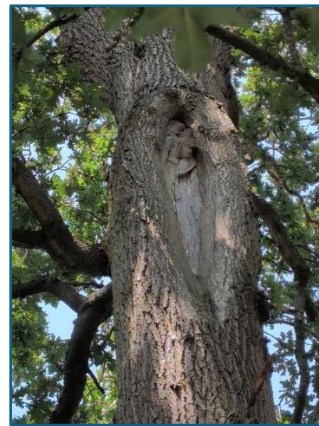
*Southern aspect 7-8m*

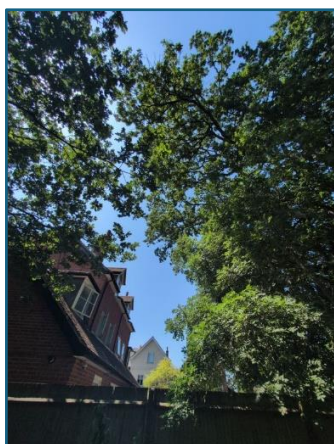
The main stem bifurcates at approximately 6m, with a significant limb extending in a south-westerly direction. The limb has an approximate circumference of 1.5m and its union with the main stem appeared visually sound at the time of inspection. The crown is asymmetrical, with a pronounced bias towards the south-west. Secondary branch growth associated with the south-western limb extends over the neighbouring property, 9 St Benet's Way, with non-structural secondary branches extending approximately 1-2 m beyond the roofline of the main structure. Further secondary branch growth within the upper crown overhangs the rear garden of 9 St Benet's Way.

*Canopy overhanging back garden and rear elevation - 9 Benets Way*

- **The southern and south-western aspects of the crown are reduced by pruning secondary branches back to suitable growth points to achieve a minimum clearance of 4m between the rear elevation of the dwelling and the retained canopy.**
- **Significant dead wood greater than 2.5cm in diameter should also be removed throughout the crown.**
- **The child's trampoline should be relocated from beneath the canopy to reduce the period of occupancy beneath the tree.**

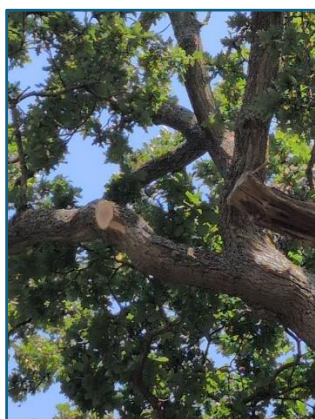
The report was commissioned following the recent failure of a branch from the tree. Evidence of recent pruning was observed at approximately 9m on the south-western aspect, where works had been undertaken to make safe the affected limb. The branch had an approximate circumference of 60 cm. At the time of this inspection, no obvious visual defect or specific causal factor could be identified to conclusively explain the branch failure. Branch failure can occur because of several individual or combined factors, including localised structural weakness, previous damage, loading from wind or rainfall, changes in branch mass and leverage, or internal dysfunction that may not be externally visible. It is therefore not possible, based upon the observable evidence available at the time of inspection, to determine the precise cause of the recent branch failure.

*Remedial work to make affected limb safe*
