Arboricultural Survey Reading Gateway Retail Park

READING GATEWAY  
GATEWAY PROCTOR  
END SOUTH  
READING  
RG2 0GG

EXISTING  
FEATURES  
& OVERLAY

CA- RGW-2026-02 Rev F

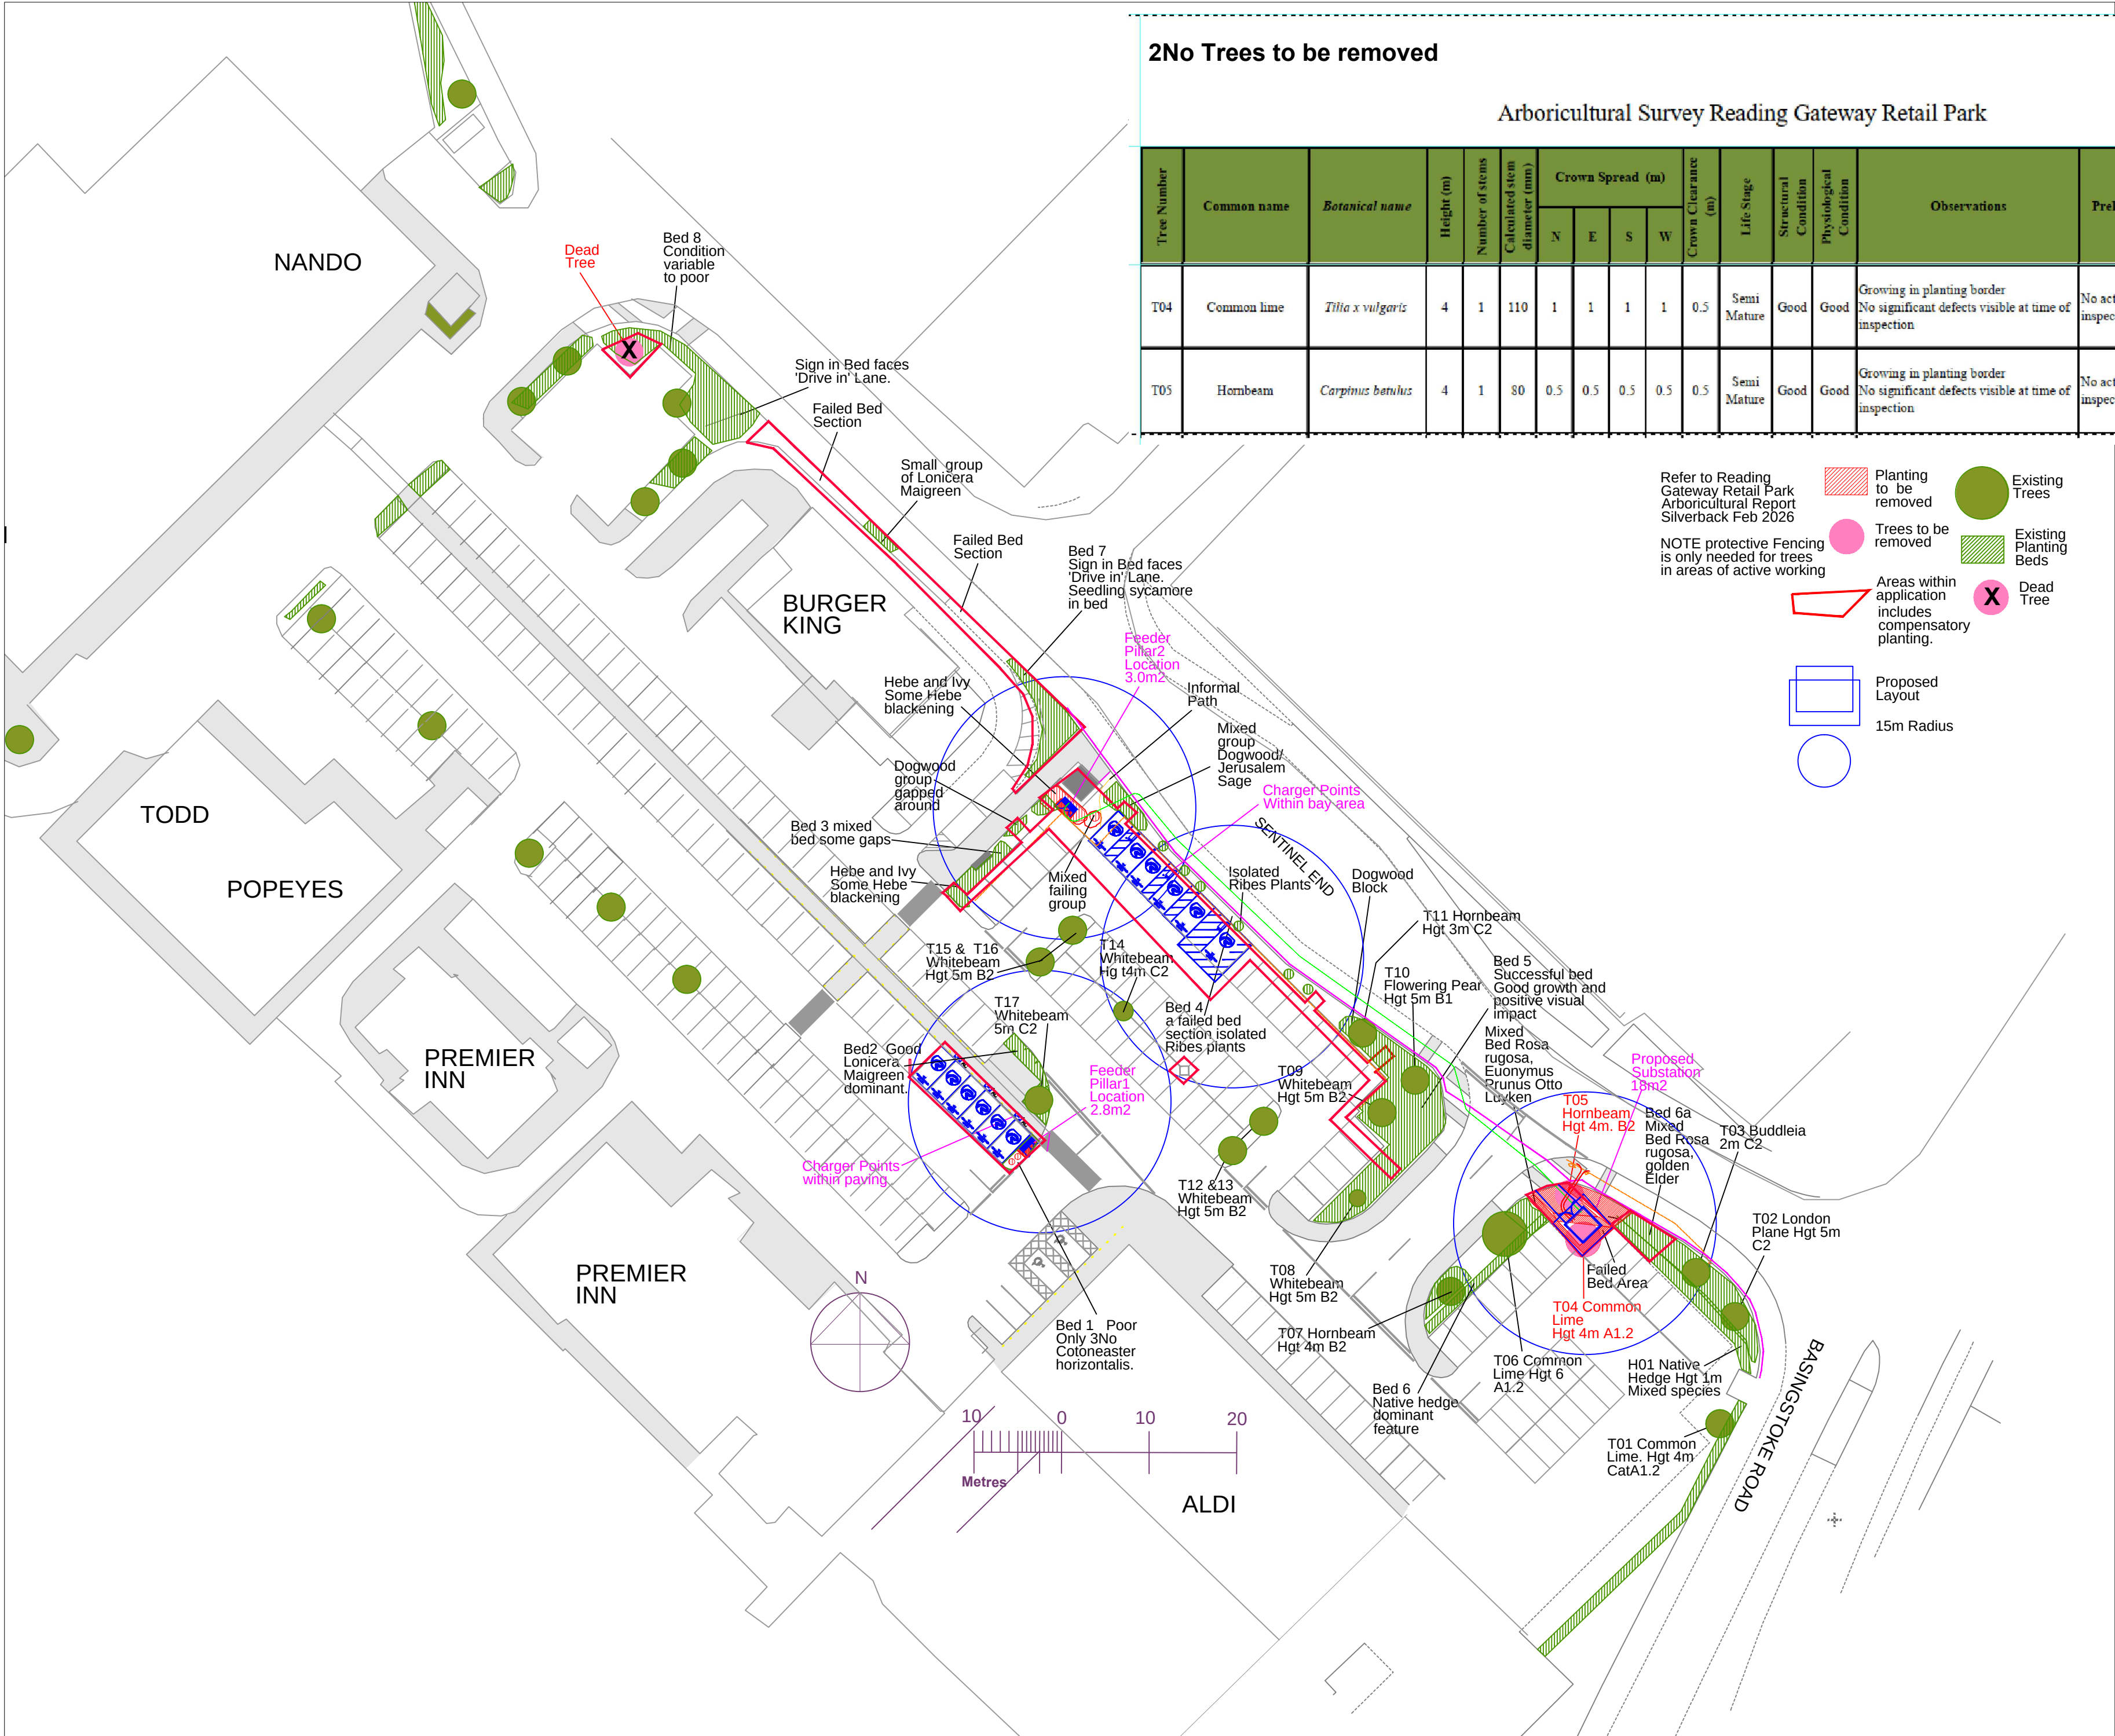
2No Trees to be removed

| Tree Number | Common name | Botanical name | Height (m) | Number of stems | Calculated stem diameter (mm) | Crown Spread (m) | | | | Crown Clearance (m) | Life Stage | Structural Condition | Physiological Condition | Observations | Preliminary Recommendations | Remaining contribution (yrs) | BS Category | Root Protection Area Radius (m) | Root Protection Area m2 |
|---|---|---|---|---|---|---|---|---|---|---|---|---|---|---|---|---|---|---|---|
| T04 | Common lime | <i>Tilia x vulgaris</i> | 4 | 1 | 110 | 1 | 1 | 1 | 1 | 0.5 | Semi Mature | Good | Good | Growing in planting border<br>No significant defects visible at time of inspection | No action required at the time of inspection. | 40+ Years | A1.2 | Radius: 1.3m | Area: 5 sq m |
| T05 | Hornbeam | <i>Carpinus betulus</i> | 4 | 1 | 80 | 0.5 | 0.5 | 0.5 | 0.5 | 0.5 | Semi Mature | Good | Good | Growing in planting border<br>No significant defects visible at time of inspection | No action required at the time of inspection. | 40+ Years | B2 | Radius: 1.0m | Area: 3 sq m |
