## ARBORICULTURAL REPORT

# **Common Ground Estates – The Monastery, Carmelite Drive, Reading**

Tree Condition Report

August 2026

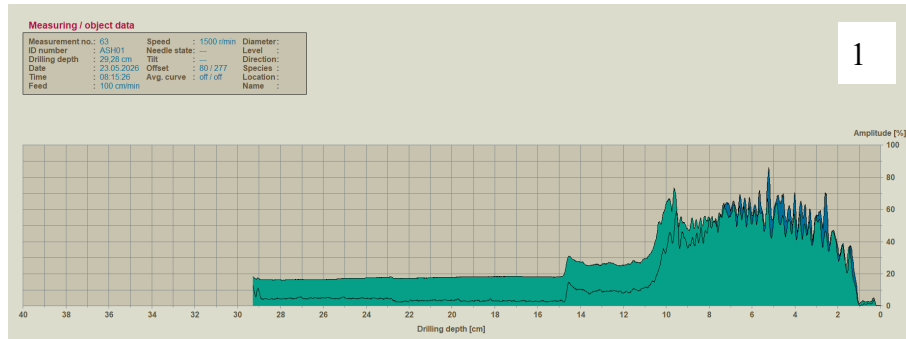
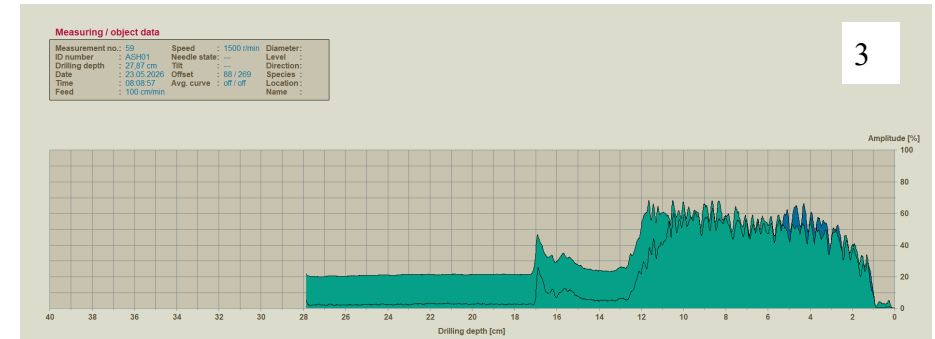
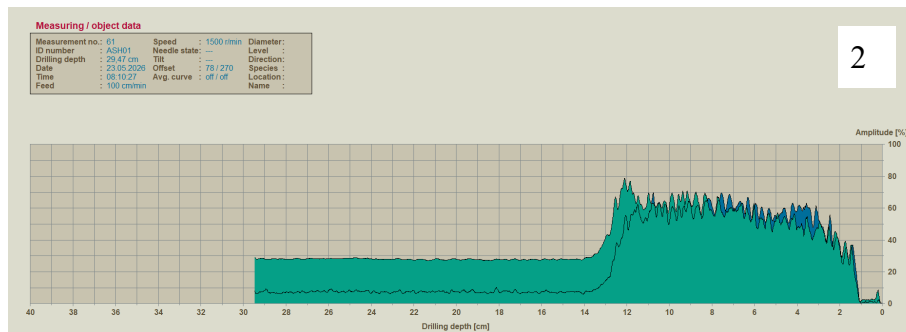
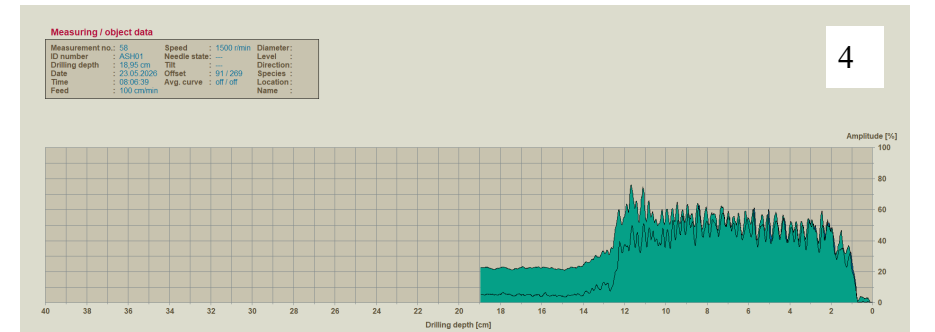
## Appendix 1 – Resistograph Readings

- 5.2 The locations for the Resistograph assessment were informed by the findings of the previous inspection undertaken by Treetech Arboricultural Services Limited. A further area of concern was also identified at a branch arising from the affected stem, which contained a separate cavity.
- 5.3 A total of four Resistograph drill readings were undertaken at locations selected to establish the extent and distribution of the internal cavity.
- 5.4 All four drill readings automatically retracted before traversing the full diameter of the stem, consistent with encountering a significant void or loss of resistance within the stem. Consequently, the readings could not be used to establish the full extent of the residual sound wood. The

assessment was therefore supplemented through probing and sounding with a rubber mallet.

- 5.5 The affected stem was measured at approximately 380mm diameter at the assessment locations, with residual wood thickness recorded at approximately 100–120mm on either side of the cavity. This indicates a substantial proportion of the stem cross-section is affected by internal decay and/or hollowing.
