# Connick Tree Consultants

## ARBORICULTURAL REPORT Individual Tree Assessment Aerial and Tomography

| CLIENT | Mr Andrew Hall for Knighton Close Residents |
| SITE | Land opposite 6 and 7 Knighton Close, Caversham, Reading.<br>RG4 7SZ |

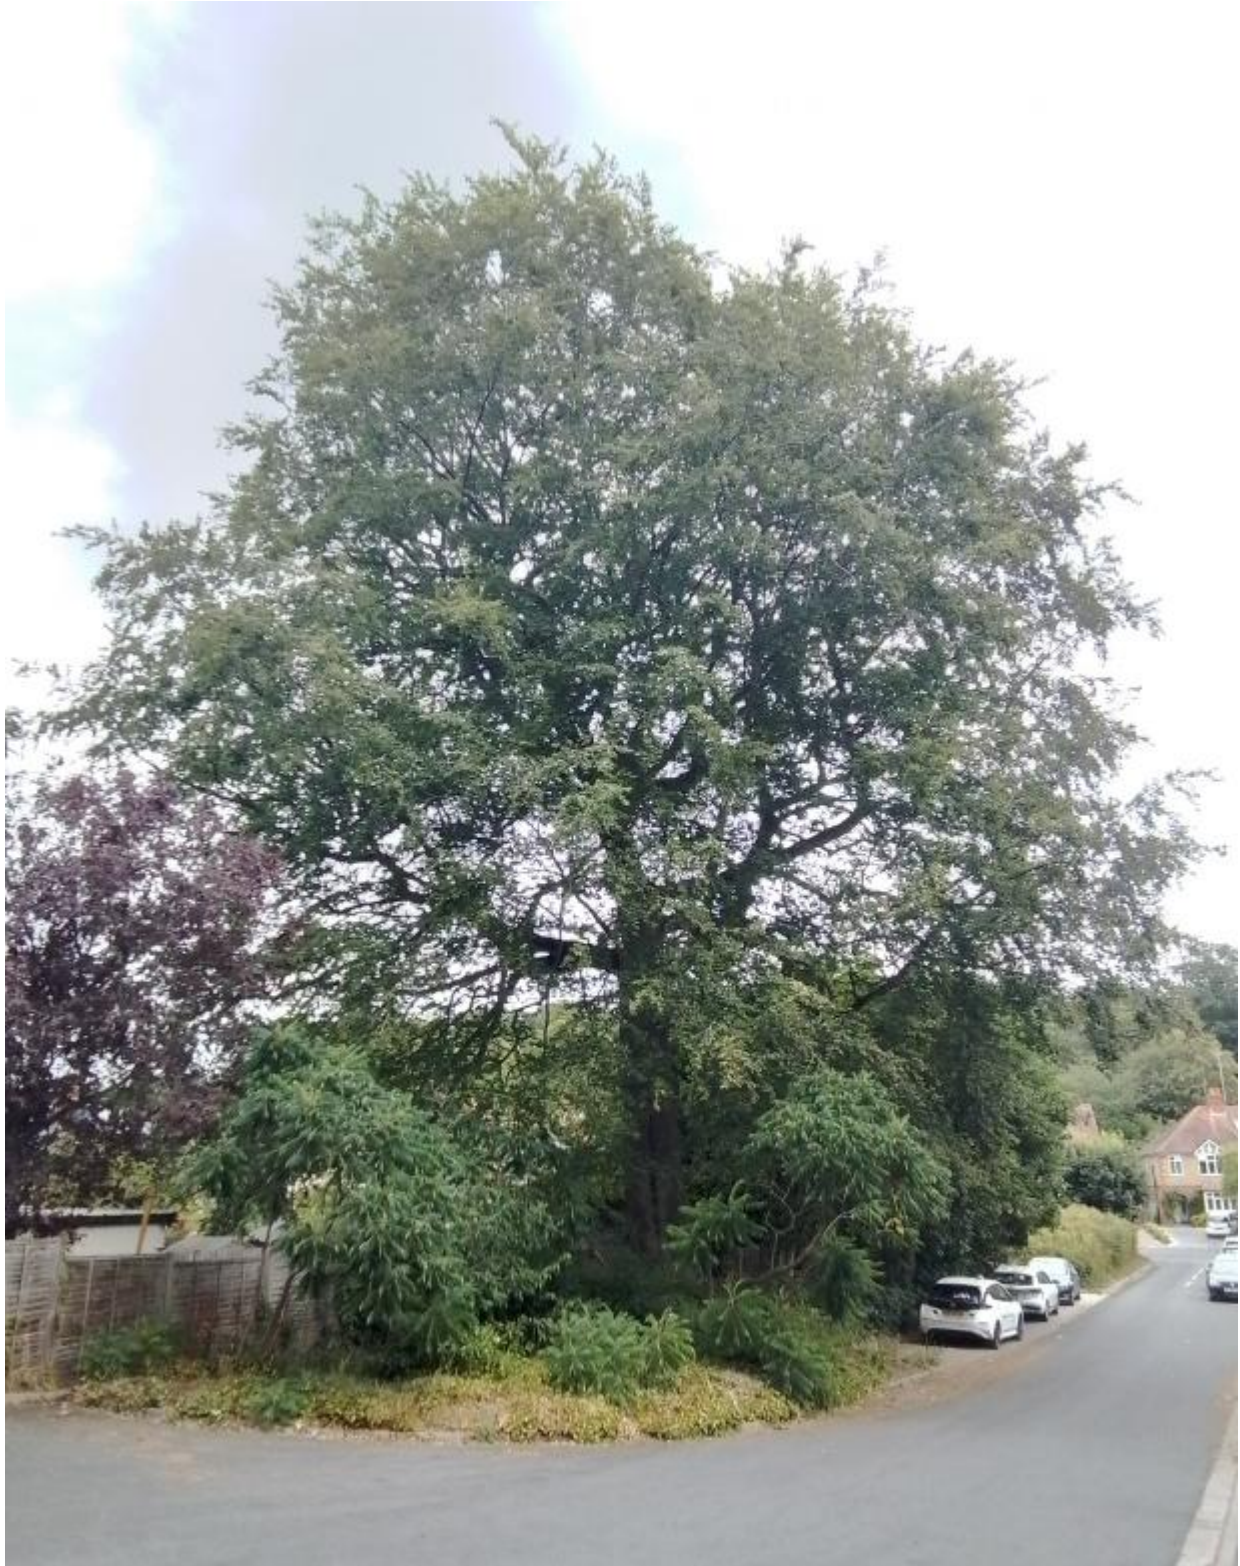
Photograph 1: Showing subject Beech T1 to centre of image

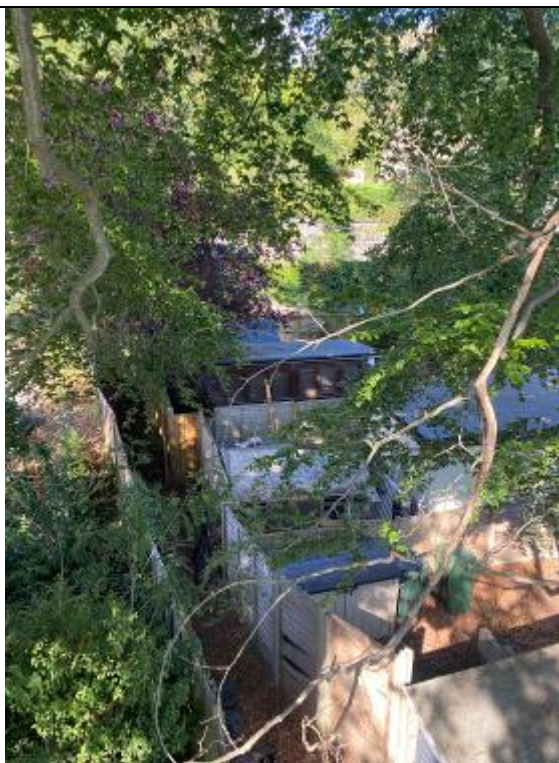
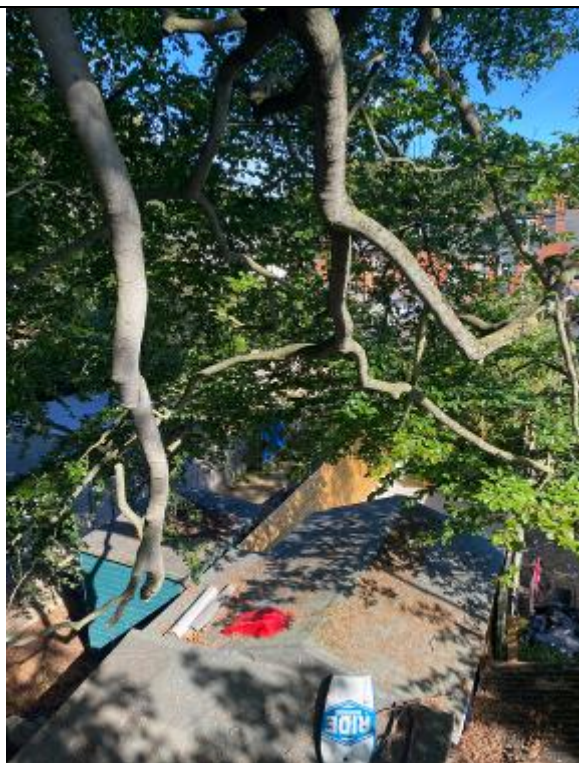
The crown of the subject Beech is extended to the north from a primary scaffold limb. The crown structure extends with long secondary and tertiary branches, many of which descend to the shed roof height. The crown does, however, contain numerous upright secondary limbs that could be utilised in target pruning. (**Images A and B.**)

It is recommended that the Beech tree is subject to a targeted crown reduction focussed on the north, north west and north east low to mid crown.

The reduction will remove approximately 4 metres of secondary limb growth back to significant upright limbs. The removal of the lower drooping branches over shed roofs, also to be undertaken. The image below shows the area requiring significant pruning in red.

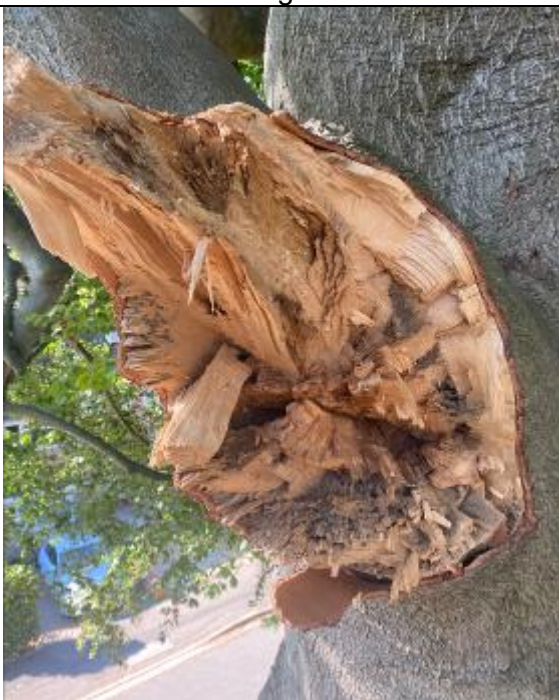
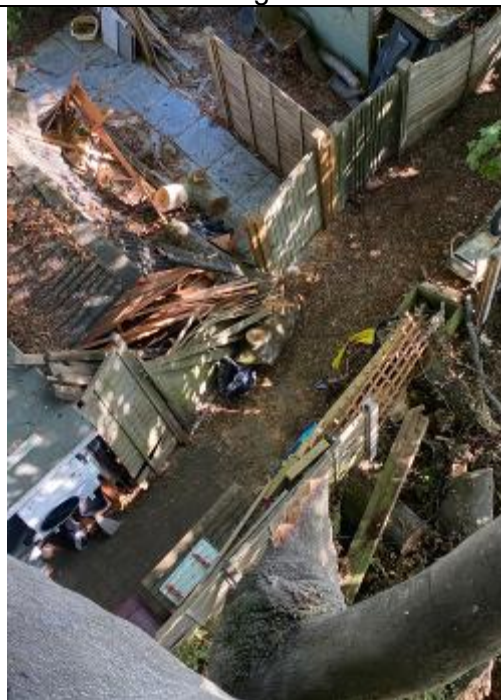
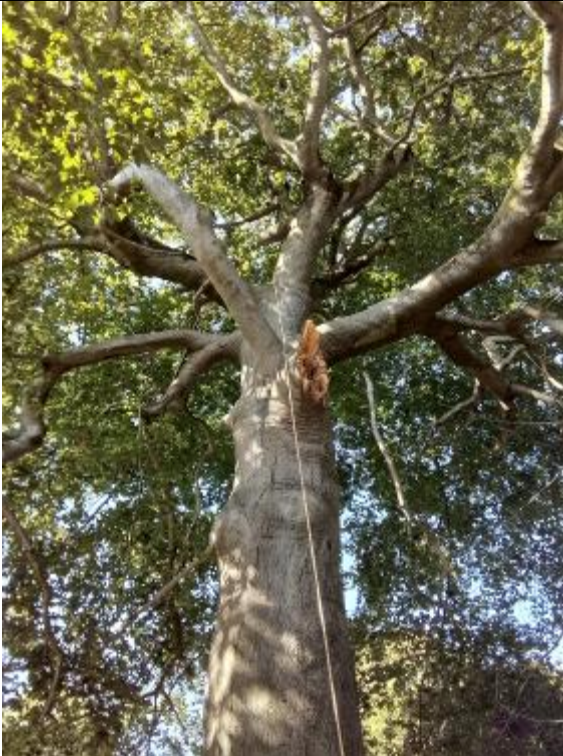
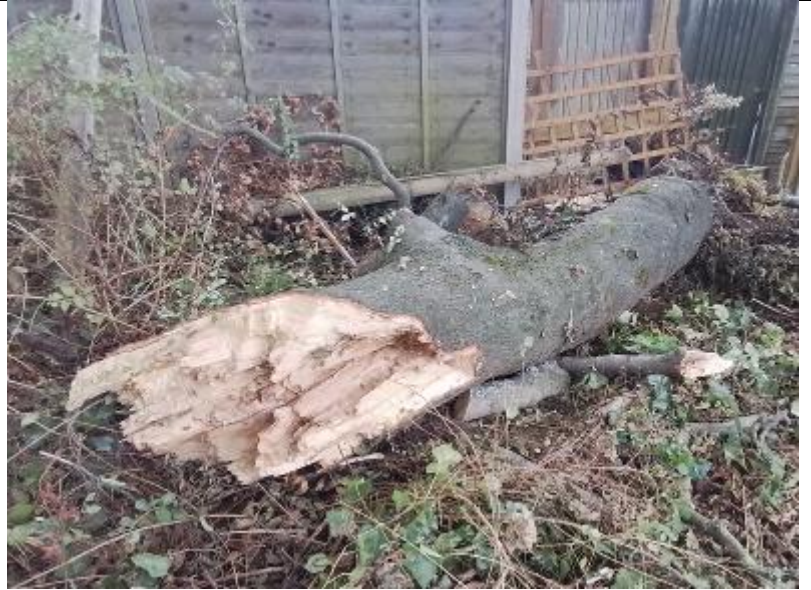
A primary scaffold limb has failed in the north east crown at 8.5 metres above ground level. The limb fractured close to the stem but did not fail at the union with the stem. Short fibres extend from the fracture point. The limb failure has opened the northerly crown to south easterly winds. (**Images C,D,E and F**)

The loss of the large limb in late May appears to have occurred during the night. The limb loss does not meet the anecdotal and limited research information available relating to the conditions in which 'Summer Branch Drop' occurs.

The species is susceptible to the phenomenon, the crown is large and the weather has been exceptionally hot and dry, but the timing of the loss is not consistent with recorded instances.

Although Summer Branch Drop shouldn't be ruled out as a potential issue, the failed limb is more likely to have suffered from storm damage.

The average wind speed in Caversham throughout May 2026 was 8-10 mph. There were however maximum gusts of 36 mph which equate to a force 7- near Gale on the Beaufort Scale. The adjacent Sycamore trees had been 'topped' some time prior to the incident and this may have reduced the mass dampening effect that the trees mutually benefited from. The full healthy leaf on the extended Beech limb acting as a lever arm once exposed.

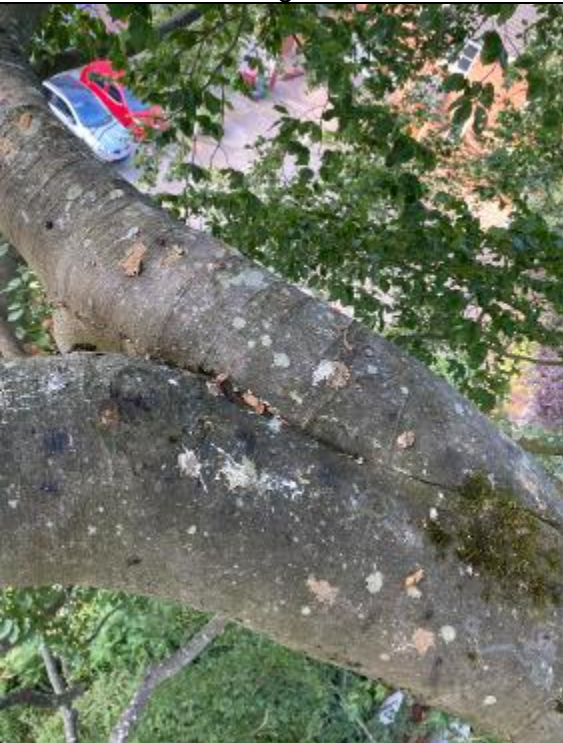
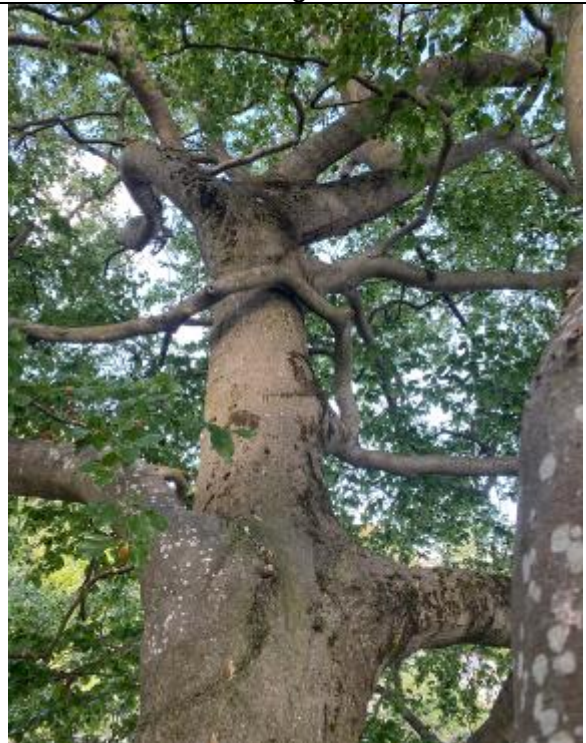
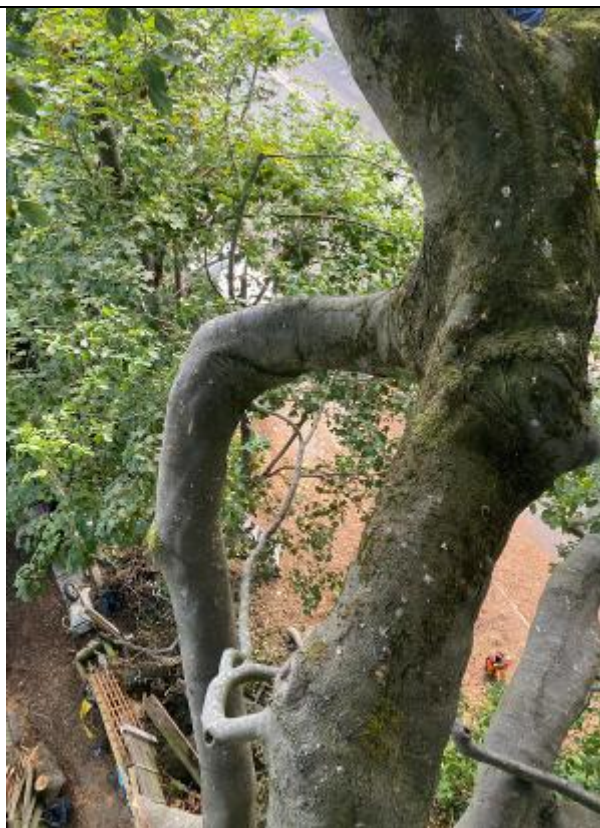
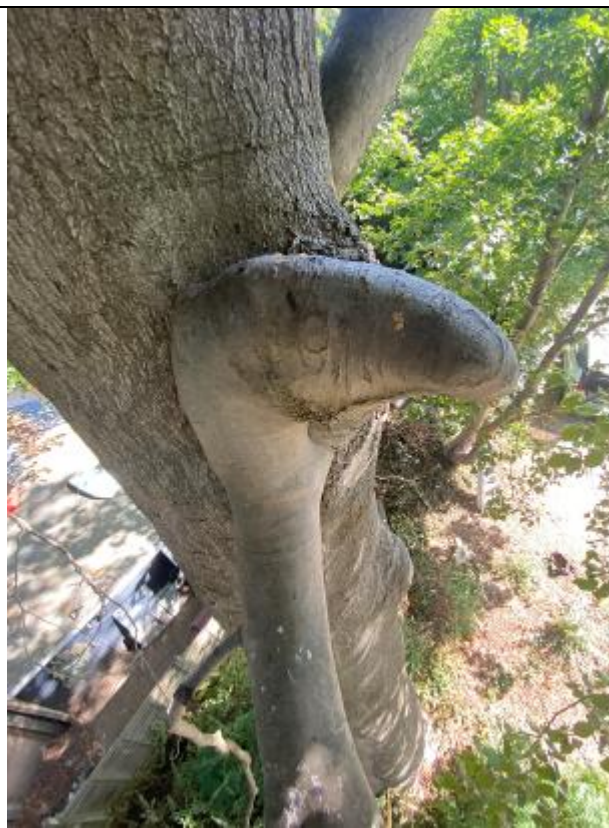
The crown structure is typical of a mature Beech, with numerous crossing branches, dog legged branches and some fusing of limbs. Most notably by the failure point back into the southern crown structure. (**Images G,H,I and J**) There is very little evidence of deadwood throughout the mid and upper crown, no apical dieback is evident and the leaf is of a good colour and dense on the branch. The continued drought conditions do not appear to be affecting the tree at present.

The crown assessment found the structural limbs and branches to be of a normal appearance with no decay visible, no squirrel damage or sun scorched upper branch surfaces. There were a number of peculiar branch shapes and fused limbs, but all major limbs and unions appear normal.

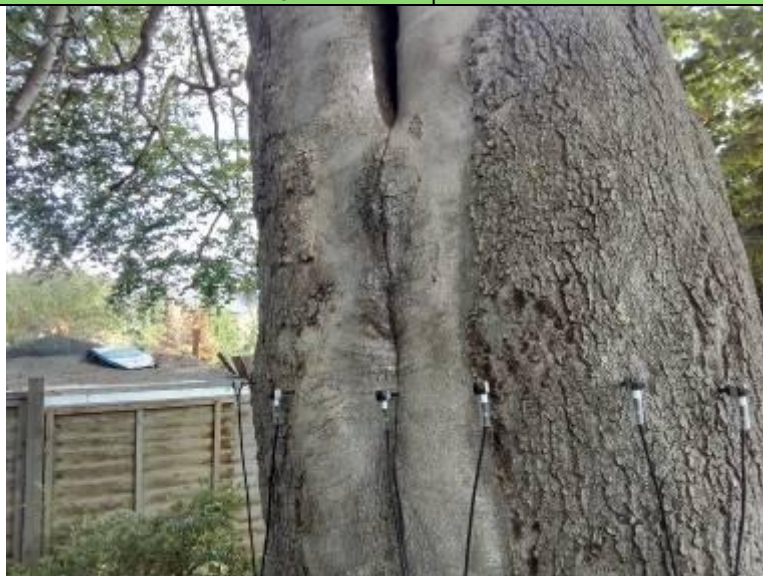
Image 1 170cm Layer

Due to the above observations we decided to undertake a sonic tomography assessment (SOT) of the stem at 170cmH, 250cmH and 330cmH. These will be referred to as layers in this report.

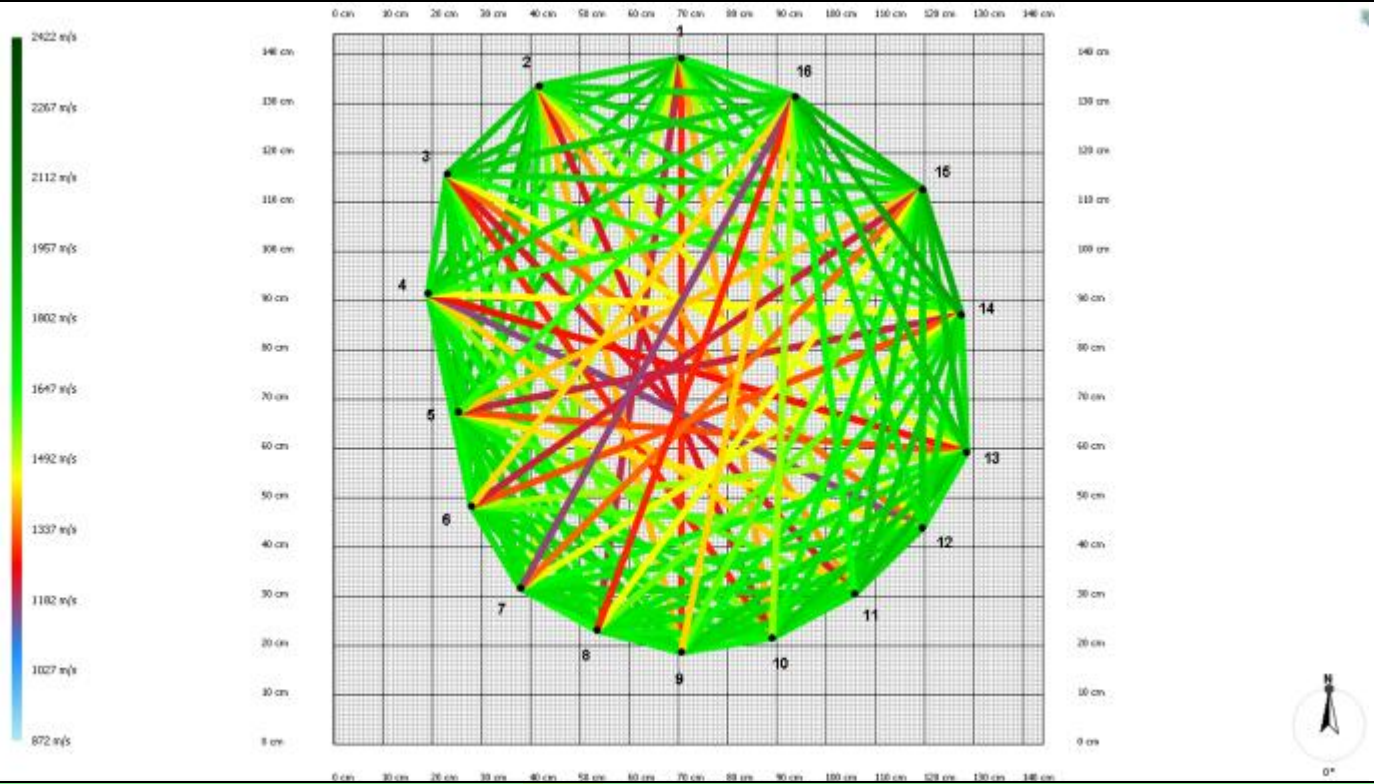
Image 5. 170cmH layer sound speed graph

- An example of how the SOT data is processed is shown above in **Image 5** using the 170cmH layer. This shows the variations in the transfer of sound through the stem. The speed sound is transferred between sensors is coloured depending upon the time taken in meters per second.

- The green lines indicate high sound transfer abilities between sensors indicating that the wood in these areas is generally free of defects.  
The darker red through to light blue lines indicate a slower transfer of sound suggesting decay is present within the wood.

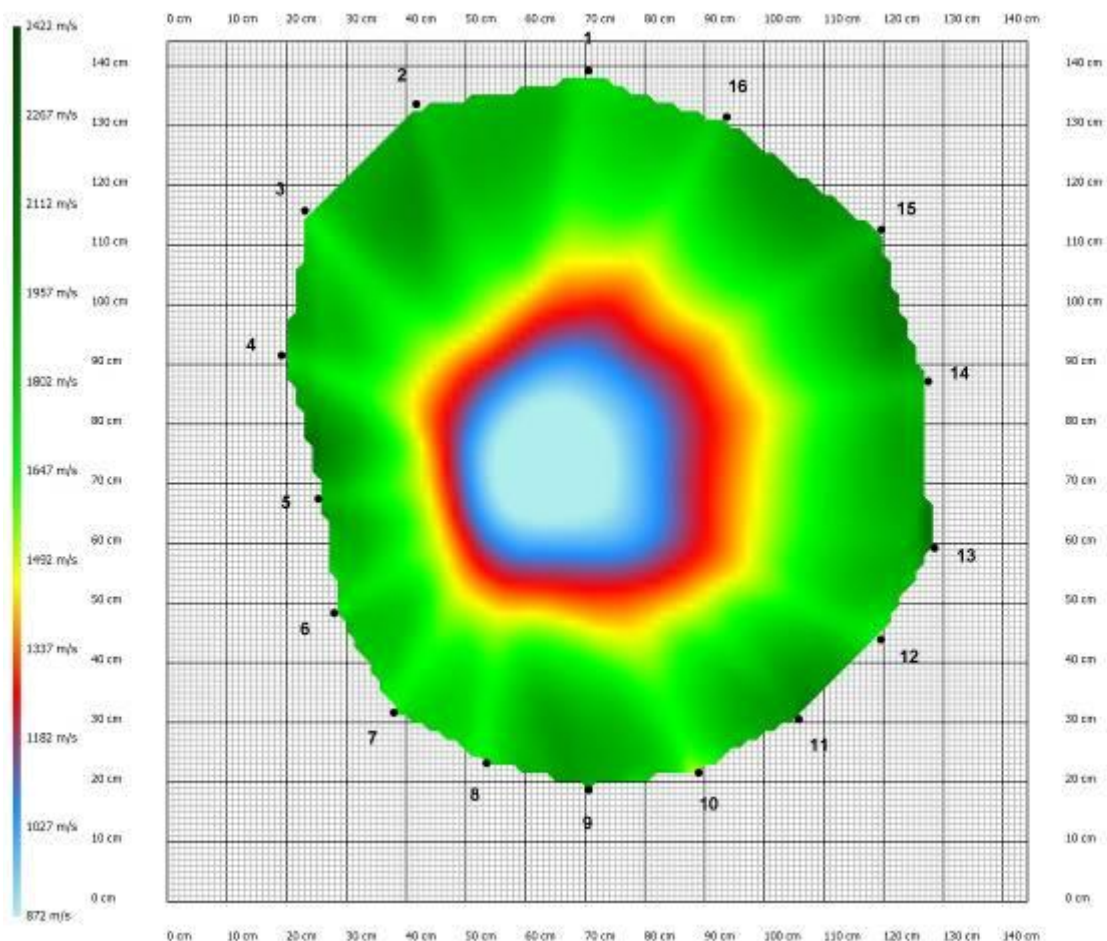
Image 6. 170cmH layer - 2D Map

- The 2D layer( **Images 6, 8 and 10**) provides a pictorial representation of the sound transfer between sensors. This gives a simplified view of the data gathered and indicates visually any transition from unaffected to decayed wood across the section of stem assessed. These images show that ripe wood decay is present within the stem around the cavity site.

- Analysis of the data collected indicates that the potential extent of decay for each section is:  
170cmH layer 27%  
250cmH layer 46%  
330cmH layer 37%

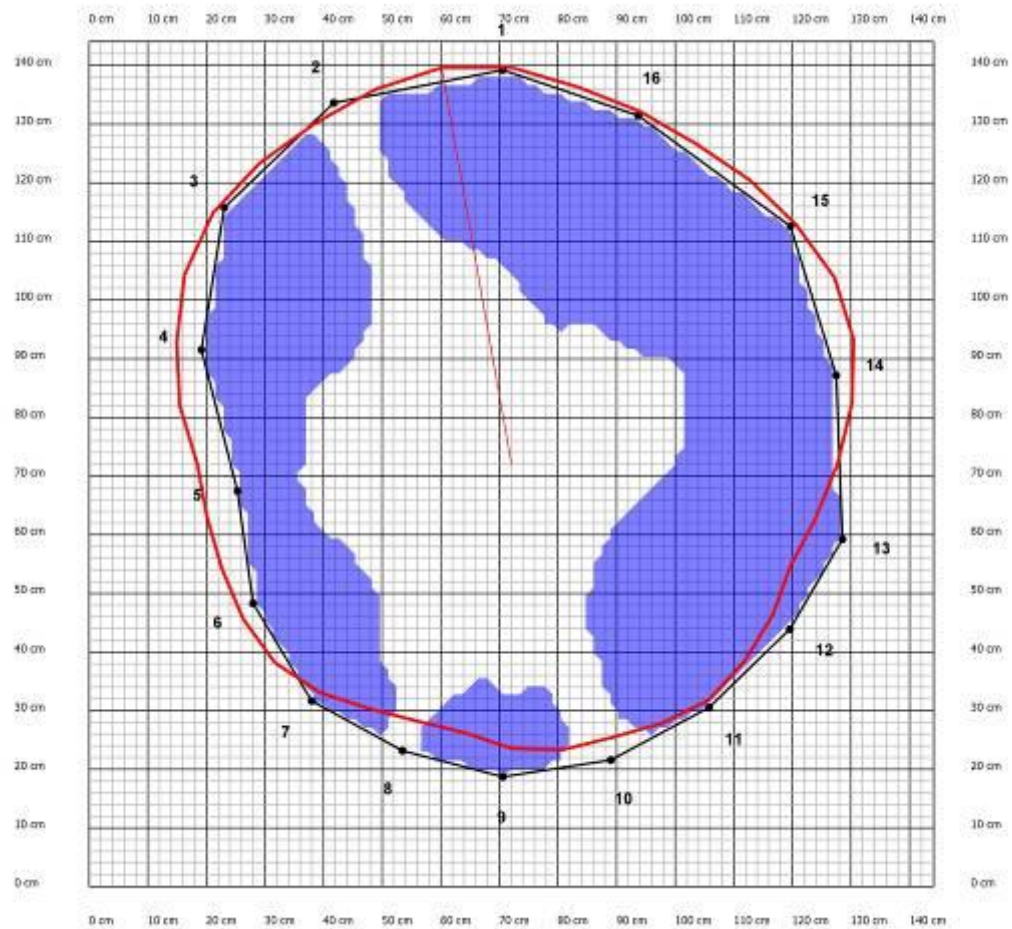
Image 7. 170cmH layer – Biomechanical Layer Map

- The biomechanical layer maps (**Images 7, 9 and 11**) are generated by the software. These consider the on-site measurements recorded for the tree, calculations using **Image 4** and the SOT results.

| 170cmH layer | 534% |

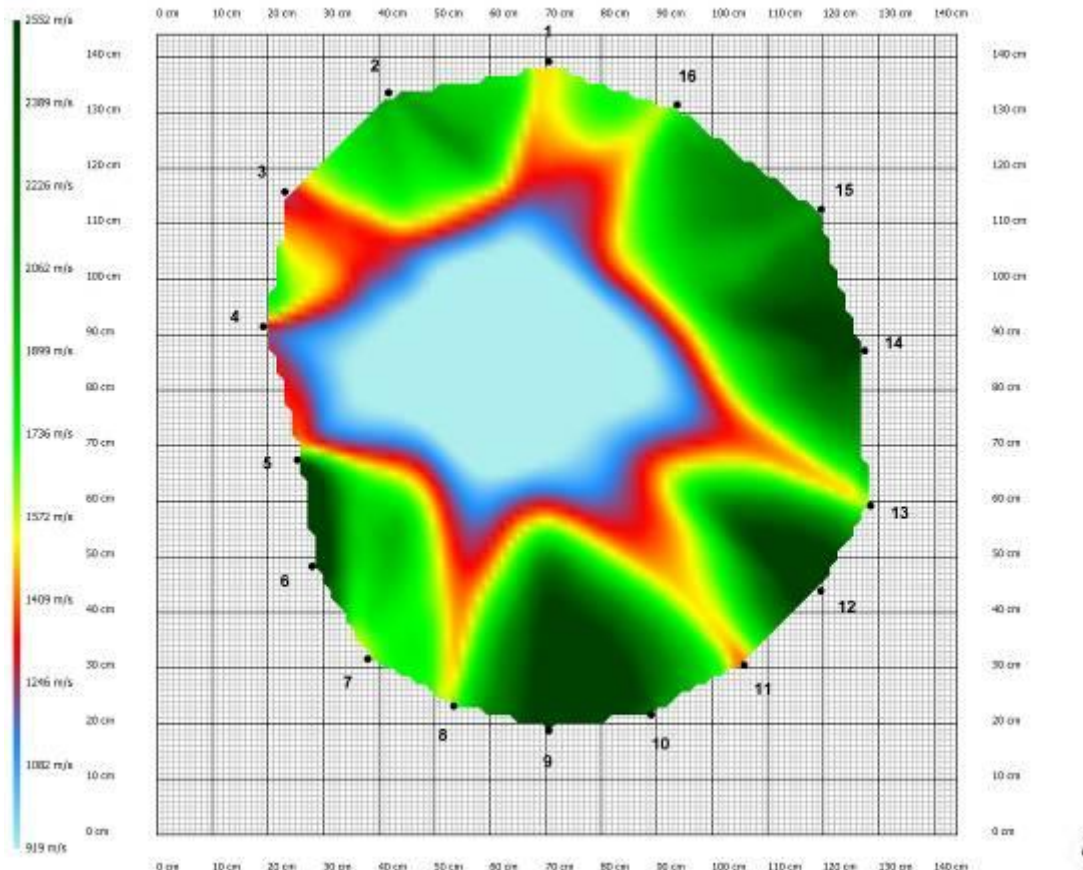
Image 8. 250cmH layer - 2D Map

- The software did identify possible cracking within the wood. Between sensors 5-7 at layer 2. The visual inspection of the stem shows this to be the location of the cavity opening and this has been interpreted by the software as a 'crack'.

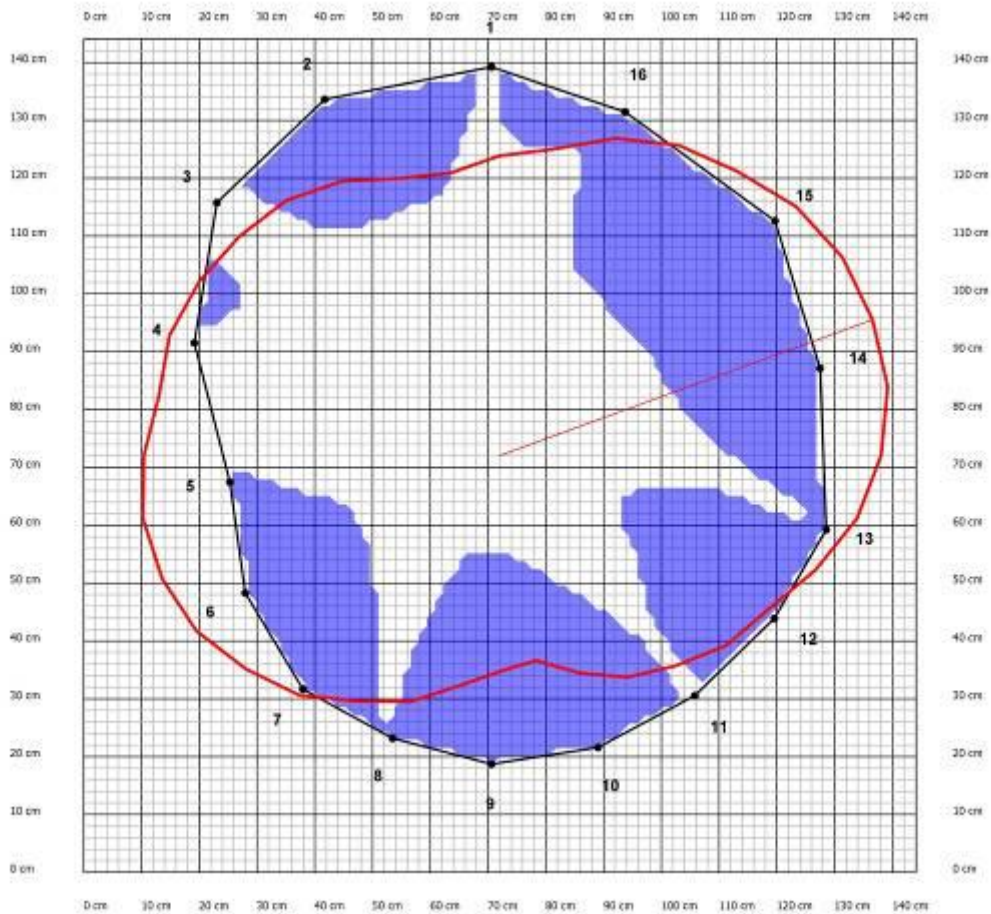
Image 9. 250cmH layer – Biomechanical Layer Map

| 250cmH layer | 339 % |

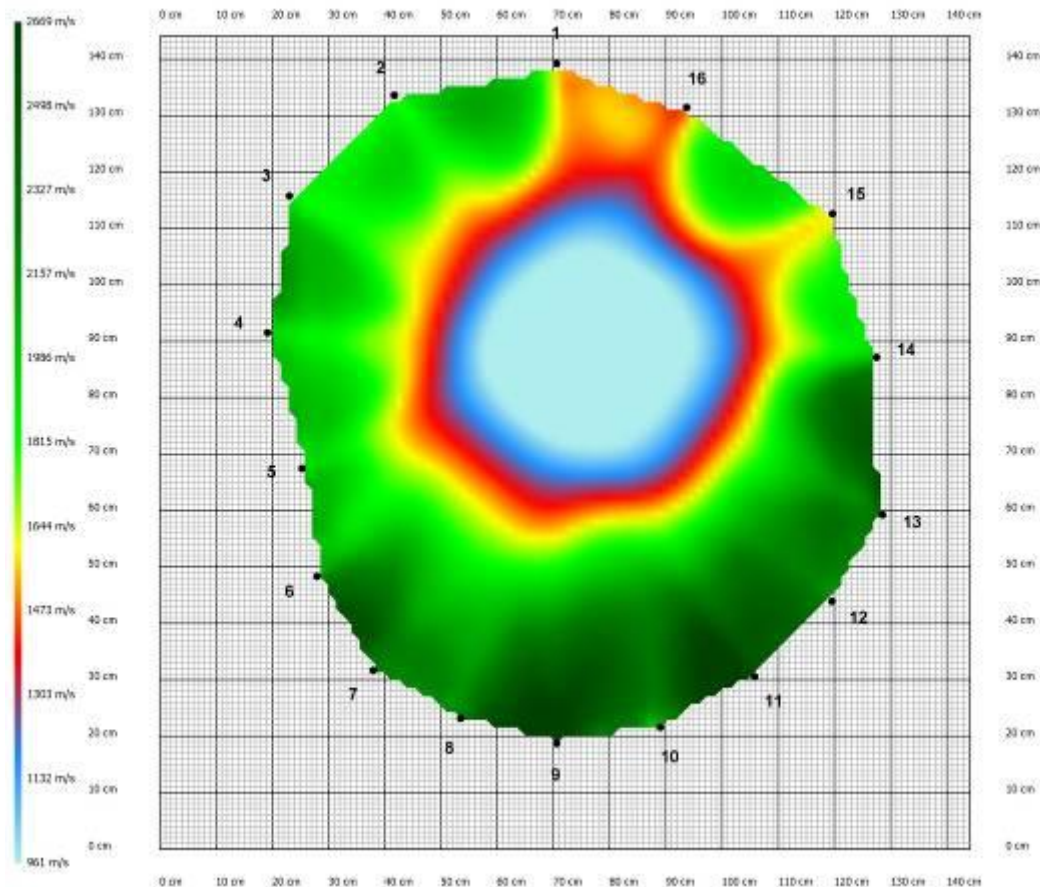
Image 10. 330cmH layer - 2D Map

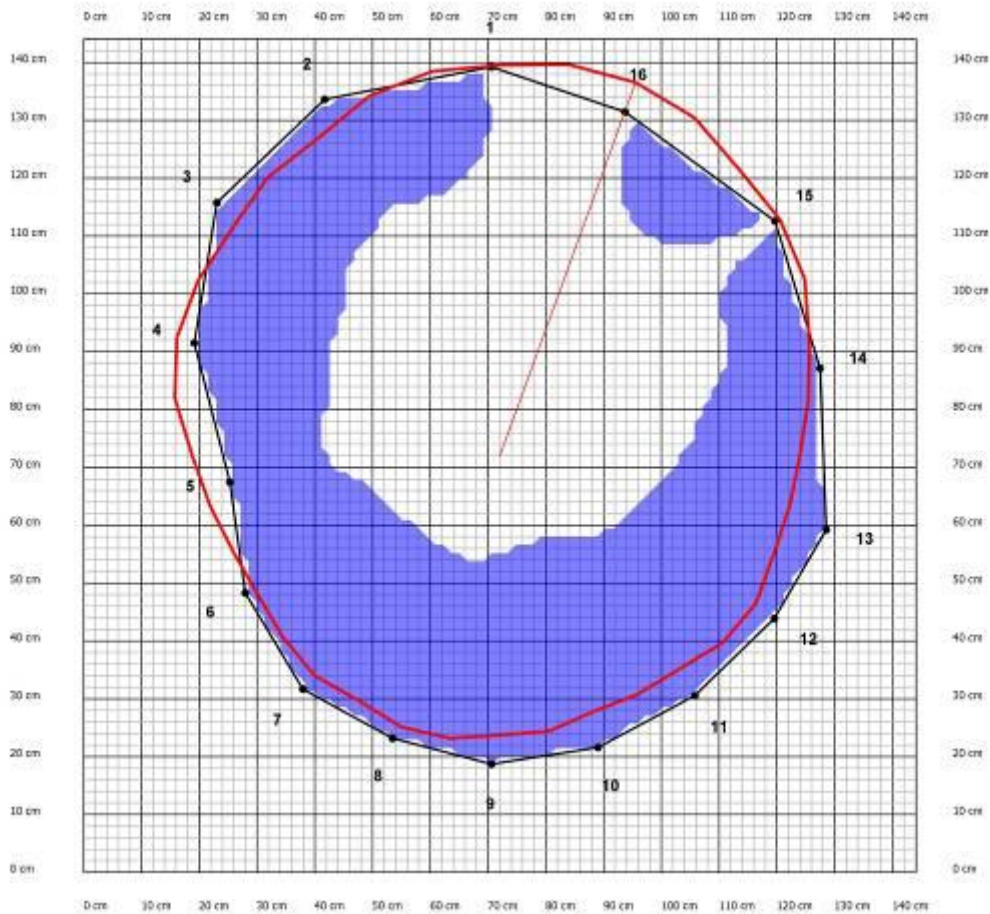
Image 11. 330cmH layer – Biomechanical Layer Map

| 330cmH layer | 408 % |

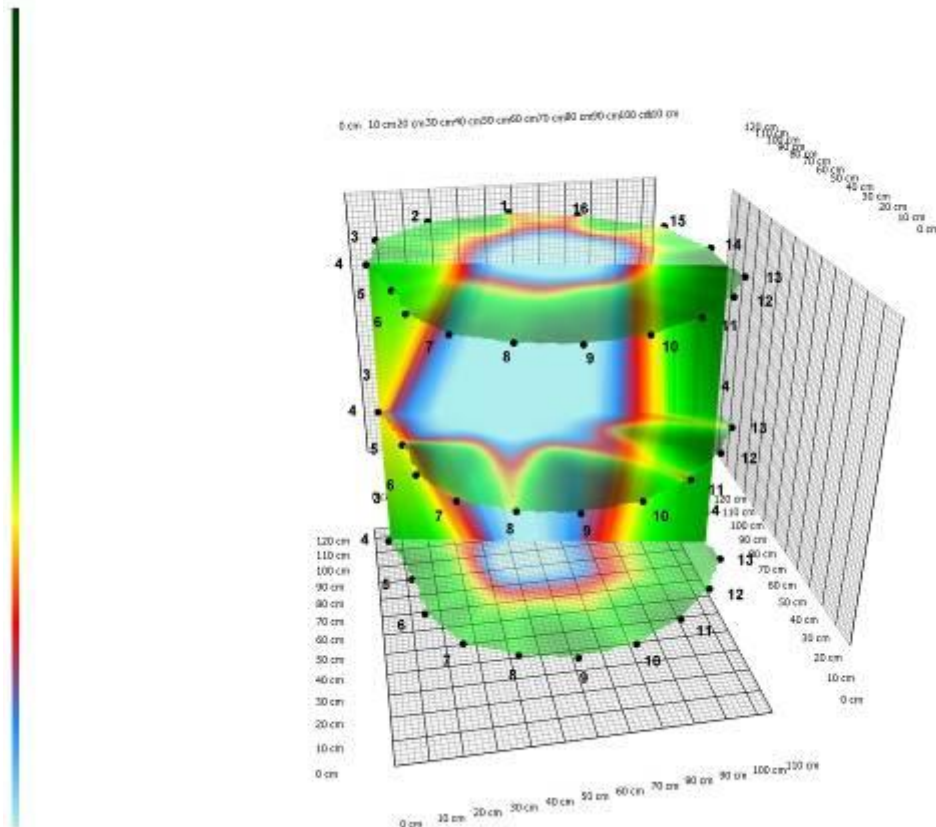
Image 12. Multilayer view

- The Multilayer view (**Image 12**) shows the layers through the lower stem which have been 'stitched' by the software into a continuous profile. To represent the area between the assessment layers.

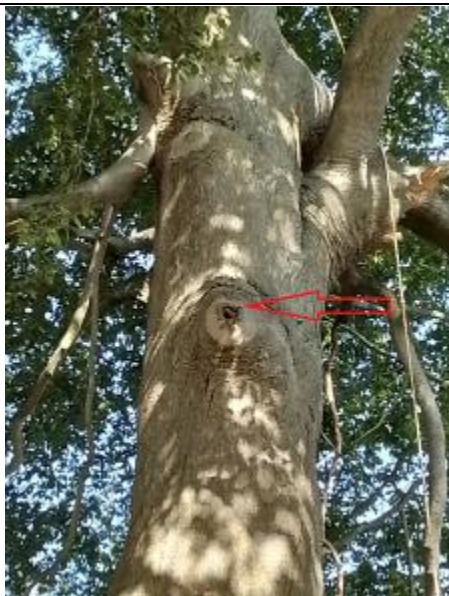
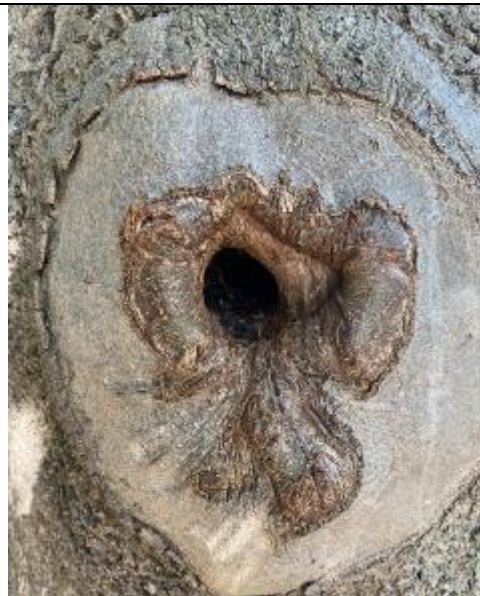
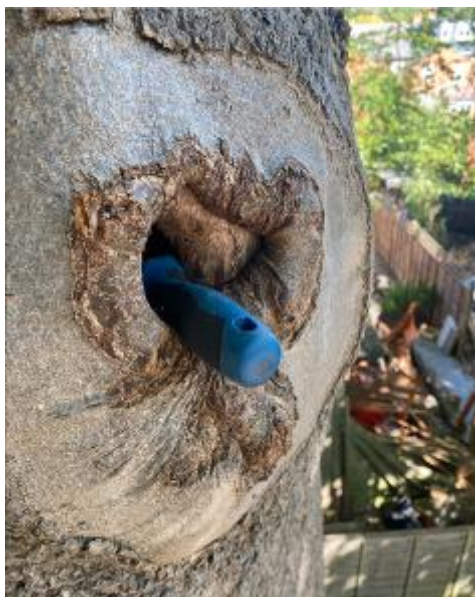
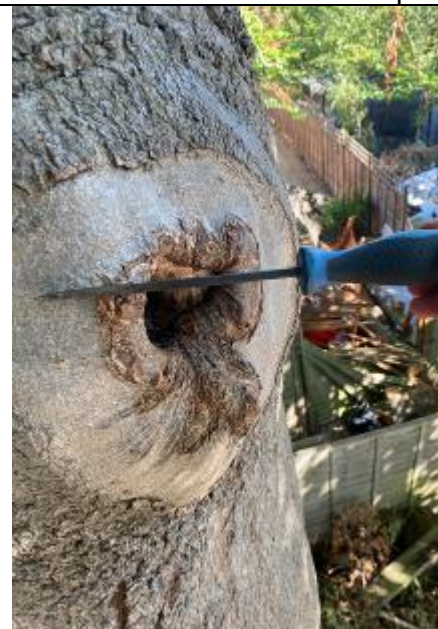
There was low resonance picked up in the stem to the west, above and around the visible cavity opening. No low resonance was heard around the woodpecker hole on the southern stem or on limbs within the crown structure.

I. Occluded wound with woodpecker hole

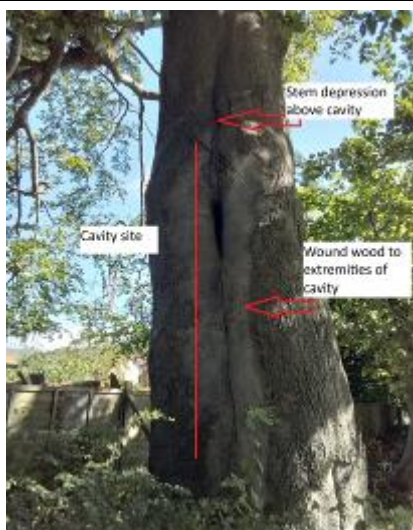
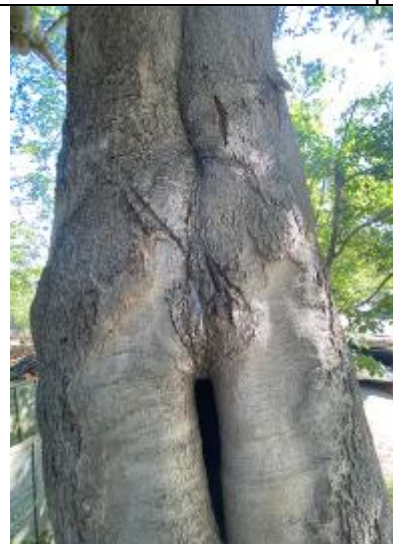
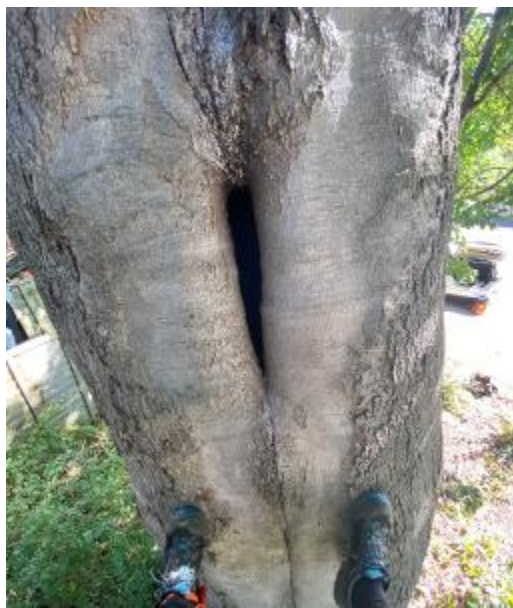
The historic cavity on the western stem extends from 1 metre above ground level to 3 metres, there is approximately 25cm of callus tissue surrounding the site, this is forming a strong 'rams' horn' appearance around the edge of the cavity.

There is a large historic cavity on the western side of the stem (**Photos V, VI and VII**)

V. Annotated Cavity photograph

The visual assessment of the tree stem indicates that it has good vitality and is laying down new wound wood sufficient to bolster the wound site. The visible decay lies within the ripe wood of the Beech stem and is not colonised by any visible fungi at present.

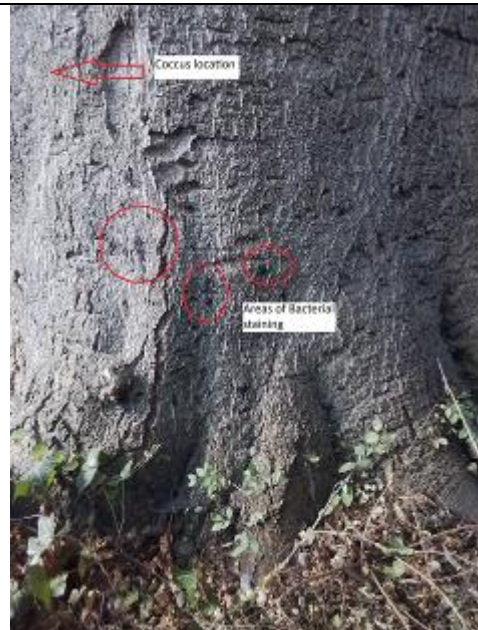
There is bacterial staining on the lower north east buttress root extending to 50cm above ground level. The staining appears to be restricted at present, but the limb failure is above this location. The lower north east stem also appears to have Felted Beech Scale (*Cryptococcus fagisuga*) which may be the vector of Beech Bark Disease (*Nectria coccinea*) and the resultant staining of the bark in this area.

VIII. Lower north east stem

The lower north east stem (**Photo VIII**) is the area of stem with some concern. If the dark bacterial staining is caused by Beech Bark disease. Continued spreading of the fungi through the activities of the coccus beetle may result in the scattered areas of necrotic bark coalescing to produce larger dead areas. The death of the bark in turn may cause localised disruption to the sapwood. Drought conditions could

exacerbate these symptoms. The disease may however, abate over time depending on environmental conditions with complete tree death rare amongst specimen mature trees.
