Tree Top Arborists

CAVERSHAM PLACE  
RICHFIELD AVENUE  
READING  
RG1 8BY

CF0024

(Survey conducted on 03/07/26)  
(Amended for TPO application on 03/09/26)

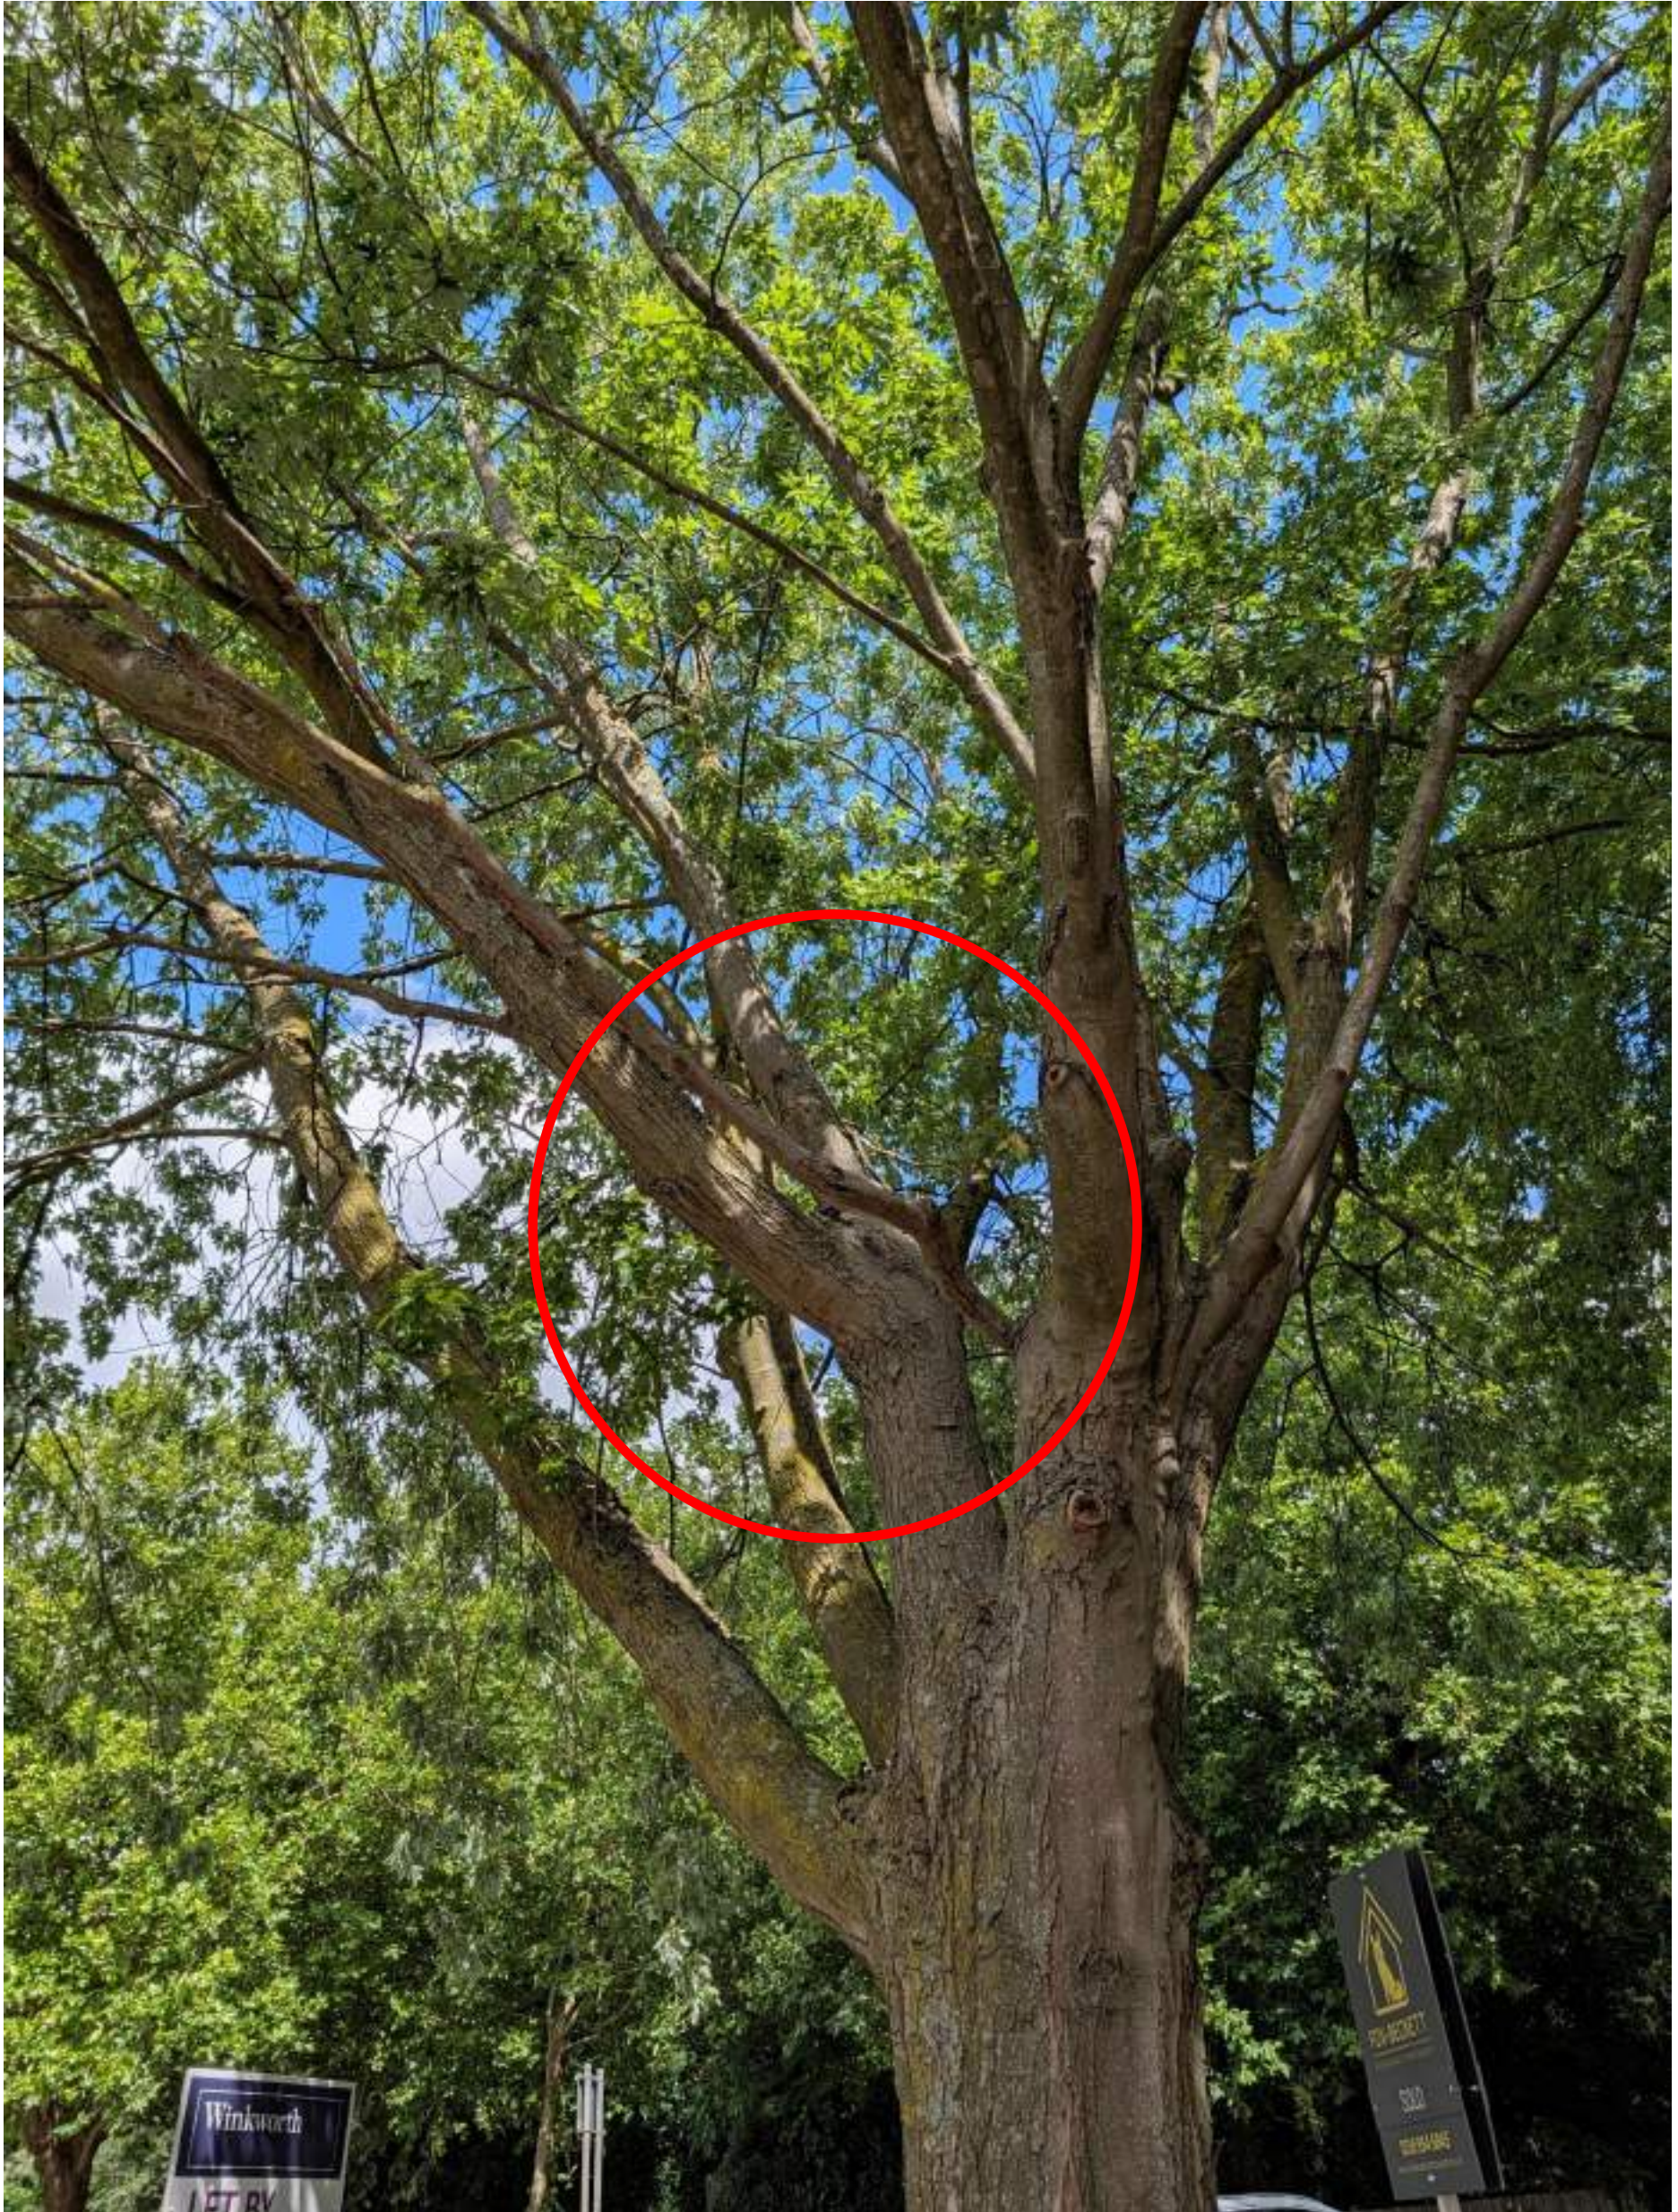
B.1 – T001 image highlighting significant deadwood over parking bay.

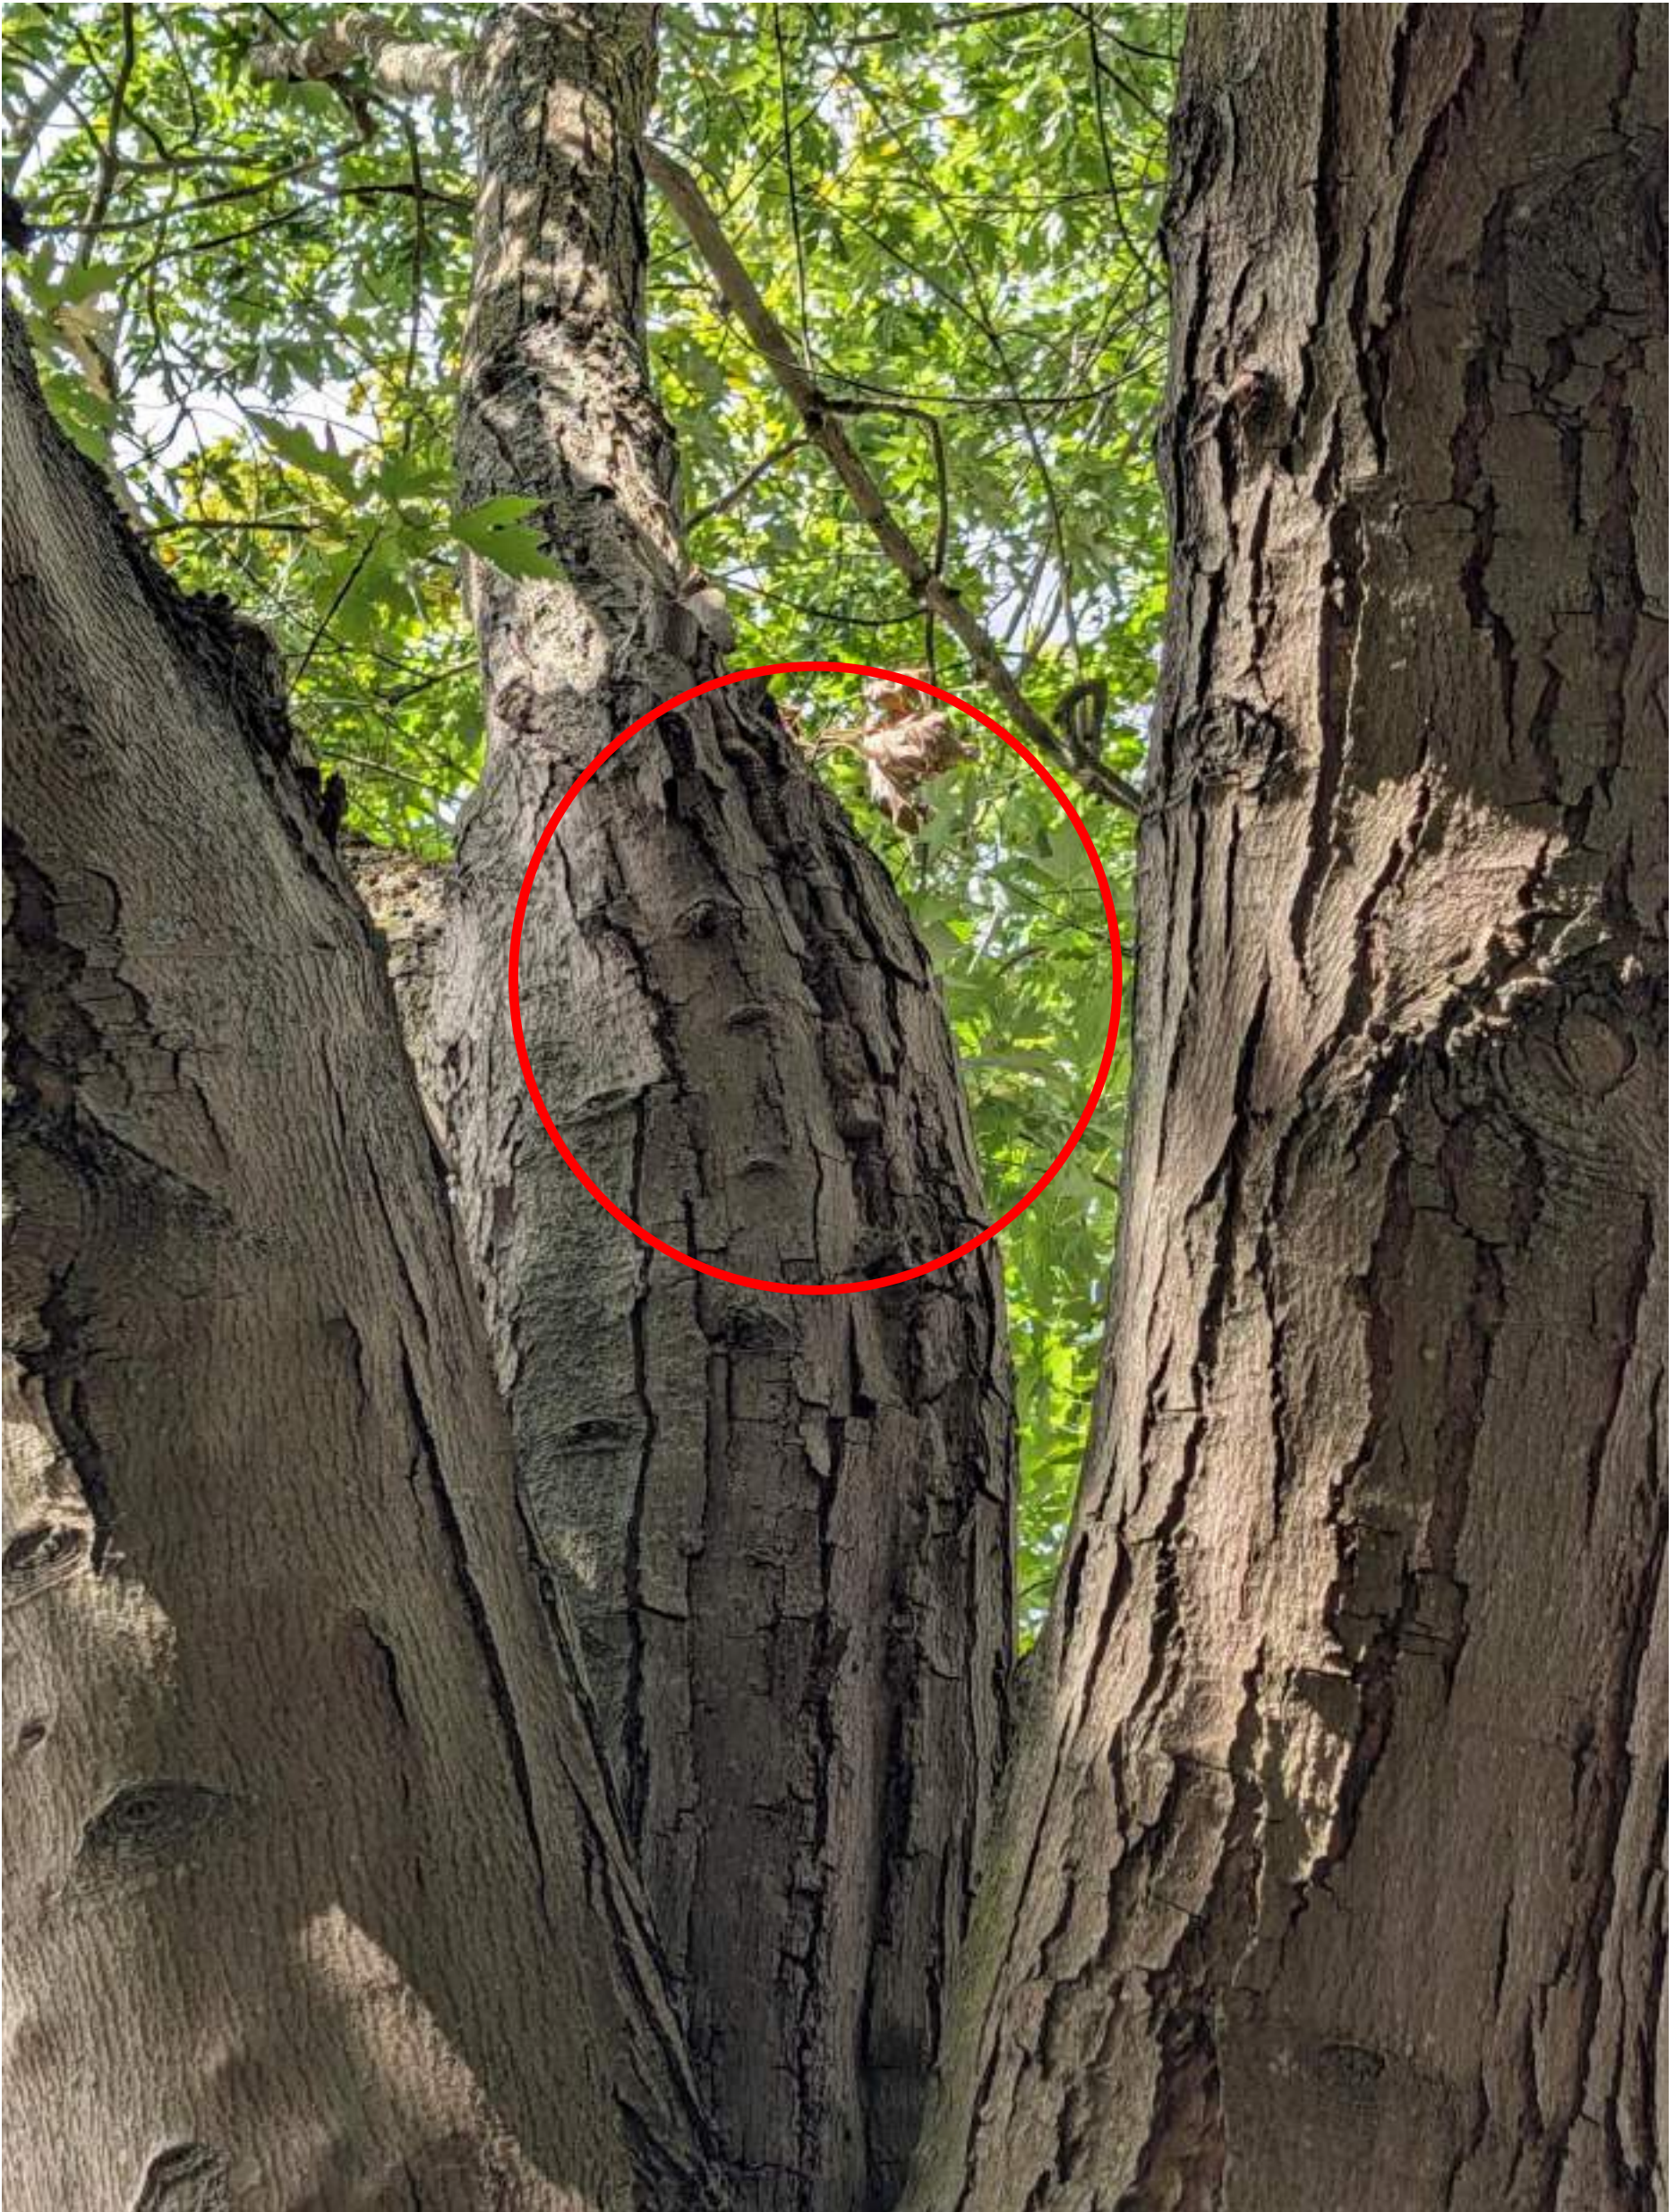
B.2 – T001 Highlighting area of dysfunction on top side of west scaffold limb.

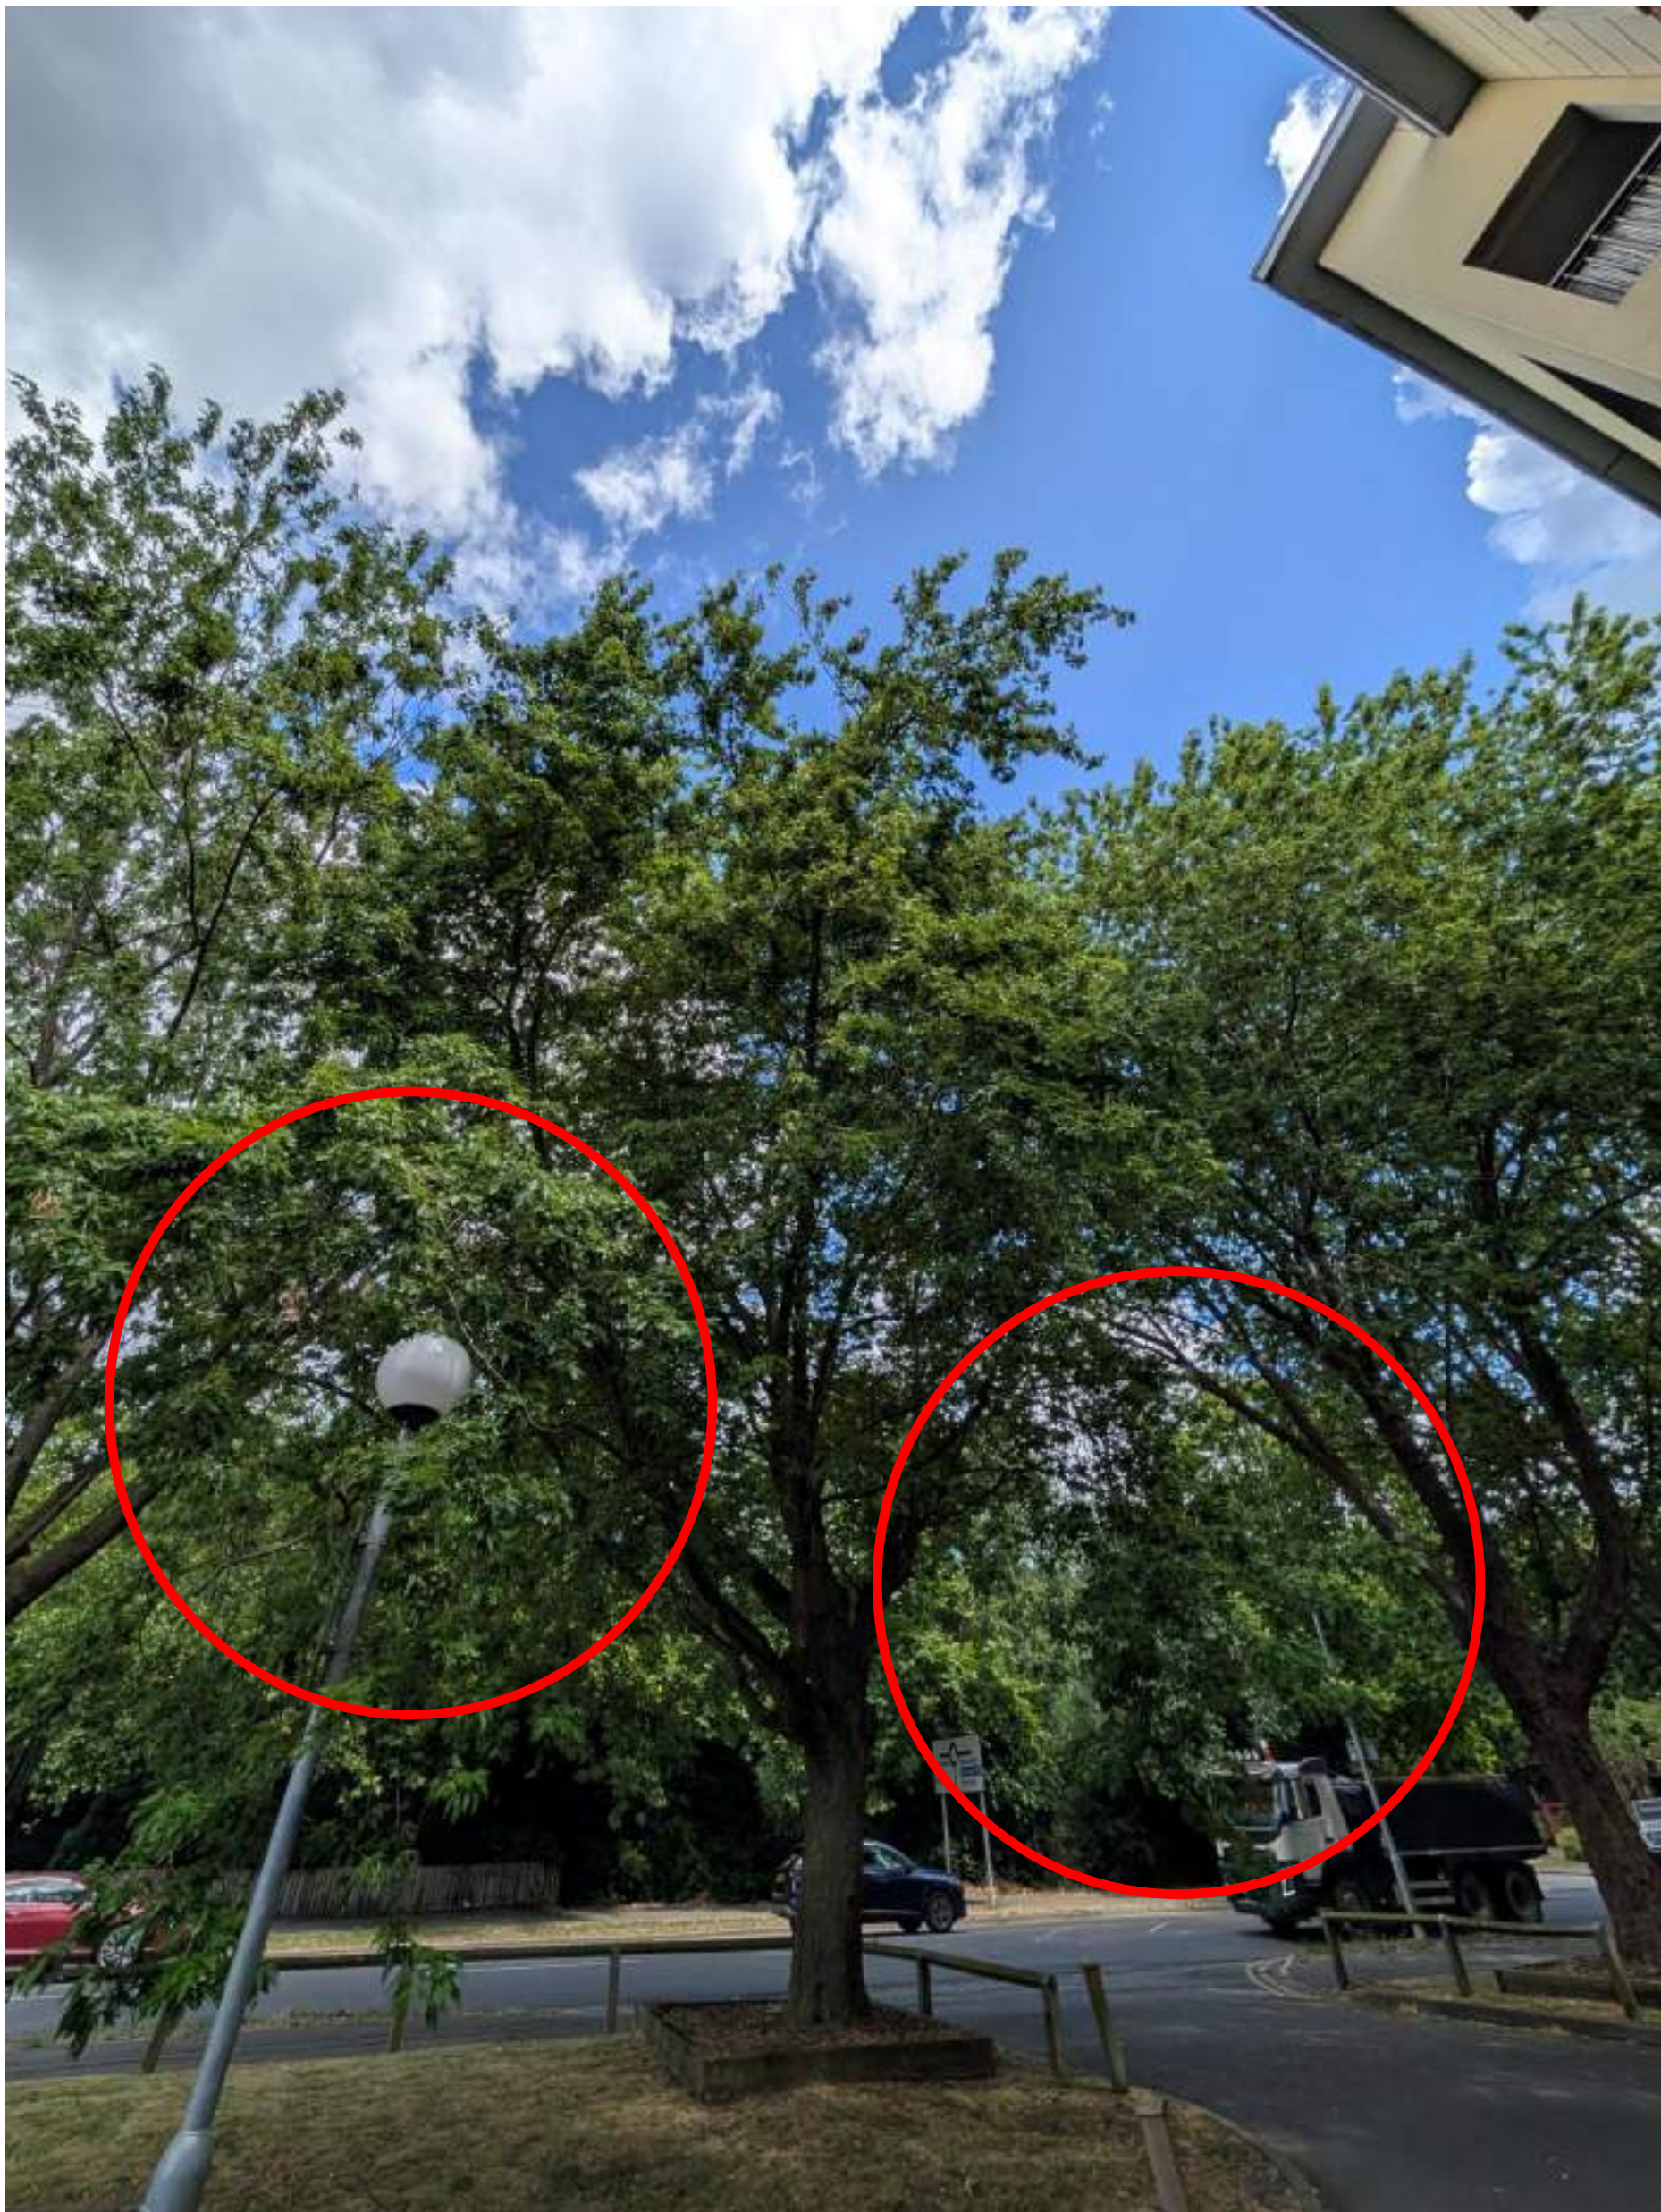
B.3 – T002 highlighting low limbs over entrance and interfering with lighting.

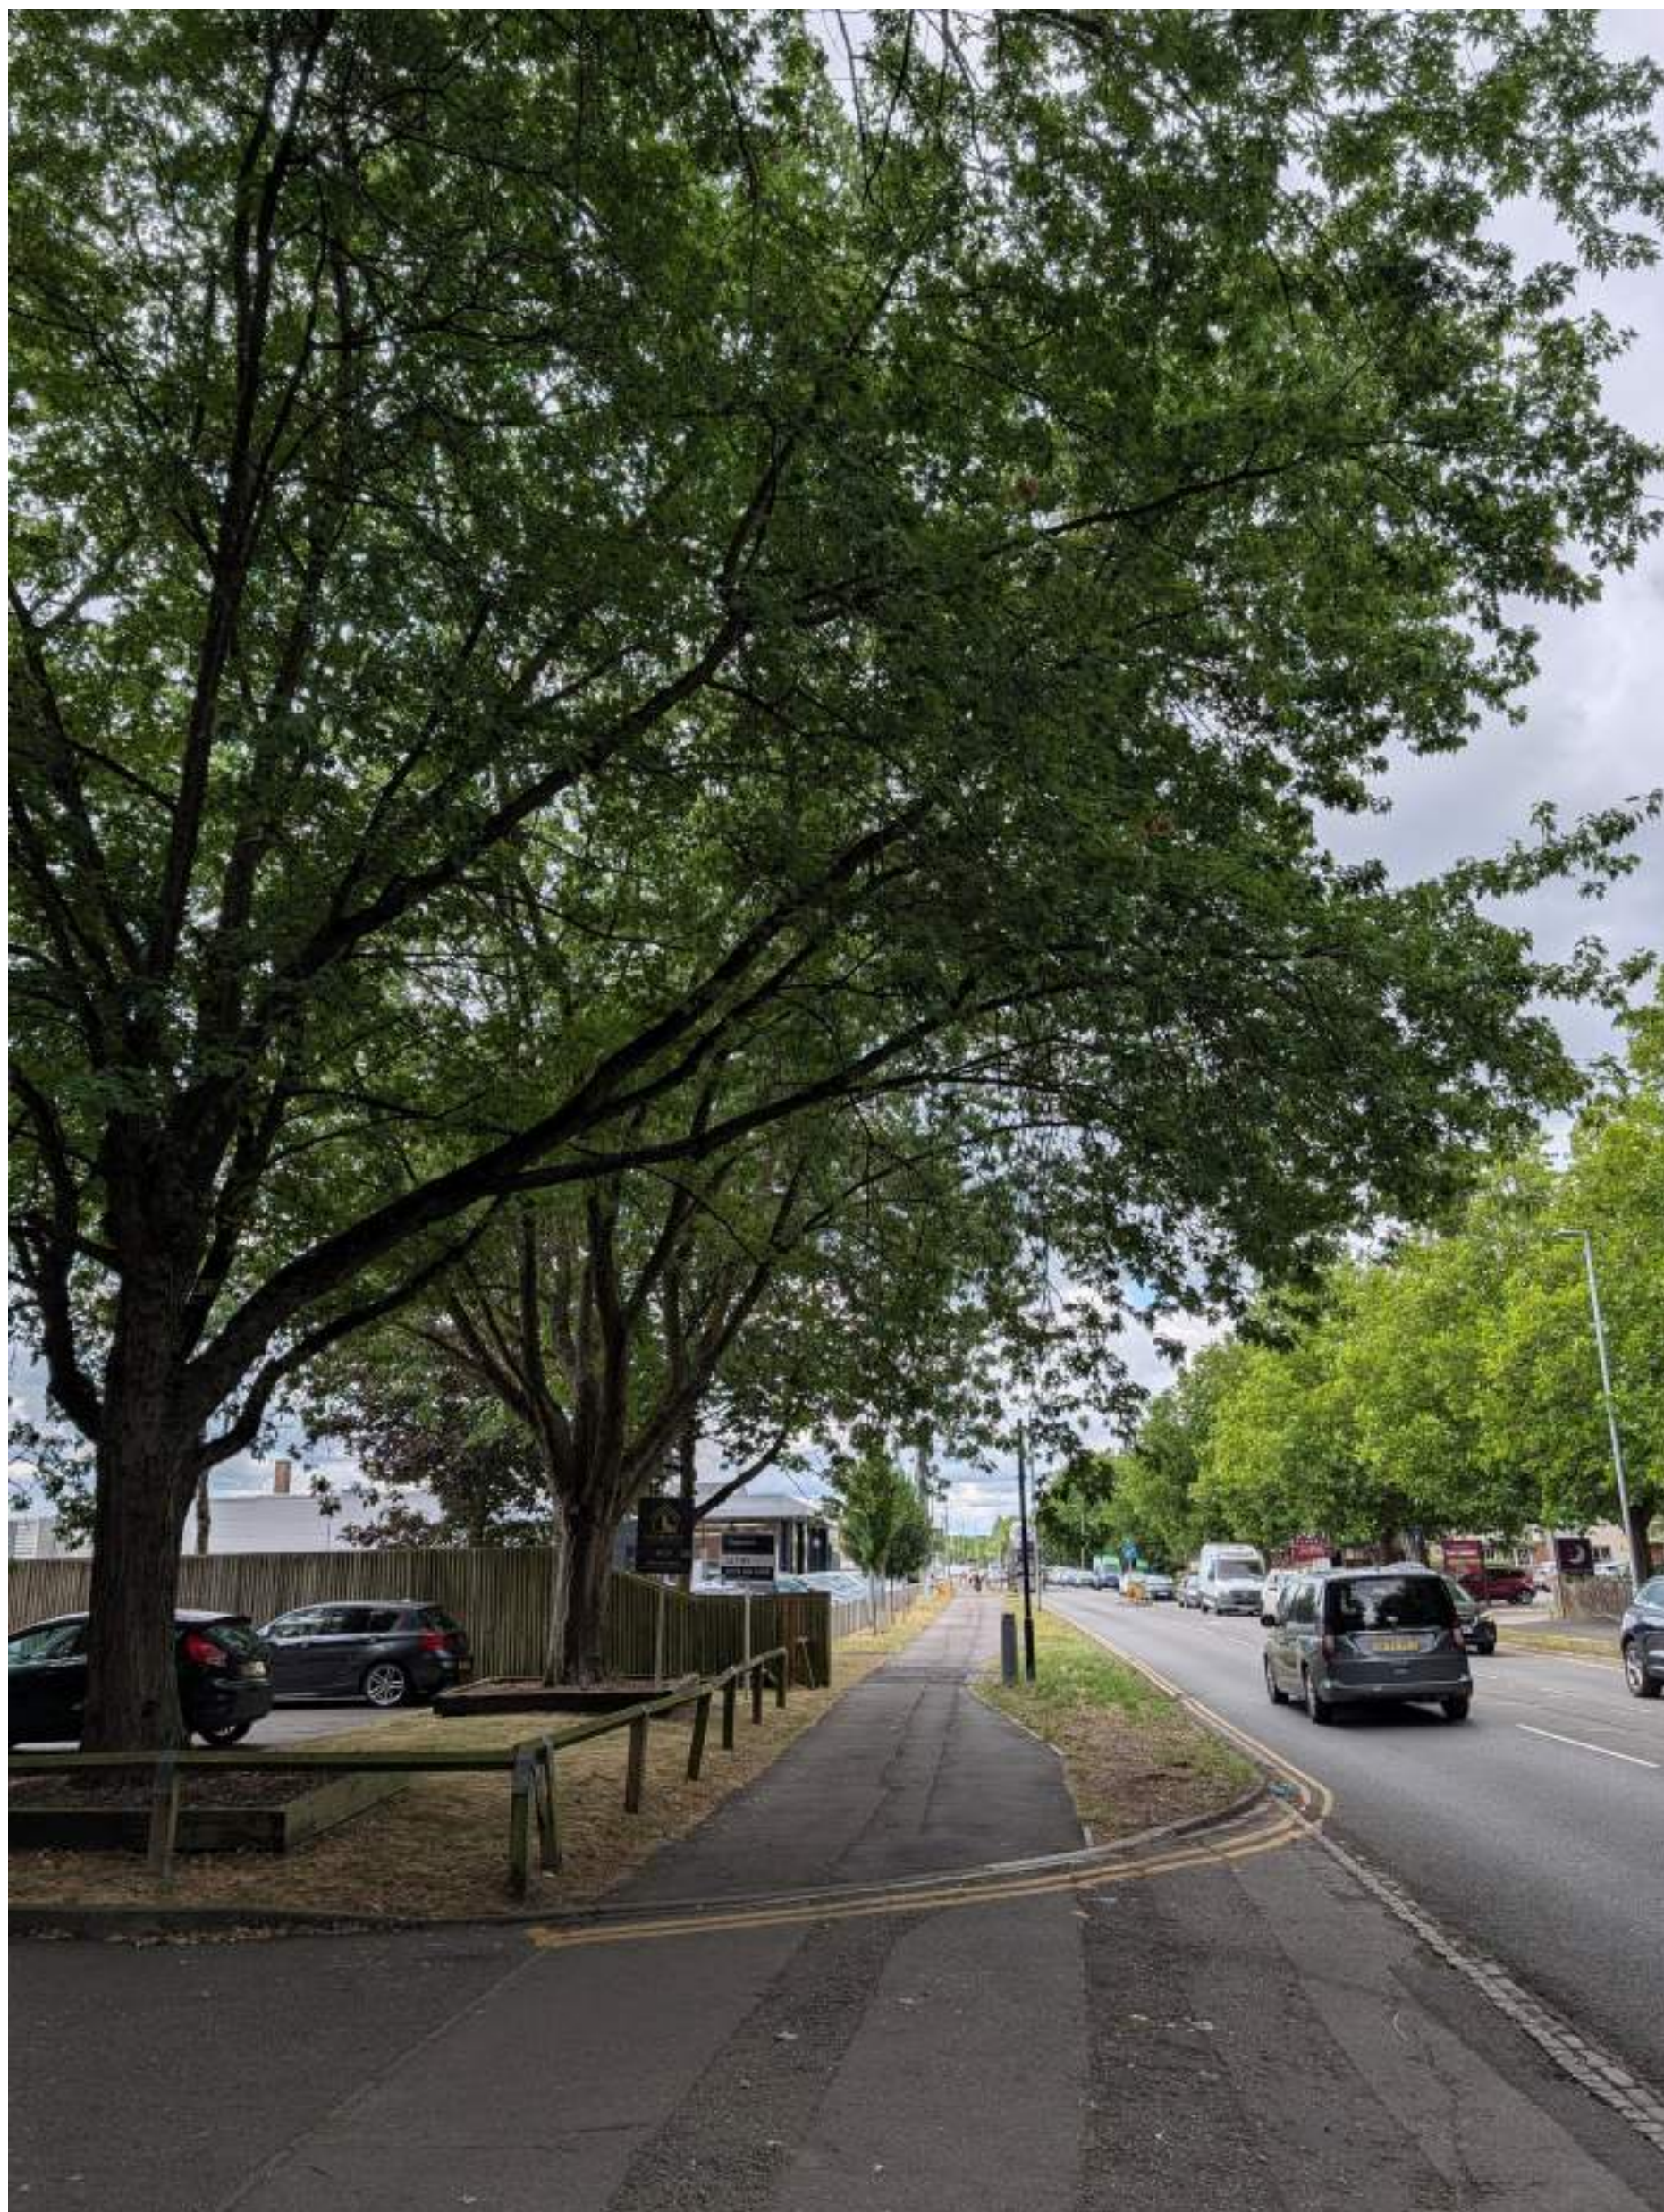
B.4 – T002 Showing overextended limbs over footpath and road.

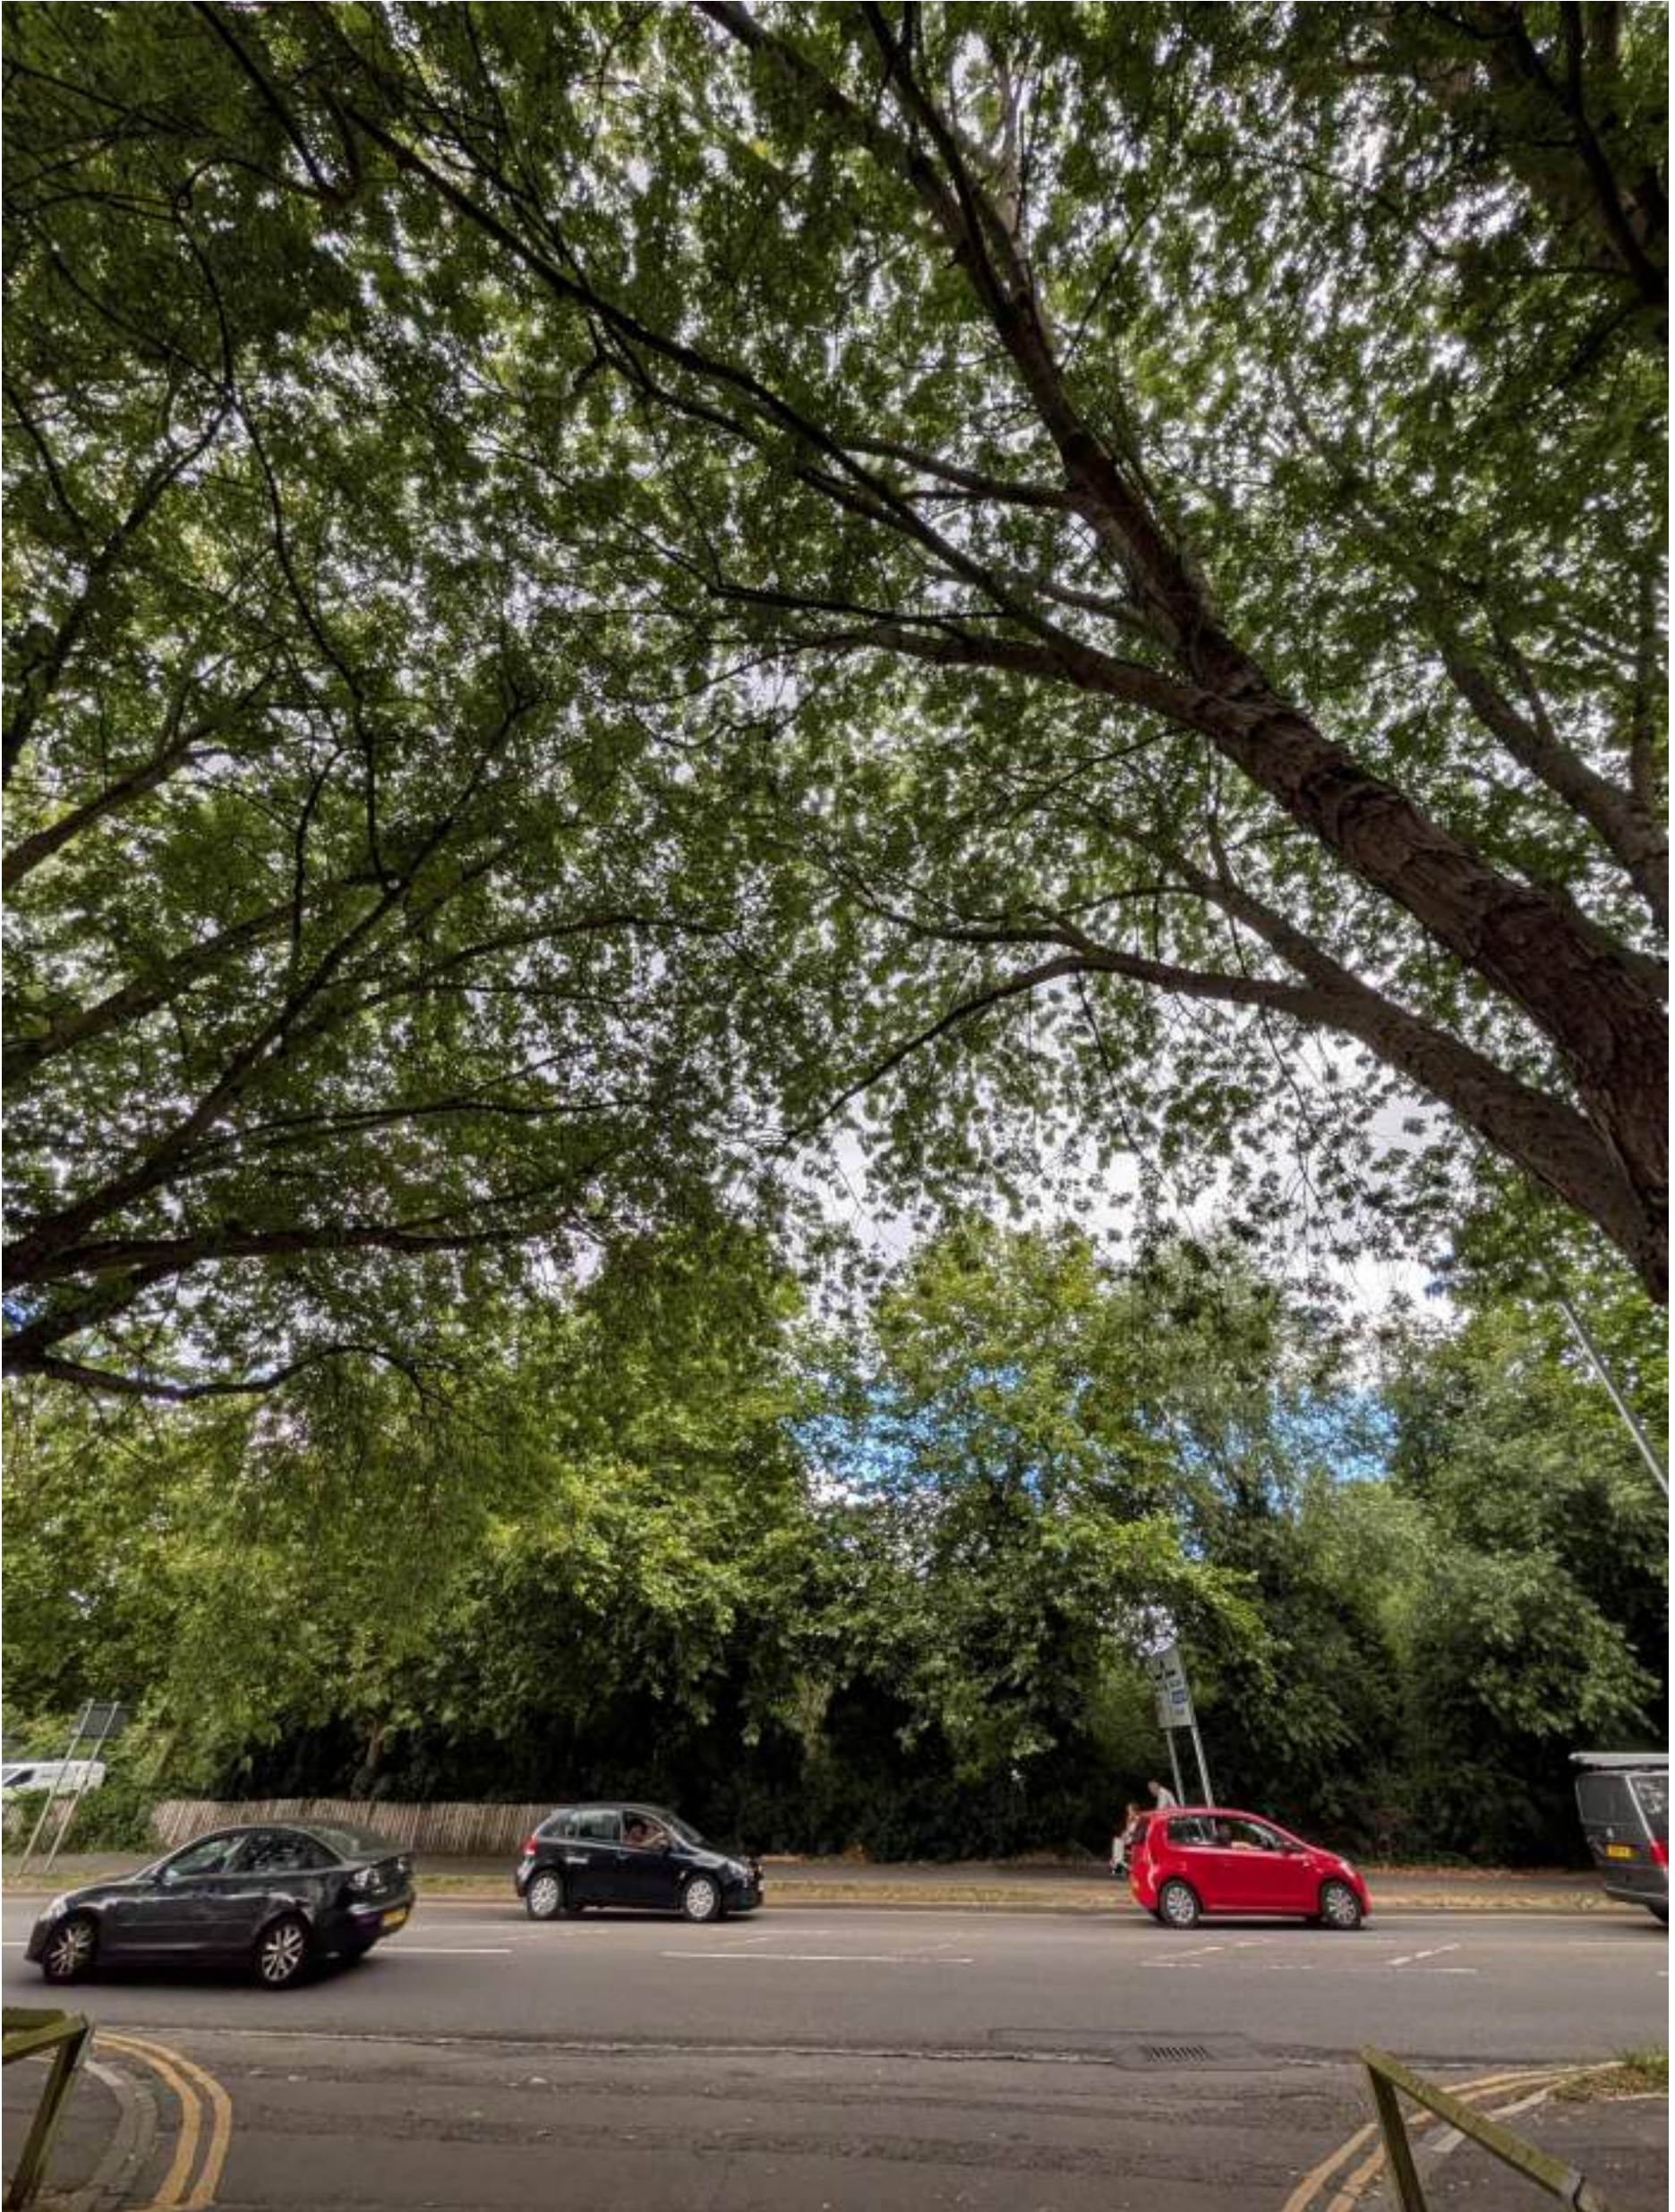
B.5 – T002/3 showing large laterals over entrance, footpath and road.

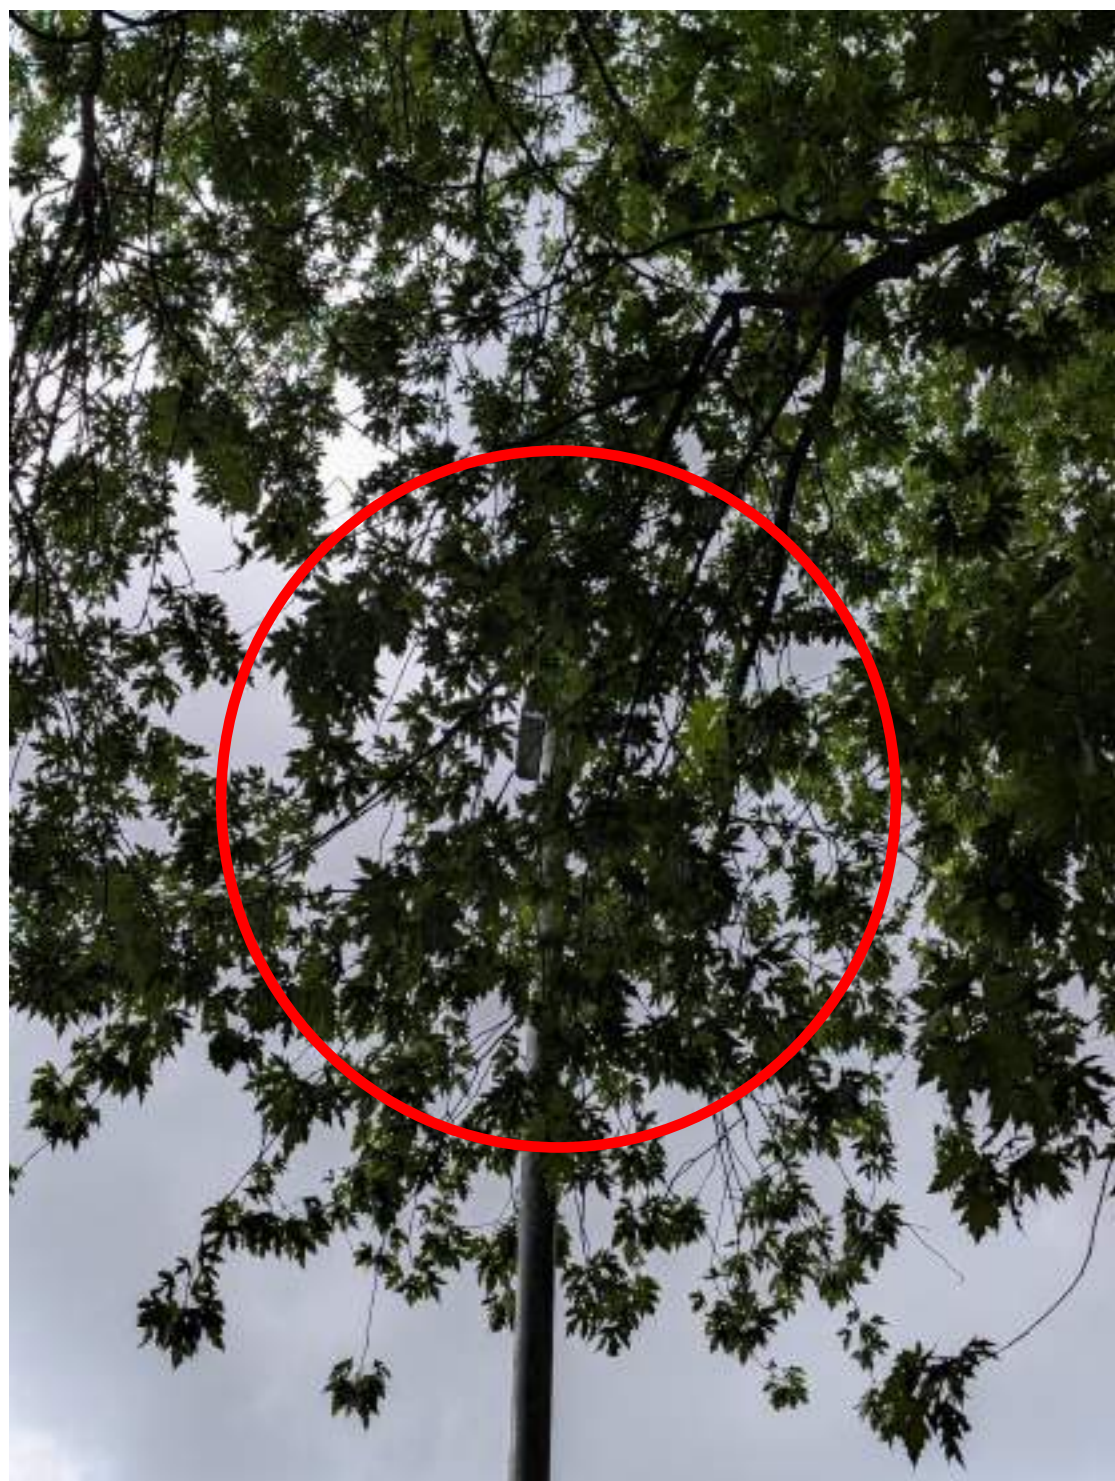
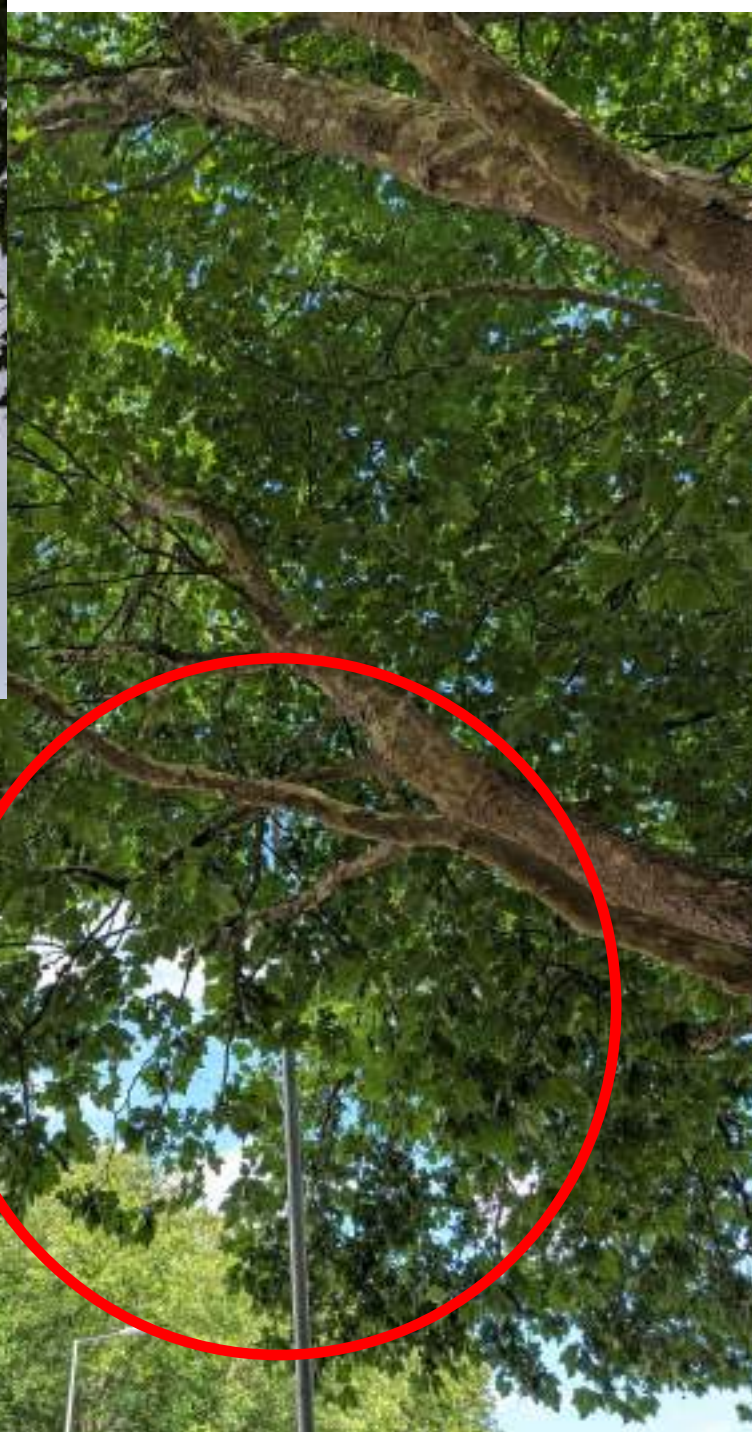
B.6/7 – T003/7 highlighting interference with street lighting.
