Tree Top Arborists

CAVERSHAM PLACE  
RICHFIELD AVENUE  
READING  
RG1 8BY

CF0024

(Survey conducted on 03/07/26)  
(Amended for TPO application on 03/09/26)

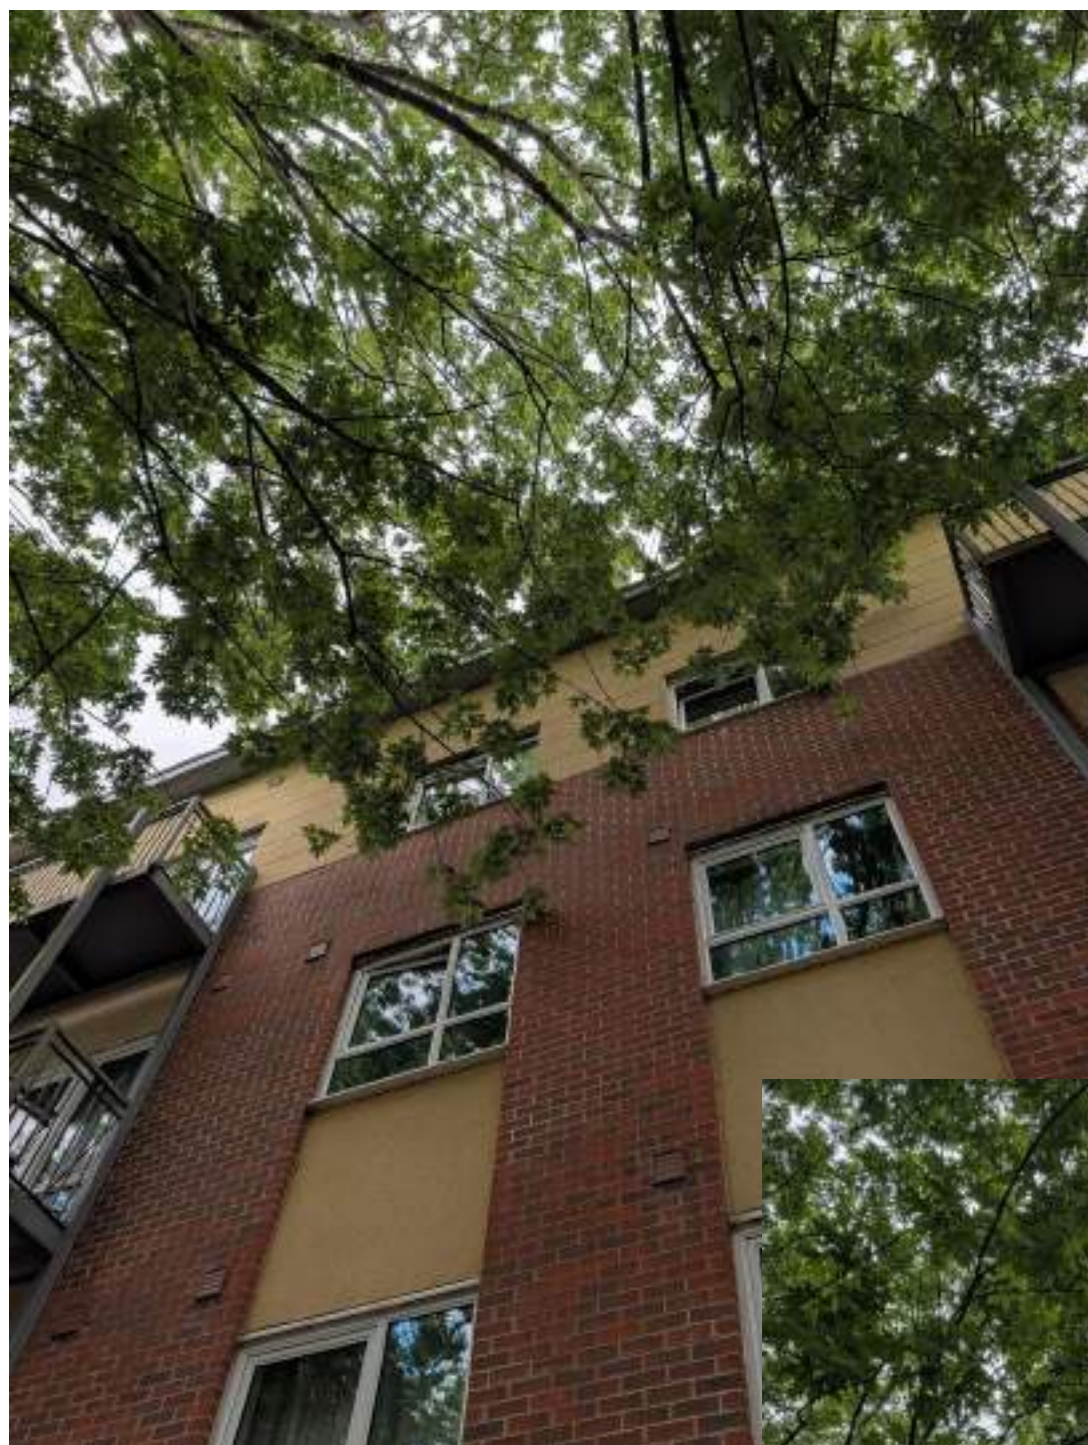
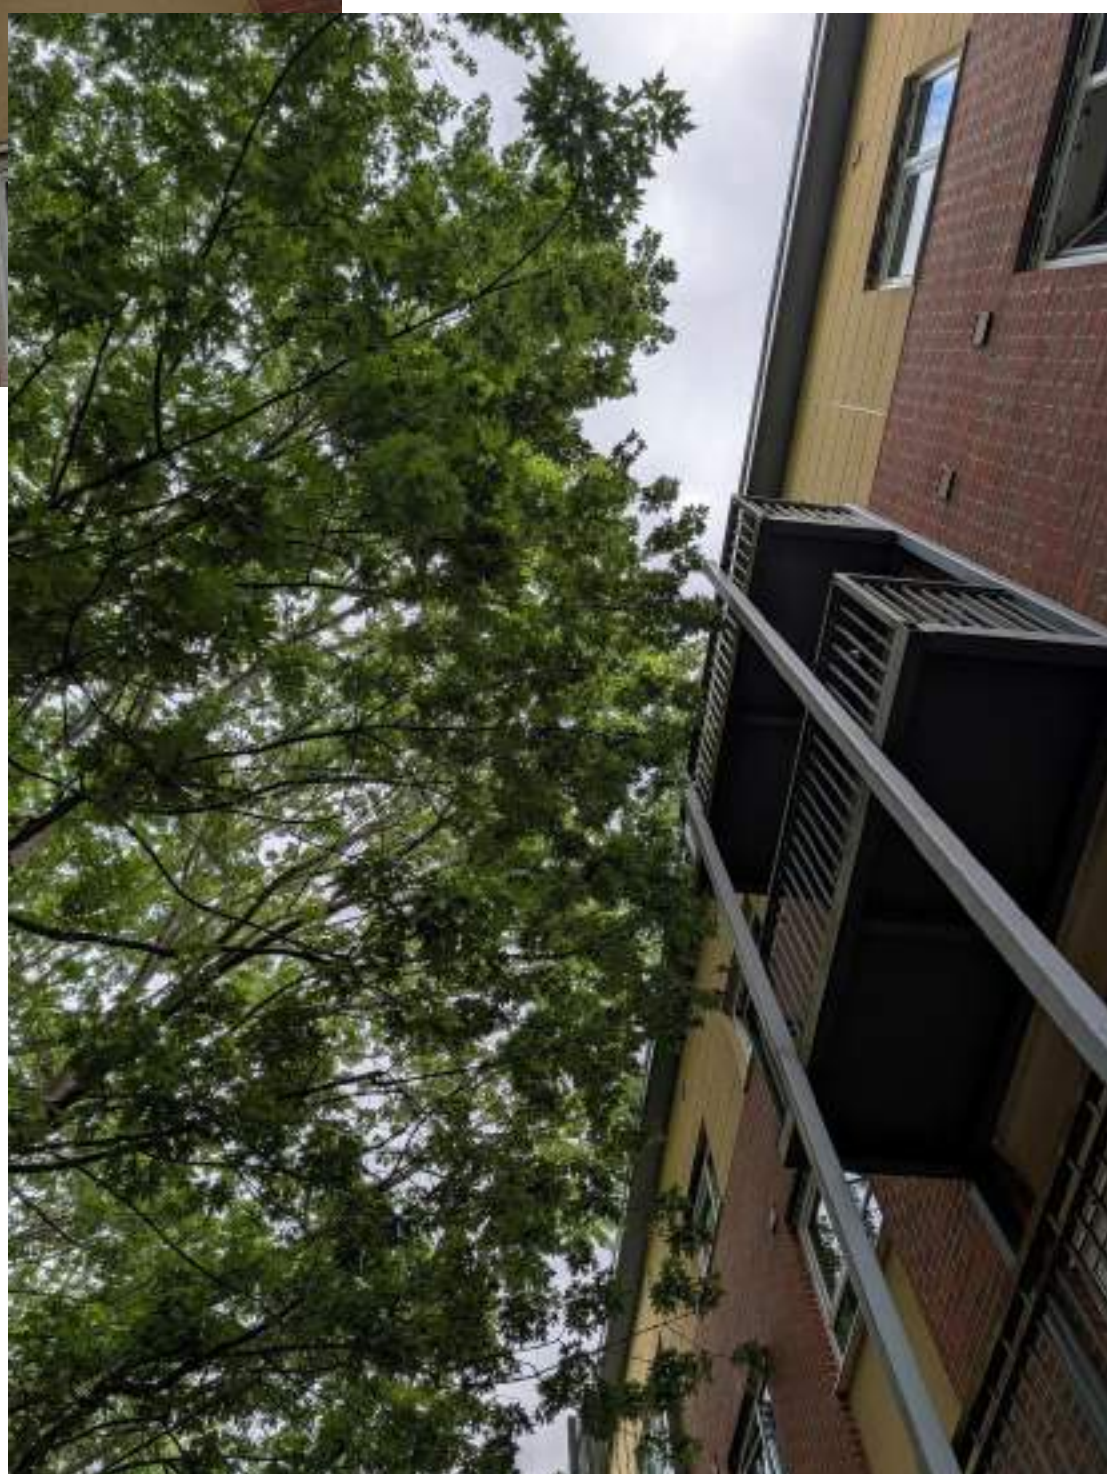
B.8/9 – T004/5 Showing proximity of limbs to building and balconies.

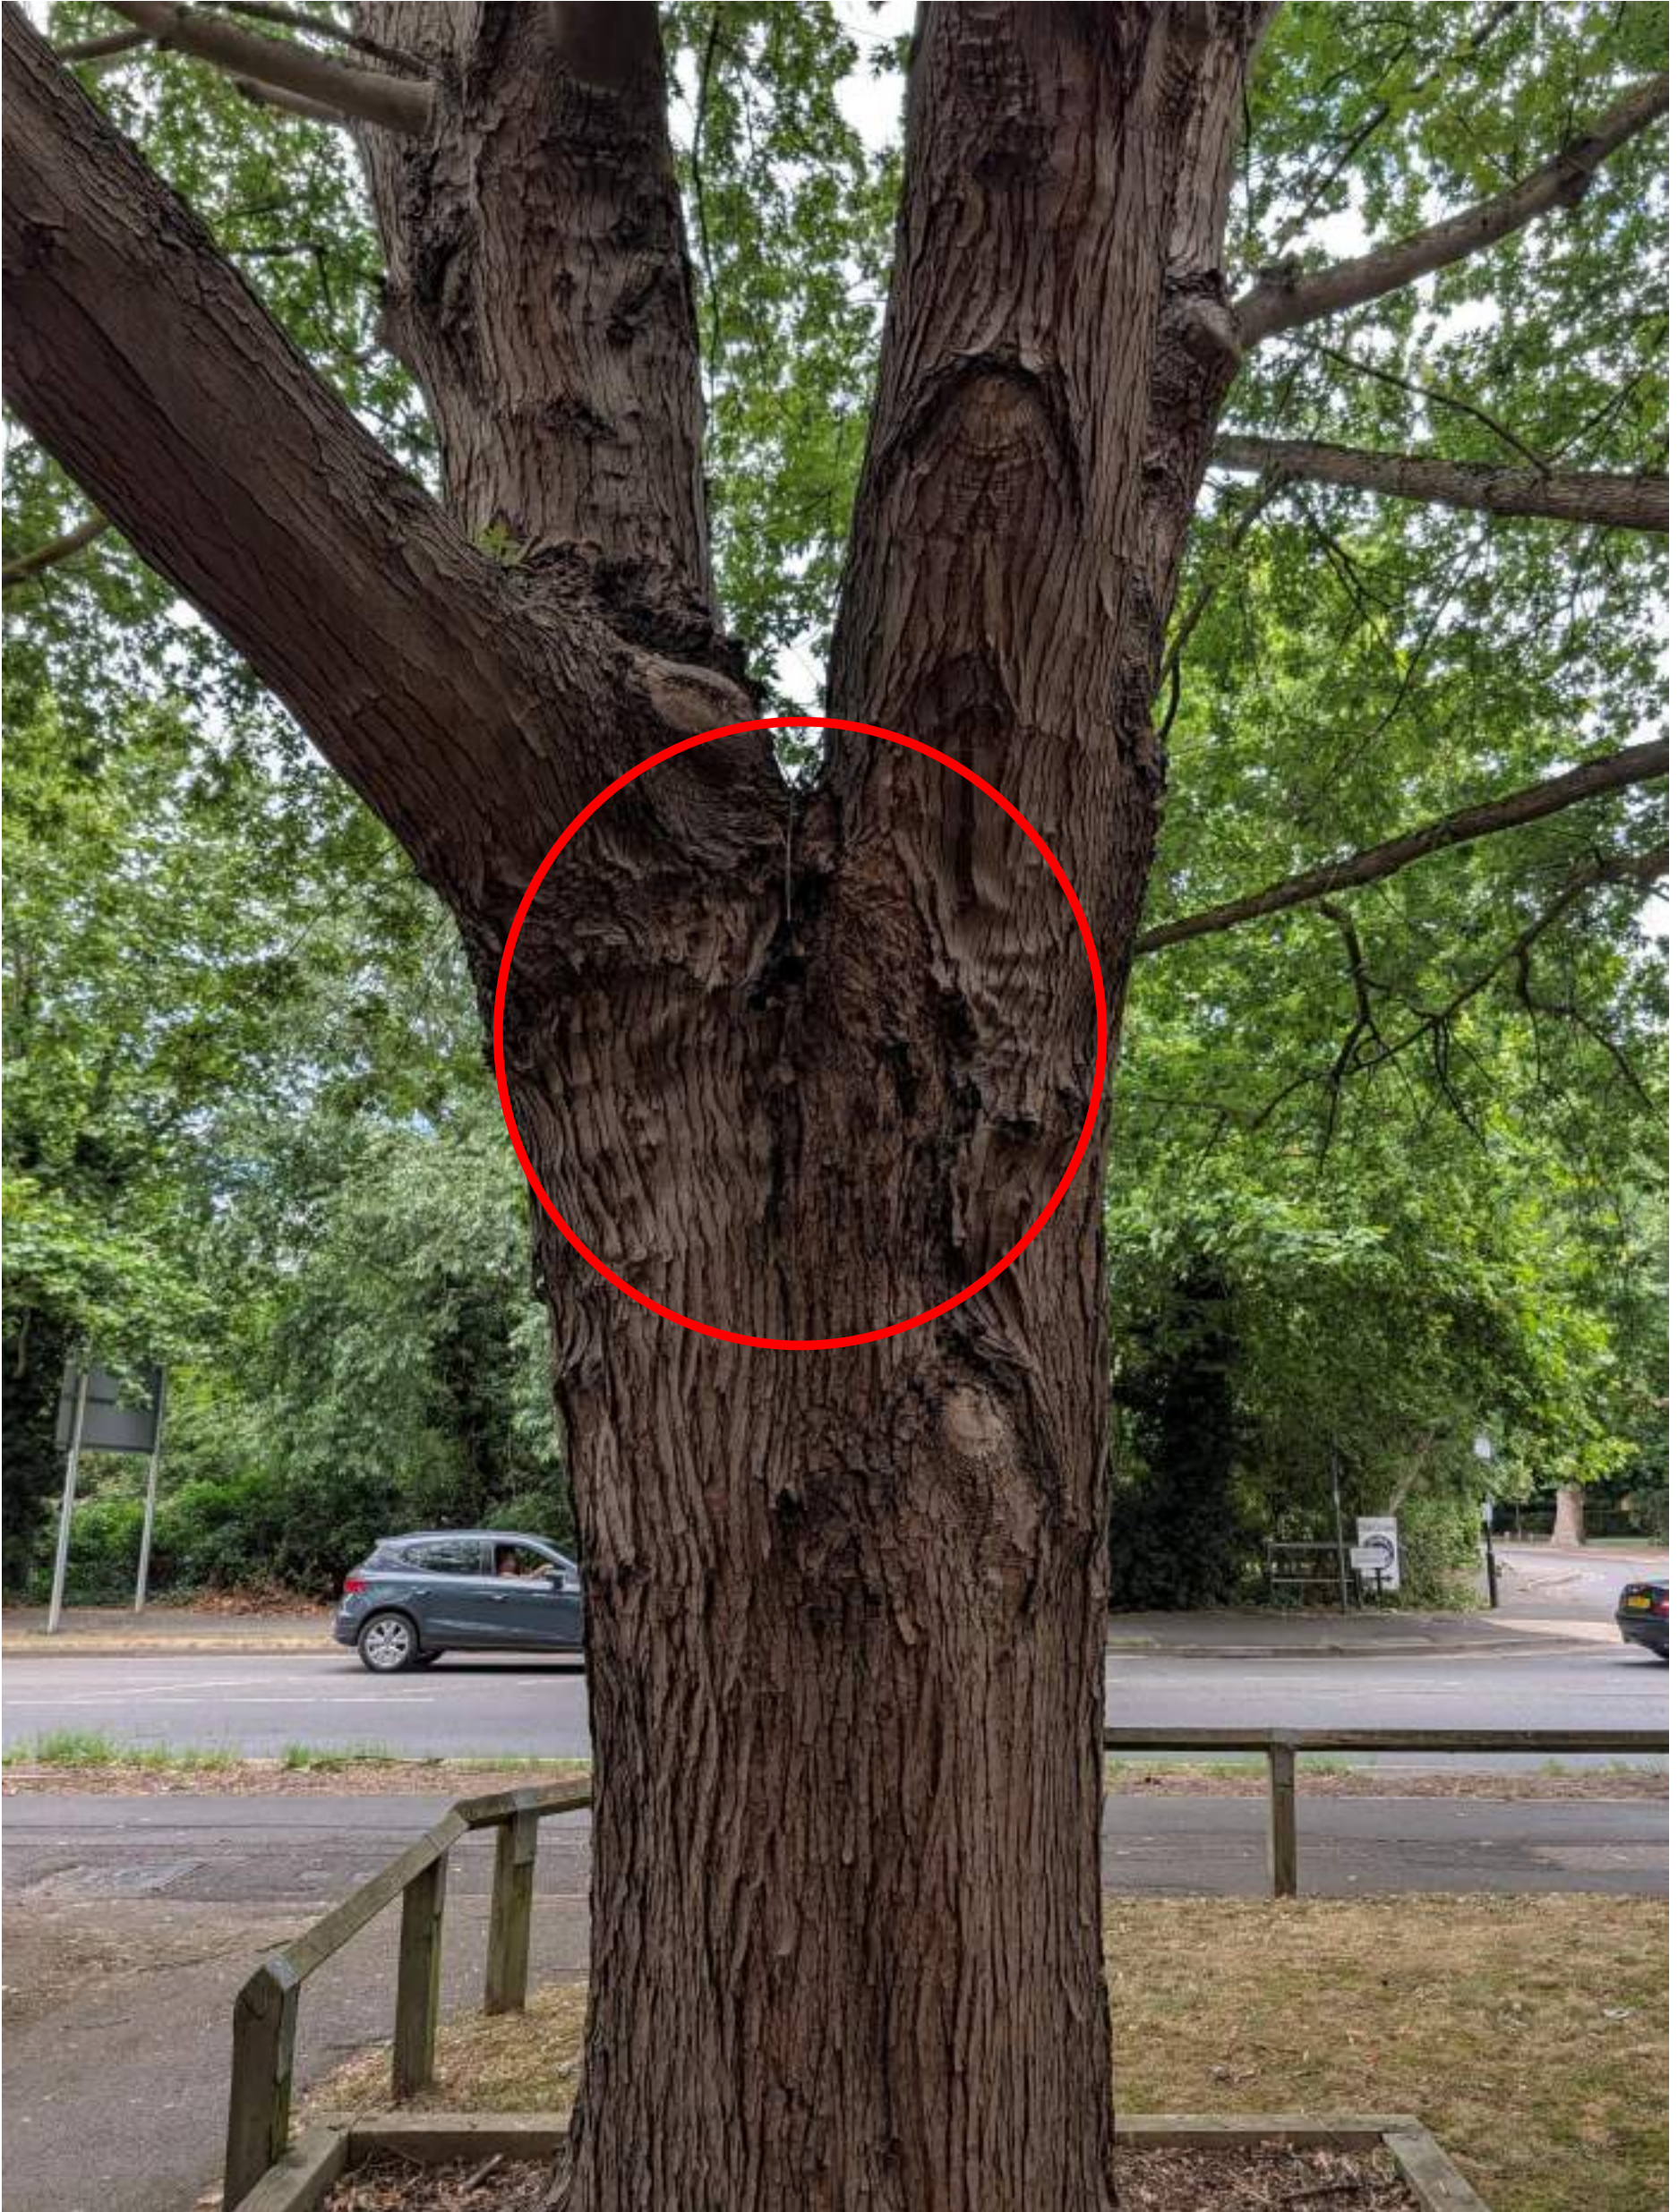
B.10 – T005 Highlighting included union

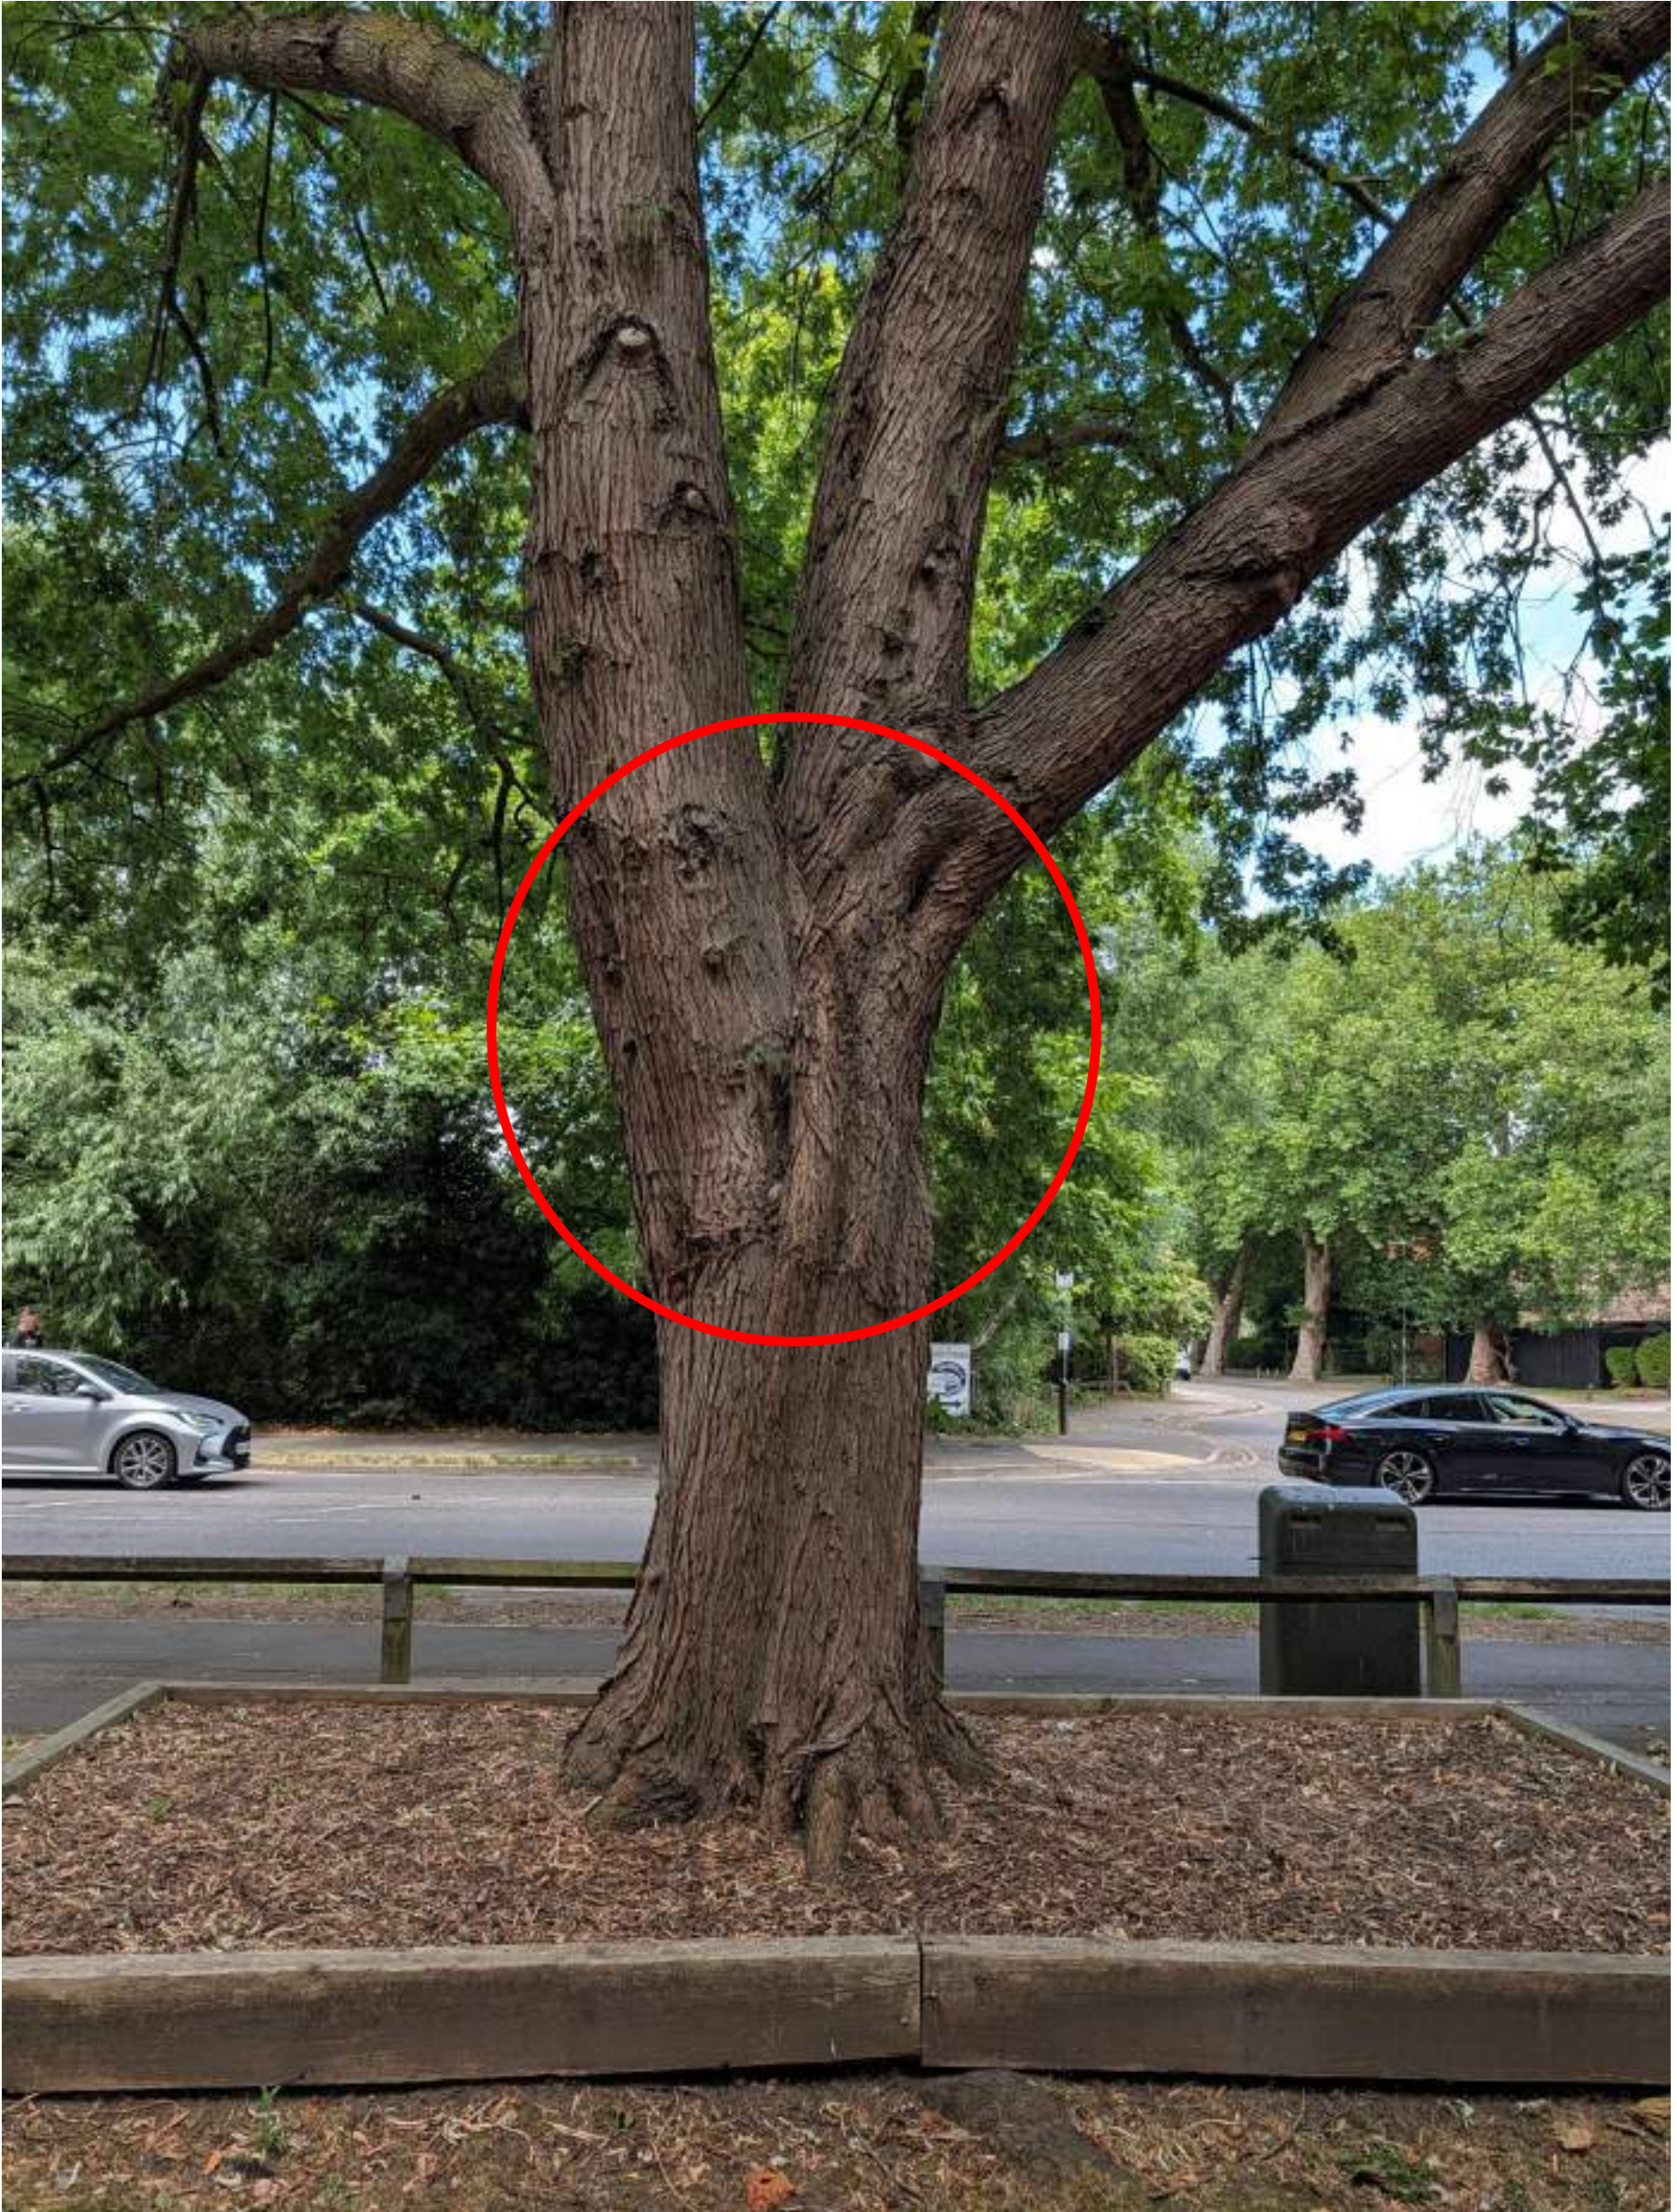
B.11 – T006 Highlighting included union and also showing damage to planting pit.

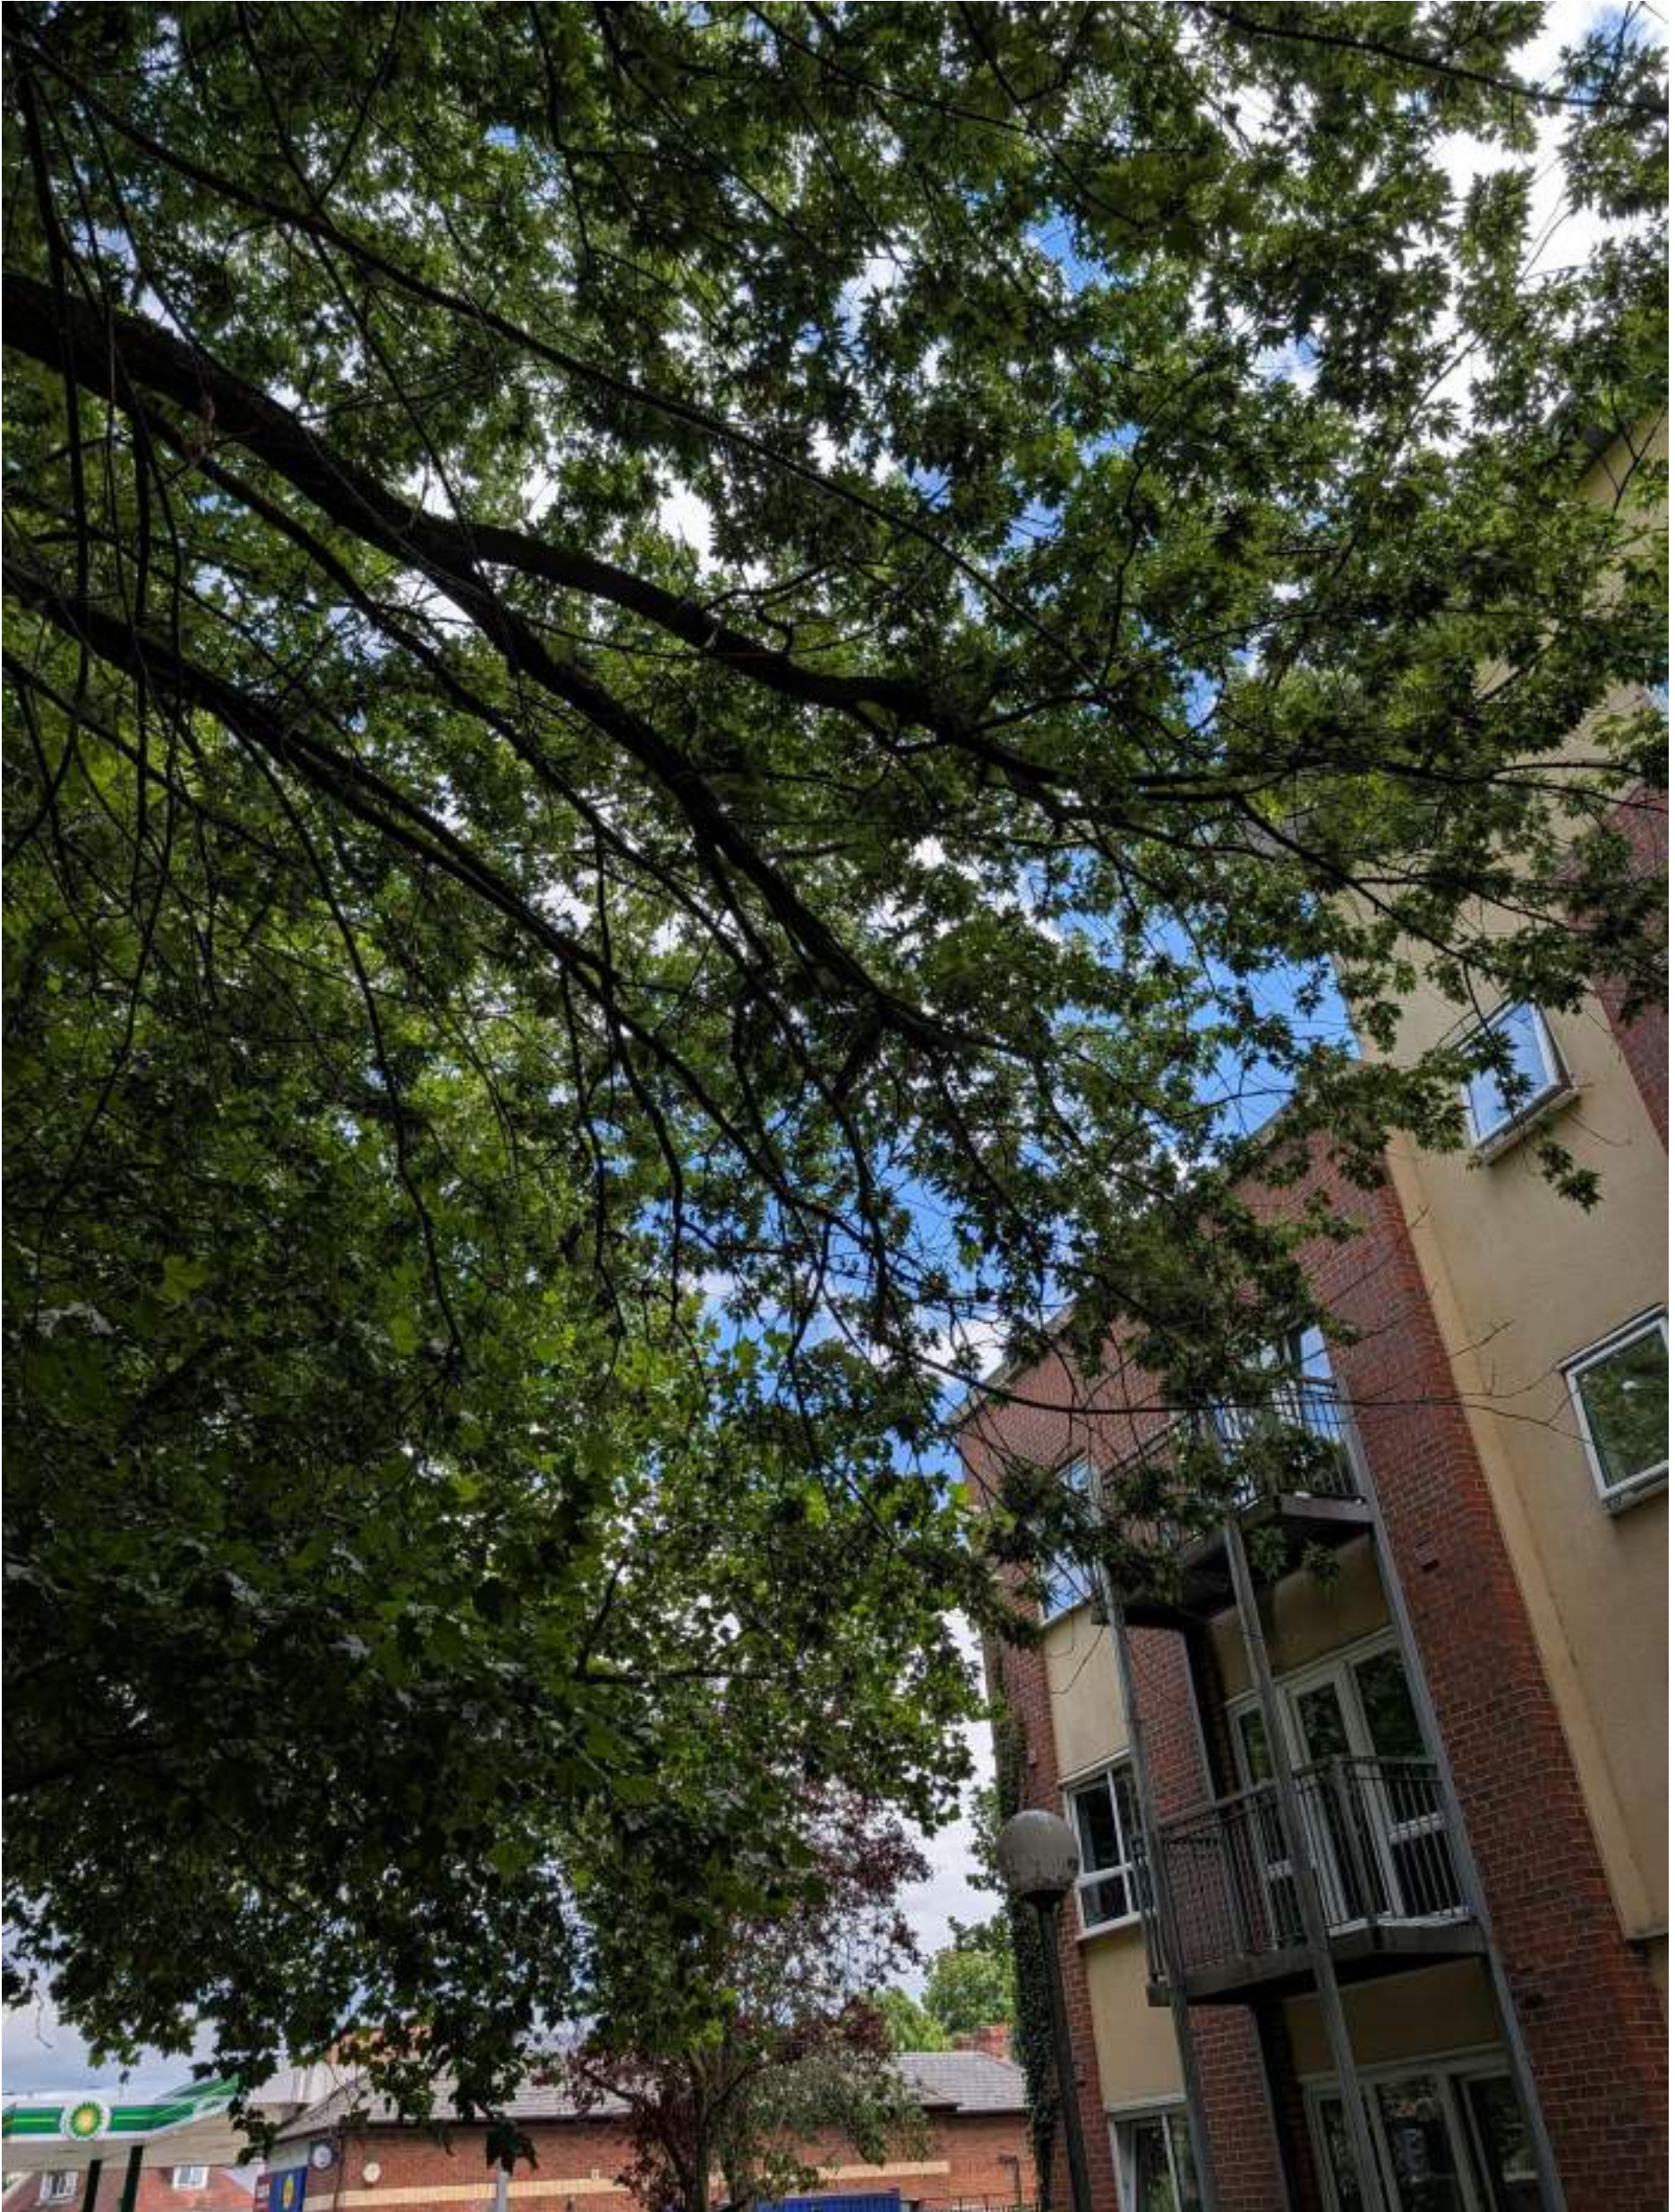
B.12 – T006 showing overextended lateral growing to south-east.

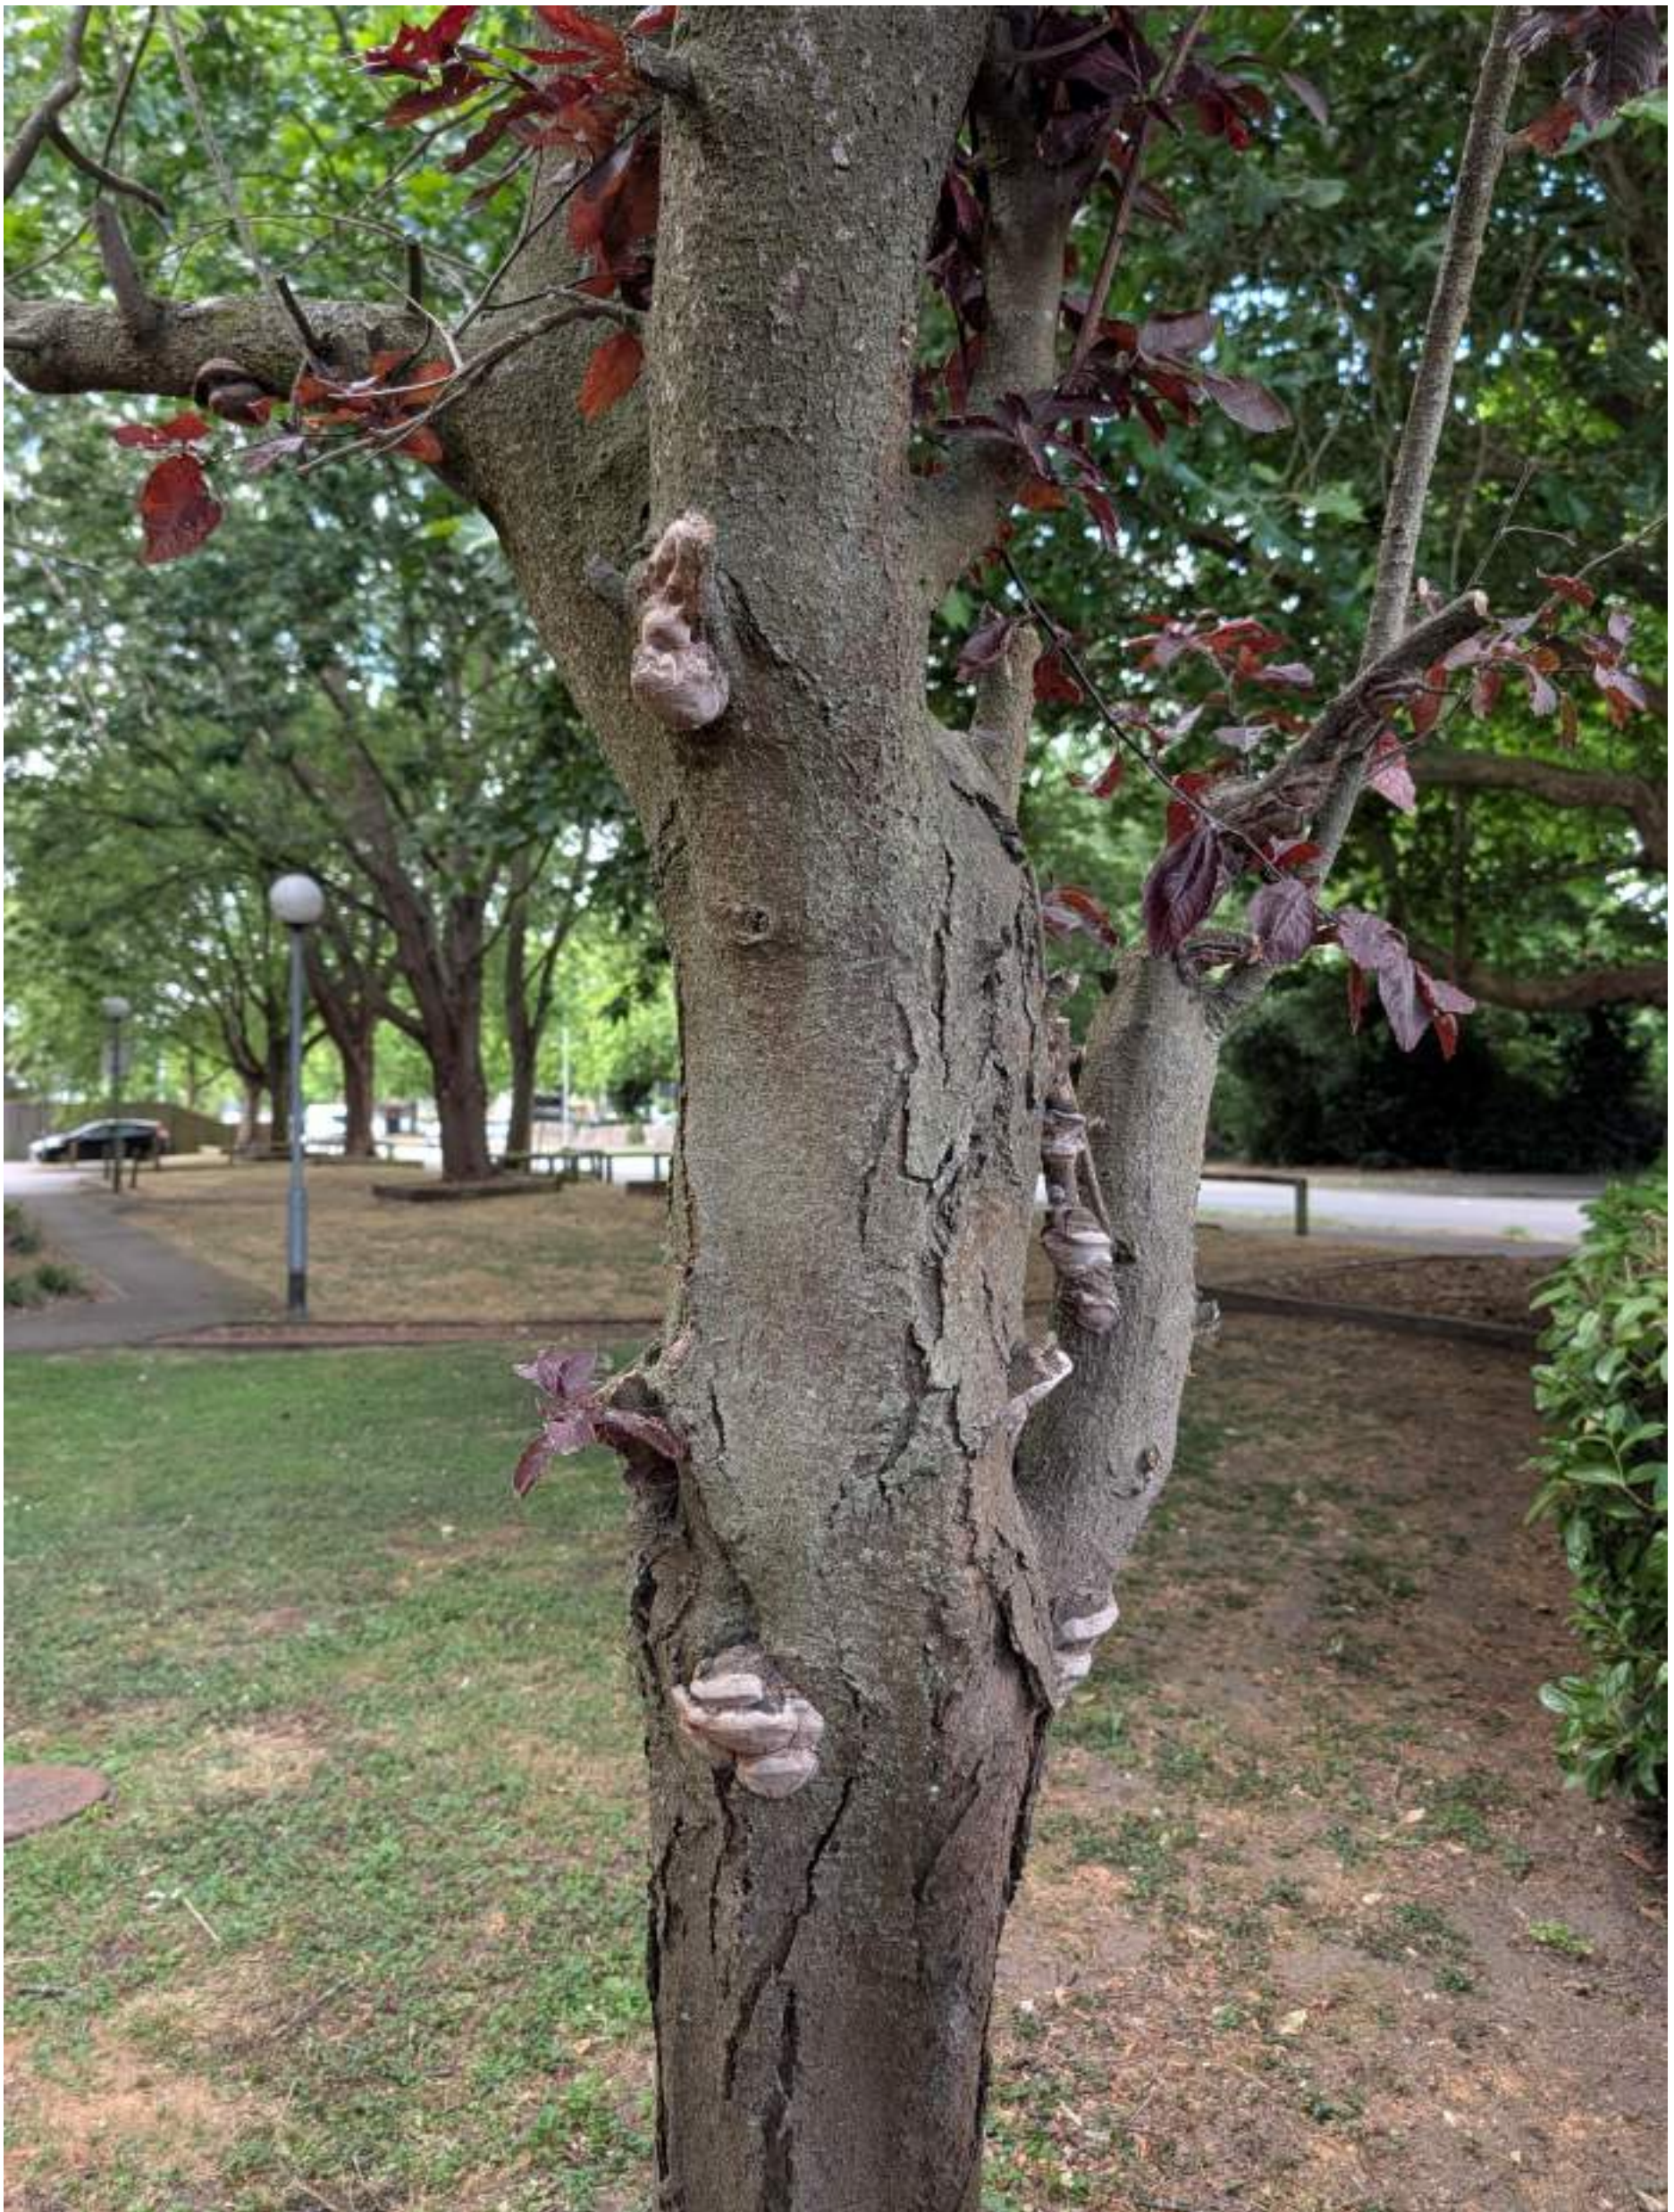
- **Cushion Fungus (*Phellinus pomaceus*):** Multiple fruiting bodies were identified on the stem, limbs and deadwood of the Purple plum (T008). *Phellinus pomaceus* is a white rot decay fungus that specifically targets *Prunus* species, degrading the lignin and cellulose within the wood. Its extensive presence up to 3m on the stem indicates significant internal dysfunction and decay, the result of this will likely be the death and failure of the tree into the nearby fencing and so removal has been recommended.

B.13 – T008 Showing multiple fungal brackets.

- Felling of T008 is required due to the fungal colonisation of *Phellinus pomaceus*. This has likely caused structural degradation which will likely cause tree death and/or failure; as such it is recommended to fell to ground level to remove the risk.

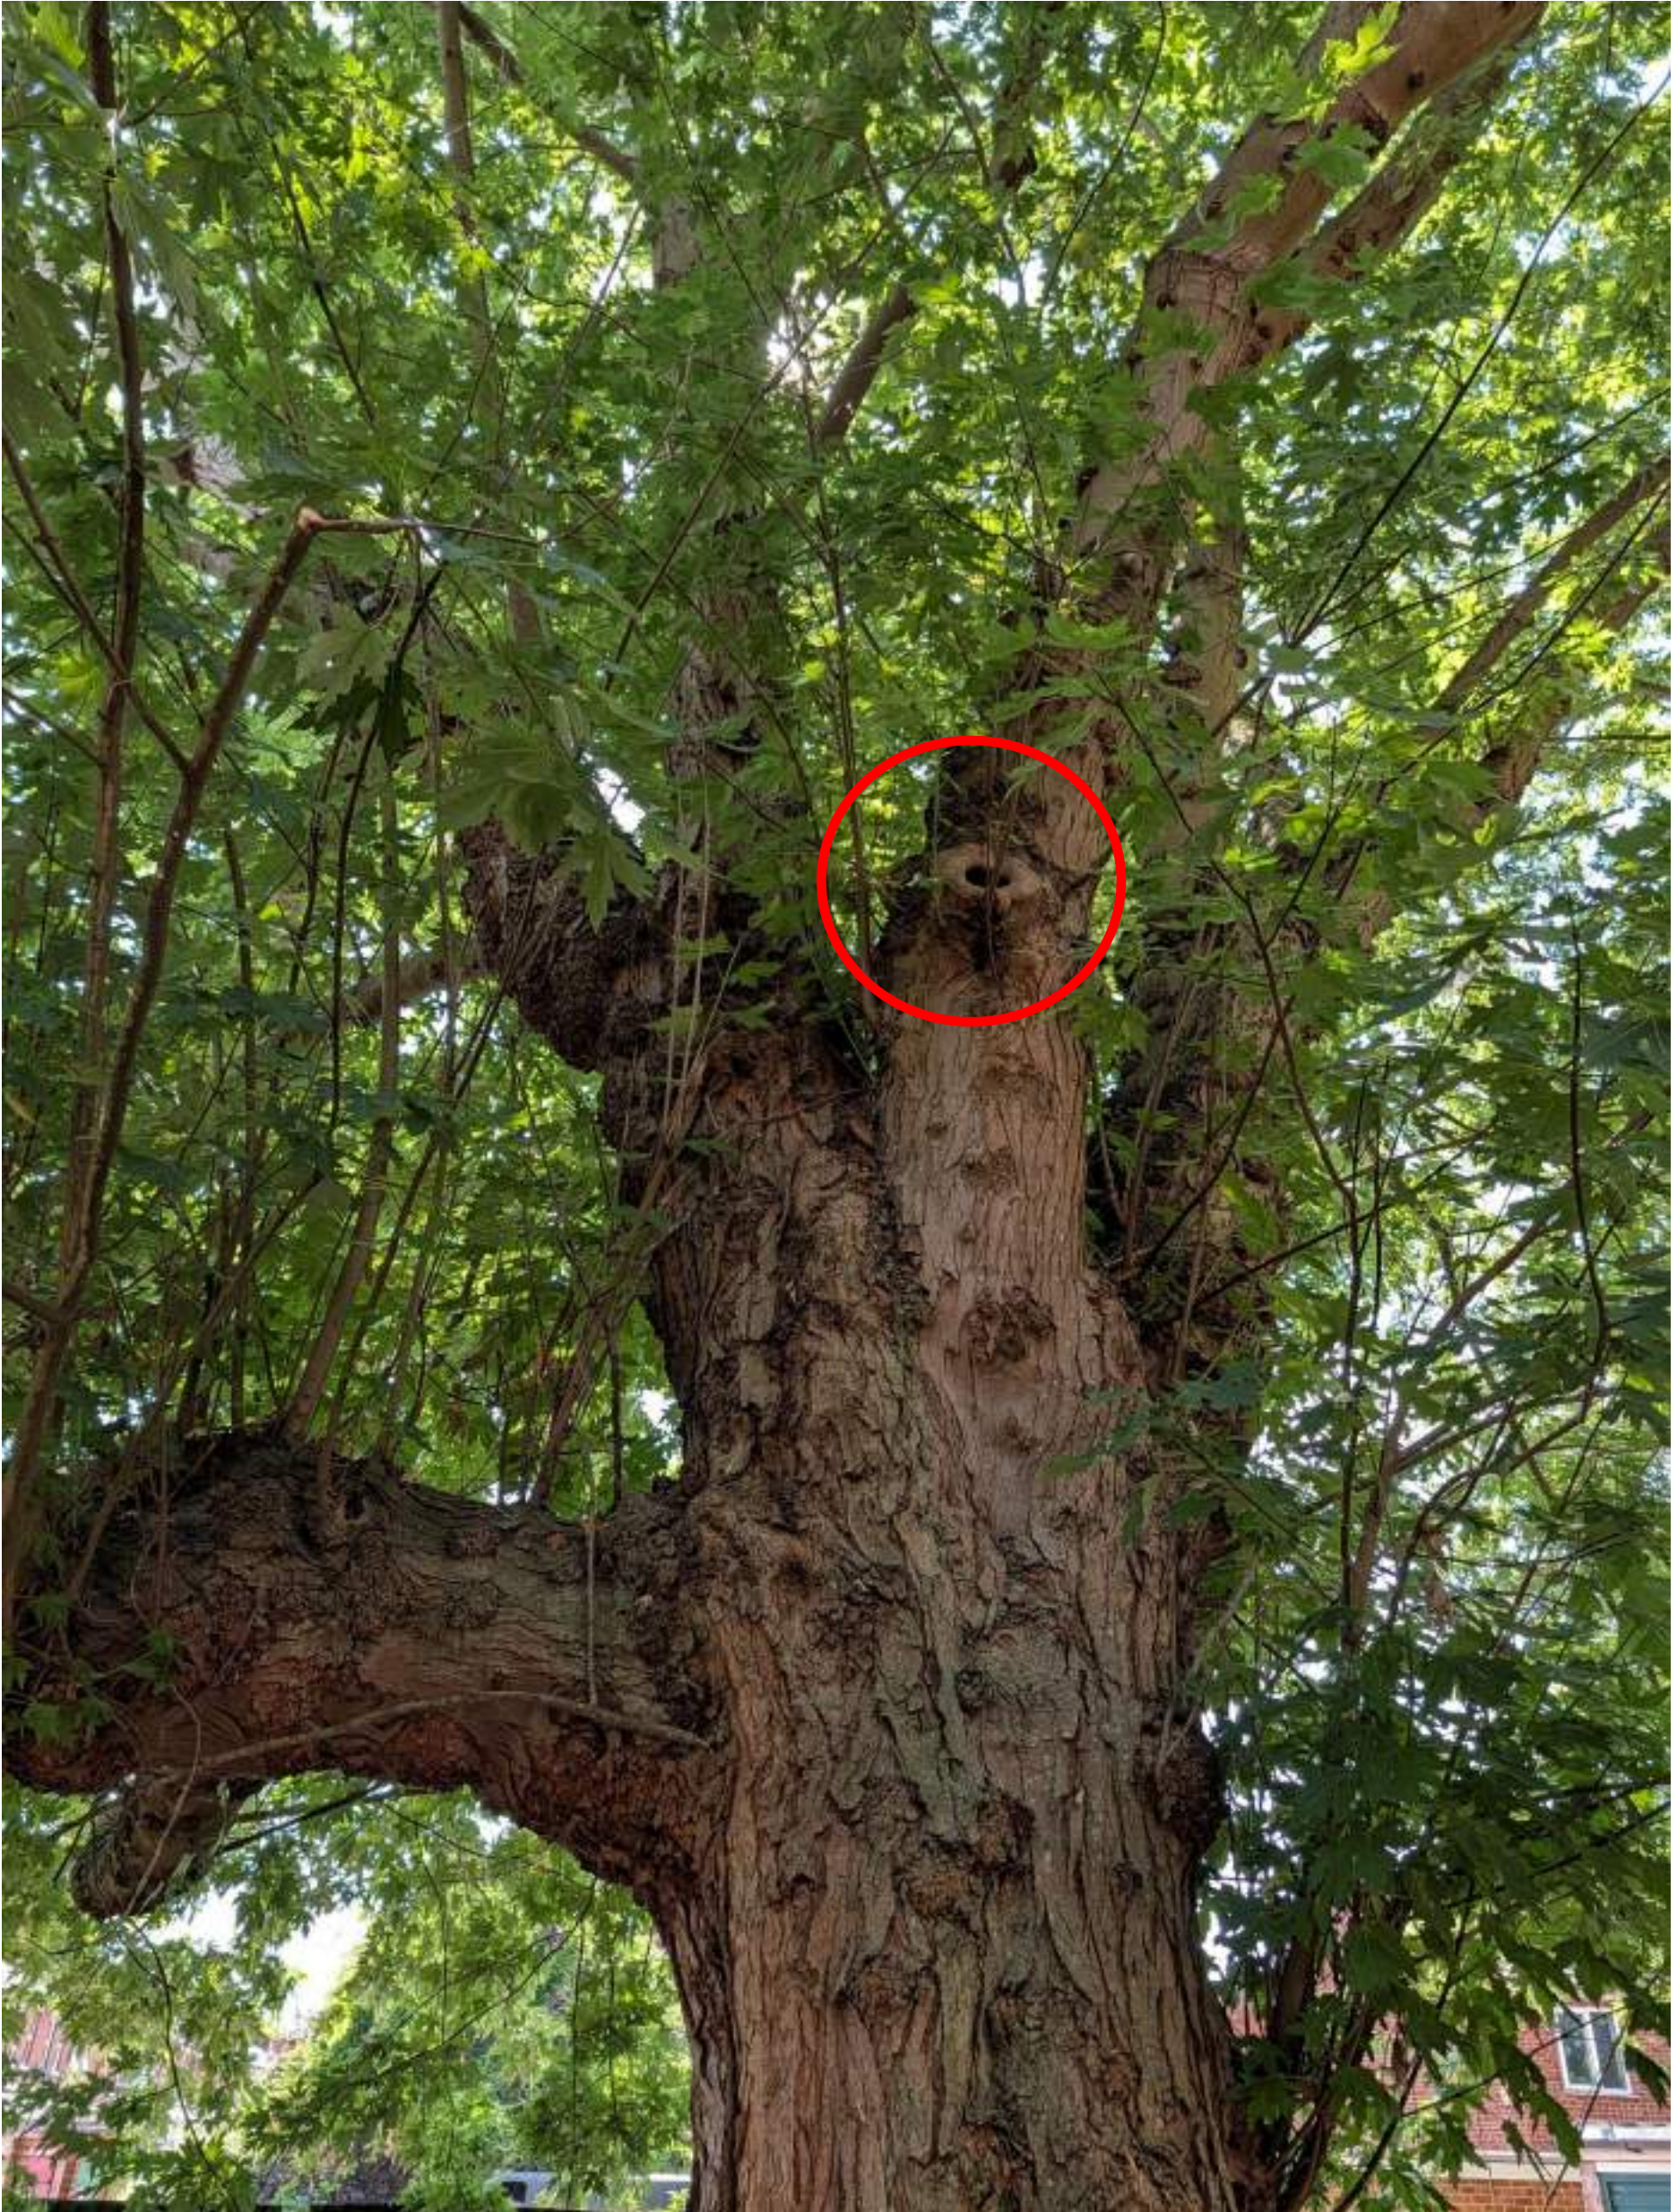
- **Suspected Verticillium Wilt (*Verticillium albo-atrum*) / Drought Stress:** A mature Silver maple (T011) is displaying severe signs of vascular dysfunction, characterised by sporadic crown dieback, limb failure and masses of epicormic growth extending from the base up through the lower limbs. These symptoms are strong indicators of a vascular wilt disease such as *Verticillium*, which invades the xylem via the root system and blocks water transport. Whether driven purely by fungal colonisation, or compounded by successive drought years, or a combination of multiple stressors, the tree is evidently in decline and poses an increased risk of failure over the adjacent garages, boundary lines and grass play area.

B.14 – T011 showing masses of epicormic growth on lower stem and limbs and highlighted cavity in stem.

- Crown reductions: T011 is exhibiting signs of physiological decline—displaying symptoms consistent with vascular wilt or acute drought stress, combined with high-risk structural faults such as hazard beams, therefore it is recommended that a crown reduction (4–5m) be carried out to mitigate the immediate risk of structural failure over nearby targets.
