Tree Top Arborists

CAVERSHAM PLACE  
RICHFIELD AVENUE  
READING  
RG1 8BY

CF0024

(Survey conducted on 03/07/26)  
(Amended for TPO application on 03/09/26)

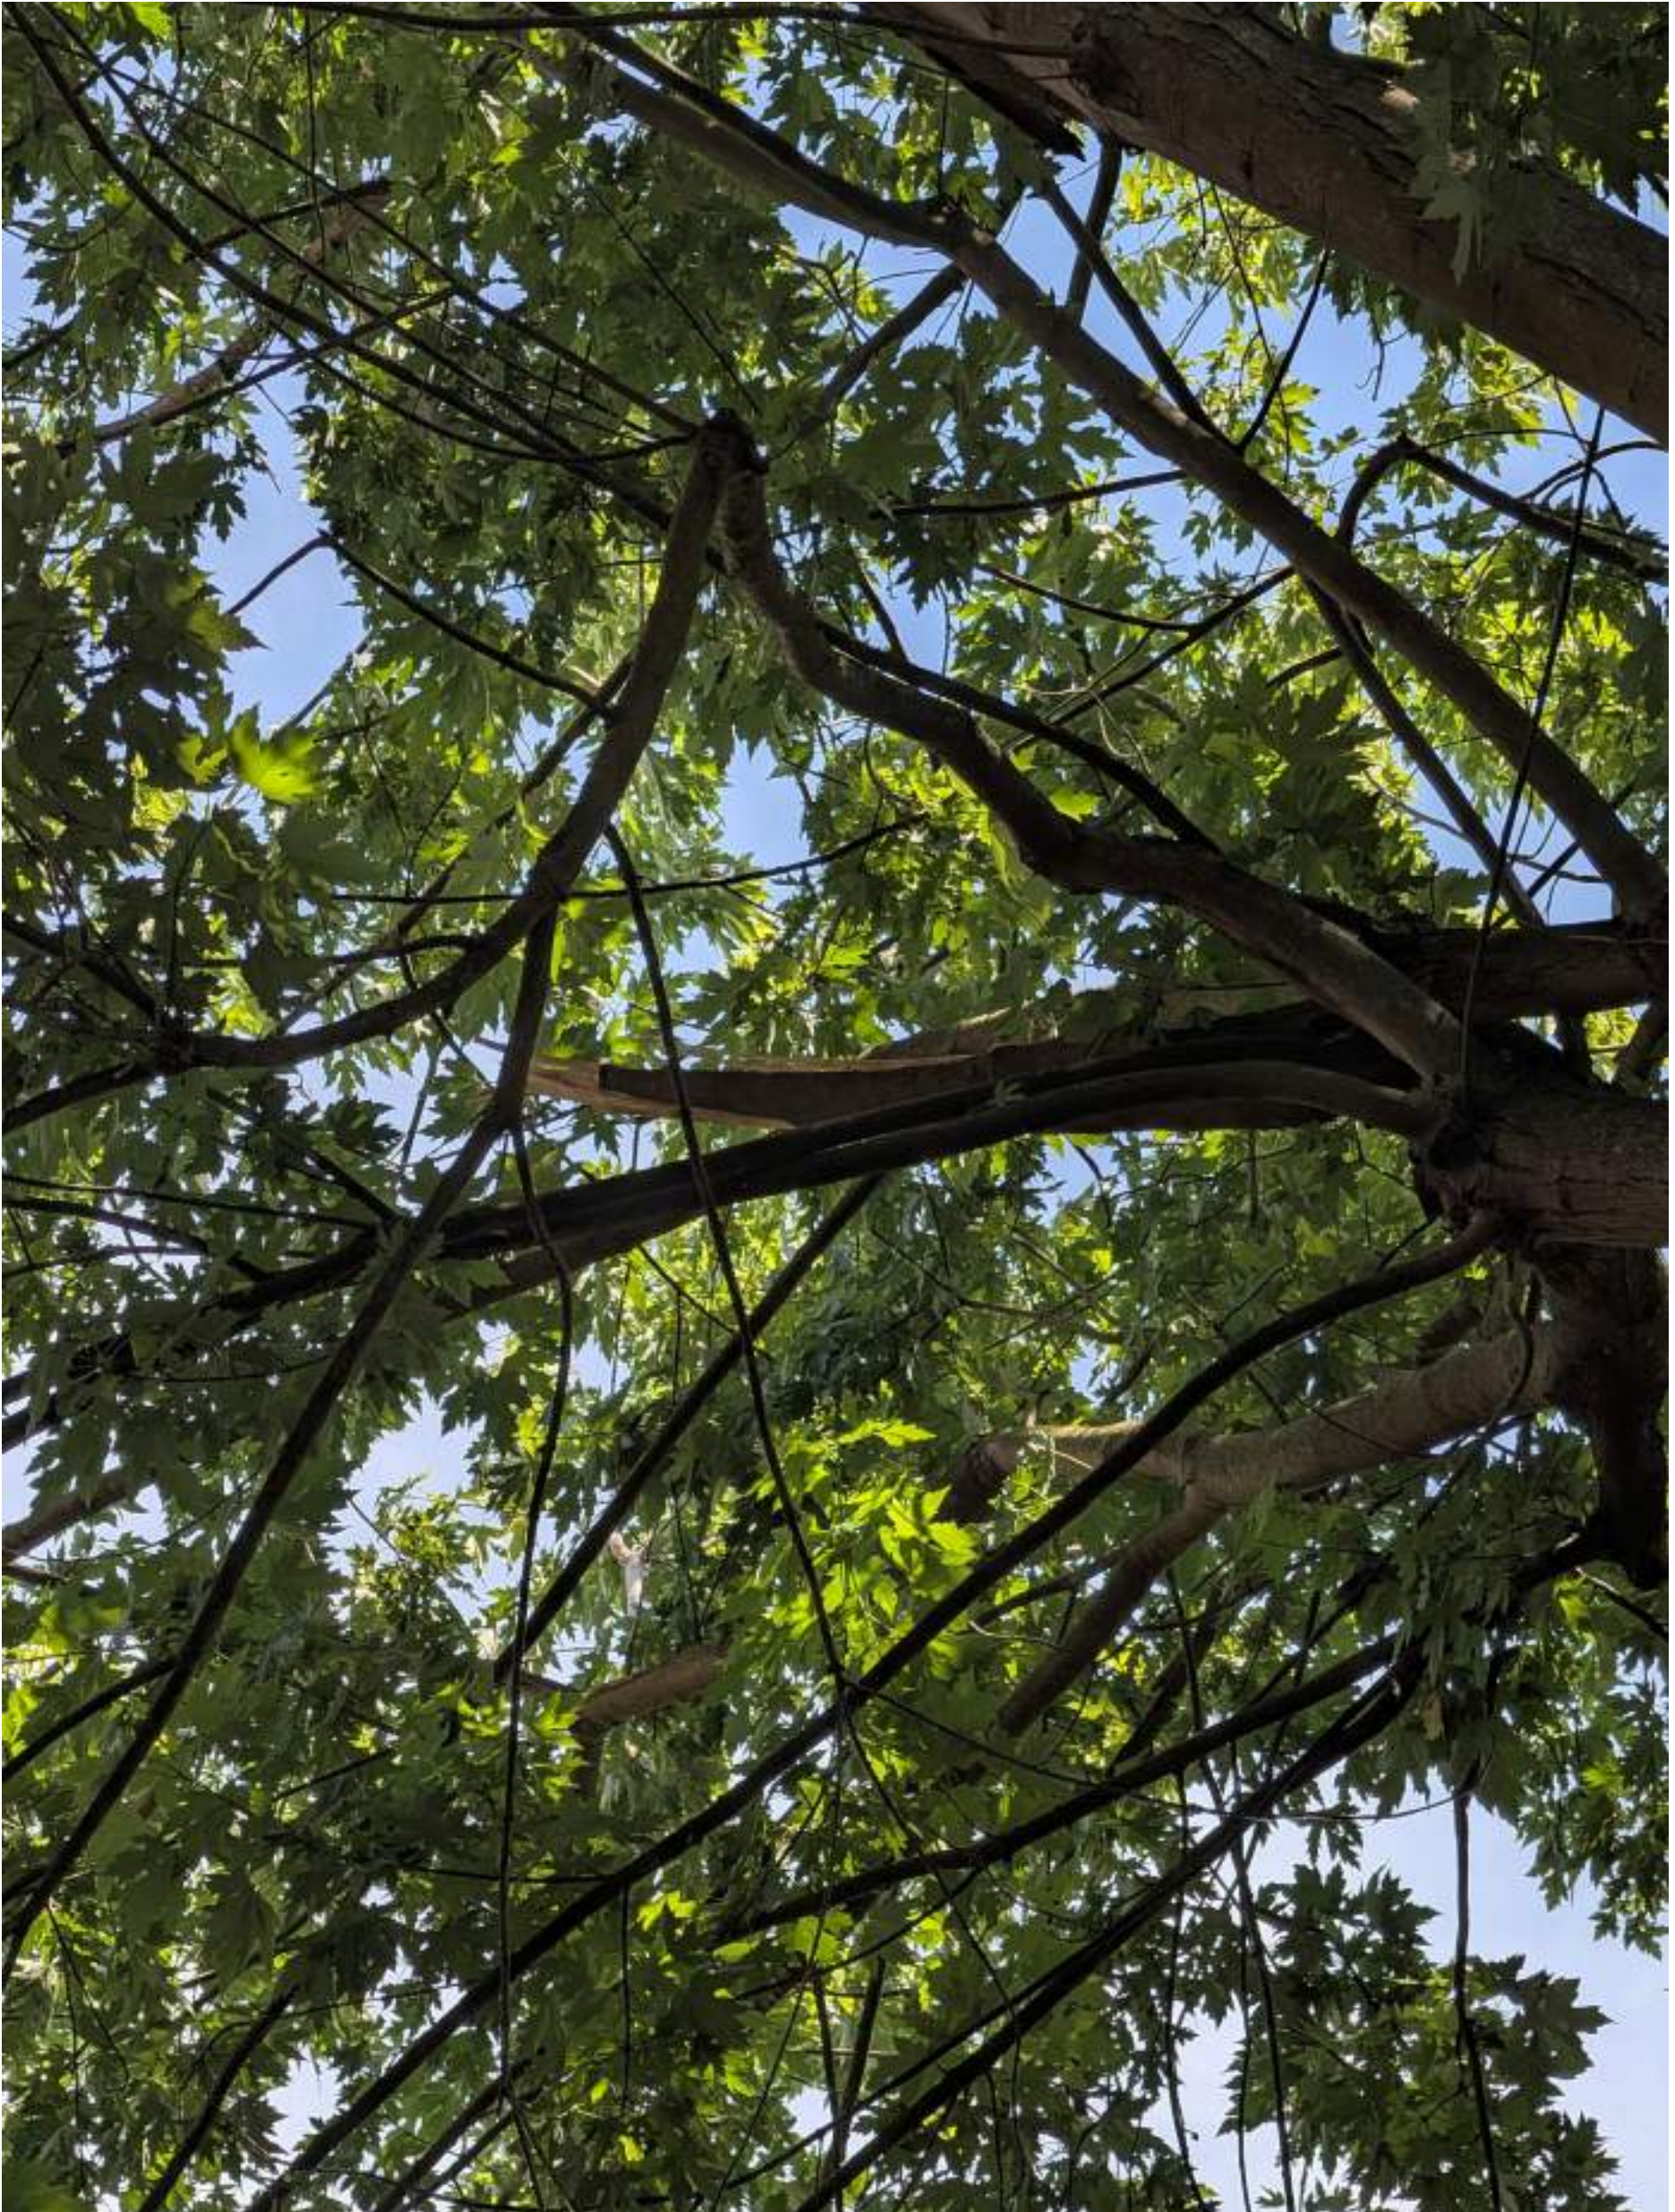
B.15 – T011 showing poor historical pruning site and failed limb.

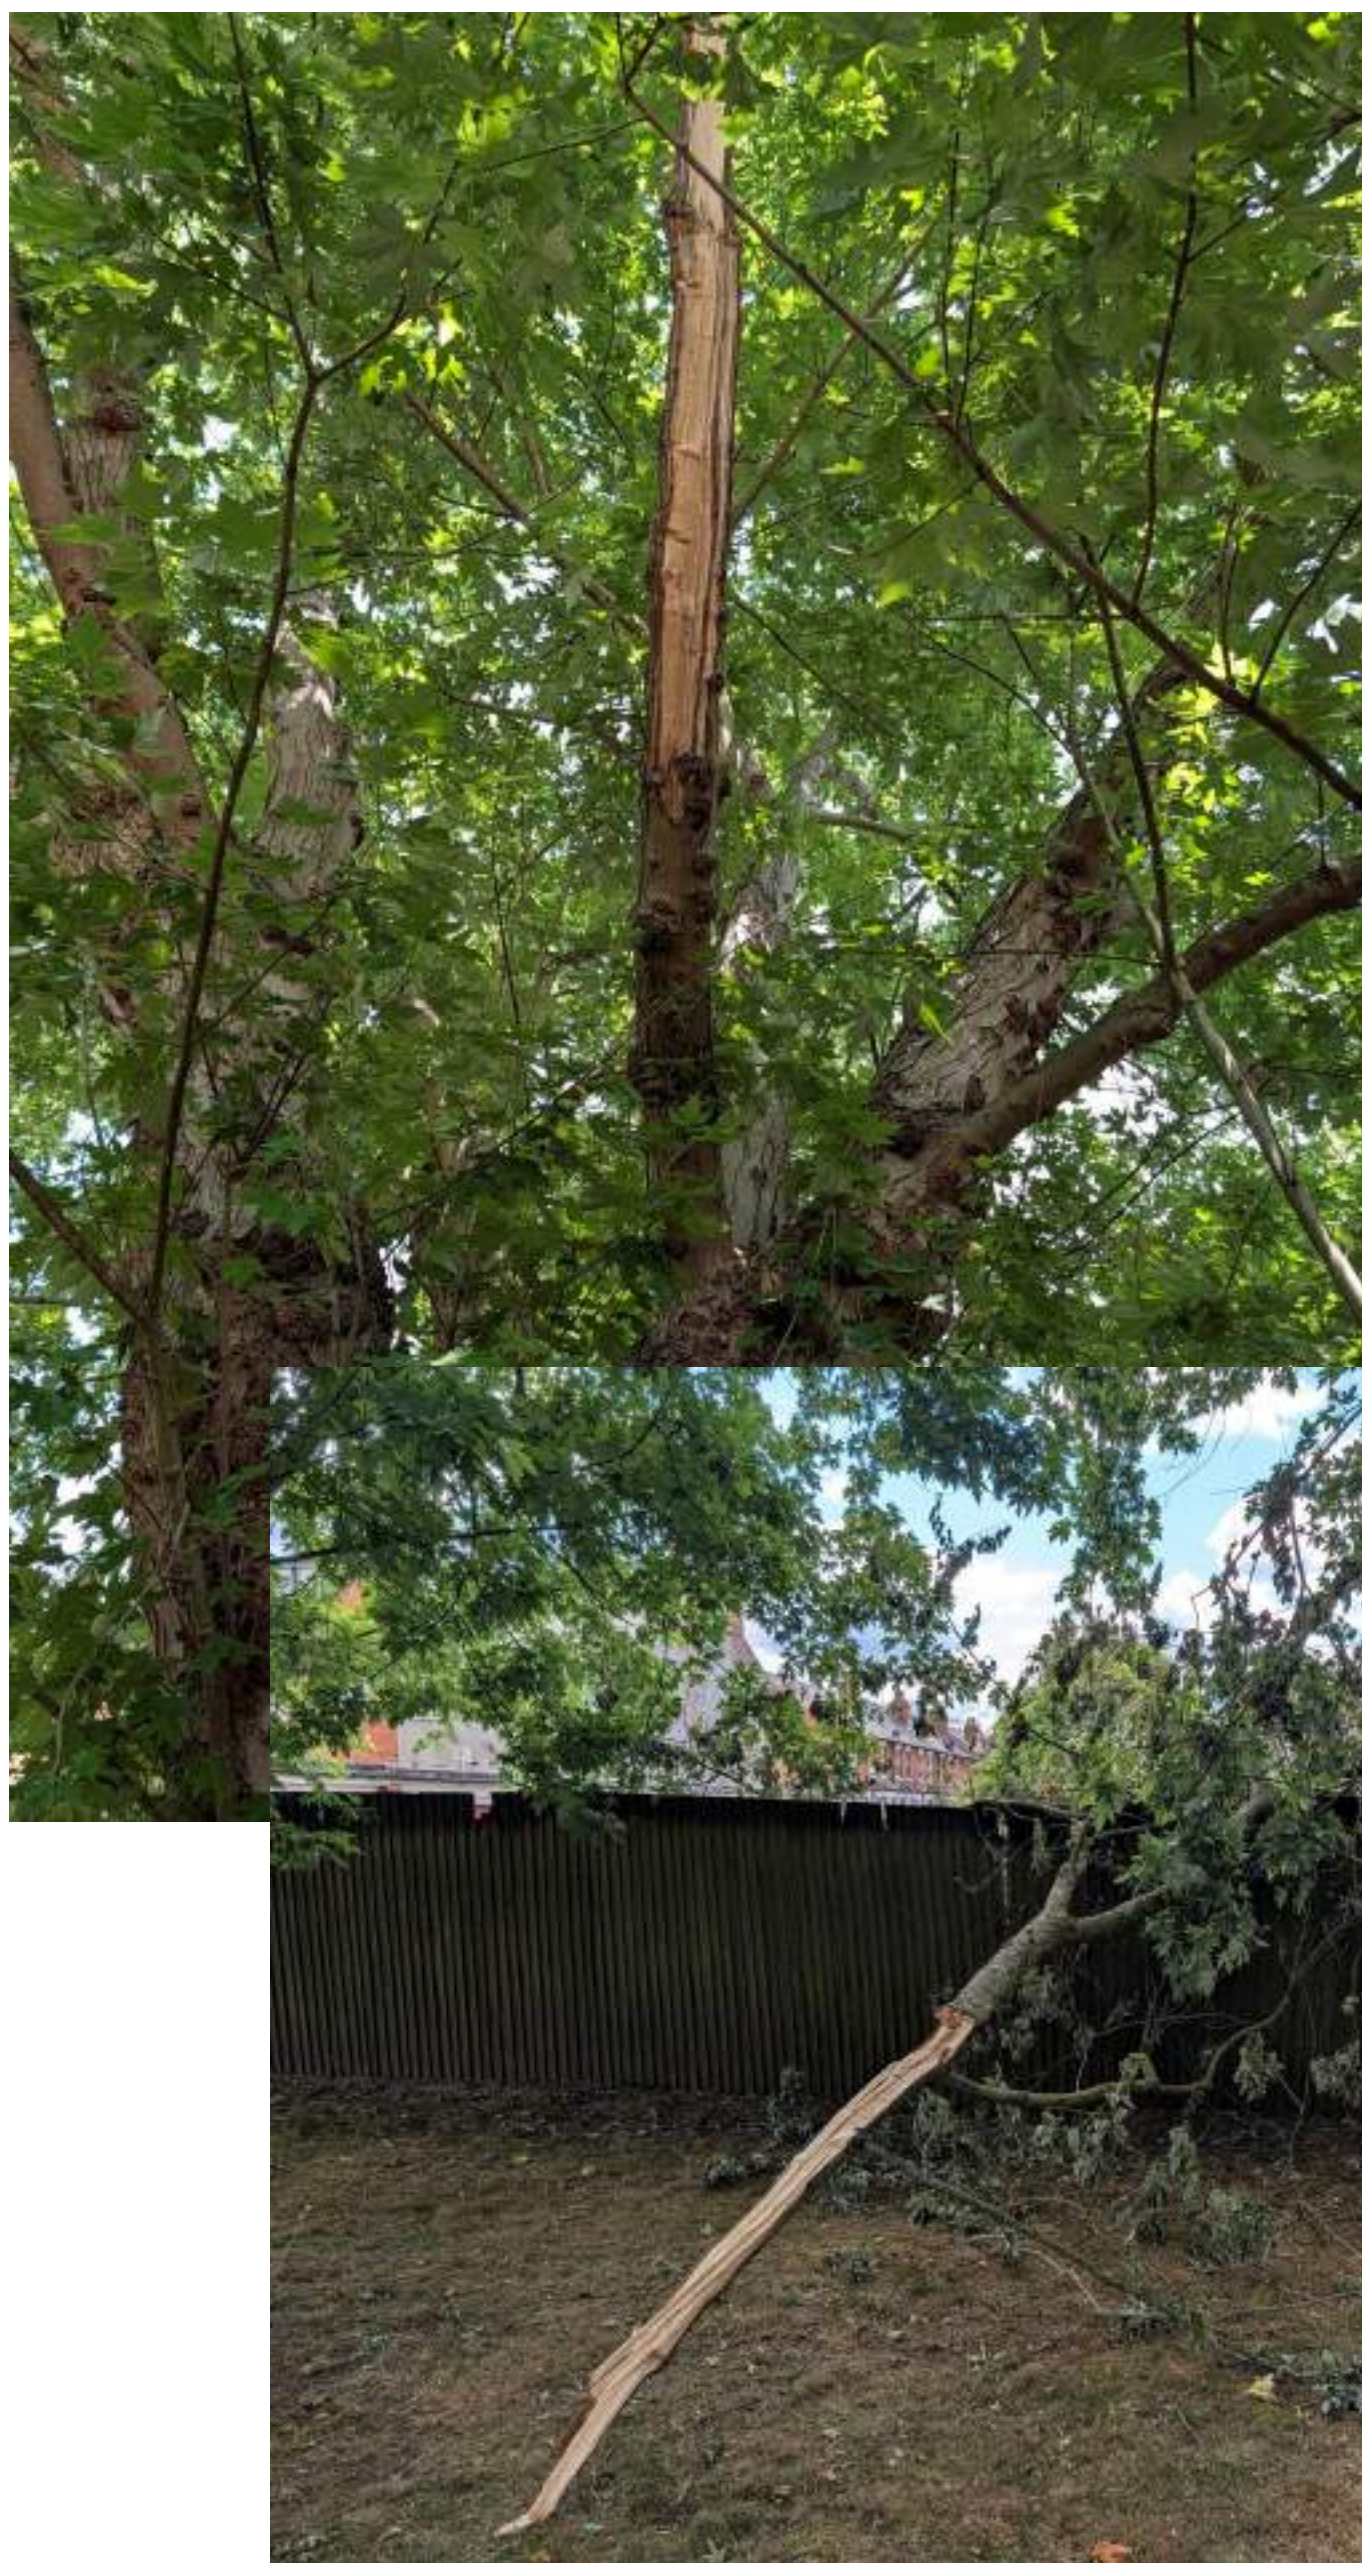
B.16/17 – T011 showing previously failed limb.

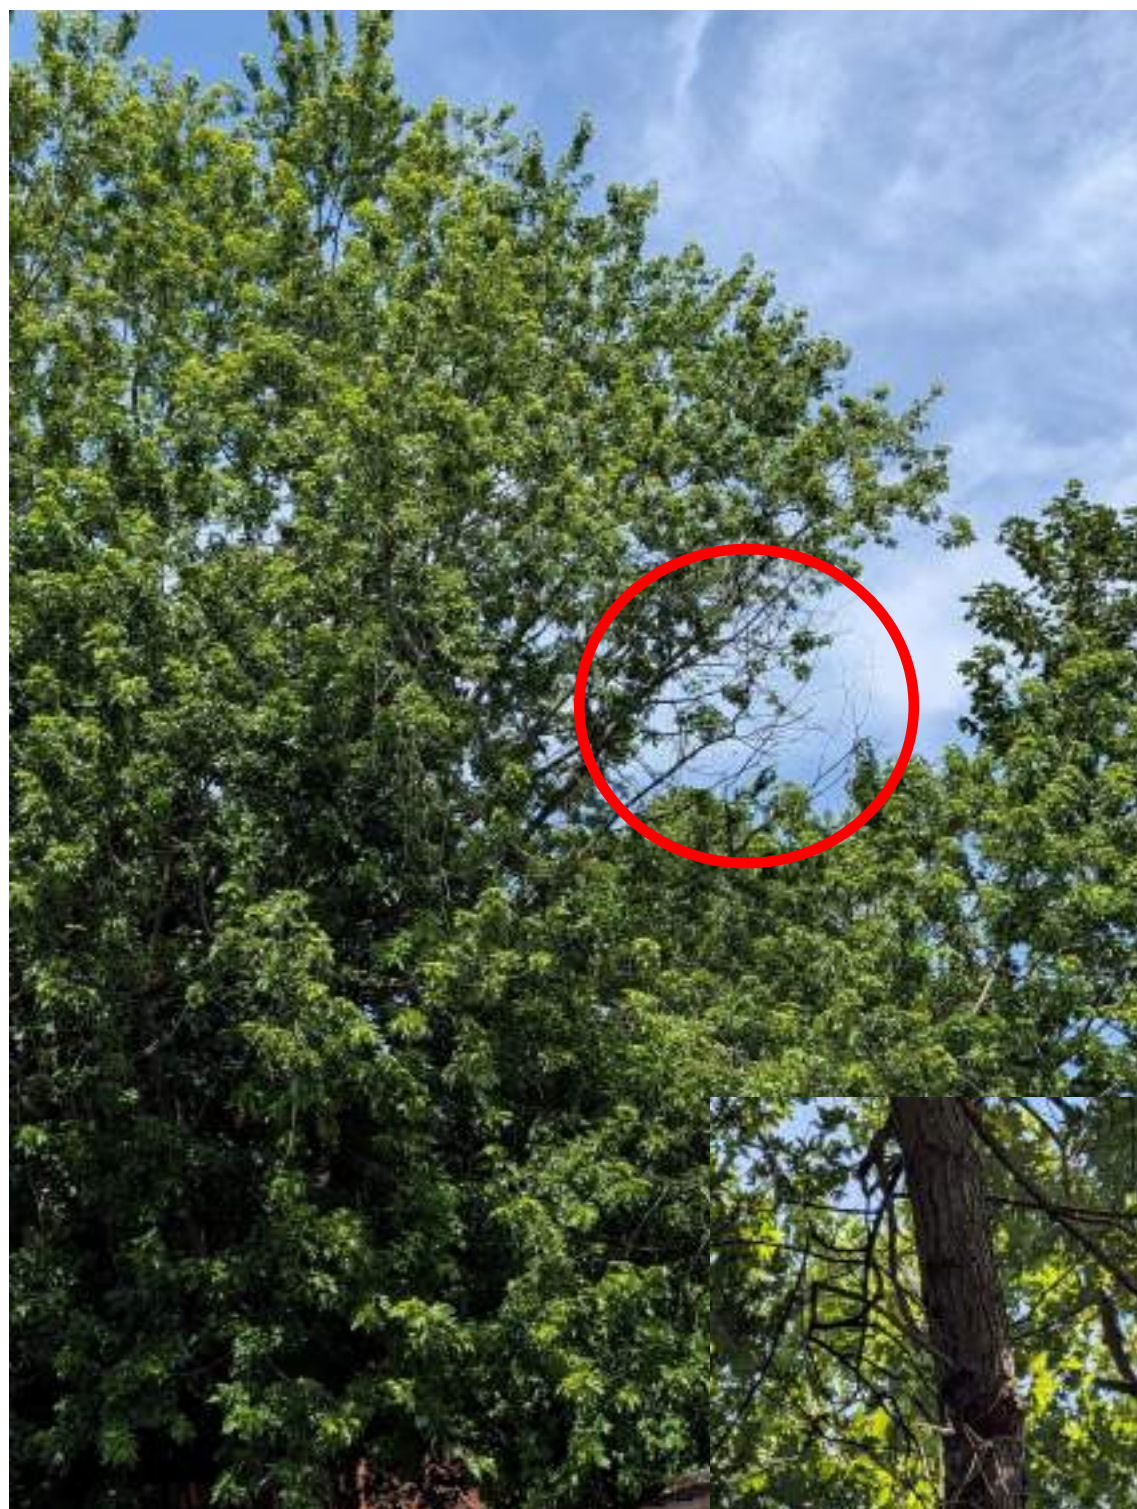
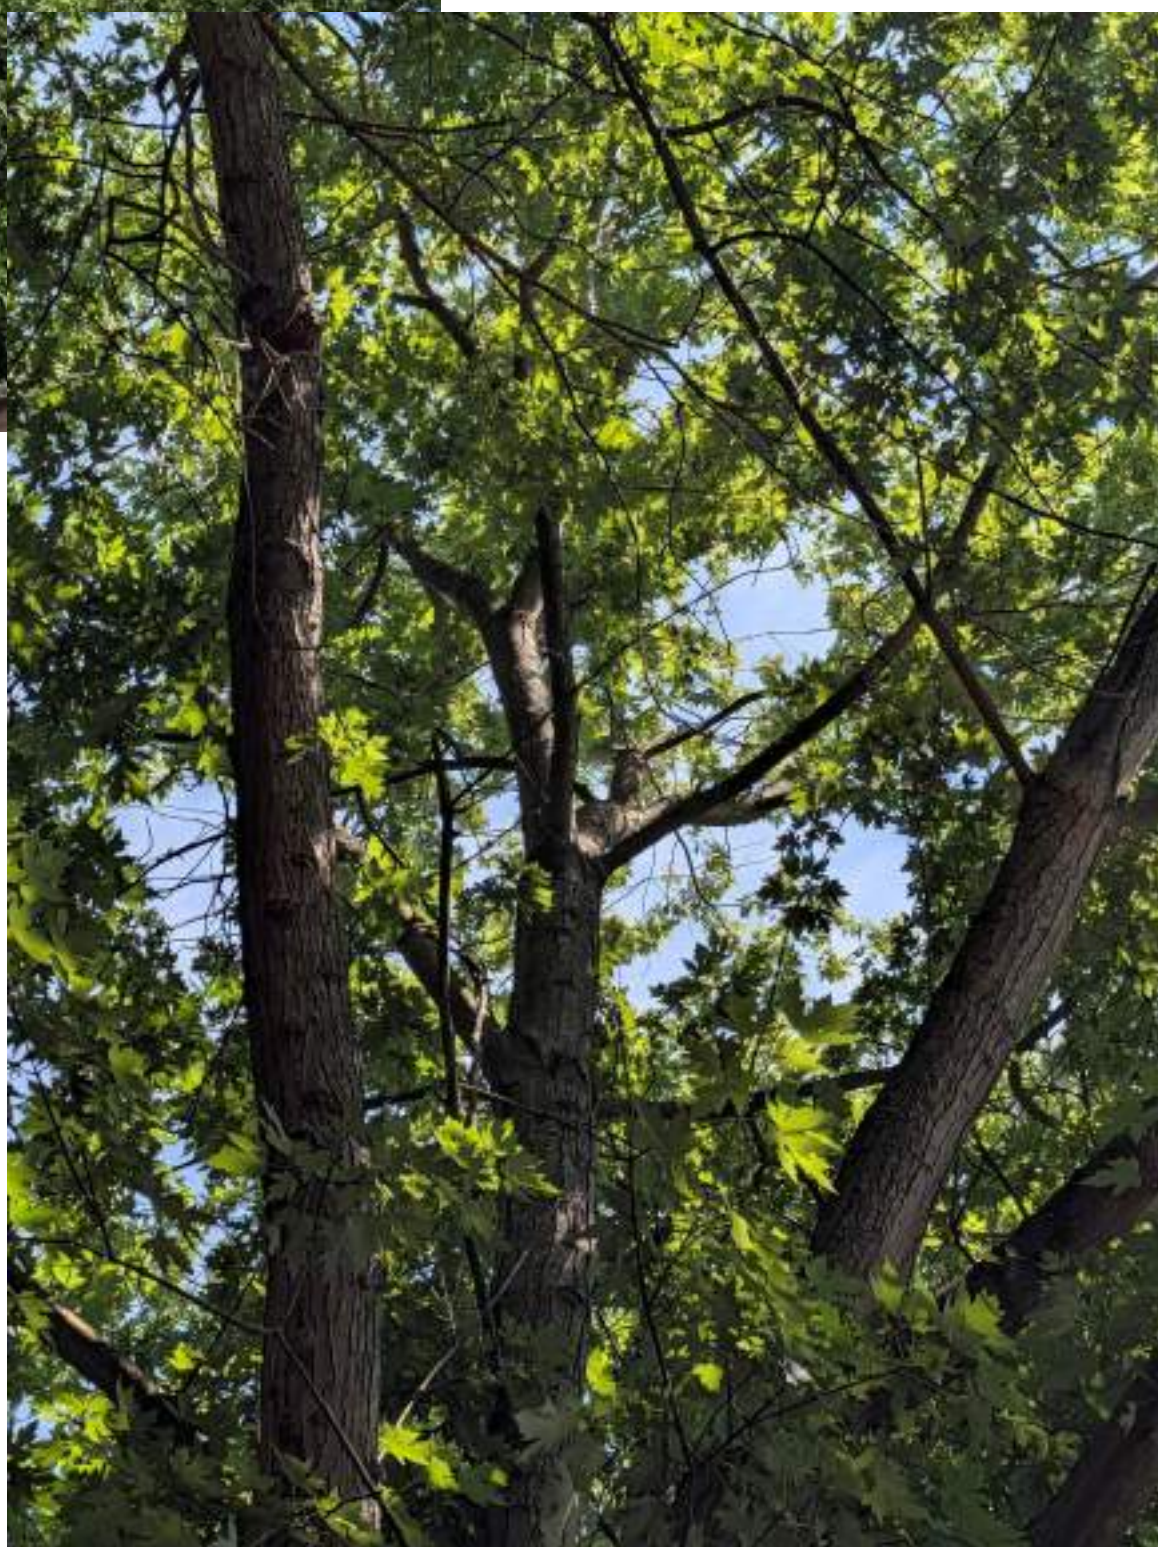
| | | | | | state. The combination of these issues could indicate the presence of fungal colonisation such as Verticillium wilt ( <i>Verticillium albo-atrum</i> ) which infects the tree through the roots and causes vascular dysfunction resulting in sporadic dieback of the crown. These issues could also be caused by drought from the recent hot summers and lack of rainfall or a combination of multiple stressors. | | | |

B.18/19 – T011 showing dieback of crown.

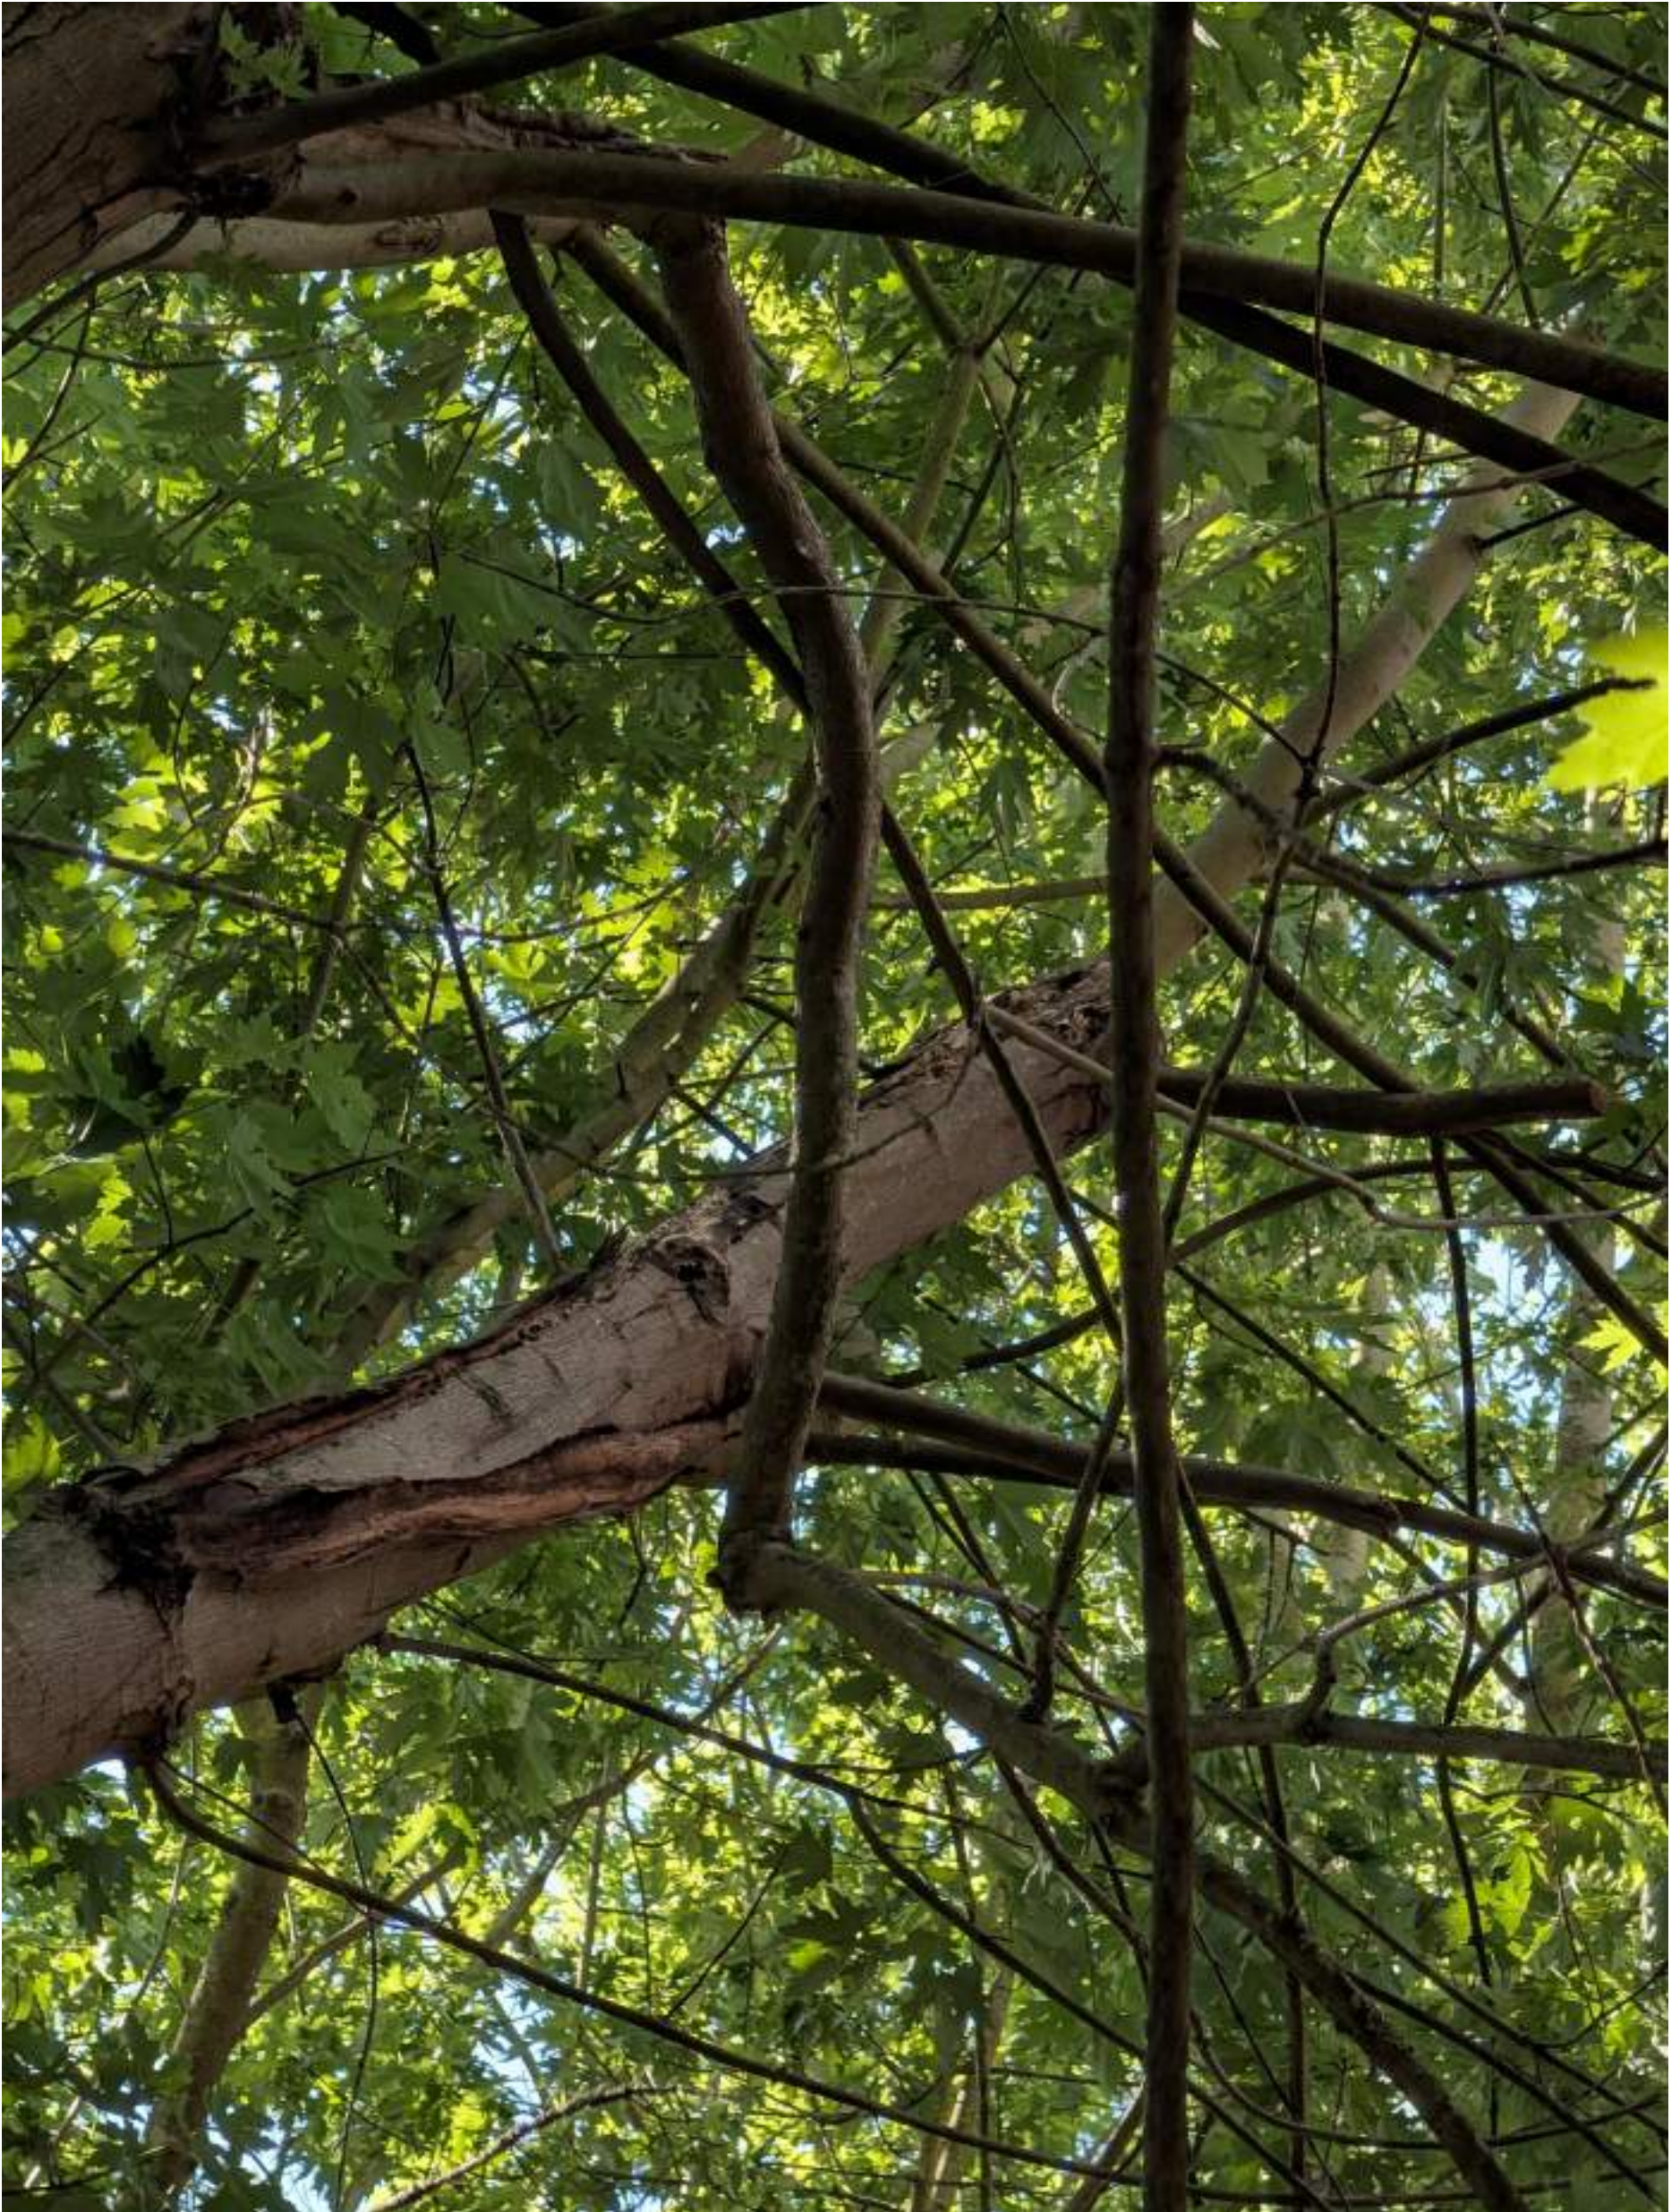
B.20 – T011 previously pruned limb now decaying with area of dysfunction below.

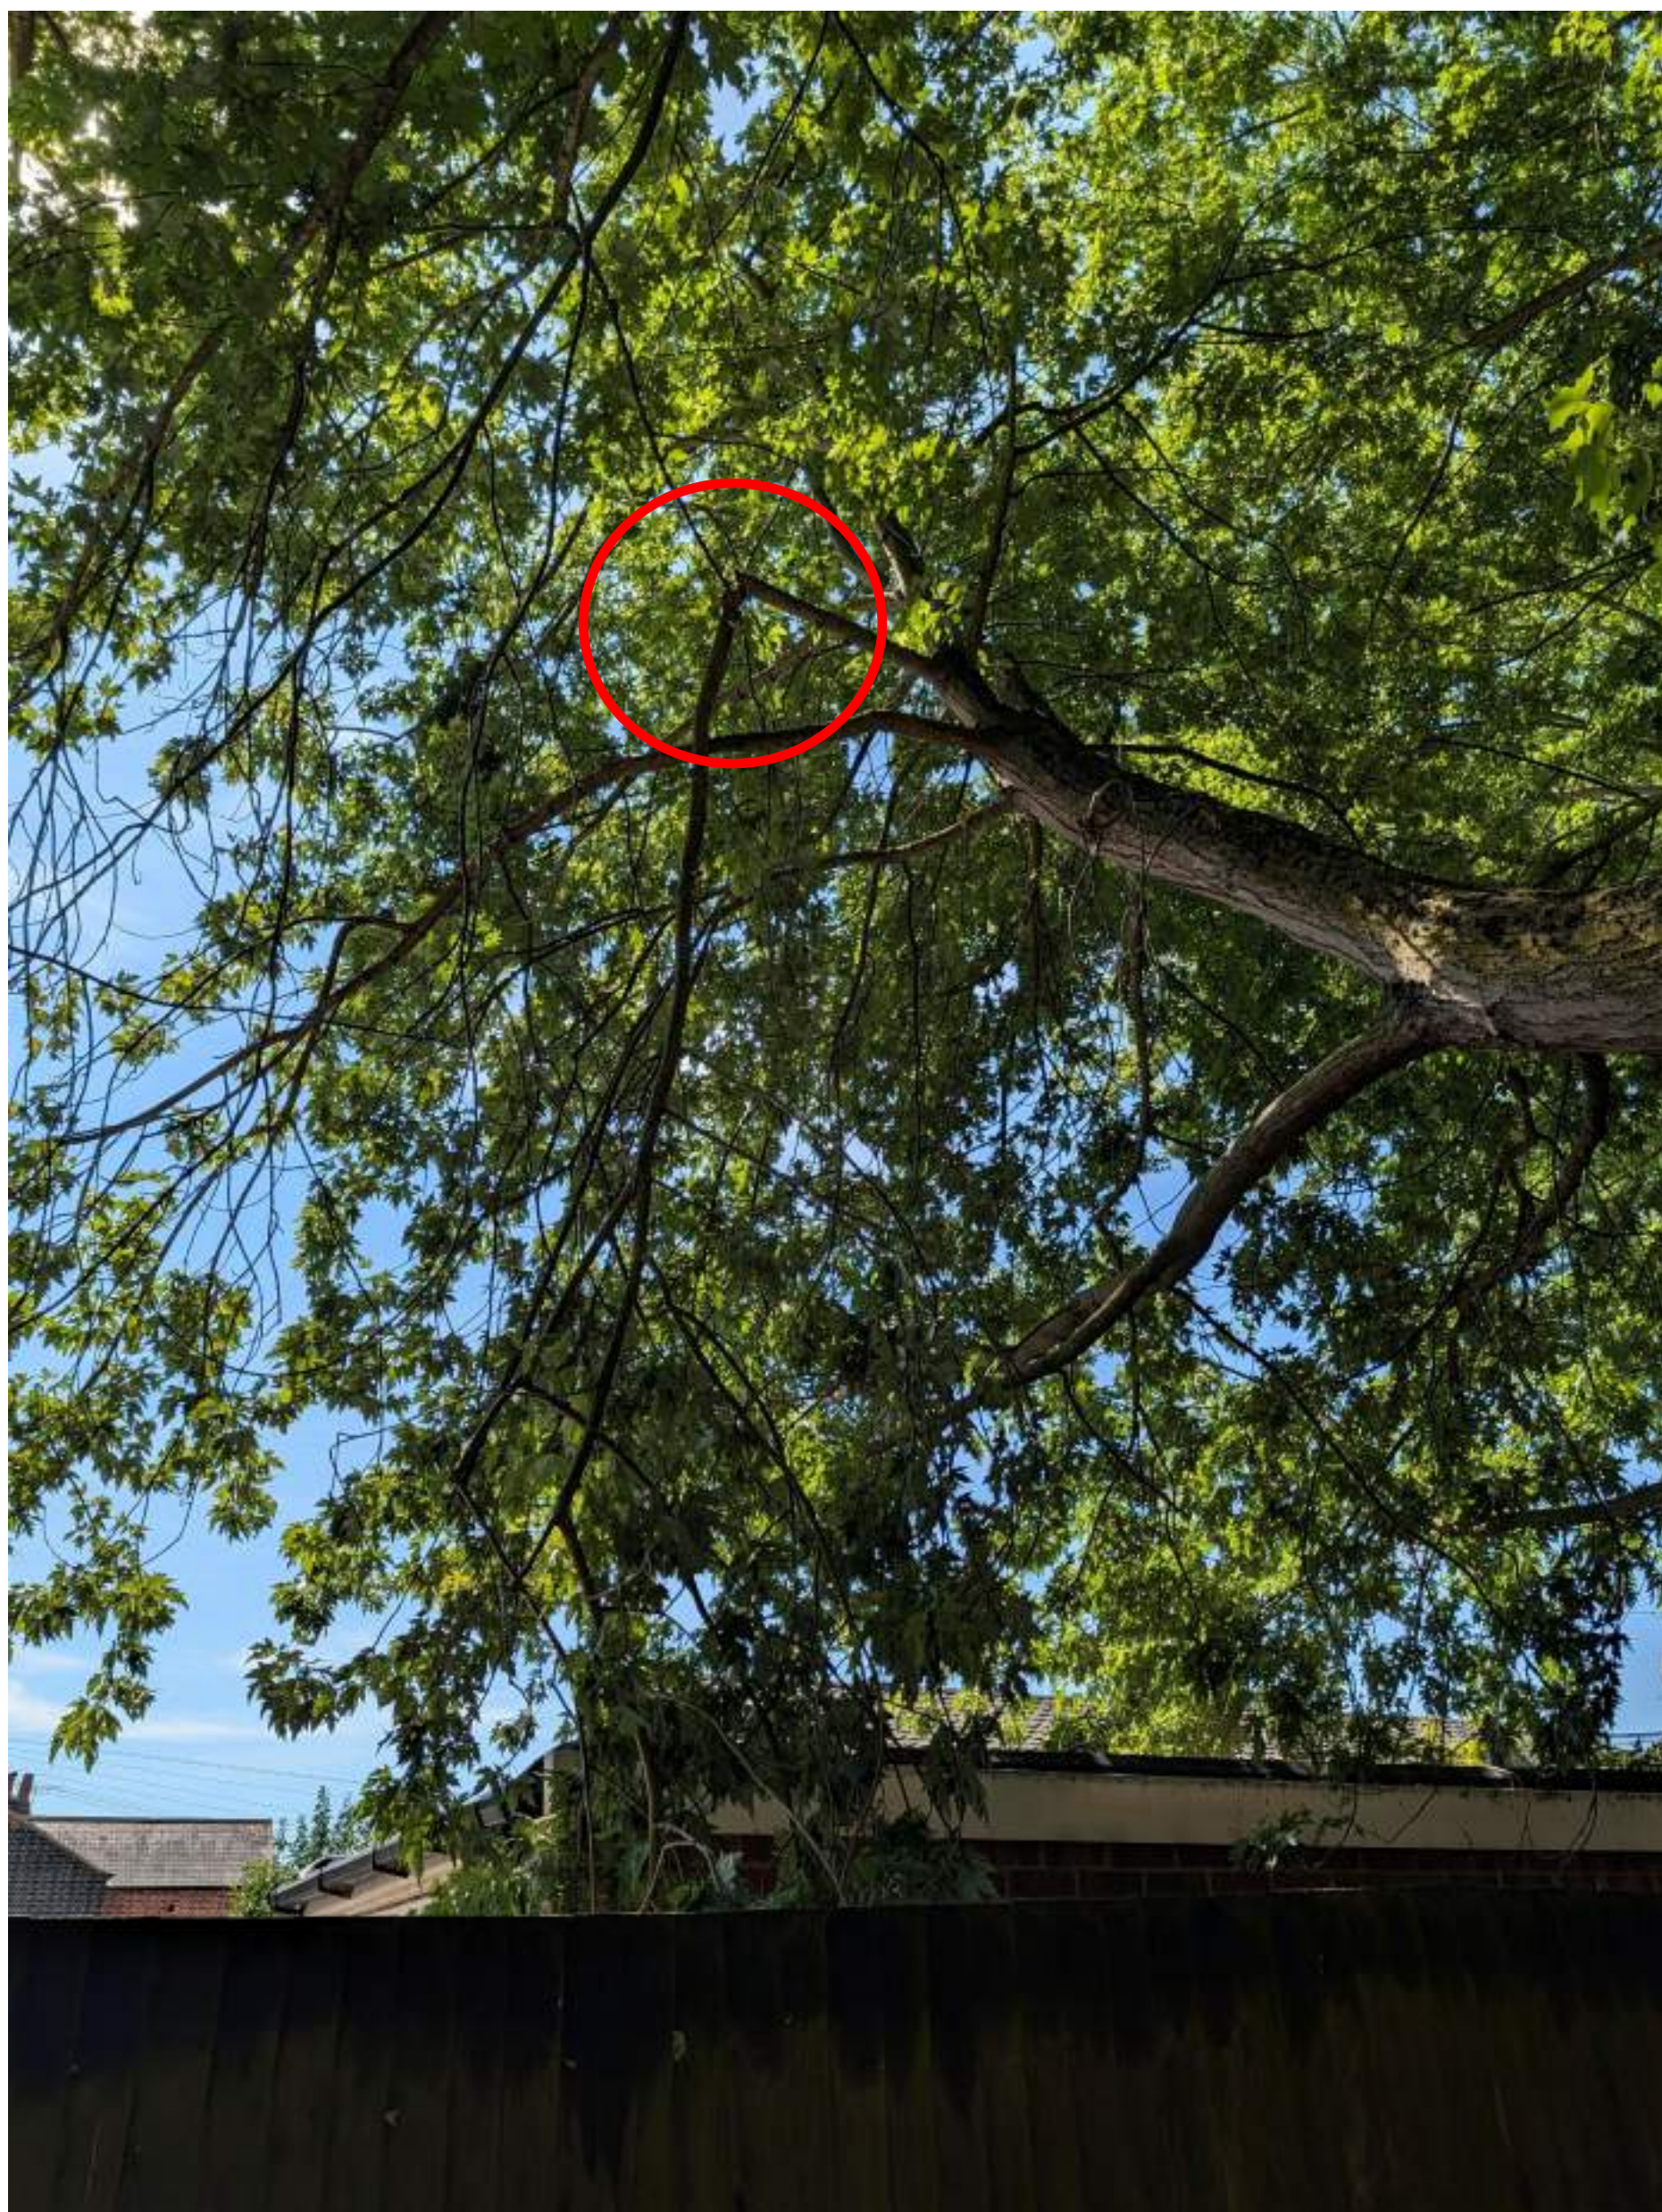
B.21 – T012 showing multiple limbs interfering with building and highlighted snapped hanging branch.

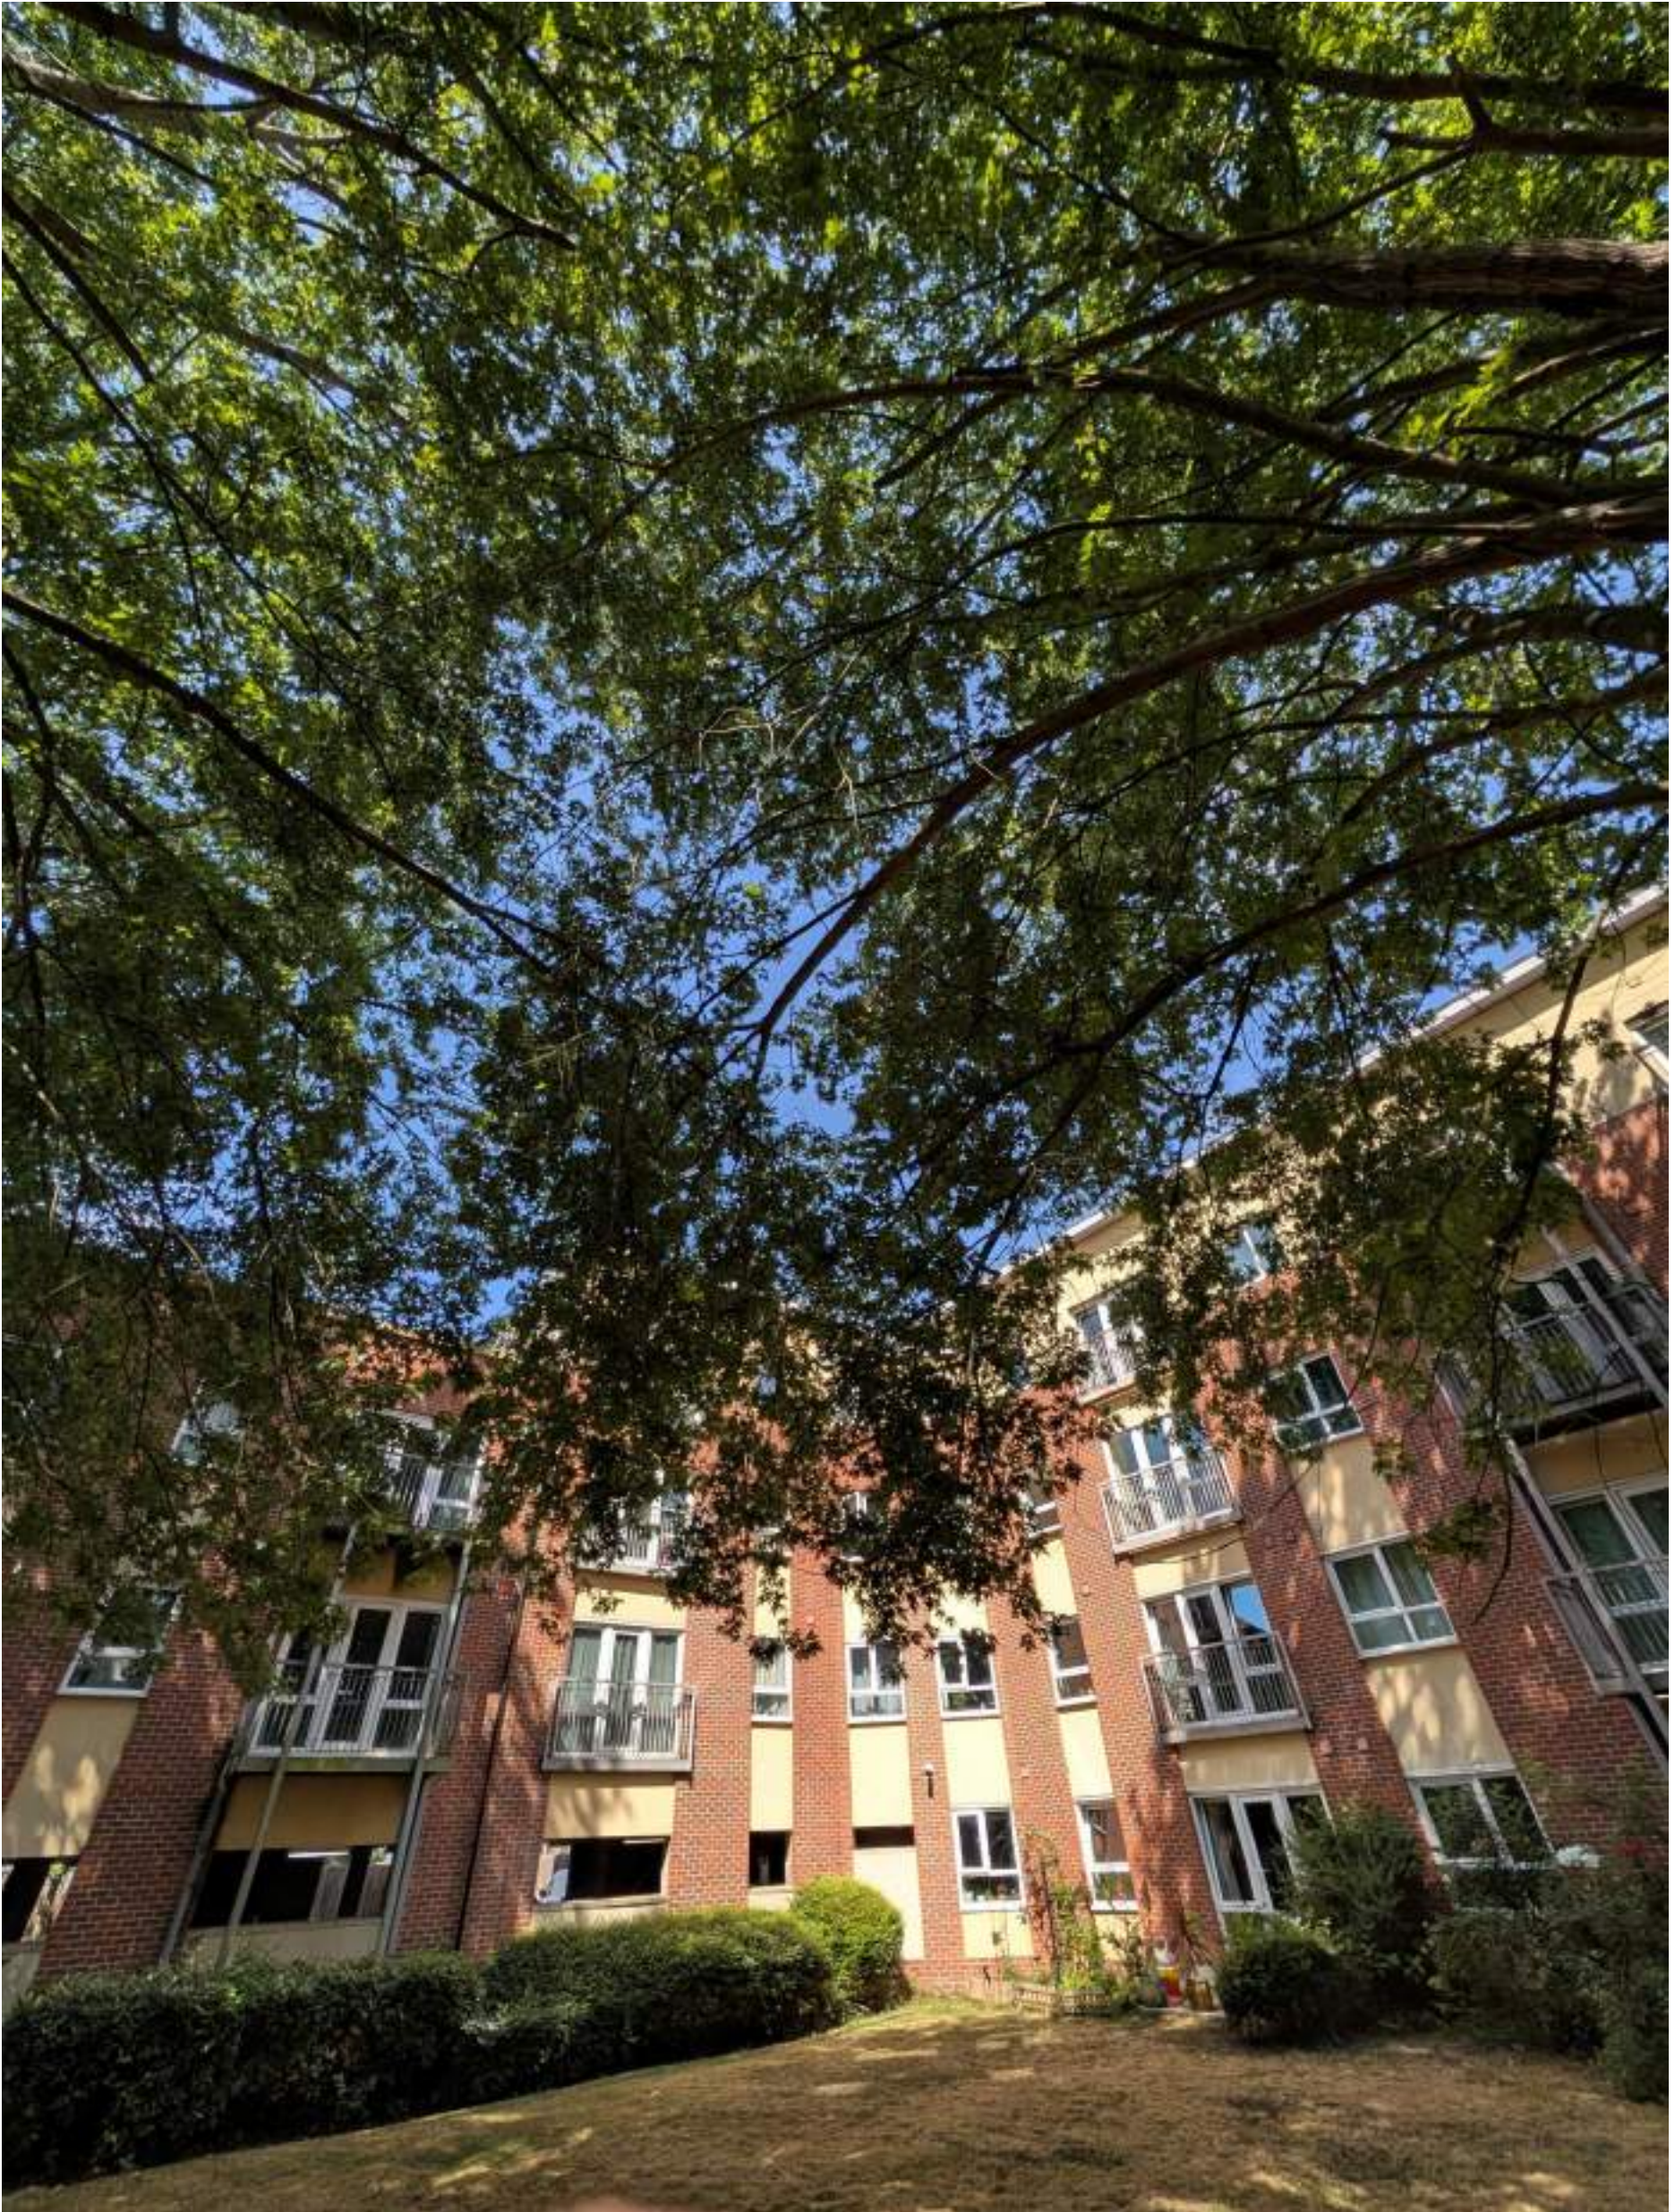
B.22 – T013/15 showing large laterals from both trees growing into each other, limb from T013 is over 10m in length.
