Tree Top Arborists

CAVERSHAM PLACE  
RICHFIELD AVENUE  
READING  
RG1 8BY

CF0024

(Survey conducted on 03/07/26)  
(Amended for TPO application on 03/09/26)

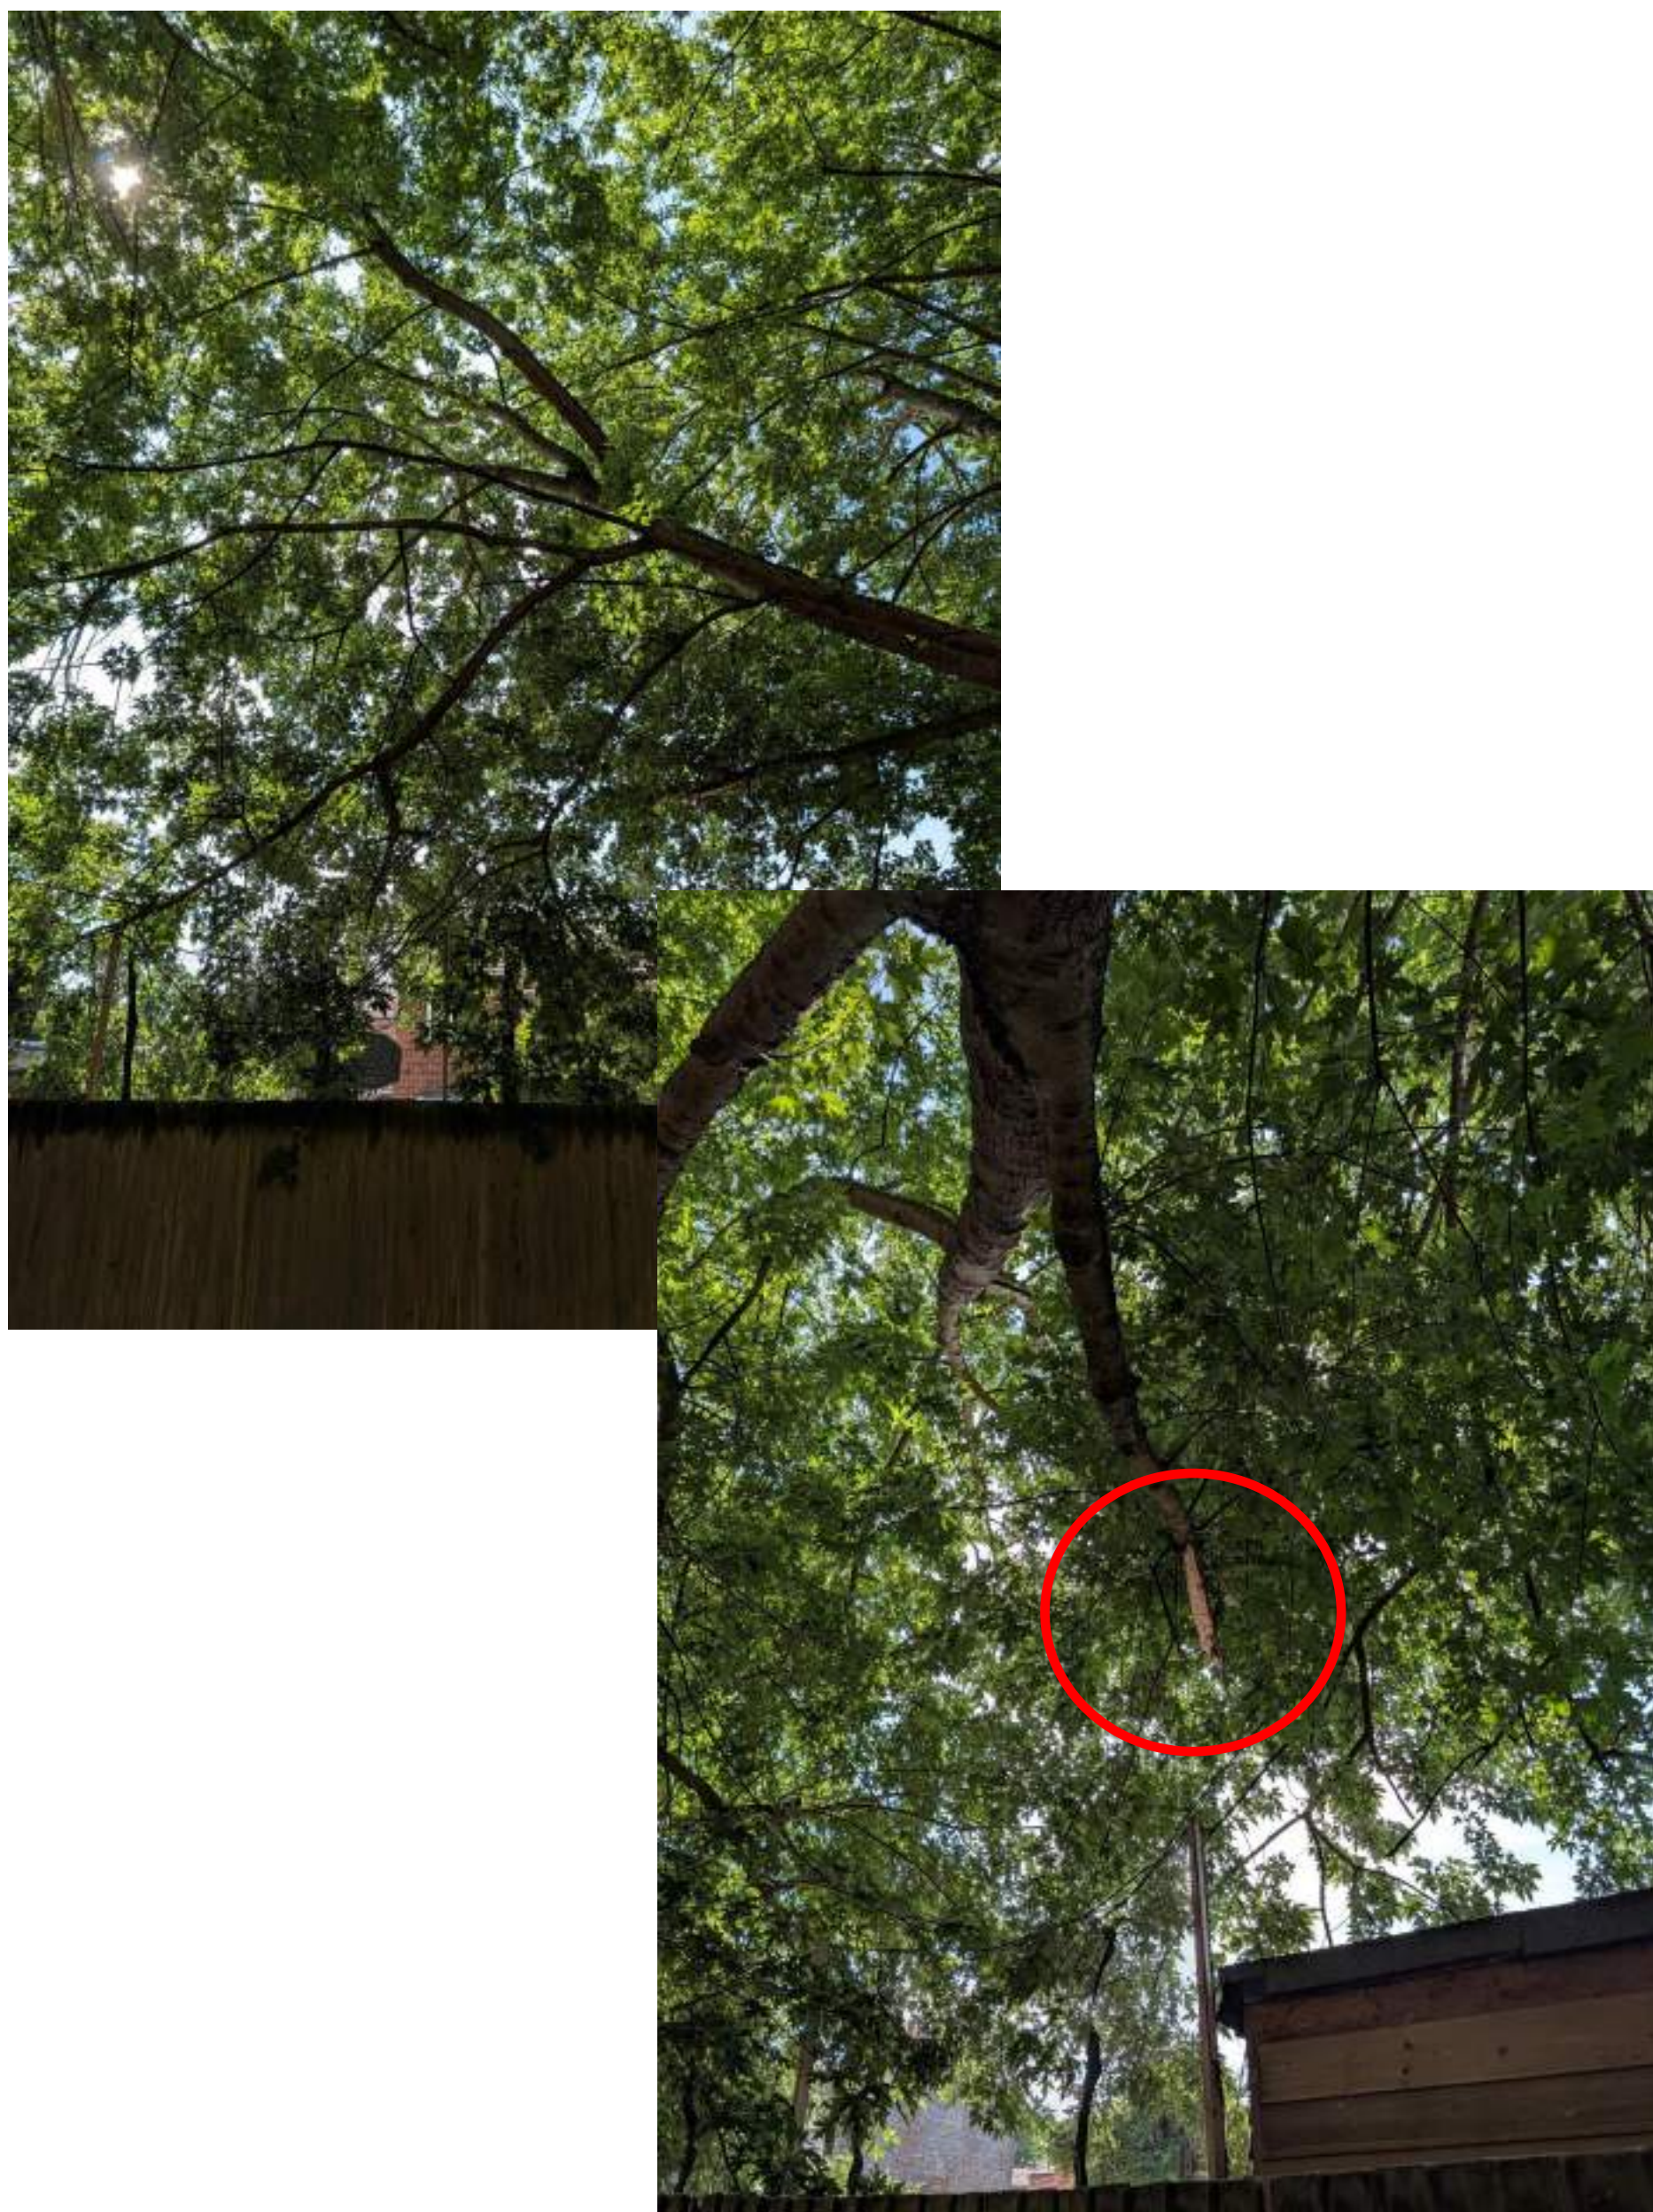
B.23/24 – T014 large laterals overhanging boundary line and highlighted previously failed limb from same laterals.

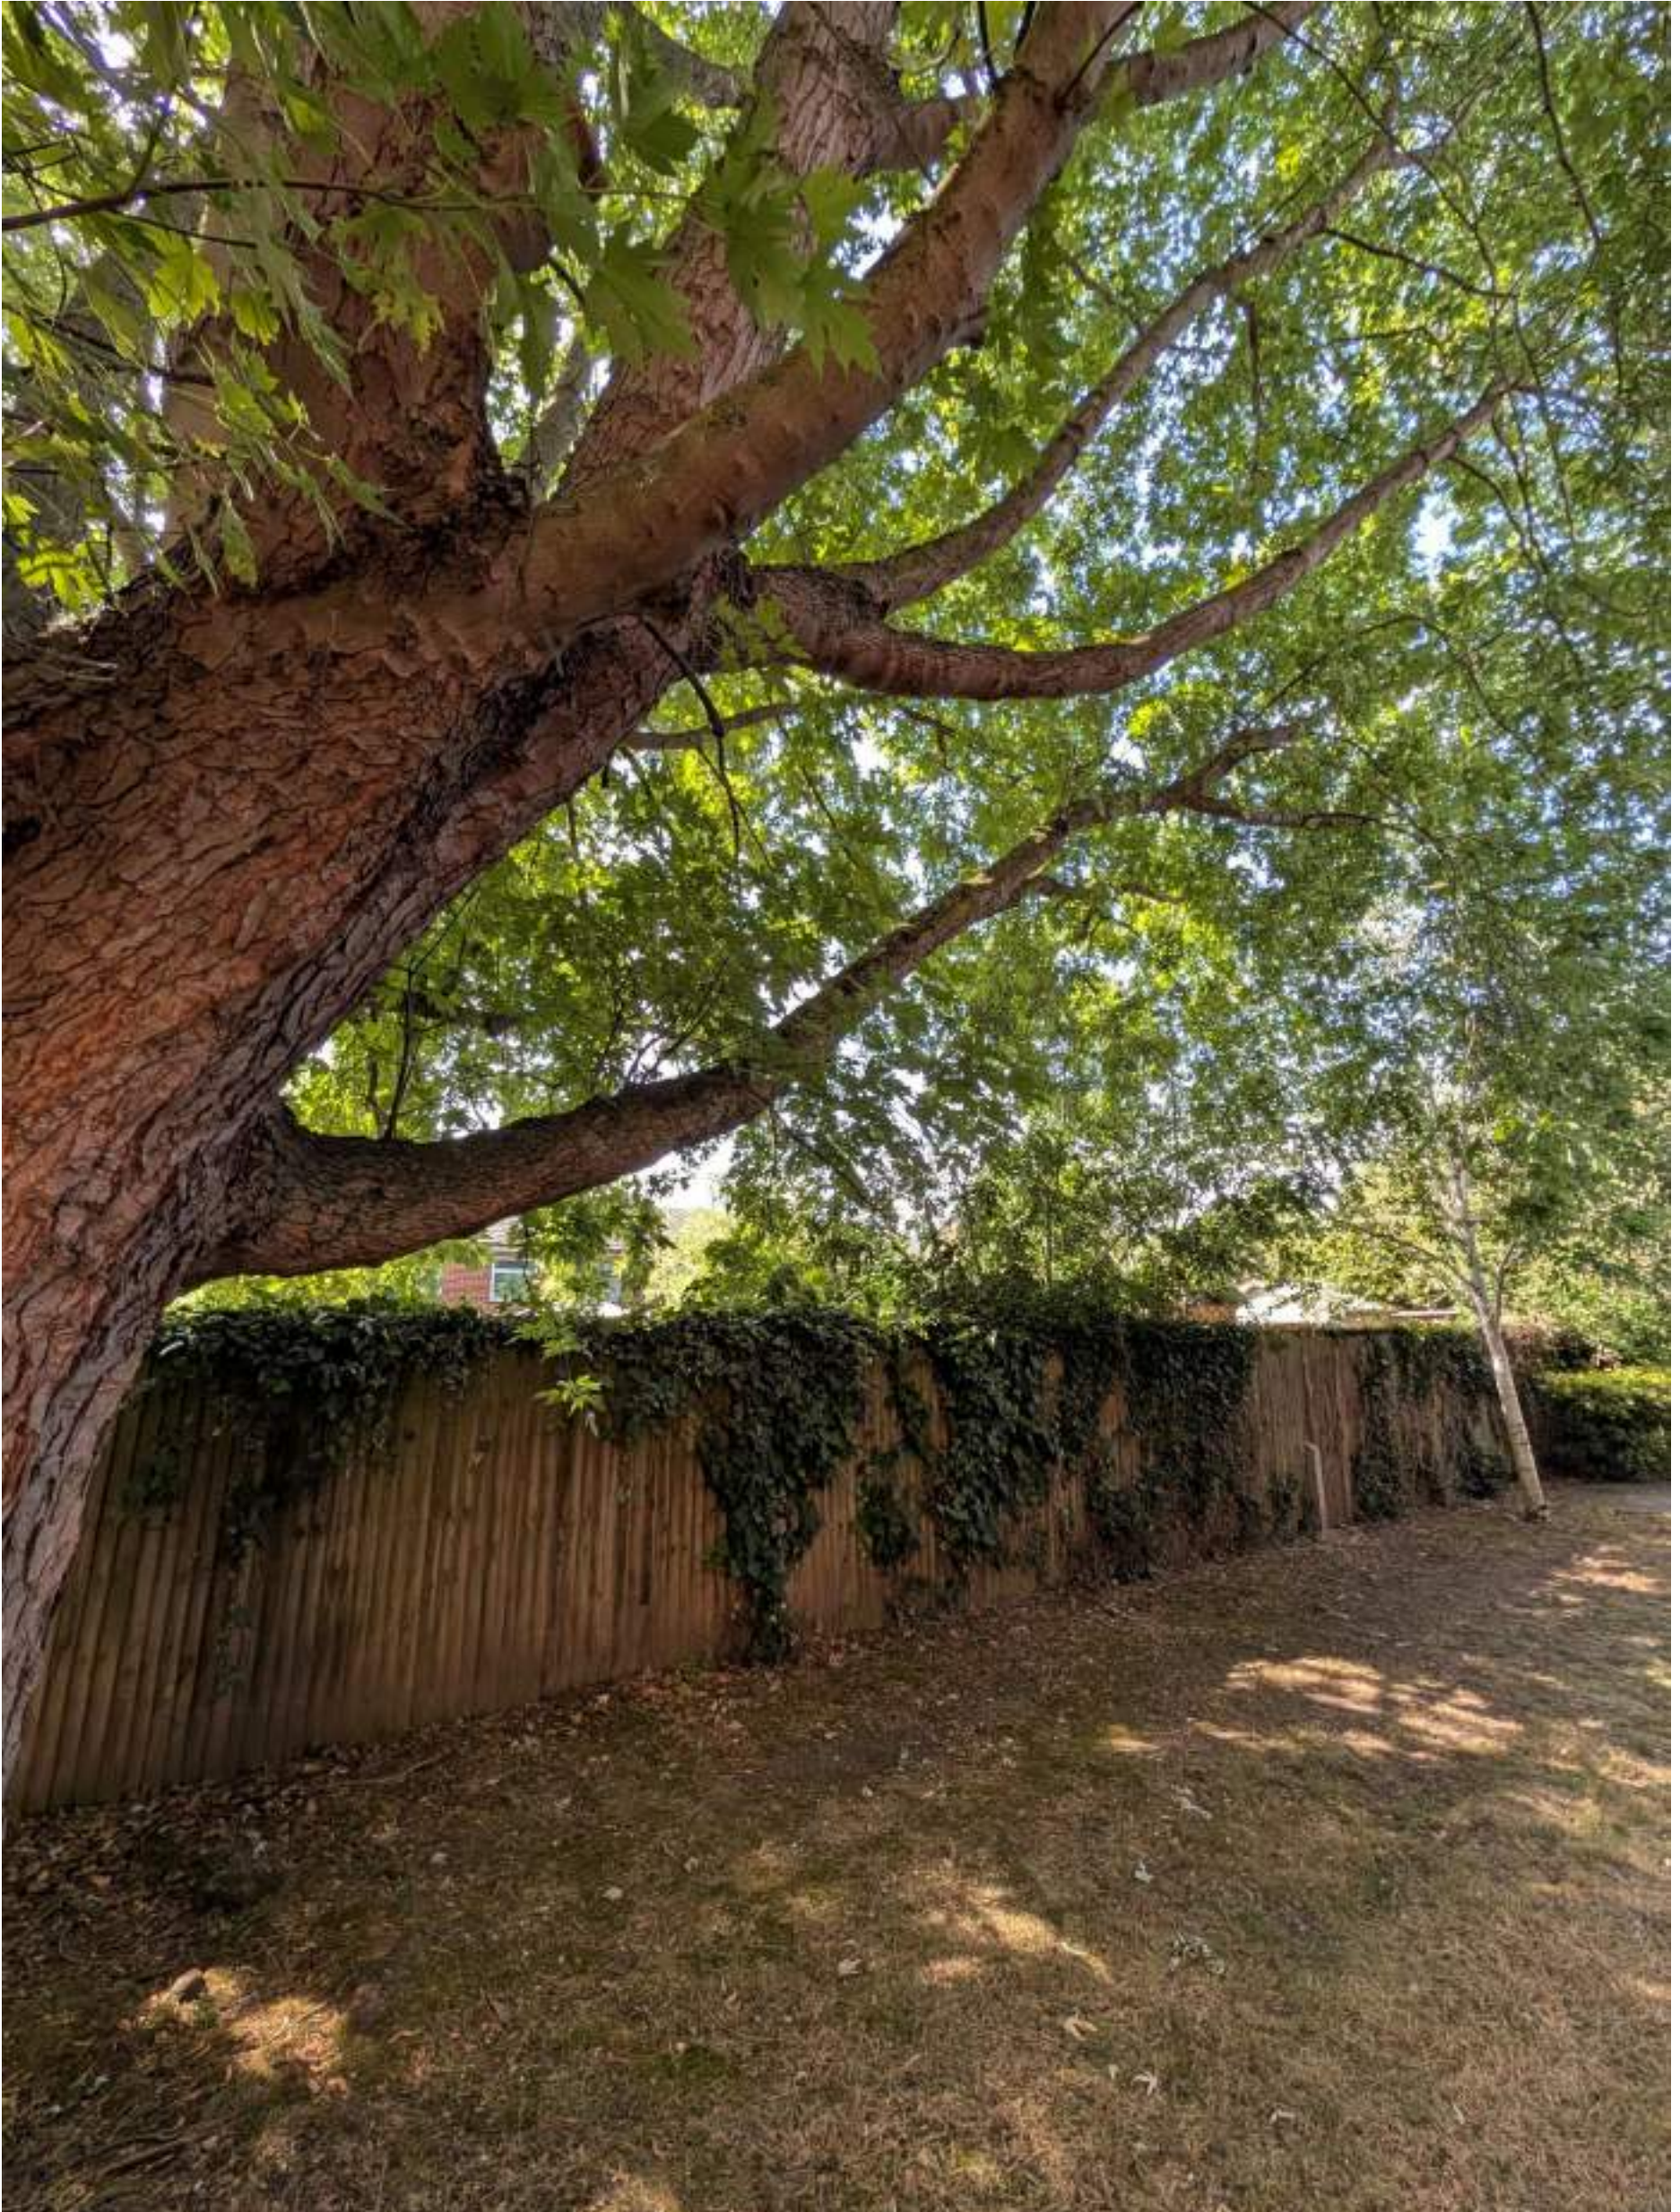
B.25 – T015 showing overextended laterals growing over boundary and grass area towards footpath.

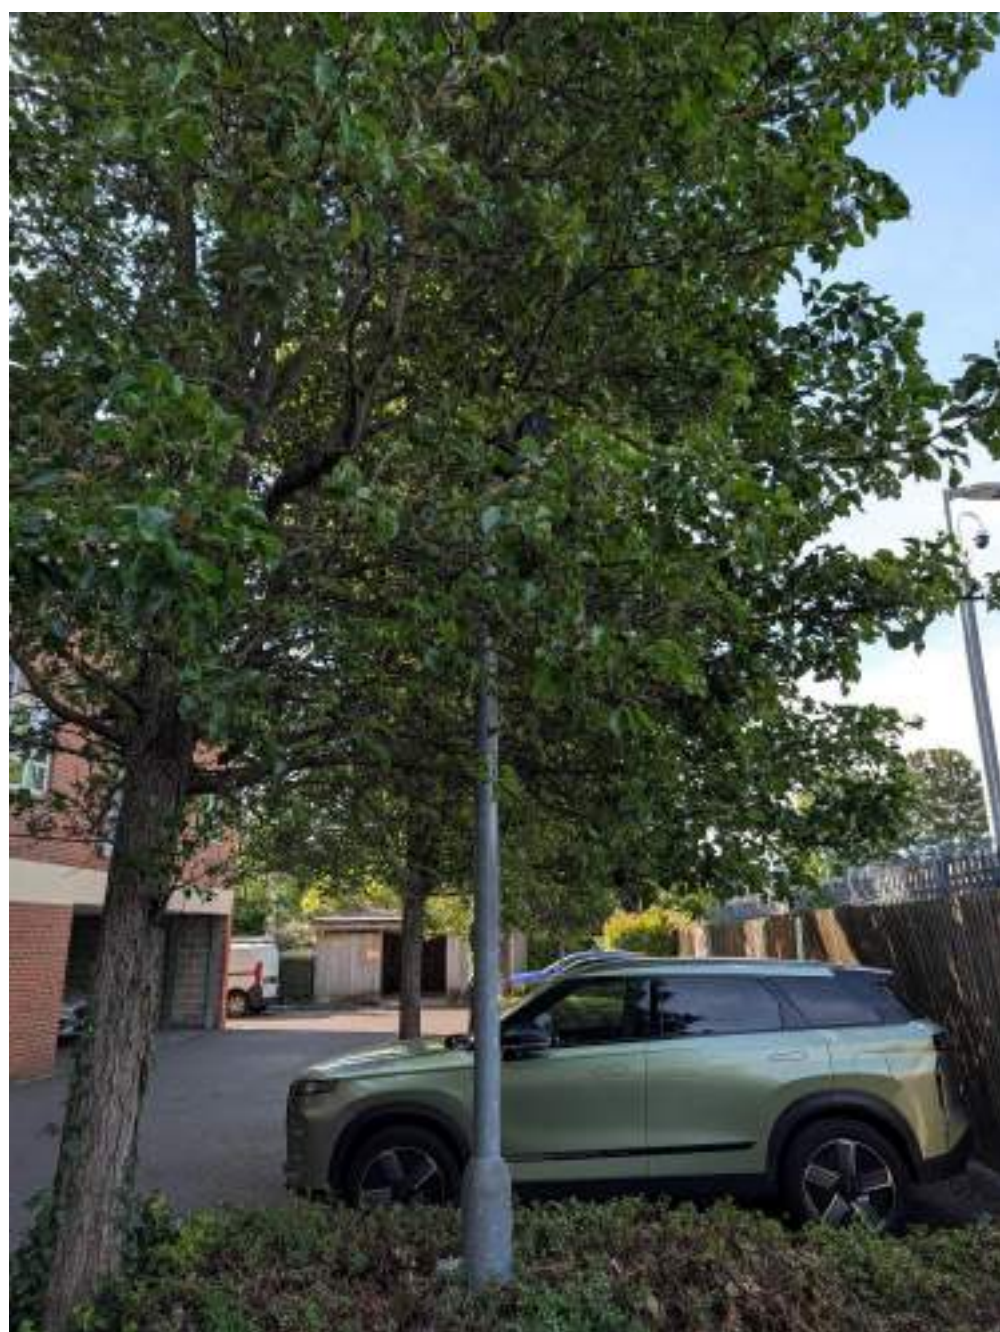
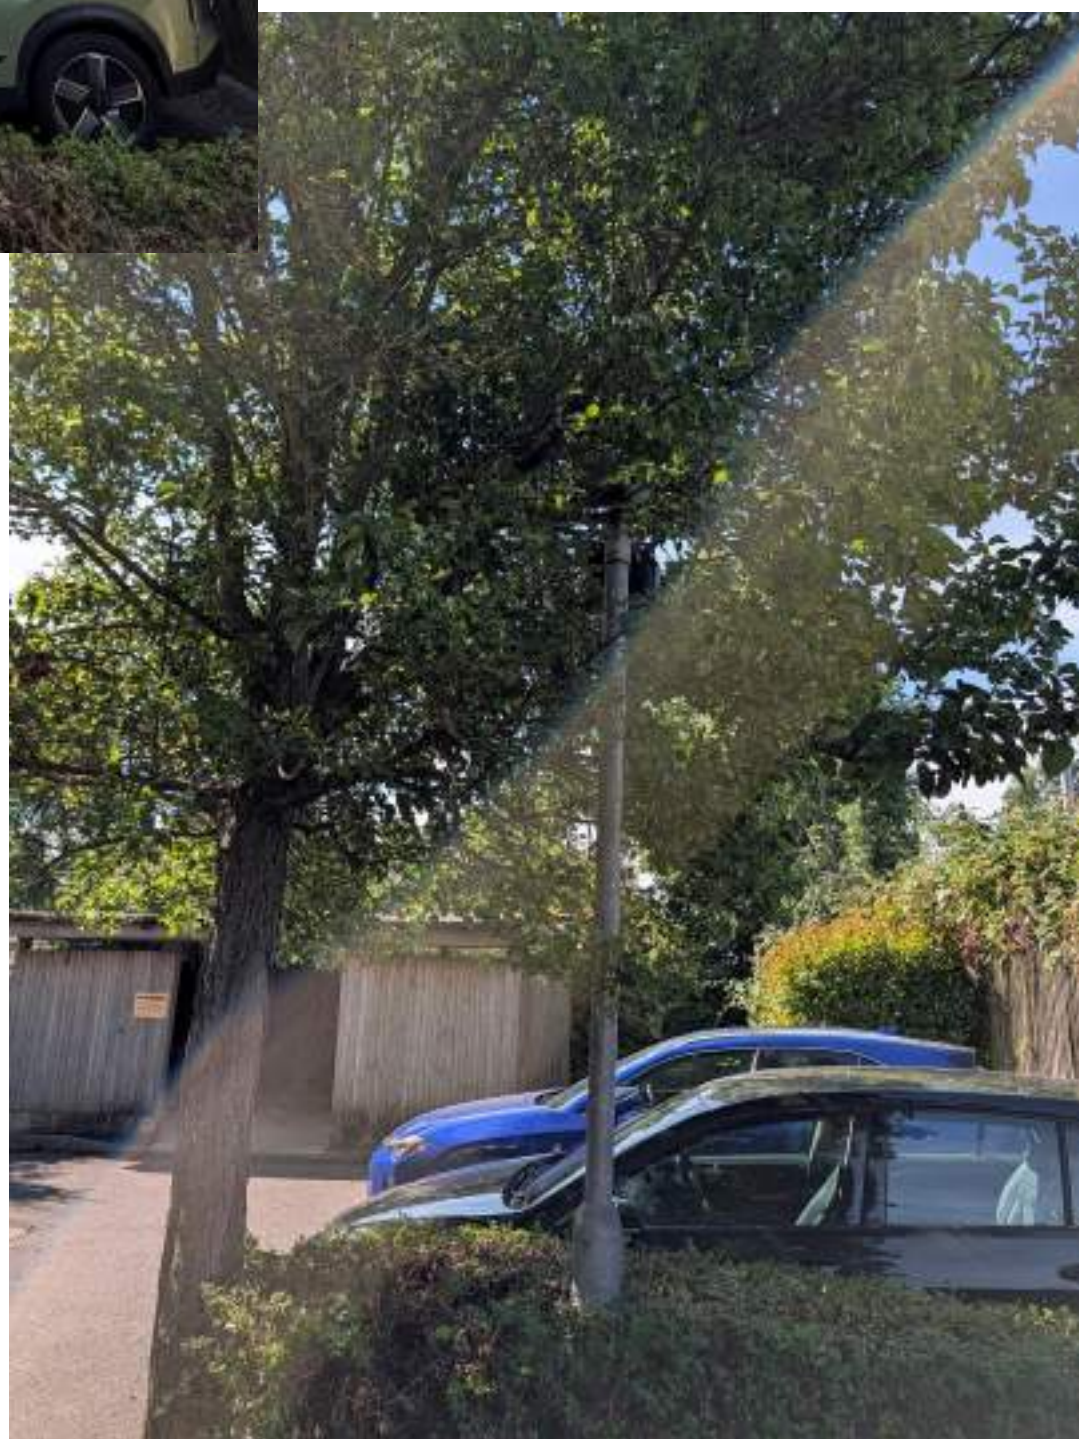
B26/27- G001 showing crowns engulfing carpark lighting.

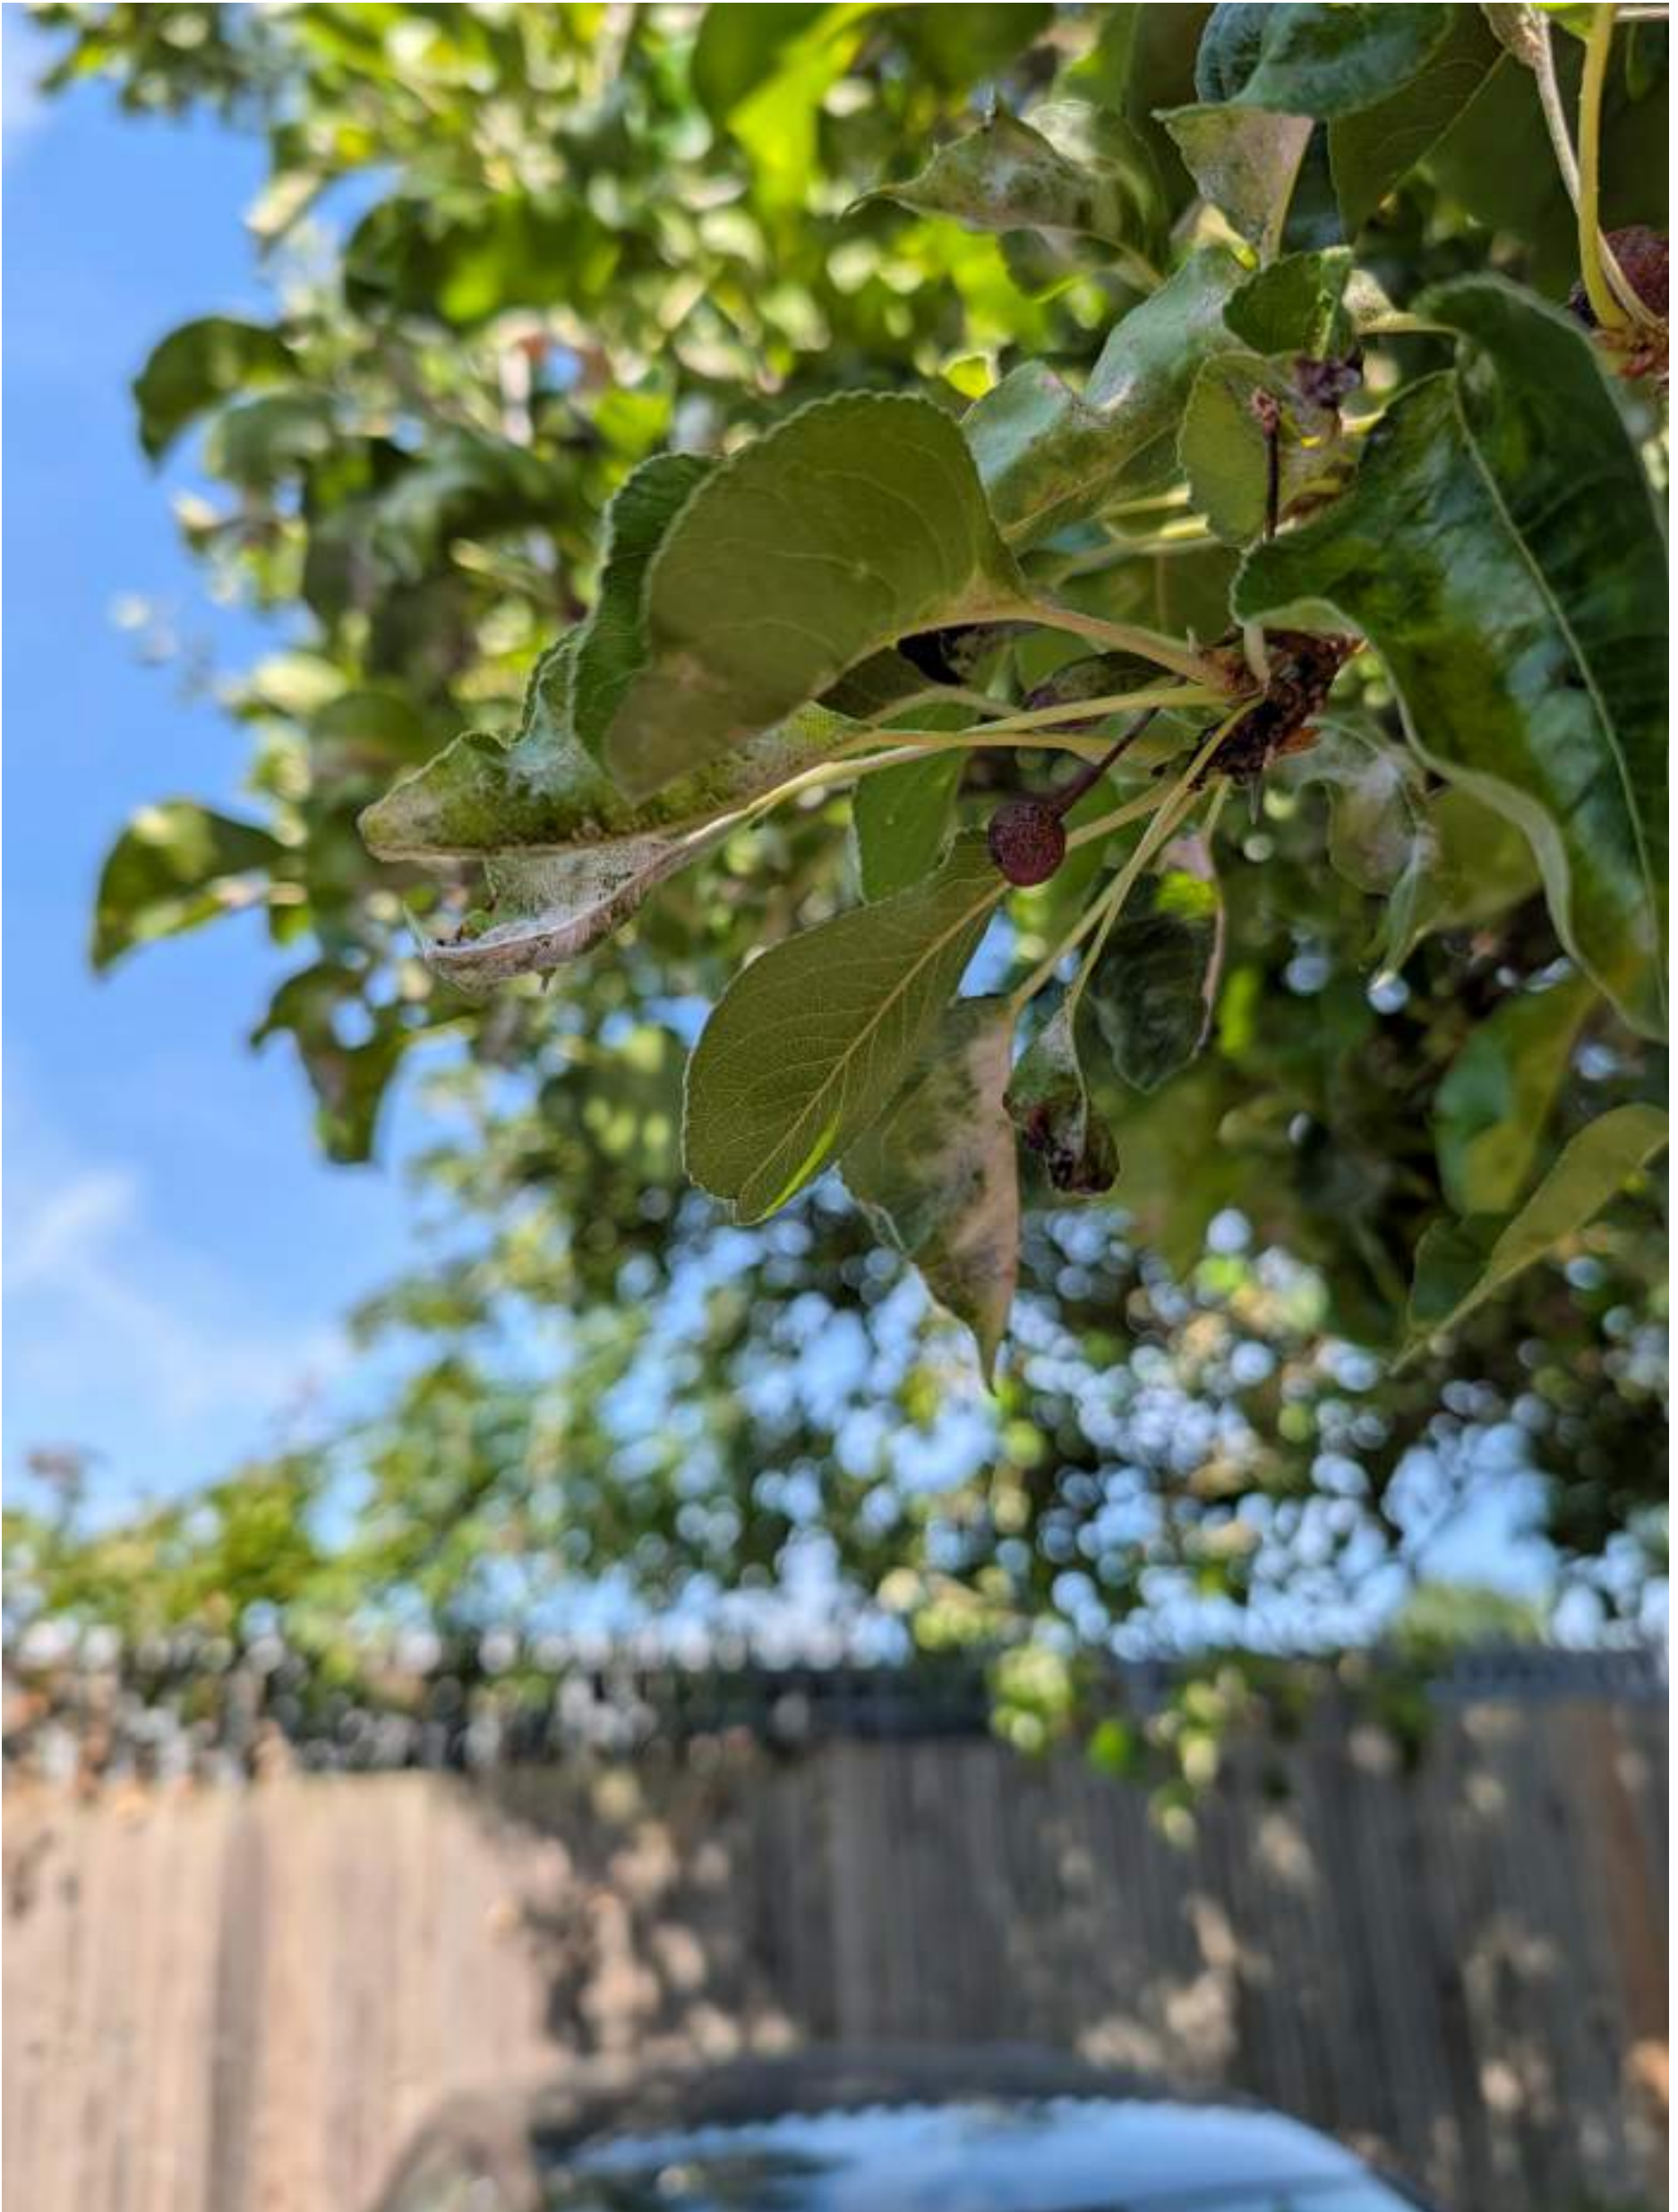
- **Powdery Mildew:** Identified within the *Pyrus calleryana* 'Chanticleer' group (G001). This fungal disease appears as a white, powdery coating on the foliage, leading to necrotic leaves. Currently, the damage is not extensive and does not heavily impact the overall vitality of the group, though the trees' restricted rooting environment in the parking area may be compounding their stress levels and as such spraying to control the issue is recommended.

B28- G001 showing powdery mildew.
