# HSEQ Inspection (S2313316)

| 20, ST. PETERS HILL, CAVERSHAM,, Reading RG4 7AX, United Kingdom | | | |

| Tree Cutting Request Inspection | | | |

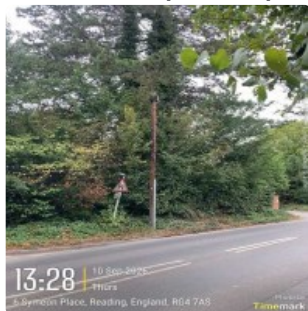
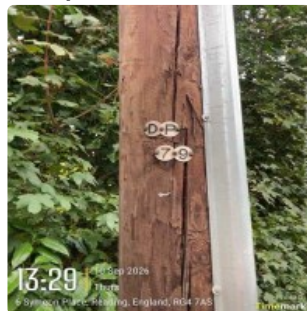
**5 Please upload a photo of the pole.**

Tree Cutting Required To Enable Installation To Take Place Or Blue Rope To Be Installed To Enable Installation To Take Place.
