# Tree Inventory Report

Reading Borough Council

16 September 2026

Unique ID: 07N6  
Parks  
Quercus sp.  
W3W: solar.salads.towers

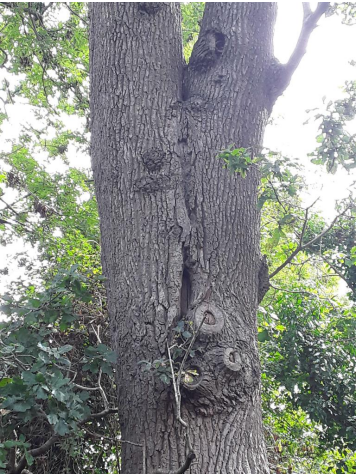
Overview Photos

| Inventory | |
|---|---|
| Condition | Poor |

| Considerations | |
|---|---|
| Consideration | C Stem Bark damage |

| Considerations | |
|---|---|
| Consideration | C Stem Included bark / Forked trunk |

| Considerations | |
|---|---|
| Consideration | C Stem Decay / Cavity |

| Considerations | |
|---|---|
| Consideration | D Crown Decay / Cavity minor |

| Comment | |
|---|---|
| Comment | Large fungal fruiting body (laetiporus sulphureus) seen at approx 5m whilst on Winterberry way. FFB growing on main stem directly below cavity and included union with high likelihood of catastrophic limb failure resulting in significant potential for... |

| Comment | |
|---|---|
| Comment | large sections of tree to fail into garden or building due to close proximity. Additionally large wound on E side from lightning strike compounding issue. |

| Requirements | |
|---|---|
| Requirement Type | Remove crown / Monolith |
| Requirement Note | leave as monolith at union at 5m |
