# Tree Condition Survey Report (VTA)

**Site:** Parkside Care Home, Parkside Road, Reading, RG30 2DP

**Client:** Bupa

| <b>Title</b> | Tree Report: Tree Condition Report (VTA) | | | |

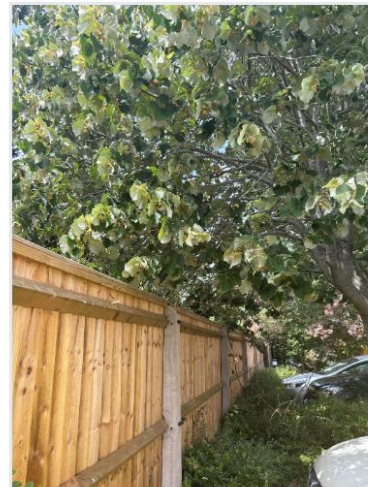
## Silver lime Tree ID #2

| Tree Survey Schedule | | | | | | | | | | | | | | | | | | |
|---|---|---|---|---|---|---|---|---|---|---|---|---|---|---|---|---|---|--|
| 2 | 1109 | Silver lime | Tilia tomentosa | 5-10m | 340 | Early-mature | Good | Fair | Wound present on the northern side of the main stem from ground level to approximately 0.4m. Associated decay and bark delamination are evident within the affected area. Sounding with a mallet indicates localised decay around the wound, with no evidence at present of extensive decay affecting the broader stem structure. The crown is exhibiting good vitality, with healthy foliage density and extension growth. The crown is low and currently in contact with the adjacent fence. | Decay | Bark Wounding/Damage, Bark Occlusion, Exudate, Acoustically tested with rubber mallet - no significant decay noted | Crown Close to Building and/or Infrastructure, Low Crown | None Observed | Car park, Fence | High | Good | Client | |

| Tree / Group ID | Common Name | Work Task | Work Priority | Description | Tag No |
|---|---|---|---|---|---|
| 2 | Lime species | Prune to Clear<br>structure/wires/buildings by 2m | Within 12 Months | Selectively prune crown to clear fence by<br>2m. | 1109 |

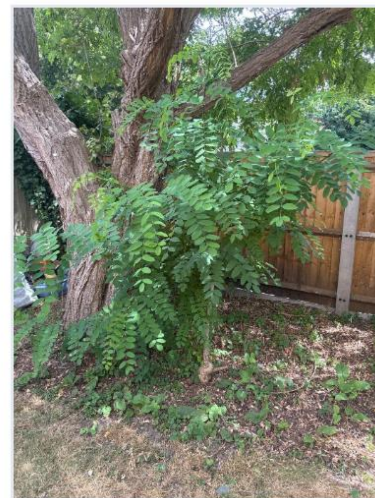
## False acacia Tree ID #7

| Tree Survey Schedule | | | | | | | | | | | | | | | | | | |
|---|---|---|---|---|---|---|---|---|---|---|---|---|---|---|---|---|---|--|
| 7 | 1115 | False acacia | Robinia pseudoacacia | 5-10m | 636 | Mature | Fair | Fair | Co-dominant stems arise from approximately 1.5m above ground level. The tree has been subject to previous crown reduction, with prolific regrowth developing from historic pruning points. Minor decay and limited dieback are evident on several retained branch stubs associated with these works. A limb extending to the south-west exhibits historic damage to the underside of the branch; the wound has partially occluded and appears stable at present. Basal suckering is present, and removal is recommended due to the spiky nature of the stems and the potential for nuisance or minor injury to site users. Overall vitality appears reasonable. | Suckering/basal growth | Stub Cuts | Co-dominant leaders, Previously Reduced | None Observed | Building, Fence, Footpath, Open space, Road | High | Good | Client | |

| Tree / Group ID | Common Name | Work Task | Work Priority | Description | Tag No |
|---|---|---|---|---|---|
| 7 | False acacia | Remove Basal and Epicormic<br>Growth up to 2.5m | Within 12 Months | Remove sucker at tree base | 1115 |

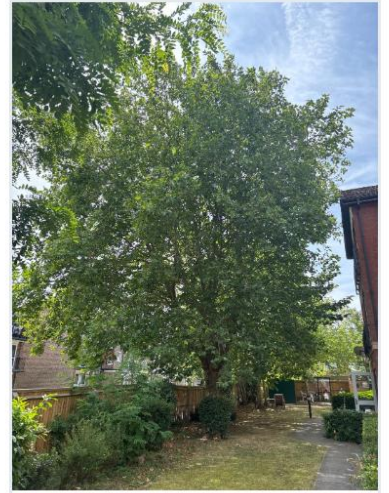
## London plane Tree ID #8

| Tree Survey Schedule | | | | | | | | | | | | | | | | | | |
|---|---|---|---|---|---|---|---|---|---|---|---|---|---|---|---|---|---|--|
| 8 | 1108 | London plane | Platanus x hispanica | 11-15m | 790 | Mature | Good | Fair | Bird box attached to the main stem at approximately 2.5m above ground level. The crown breaks at around 3.5m, forming a broad crown structure. Crossing branches are present within the crown, including areas of fused growth on eastern limbs. Minor symptoms of anthracnose are evident throughout the crown, though these are not currently considered significant to the tree's overall condition. The crown is low and in close proximity to the adjacent building, and clearance pruning may be considered if access or building clearance becomes an issue. Overall vitality appears satisfactory at the time of inspection. | None Significant | None Significant | Crossing/Rubbing Branches, Crown Close to Building and/or Infrastructure, Low Crown | None Observed | Building, Fence, Footpath, Open space, Road | High | Good | Client | |

| Tree / Group ID | Common Name | Work Task | Work Priority | Description | Tag No |
|---|---|---|---|---|---|
| 8 | London plane | Prune to Clear<br>structure/wires/buildings by 3m | Within 6 Months | Selectively prune to clear building by 3m | 1108 |
| 8 | London plane | Crown Lift to Specified Amount | Within 6 Months | Crown lift to 3m | 1108 |

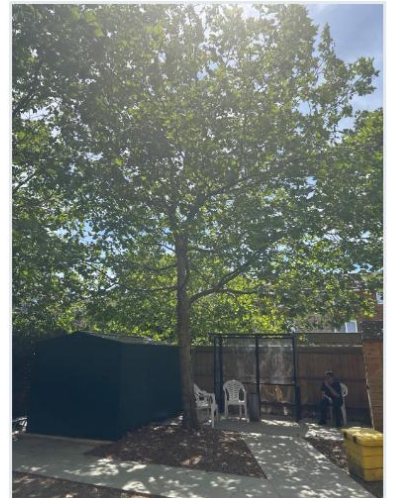
## London plane Tree ID #10

| Tree Survey Schedule | | | | | | | | | | | | | | | | | |
|---|---|---|---|---|---|---|---|---|---|---|---|---|---|---|---|---|---|
| 10 | 2222 | London plane | Platanus x hispanica | 5-10m | 260 | Semi-mature | Good | Good | Crown extends low over an adjacent sheds. Minor symptoms of anthracnose are evident throughout the crown; however, these are not currently considered significant to the tree's overall vitality or condition. | No Visible Issues or Defects | None Significant | Low Crown | None Observed | Footpath, Seating | High | Good | Client |

| Tree / Group ID | Common Name | Work Task | Work Priority | Description | Tag No |
|---|---|---|---|---|---|
| 10 | London plane | Prune to Clear<br>structure/wires/buildings by 2m | Within 12 Months | Selectively prune to clear buildings by 2m. | 2222 |
