Structural Appraisal and Remedial Scheme  
Existing chimney Structure  
at  
5 Victoria Street  
Reading  
Berkshire  
RG1 4NQ

**Clive Hudson Associates**  
Consulting Structural & Civil Engineers

## 1.0 INTRODUCTION & BRIEF.

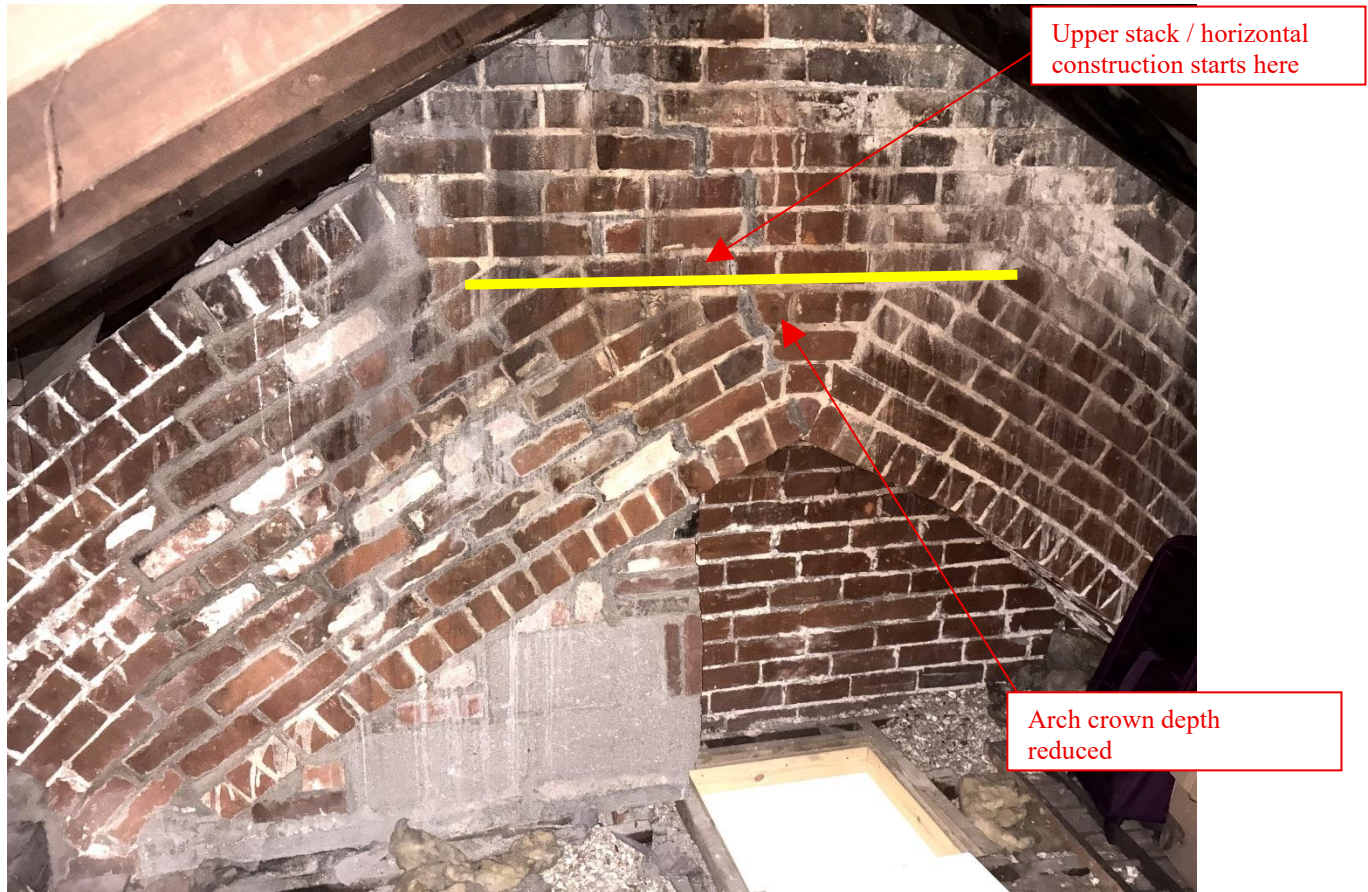
Figure 2. Chimney stack arrangement.

- 3.1 Access into the roof void was achieved via the loft hatch located above the cupboard in Bedroom 2. The chimney stack is positioned along the right-hand party wall separating Nos. 5 and 7 Victoria Street. It comprises a vaulted brick gathering structure that converges centrally to form eight flues, four serving each adjoining property. The stack above roof level is substantial, measuring approximately 1.8m deep x 0.8m wide x 0.7m above the ridge.

- 3.2 The construction of the chimney stack raises concerns about its overall structural stability. Ordinarily, one would expect the two opposing arches to meet at the centre. Curved courses of brickwork spring from the surrounding masonry and rise towards the centre, forming a gathering structure that transfers the weight of the chimney stack to the supporting chimney breasts at first-floor level.

In this instance, however, the vertical brickwork forming the upper section of the stack interrupts the continuity of the arch at its crown. This arrangement reduces the effective structural depth of the arch and prevents the two opposing sections from forming a complete, continuous arch. Consequently, the intended compressive load path is disrupted, raising concerns about the adequacy and long-term stability of the construction.

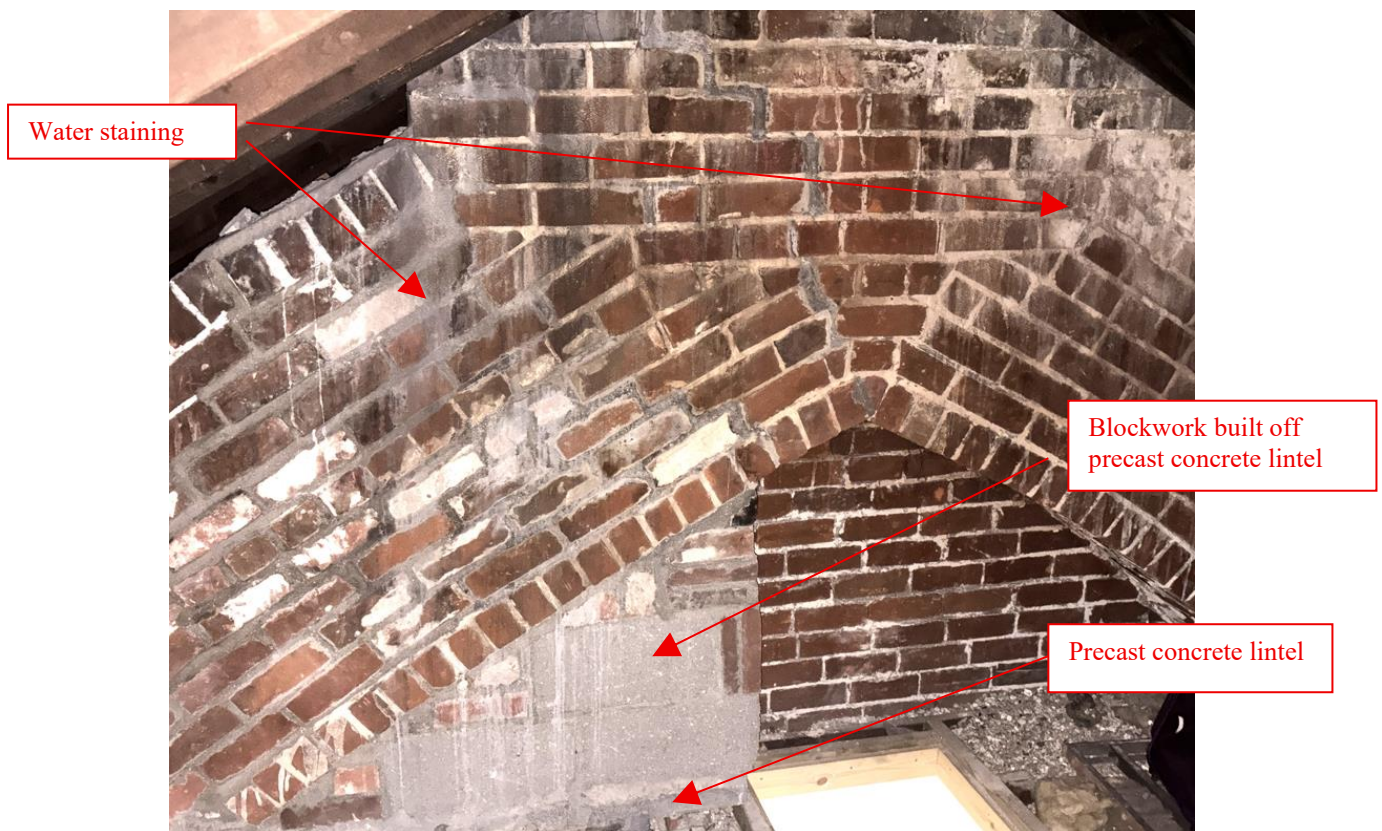
Figure 3. Chimney stack defects.

- i. Evidence of cracked / disturbed sections of masonry on the central face of the stack suggest that historic movement has occurred.
- ii. Heavy water staining was observed on the face of the stack suggesting water ingress due to a leaking roof or failed chimney flashings. The stack is constructed using lime mortar; prolonged moisture penetration could soften the mortar and reduce the arch's compressive strength.
- iii. A section of concrete blockwork has been built to the rear inner edge of the stack, providing support to the section of the stack immediately above, presumably an attempt at stabilising the defective brickwork to the face of the stack. This panel of blockwork would appear to be supported off a modern-day concrete lintel spanning from the chimney breast to the cupboard wall in bedroom 2 at first floor level.

- 6.3 We recommend the following remedial solution.
1. Erect external scaffold.
  2. Partially remove existing roof.
  3. Dismantle existing arched chimney stack down to the top of the existing chimney breasts.

4. Place concrete capping slabs on top of remaining chimney breasts.
  5. Install twin steel beams, one each side of the party wall.
  6. Place new concrete slab spanning between the two steel beams.

7. Build new stack using reclaimed brick and the existing chimney pots.
  8. Reinstall roof.

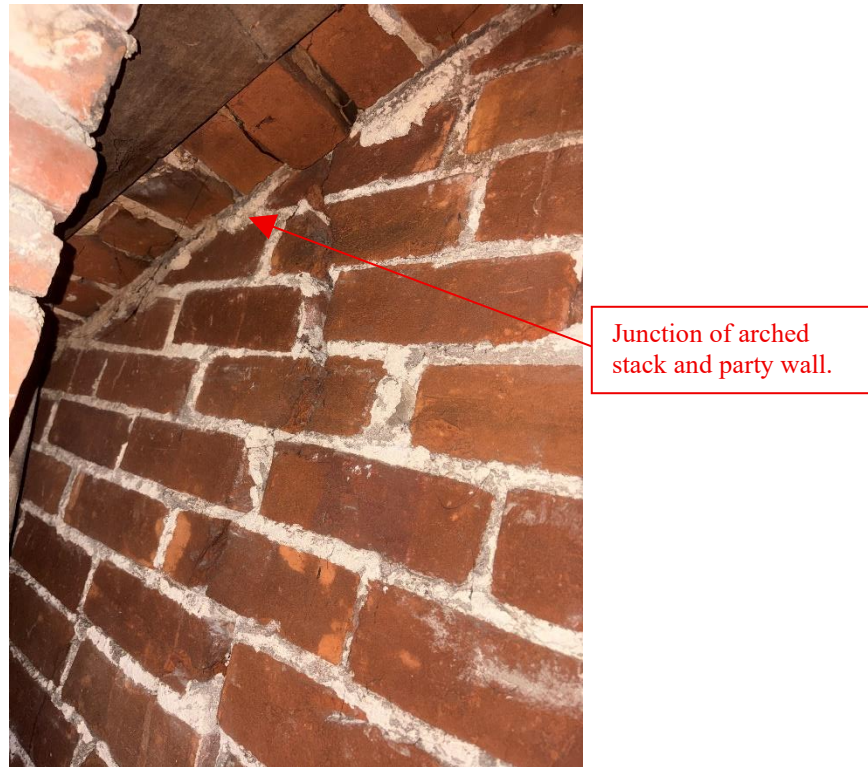
- iv. The party wall is of single brick construction (110mm) and would appear to extend through the arched stacks, presumably separating the flues. Consequently, there is no brick bond between the arched stacks and the party wall – see figure 4. A tapered crack, ranging from approximately 10mm to 35mm in width, was observed within this panel of brickwork. We are of the opinion that this cracking has been caused by historic horizontal movement of the arch imposing a horizontal load on the panel.

Figure 4. Junction of stack and party wall + Cracking to brick panel beneath arched stack.

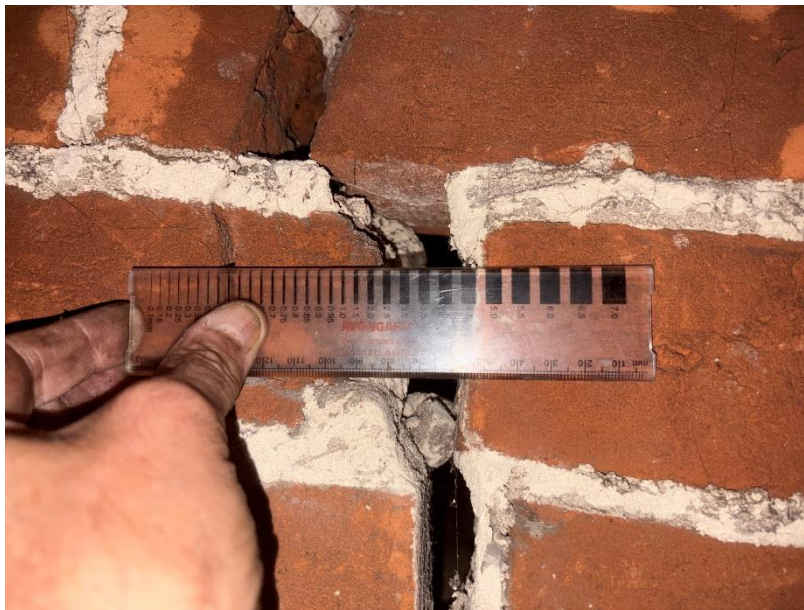
Figure 5. Cracking to brick panel beneath arched stack.

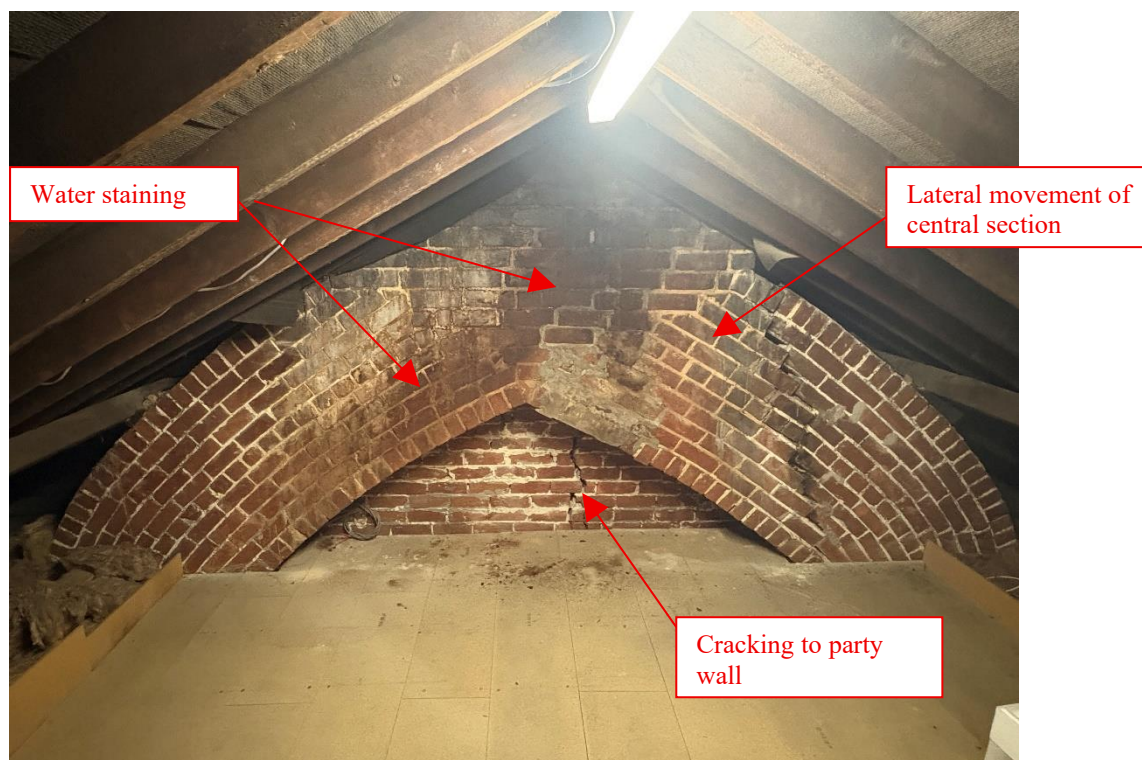
Figure 6. Chimney stack – 7 Victoria Street.

- i. Evidence of cracked / disturbed sections of masonry on the central face of the stack suggest that historic movement has occurred.
- v. Heavy water staining was observed on the face of the stack suggesting water ingress due to a leaking roof or failed chimney flashings. As discussed above, the stack is constructed using lime mortar; prolonged moisture penetration could soften the mortar and reduce the arch's compressive strength.
- ii. The central section of the stack has moved away from the right-hand section of the stack by 30mm. Our concern is that the roof frame is now providing nominal lateral support to the stack
- iii. The party wall is of single brick construction (110mm) and extends to the underside of the vaulted stack. A tapering crack, ranging from approximately 10mm to 35mm in width, mirrors that observed in number 5 Victoria Street.

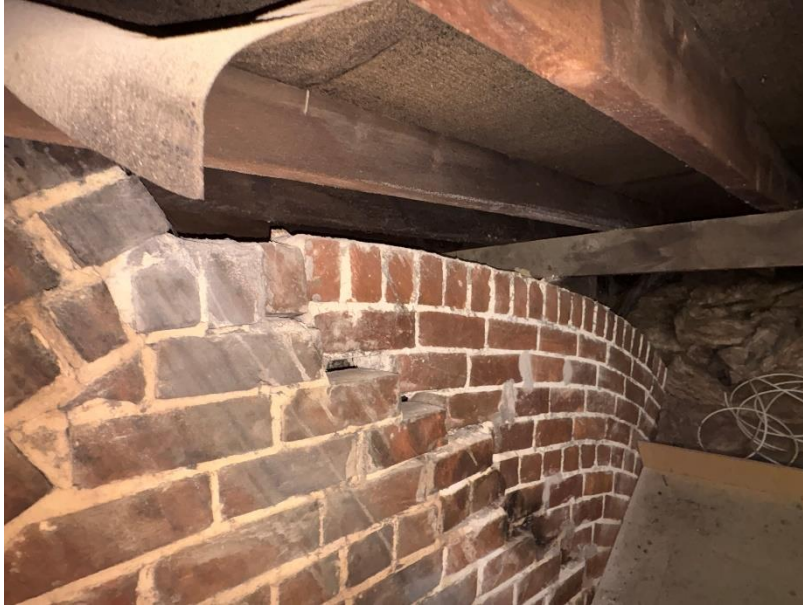
Figure 7. Chimney stack – 7 Victoria Street – lateral movement.

- 6.1 The defects observed in the arched chimney stack shared by Nos. 5 and 7 Victoria Street give cause for concern. The severe cracking and the lateral displacement of 30mm confirms that the stack has moved and it is possible that this movement will continue. There is no bond between each stack through the party wall and the stability of the stacks in their current condition is considered unreliable. The most appropriate remedial measure would be to carefully dismantle the stacks from above roof level down to ceiling level and rebuild onto a reliable structural arrangement.

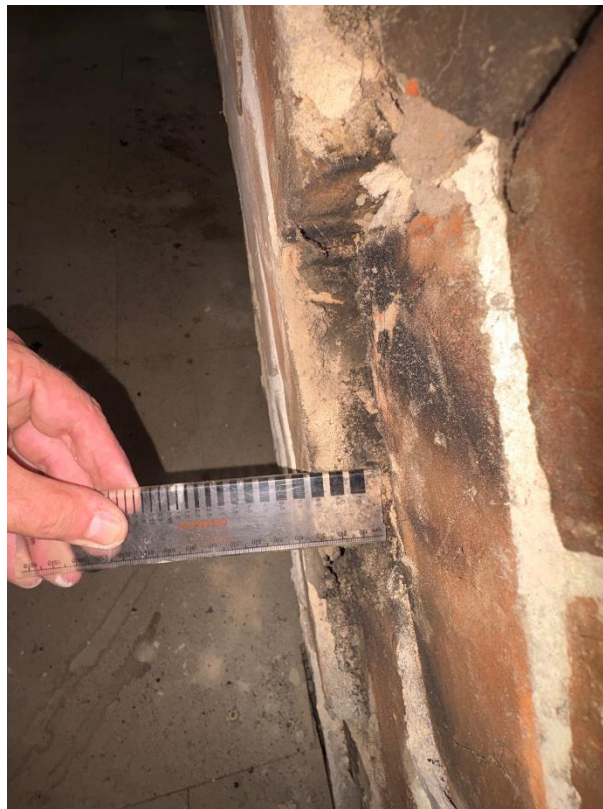
Figure 8. Chimney stack – 7 Victoria Street – lateral movement.

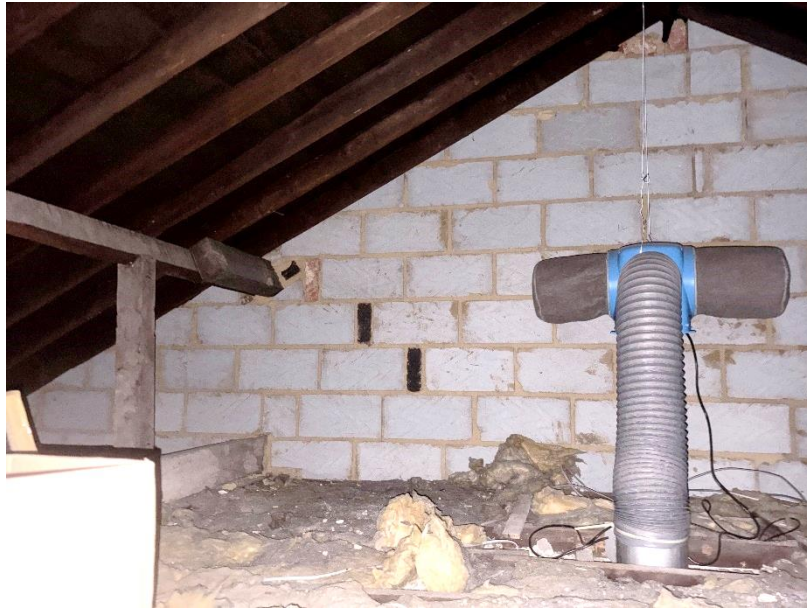
Figure 9. Party wall between 3 & 5 Victoria Street.

The party wall between 3 & 5 and 5 & 7 Victoria Street is constructed of single brick i.e. 110mm thick. The left-hand party wall within roof void between numbers 3 and 5 Victoria Street has been infilled with concrete blockwork to prevent the spread of fire between the two properties. Although the right-hand party wall is occupied by the subject chimney stack, an open void still exists between the two properties and therefore there is no effective fire break between numbers 5 and 7 Victoria Street. We therefore recommend that a suitable fire separating wall construction is installed between 5 & 7 Victoria Street. This installation should achieve a minimum of one hour fire resistance and will attract a building regulation application.
