# River Condition Assessment Report

Rose Kiln Lane, Reading

| <b>Survey Date</b> | <b>08/11/2023</b> |

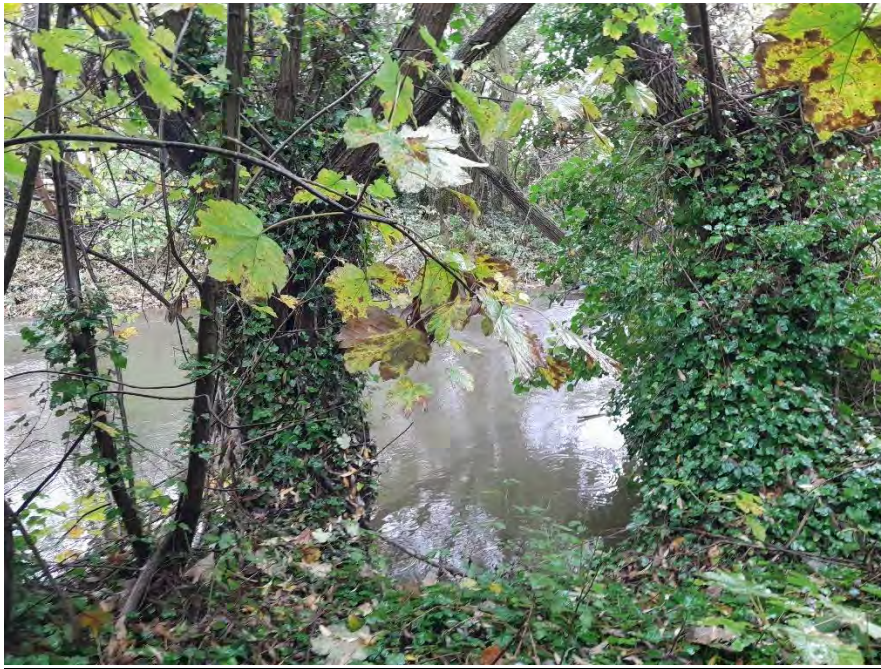
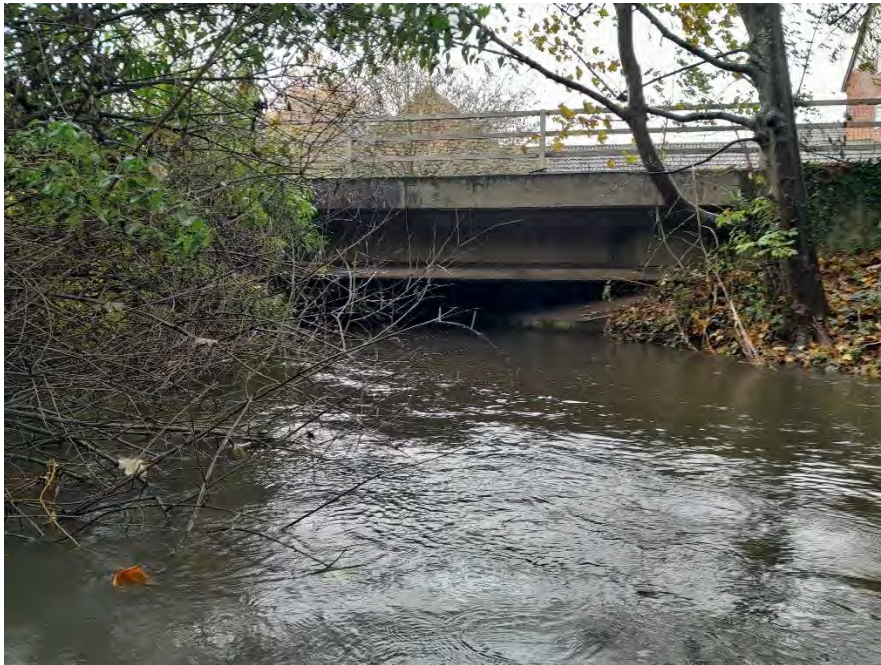
Site 1

Light within the channel will increase the aquatic morphotype richness encouraging plants such as water mint. Builders waste was discovered in the first section, removal of this will heavily improve the channel bed score.

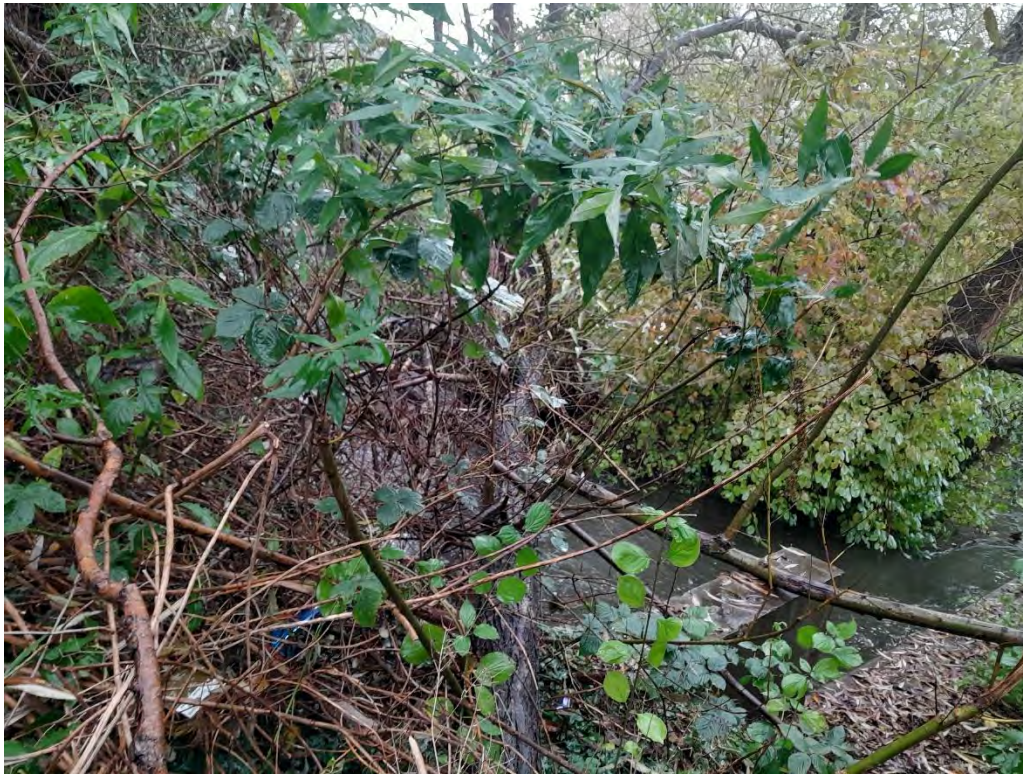
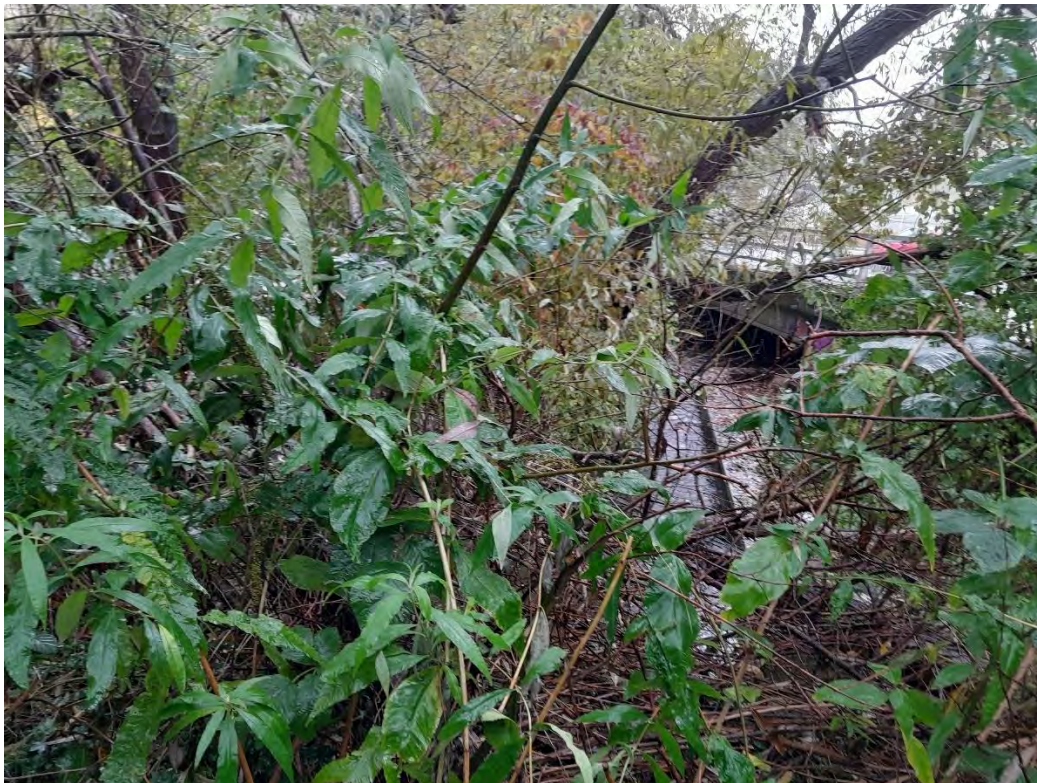
Site 5

Channel bed artificial features severity is severely affected by the two weirs at the end of the stretch. These are impacting silt levels in the brook, preventing fish migration and could potentially increase flooding through holding water back. The removal of the weir would help return natural processes to the river, allow fish to migrate up stream and would drop the river levels. This, however, would be an expensive endeavor and would require scoping, planning, costing and permissions.
