Our reference: 2484266 – George & Dragon Tree Climbing Survey Letter Report

### **GEORGE & DRAGON TREE CLIMBING SURVEY**

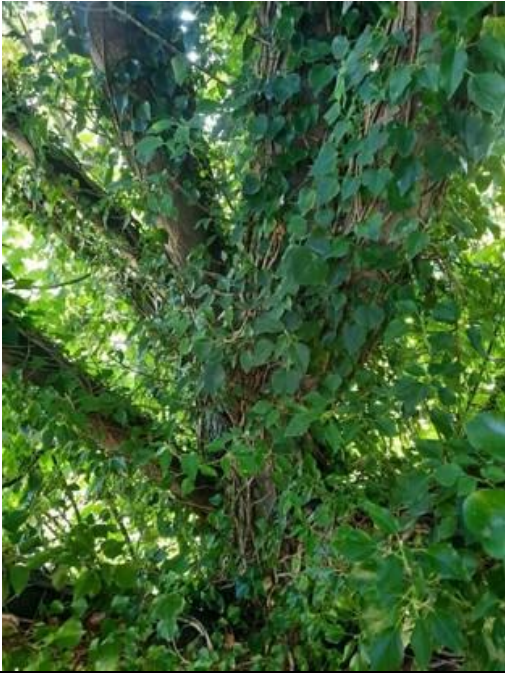
| Feature Number | Photograph | Description and Bat Roost Potential |
|---|---|---|
| PRF1<br>ivy cover | | <p>Ivy stems less than 50 mm in diameter and no matted sheets present so no roosting potential between the stems and not sufficiently dense to provide any roosting potential within the foliage.</p> <p><b>Negligible Potential</b></p> |

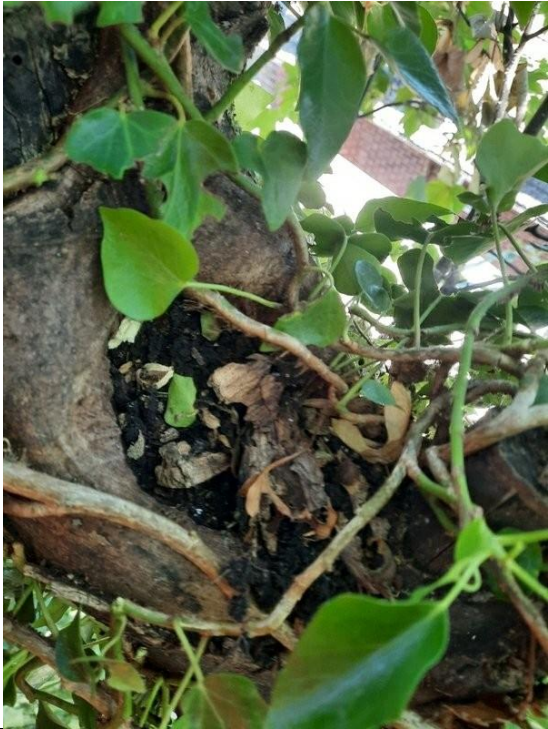
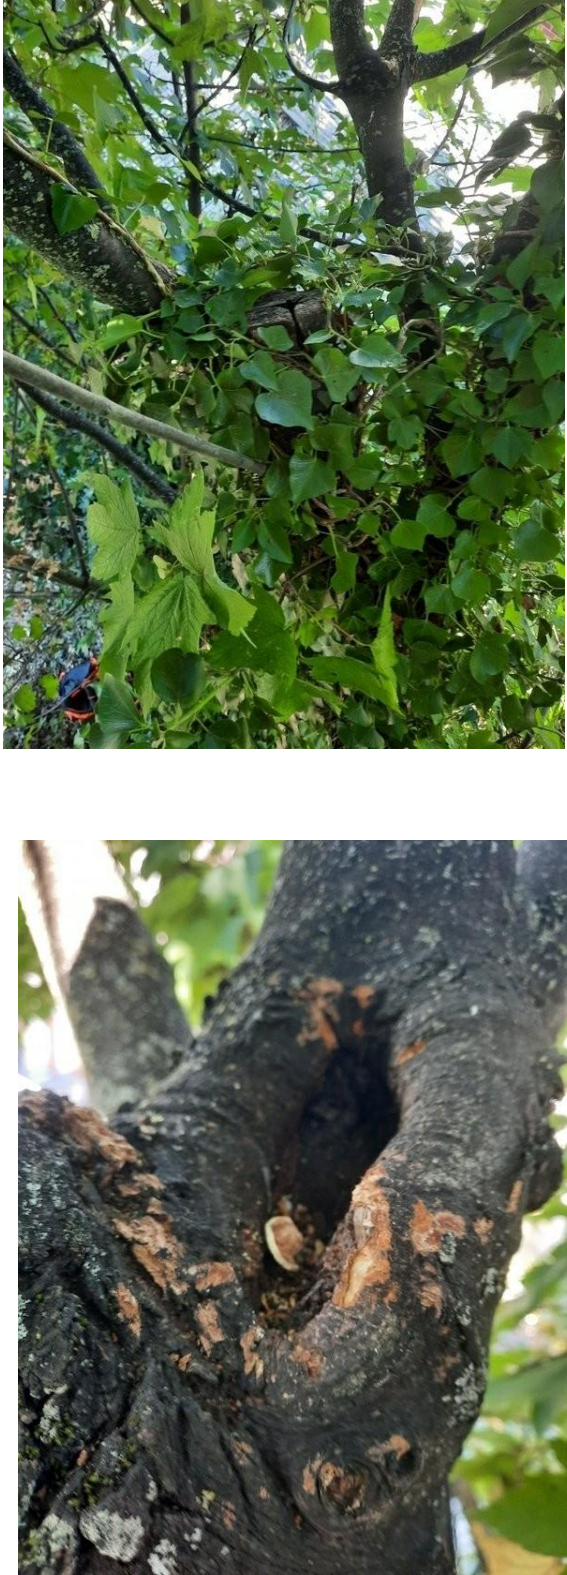
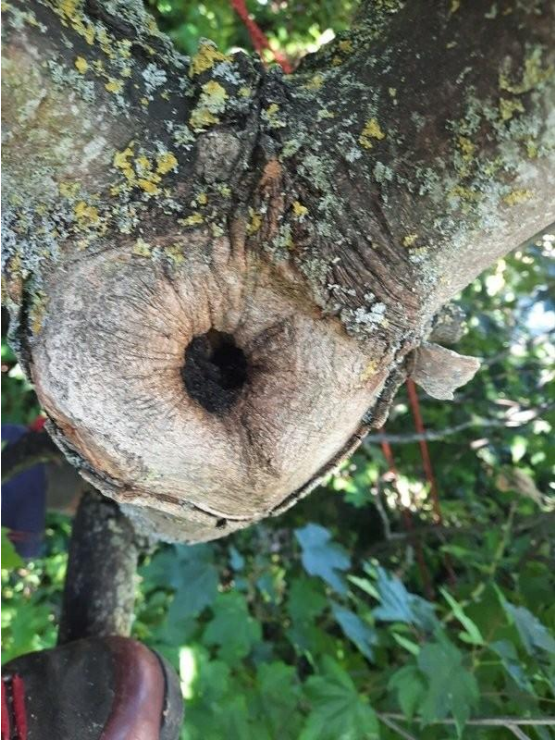
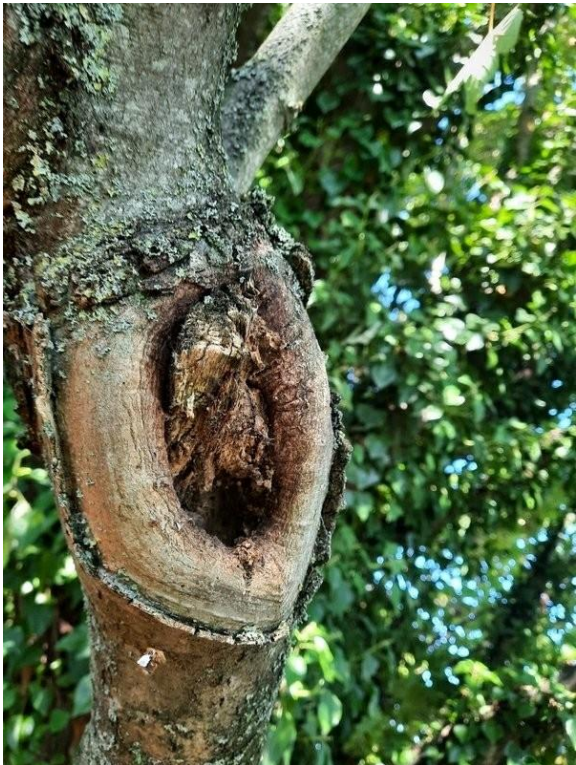
| Feature Number | Photograph | Description and Bat Roost Potential |
|---|---|---|
| PRF2 - 6<br>rot holes | | <p>Multiple superficial cavities at point of previous topping cuts throughout the crown at approximately 10 m height. Many obscured from ground level view by the ivy cover. None with any roosting suitability.</p> <p>Multiple, superficial cavities developing at the point of previous topping cuts, where the remaining branch has decayed, and wound wood formation is developing. Cavities all open and shallow and very exposed with no roosting suitability</p> <p><b>Negligible Potential</b></p> |

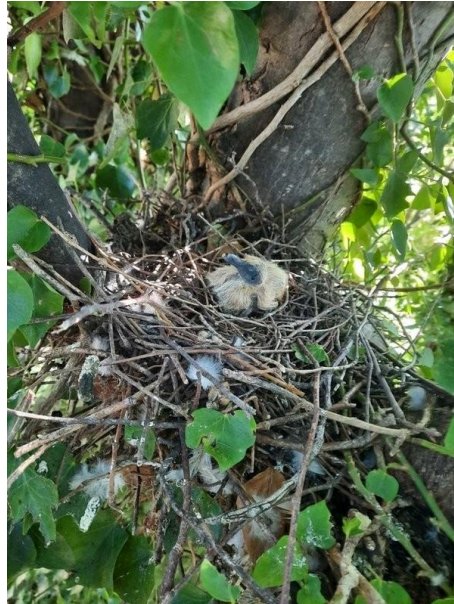
During the survey an active wood pigeon (*Columba palumbus*) nest was discovered on the tree (Photo 1).

Photo 1. Active pigeon nest with juvenile present.

All active birds' nests are protected by law. A nest is deemed to be active even if it is in the process of being built and does not yet contain eggs or young. As such, this tree cannot be felled until the young have fledged. Ideally the felling of this tree would occur outside the breeding bird season (October and February). If it is necessary to remove the tree during the breeding season, this will require a watching brief by an ecologist no more than 48 hours before the tree is removed to ensure the chicks have fledged and that no other active nests are present within the tree.
