# Design and Access Statement

Royal Berkshire NHS Foundation Trust  
North Block East Wing, London Road, Reading

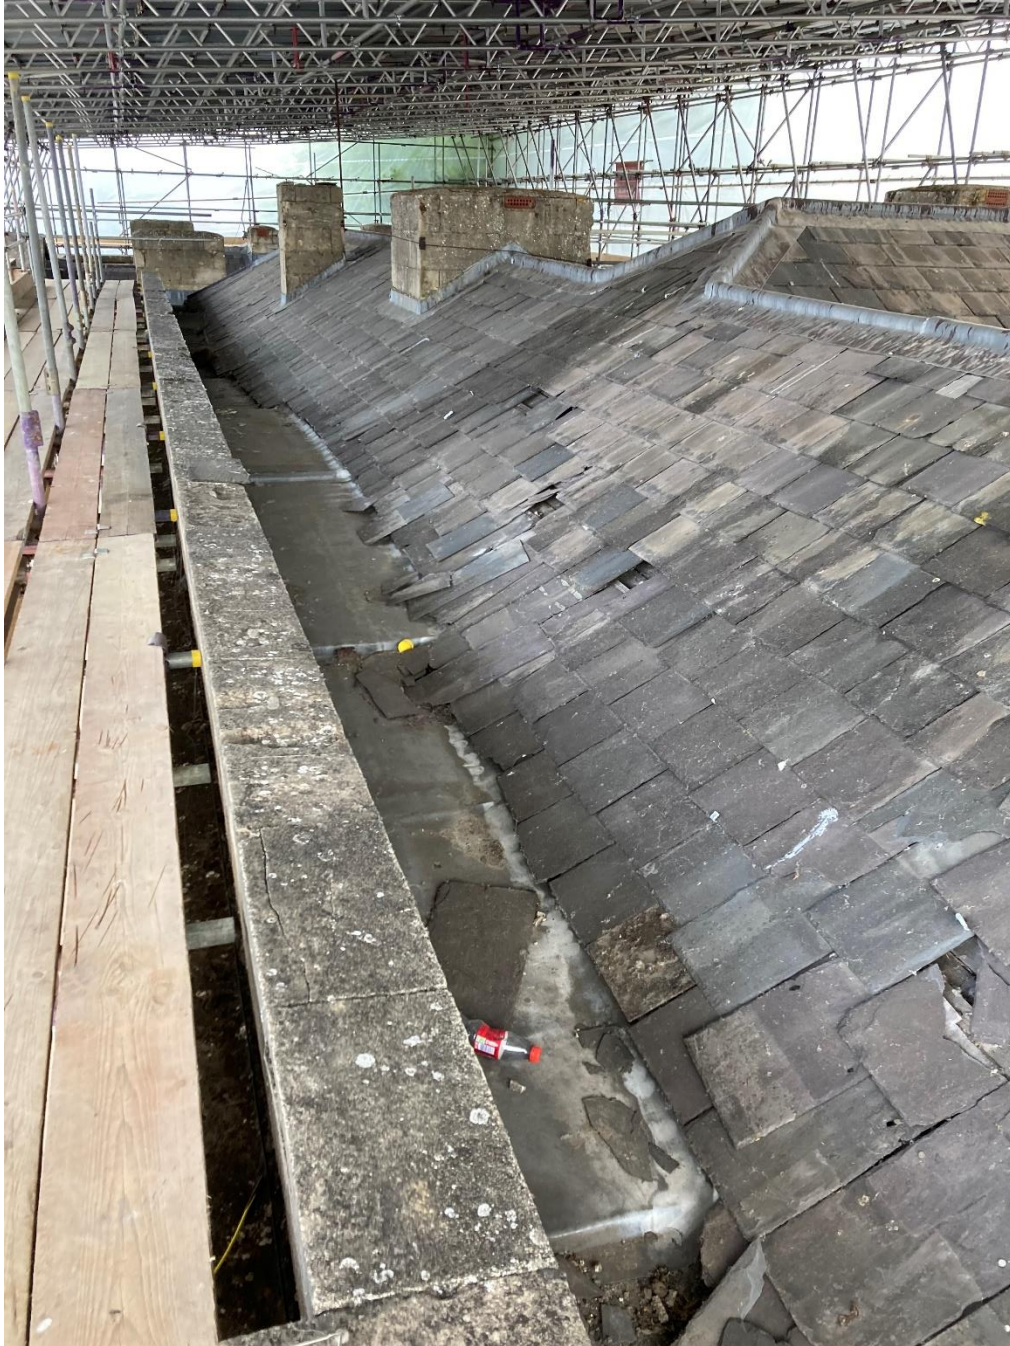
The roof is of slates nailed to battens on sarking boards. There are areas of flat leadwork in the centre, and parapet lead gutters to the perimeter. The structure is deemed unsafe so has yet to be inspected but is known to have suffered from many years of neglect. Outlets have become blocked due to lack of maintenance, and as a result water has found its way into the building over a long period of time, damaging the fabric and causing damp and rot issues throughout.

General view of the roof

- Provide scaffold inside building to create safety crash deck to allow works on the roof
- Strip slates, battens and sarking to expose roof structure
- Inspect structure including wallplates and replace timbers as necessary and spray treat the timber to remain.

- Fix new sarking boards, Tyvek membrane, battens and slates
- Re-form all flat roof areas and gutters with new timber and renew all leadwork
- Make sure rainwater outlets work correctly
- Provide lead overflow pipes through parapet to prevent build up of standing water
- Clear out loftspace and insulate

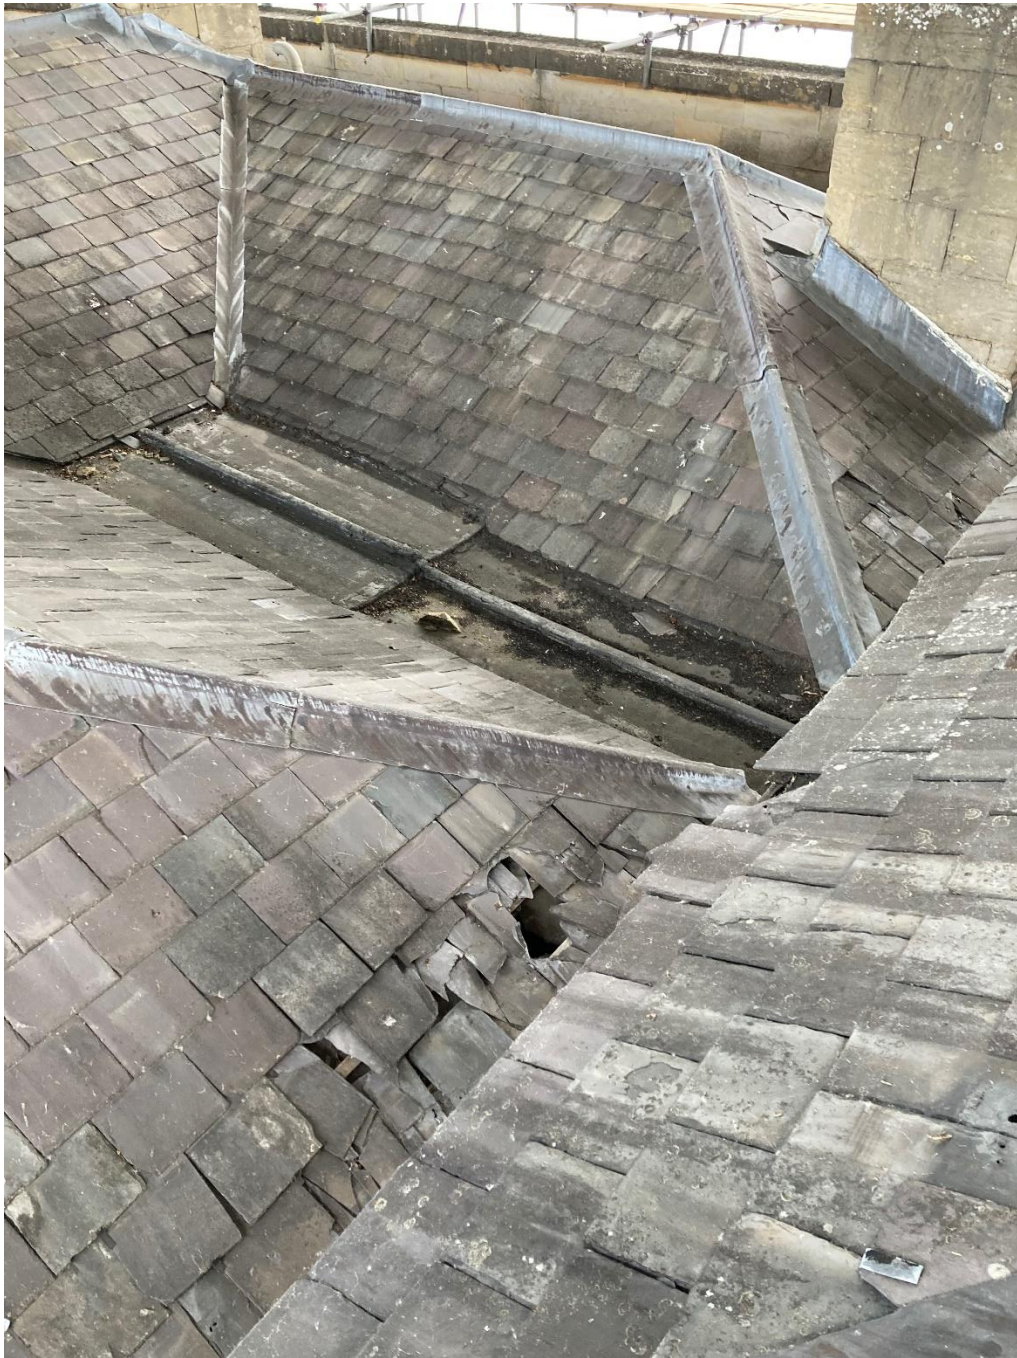
Roof damage has caused water ingress

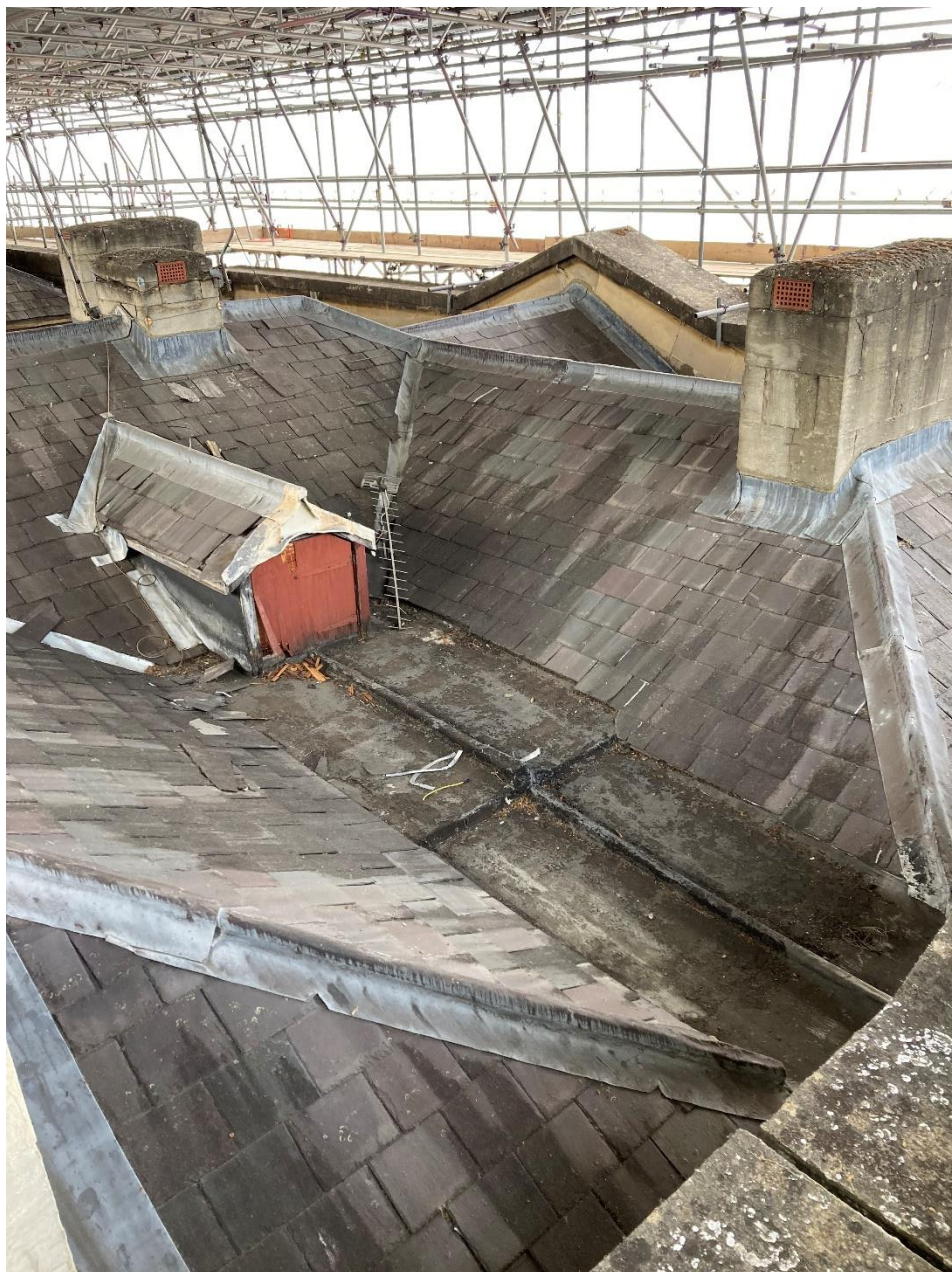
Flat lead areas and roof access

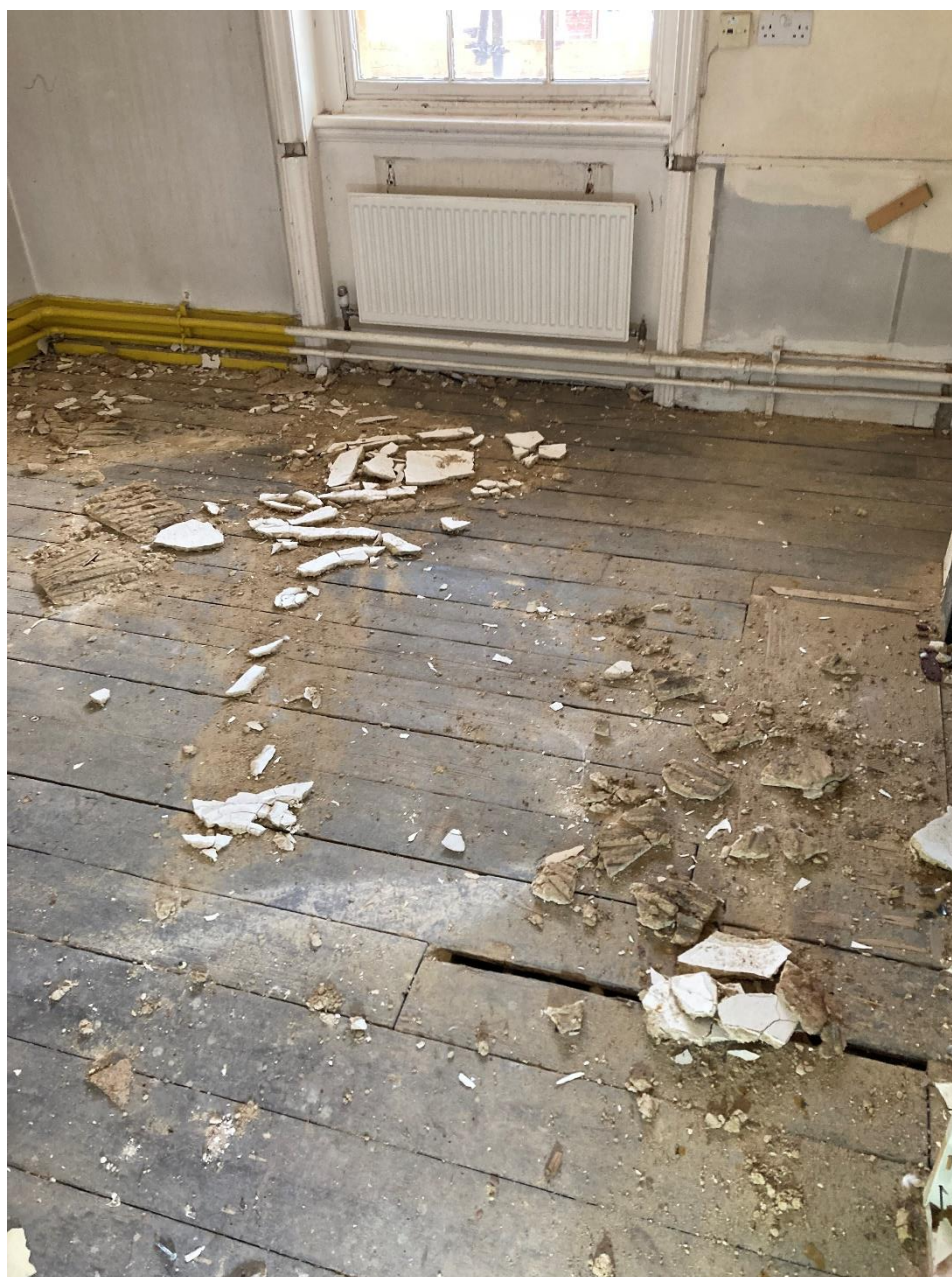
Typical boards on the second floor

In order to safely access the roof to repair and make it weathertight, we need to introduce a temporary scaffold through the building to facilitate this. All boards will be removed, marked and recorded so that they can be replaced in their original locations, and then treated for reuse. Any boards that have perished due to rot and damp, and areas that have in the past been replaced with OSB or plywood, will have new boards supplied and fitted in their place.

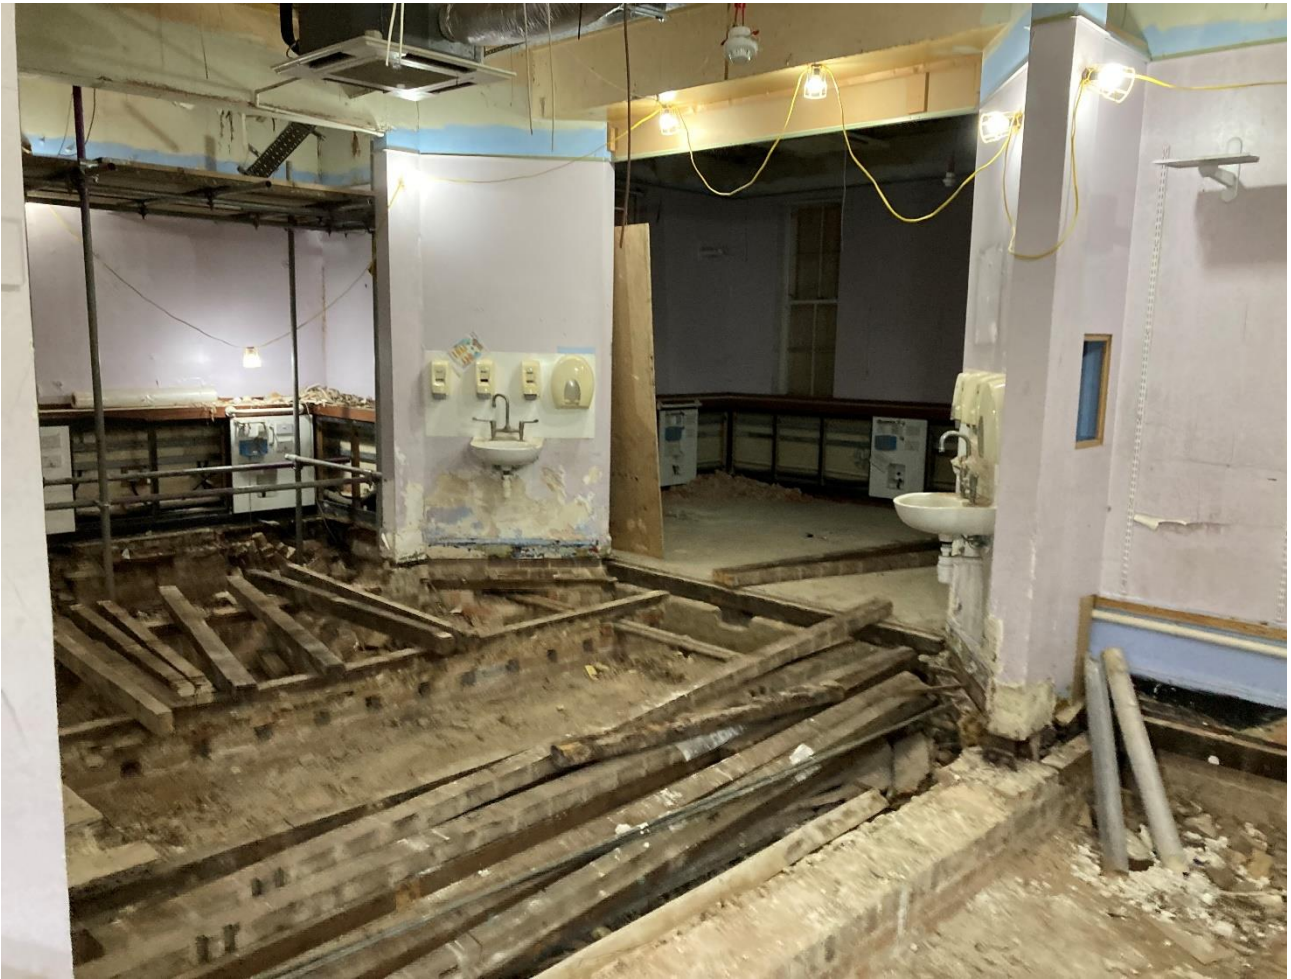
Timber suspended ground floor and concrete beyond

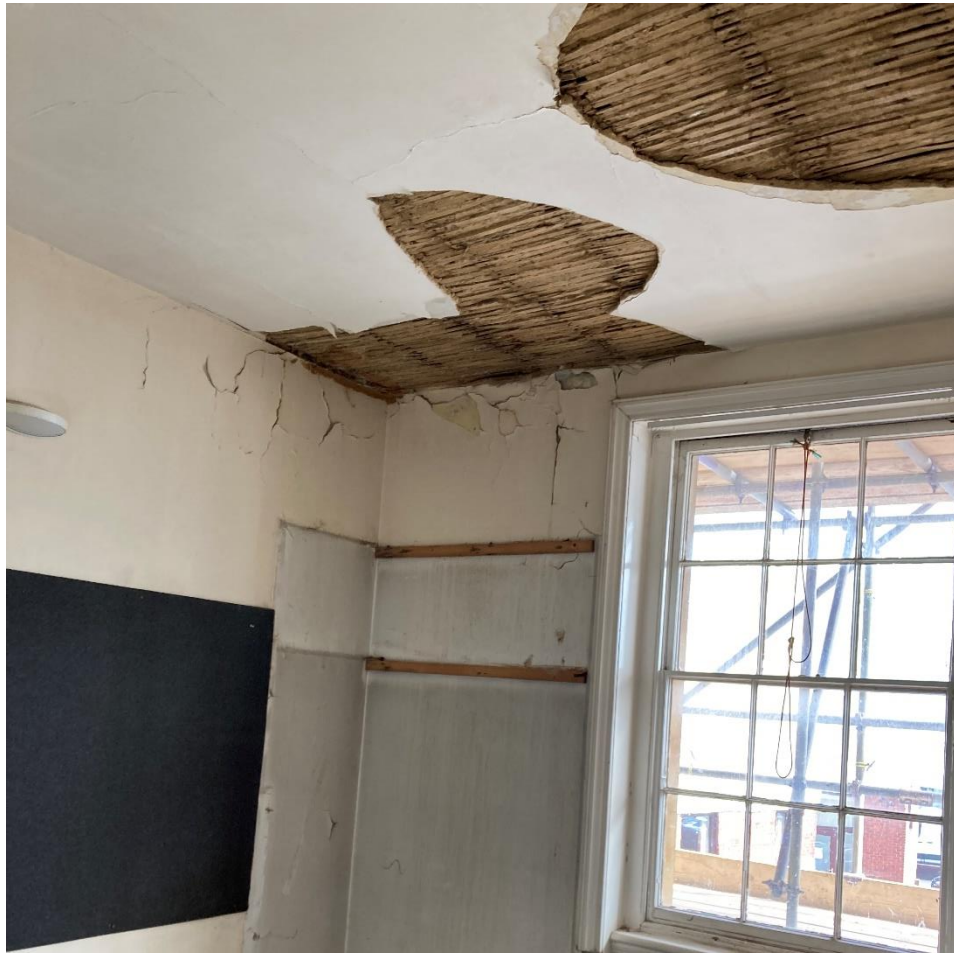
Lath and plaster ceilings are generally damaged

It is planned to replace all of the ceilings with lath and plaster as specified on the drawing.

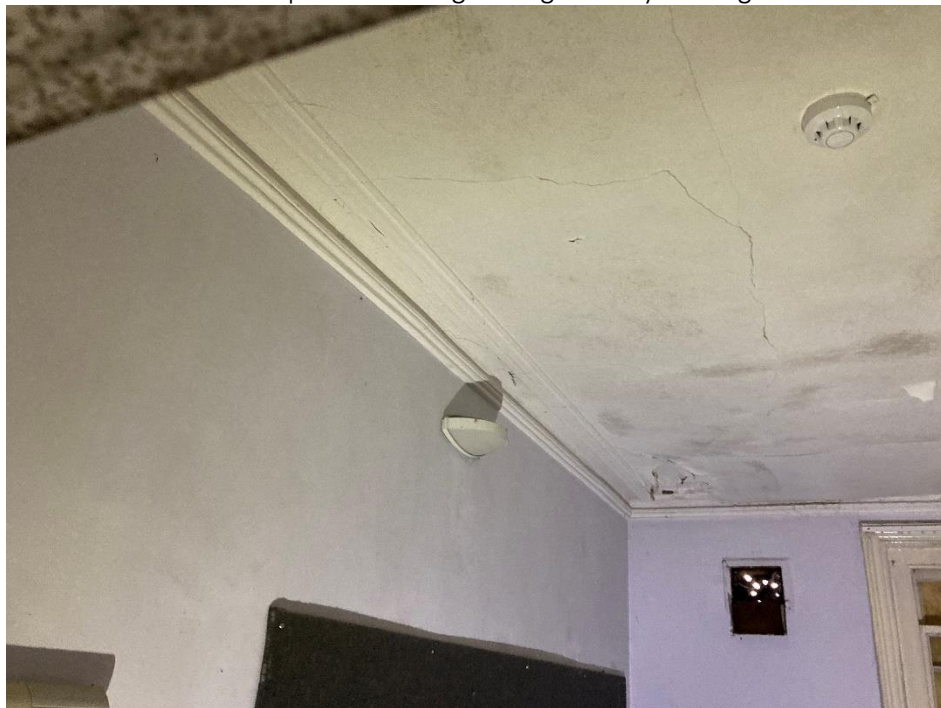
Cornice remains in a few locations on the second floor

In order to install a scaffold, most if not all of these ceilings will be removed. Areas of cornice that can remain will do so, but casts will be made of all areas so that replacement matching cornice can be manufactured.

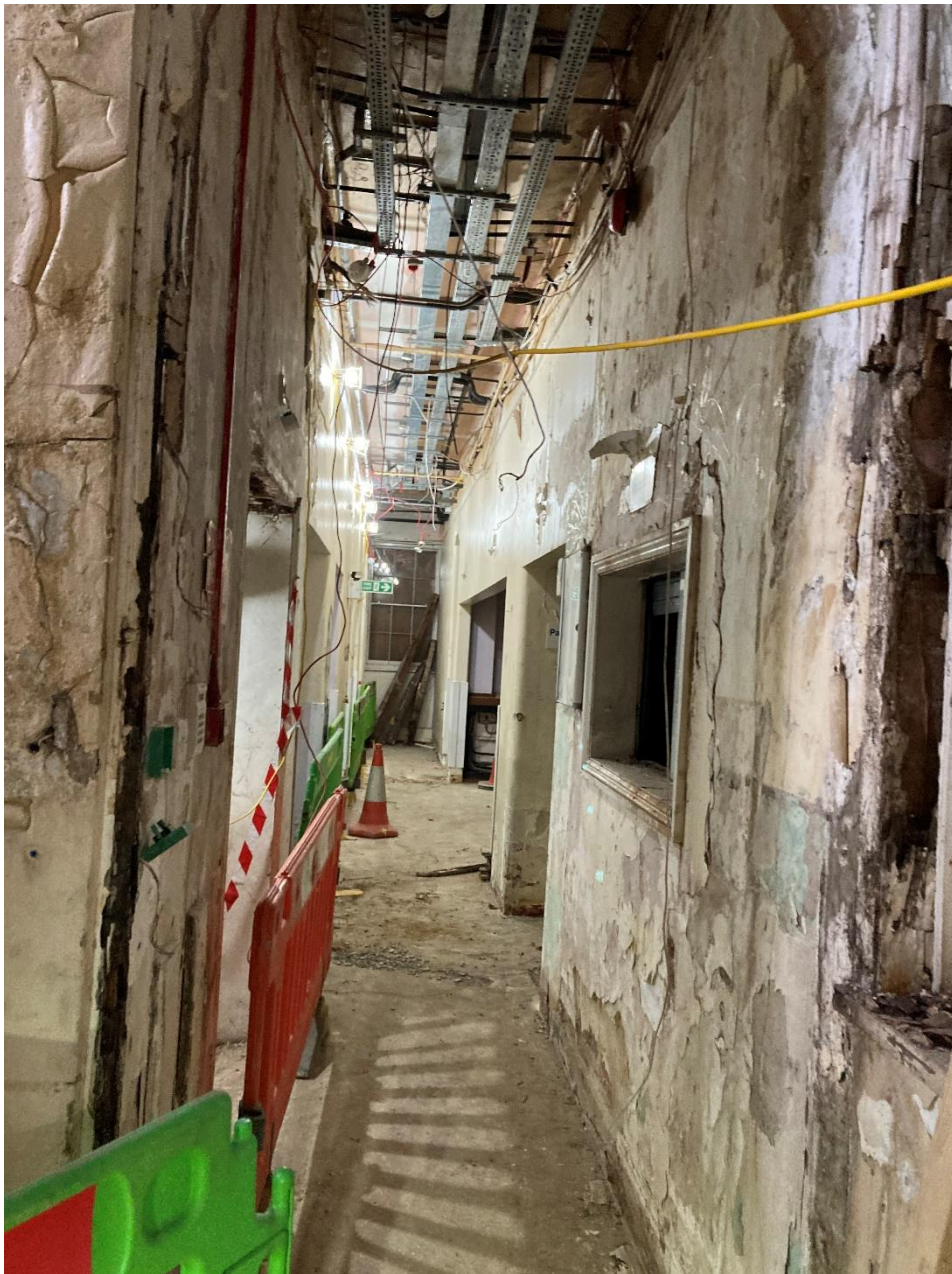
It is anticipated that areas of plaster have been damaged by the water ingress and the damp. In order to leave the building in a dry, stable and safe condition, all areas of damaged plaster will be removed.

Plaster damage in the ground floor at the north end

It is not proposed to replace the plaster as part of these works, in order to allow the structure to dry out completely. Temporary heating will be provided in the building to facilitate this.

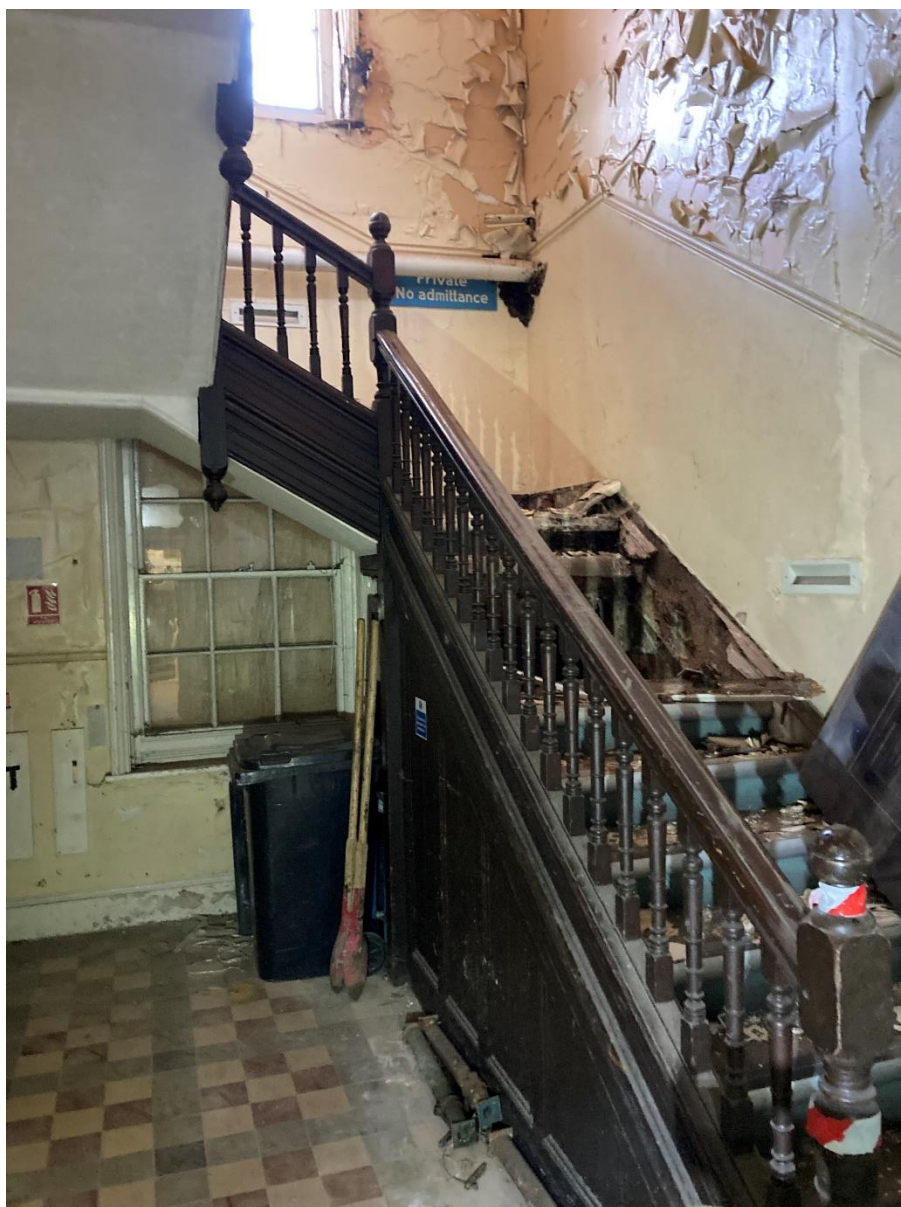
The main staircase has been destroyed by the dry rot fungus and needs to be replaced. We propose to remove this staircase and put it into safe dry storage so that a skilled joiner can create a new stair incorporating the details, and any salvageable parts of the original stair.

General view of the staircase at ground floor

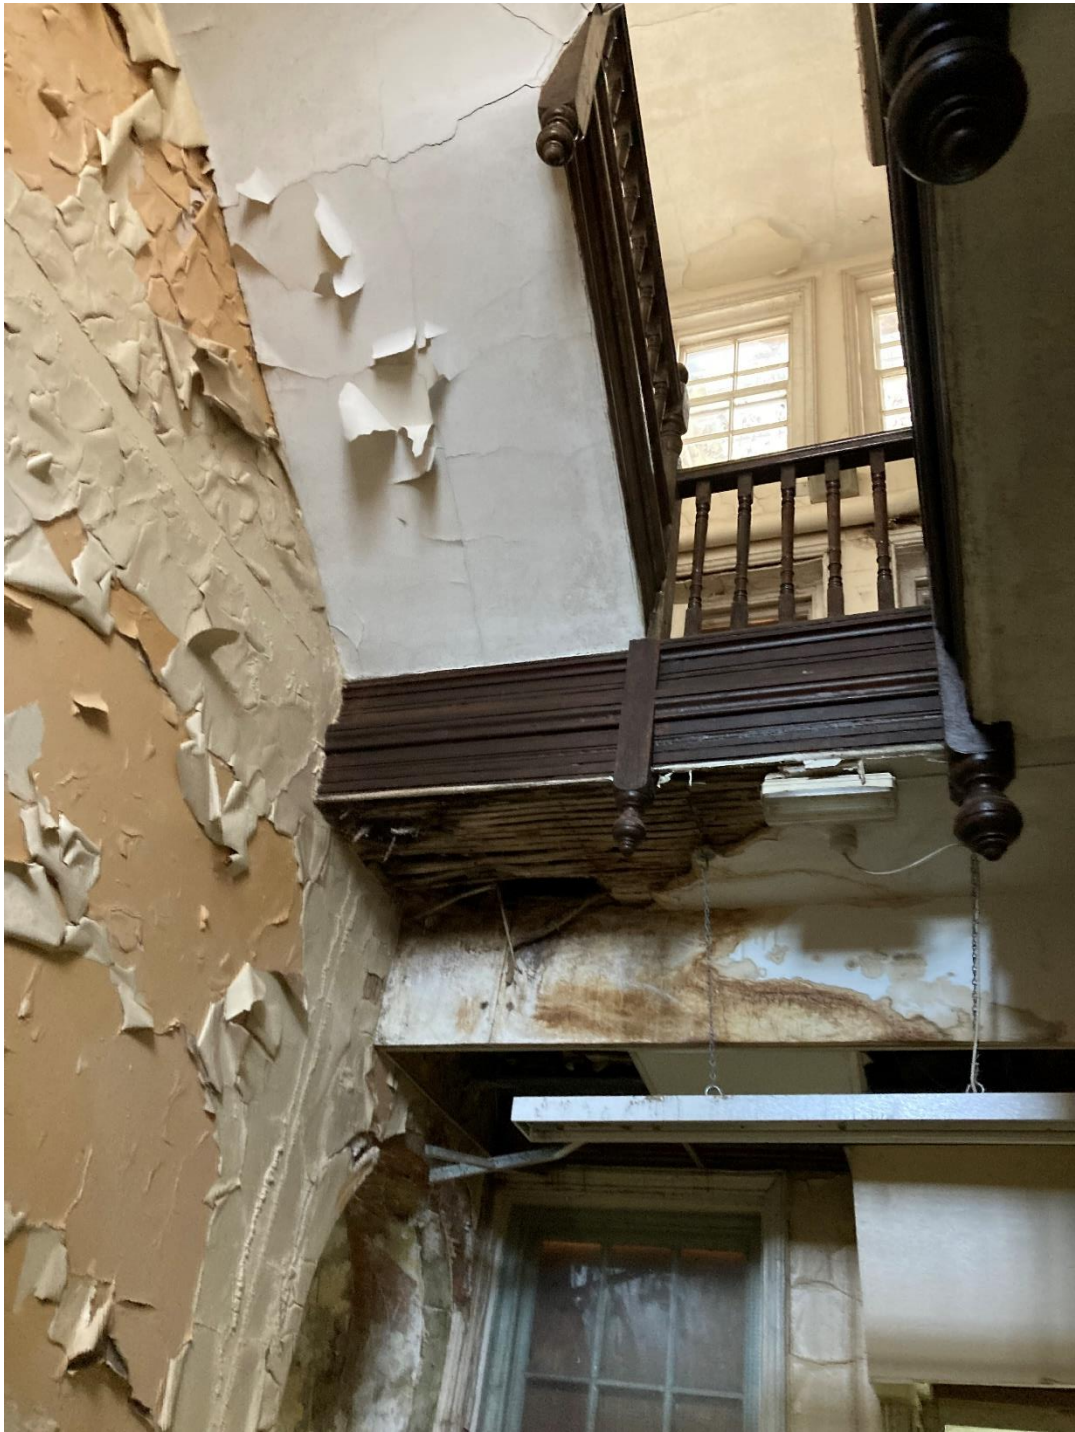
First floor landing (inaccessible)

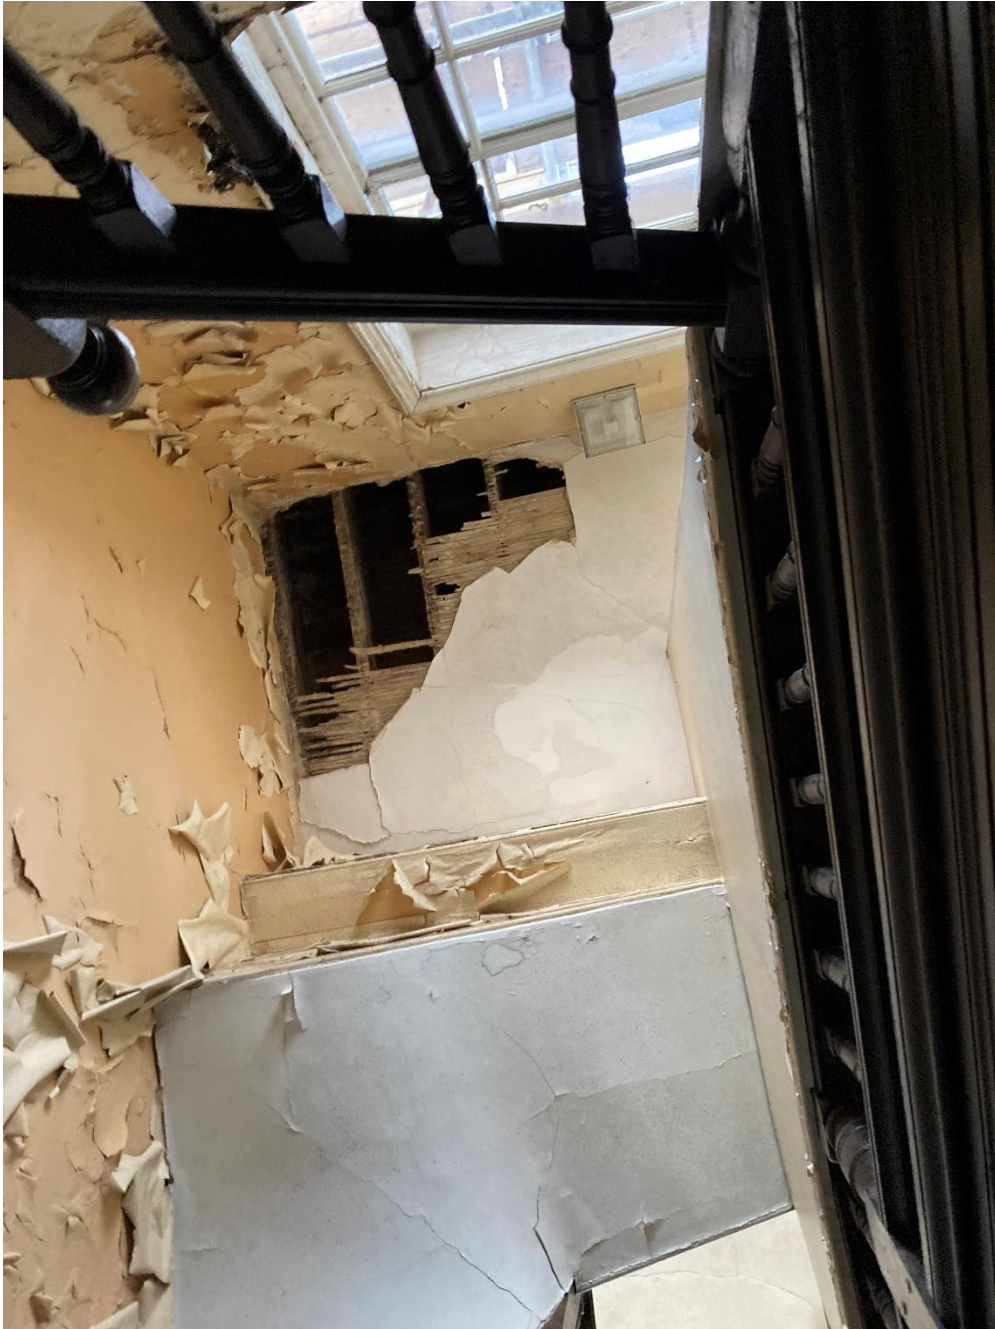
Ceiling over main stair
