31 Northcourt Avenue  
Reading  
Berkshire  
RG2 7HE

# Preliminary Bat Roost Assessment

Ref: R3153/a

**July 2022**

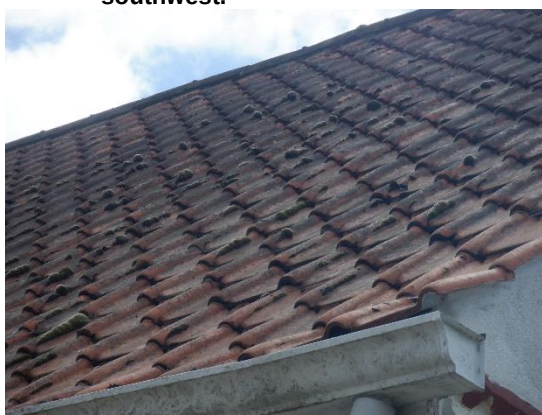
- 4.2.1** The detached chalet bungalow was of painted render, cavity wall construction with a pitched roof. A single-storey extension with a flat roof was attached to the rear and a bay window was attached to the front (**Photographs 1 & 2**). The interlocking roof tiles were in place and tightly fitted across the main roof offering no access opportunities for roosting bats (**Photograph 3; Target note 1**). The ridge tiles were in place and mortared (**Photograph 4; Target note 2**). The lead flashing was tight along the sides of the dormer window on the northern roof elevation (**Photograph 5; Target note 3**).

3. Interlocking roof tiles in place and tightly fitted.

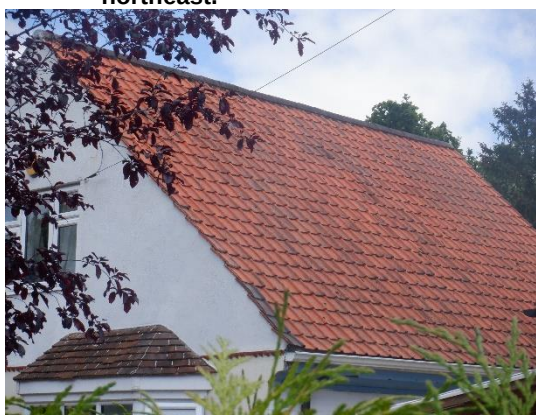
4. Ridge tiles in place and mortared.

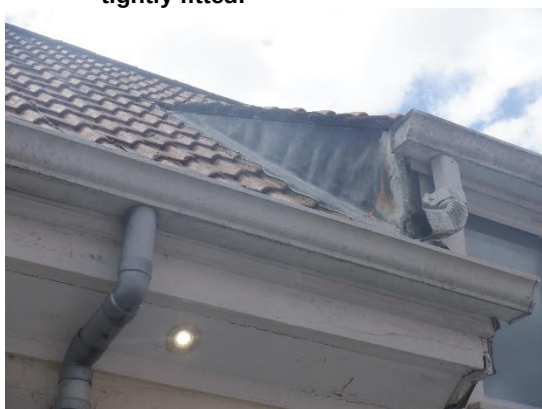
5. Lead flashing tight along the sides of the dormer window.

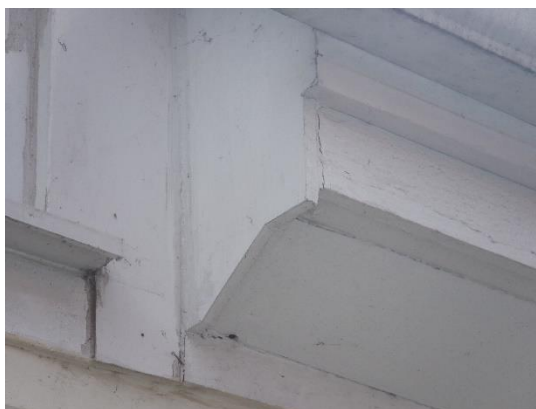
- 4.2.2** The soffit boxes were mostly of timber construction which were tight to the rendered walls at the eaves (**Photograph 6; Target note 4**). A gap was present in the mortar at the front southern corner of the eaves, which was of limited extent as further mortar was visible behind, and it did not offer any features suitable for use by bats (**Photograph 7; Target note 5**). A gap was also present between the paintwork and timber soffit in the rear northern corner of the bungalow which did not lead to any crevices for use by bats (**Photograph 8; Target note 6**). The verge tiles were tight to the rendered walls (**Photograph 9; Target note 7**). The clay roof tiles were uneven on the bay window to the front of the bungalow (**Photograph 10; Target note 8**). The single-storey rear extension was tightly fitted (**Photograph 11; Target note 9**).

6. Timber soffits tight to the rendered walls along the northwestern side of the bungalow.

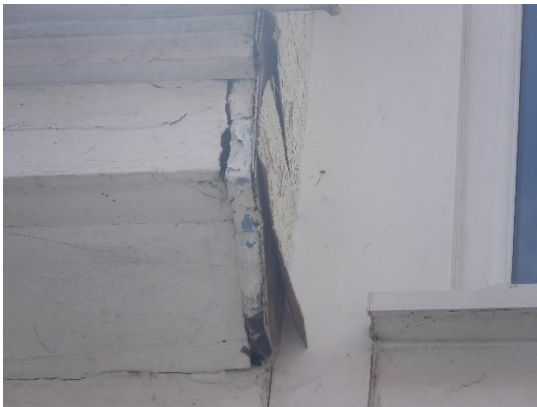
**5.1.2** The bungalow had no potential roost features suitable for use by crevice-dwelling bat species, such as the pipistrelles (*Pipistrellus* spp.) and/or small *Myotis* species, apart from a few gaps under the roof tiles on the bay window. There were a couple of gaps at the soffits but they were of limited extent and did not offer suitable crevice-dwelling opportunities for bats.

**7. Gap in the mortar with further mortar visible behind at the front southern corner.**

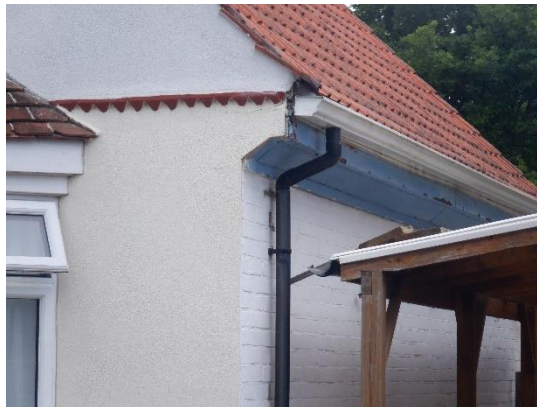
**8. A gap present between the paintwork and timber soffit in the rear northern corner.**

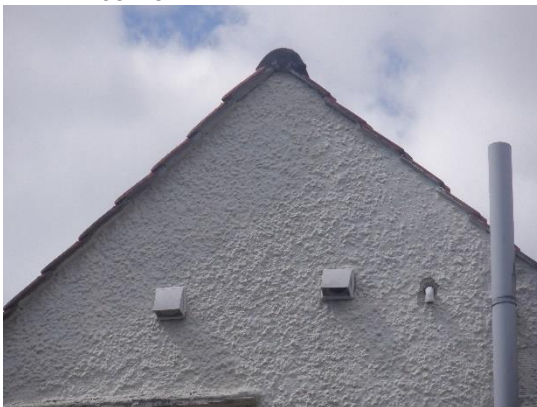
**9. Verge tiles tight to the rendered wall to the rear of the property.**

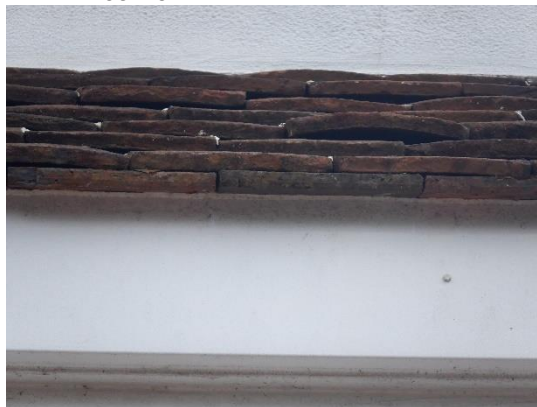
**10. Roof tiles uneven on the bay window to the front of the property.**

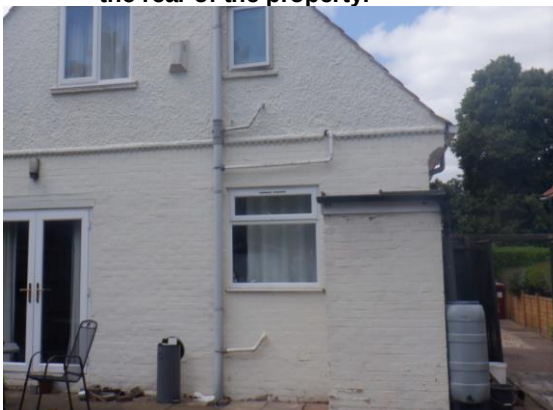
**11. Single-storey rear extension tightly fitted.**

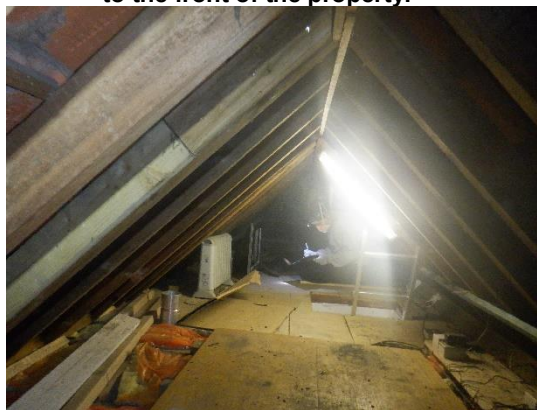
- 4.3.1** The bungalow had one roof space along the ridge. The roof space had an estimated floor-to-roof height of 1.25 metres and was accessed via a loft hatch. The floor was partially boarded at the front southeastern end of the roof space and had fibreglass

**12. Internal view of the roof space boarded at the front southwestern end.**

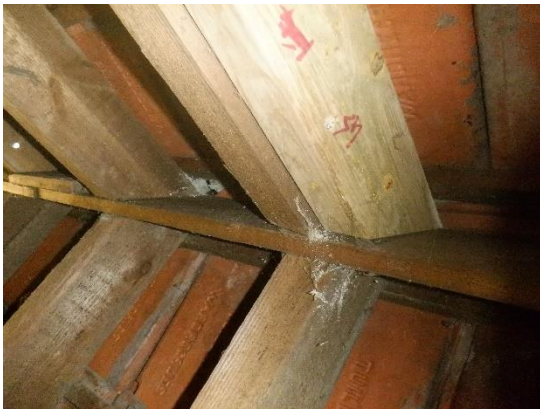
insulation (**Photograph 12; Target note 10**). The ridge was lightly cobwebbed, which can indicate little or no roosting activity by bats at the ridge (**Photograph 13; Target note 11**). The roof was unlined with the undersides of the roof tiles exposed with some daylight in places between the tiles (**Photograph 14; Target note 12**). The eaves were filled in places with insulation, foil-covered insulation and timber, and also open in places (**Photographs 15 & 16; Target notes 13, 14 & 15**). The gable ends were of blockwork cavity wall construction. A gap was present at the apex of the front southwestern gable end wall (**Photograph 17; Target note 16**). Gaps were present around the blockwork and fibreglass insulation was present filling the gaps at the rear northeastern gable end wall (**Photograph 18; Target note 17**). Two sealed ventilation ducts exited the base of the wall at the rear northeastern gable end wall (**Photograph 19; Target note 18**).

**13. Ridge lightly cobwebbed.**

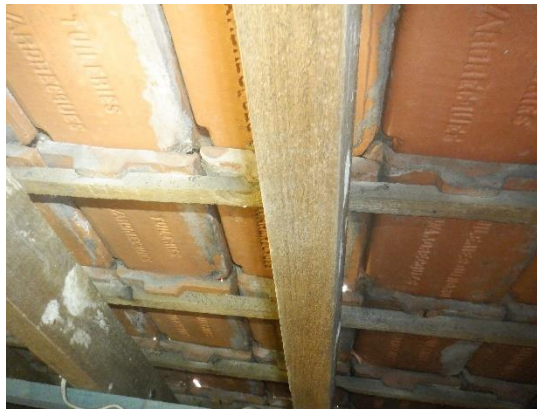
**14. The unlined roof with undersides of the roof tiles exposed.**

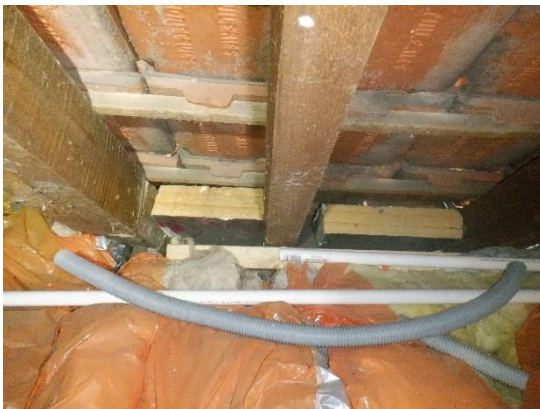
**15. Eaves filled with foil-covered insulation boards in places.**

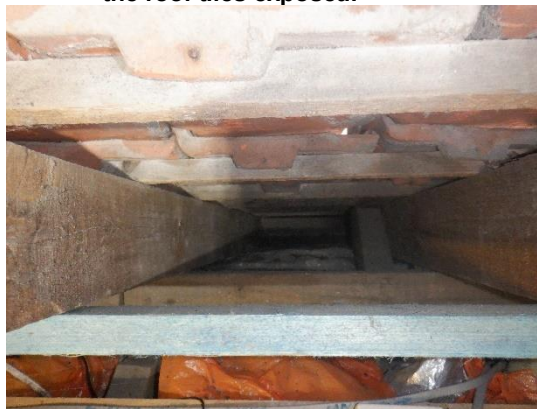
**16. Eaves open in places.**

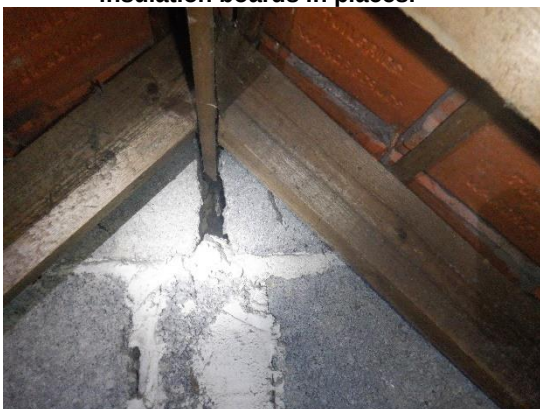
**17. Gap present at the apex of the front southwestern gable end wall.**

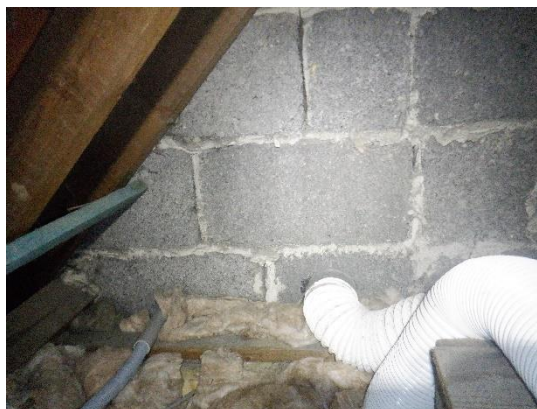
**18. Gaps present around the blockwork filled with fibreglass insulation at the northeastern gable end wall.**

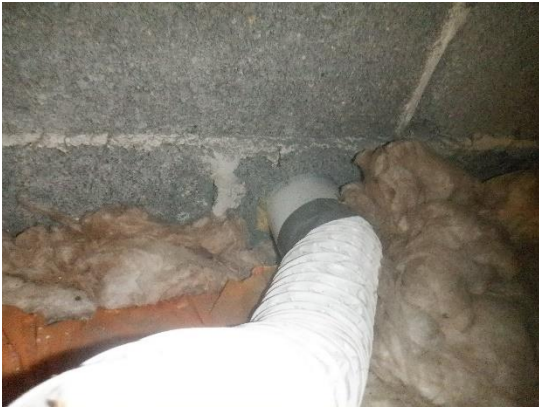
**19. Sealed ventilation ducts in the wall of the northeastern gable end wall.**
