| Site: | Caversham Park | Project ID | JT0443 |
| Figure 1 | Site Location Plan | Date: | 12/11/2021 |

| Site: | Caversham Park, Reading | Project Id: | JT0443 |
| Figure 2 | Proposed site layout | Date: | 09/12/2021 |

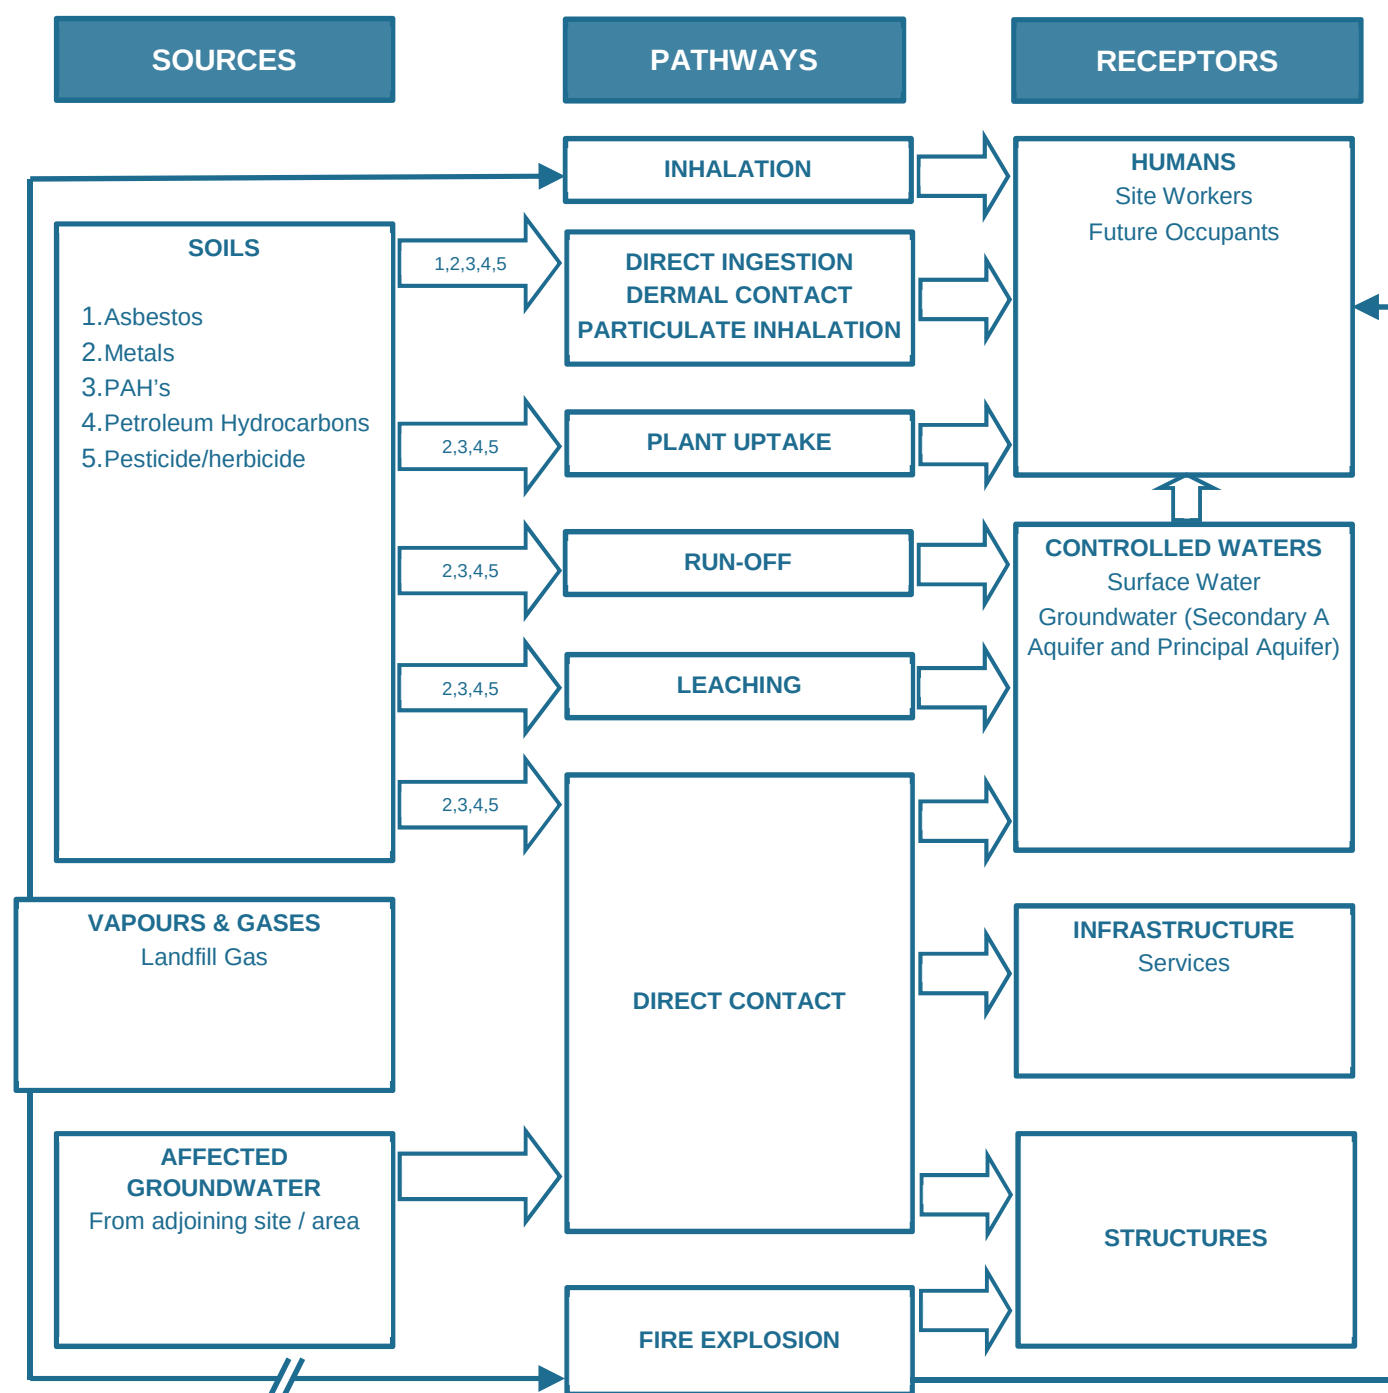
The following diagram shows the potential pollutant linkages identified for the site and summarises the preliminary conceptual model:

Denotes potential pollutant linkage not complete.

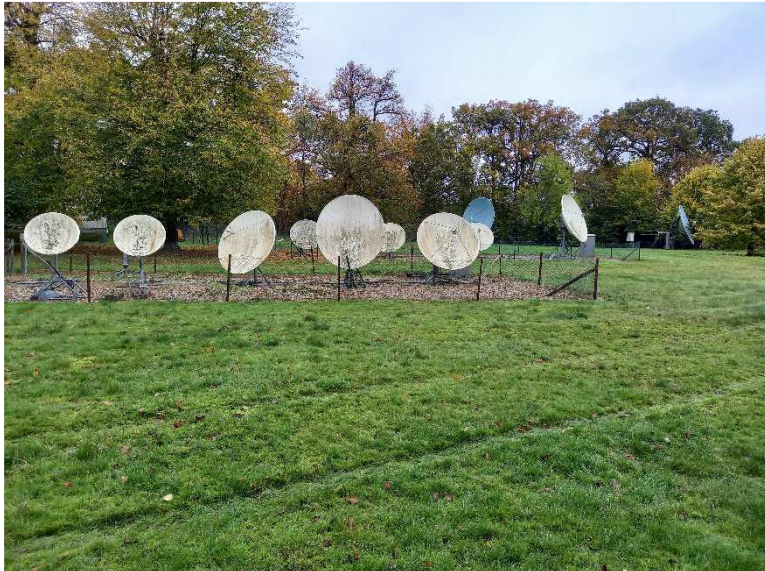
Satellite field to the east

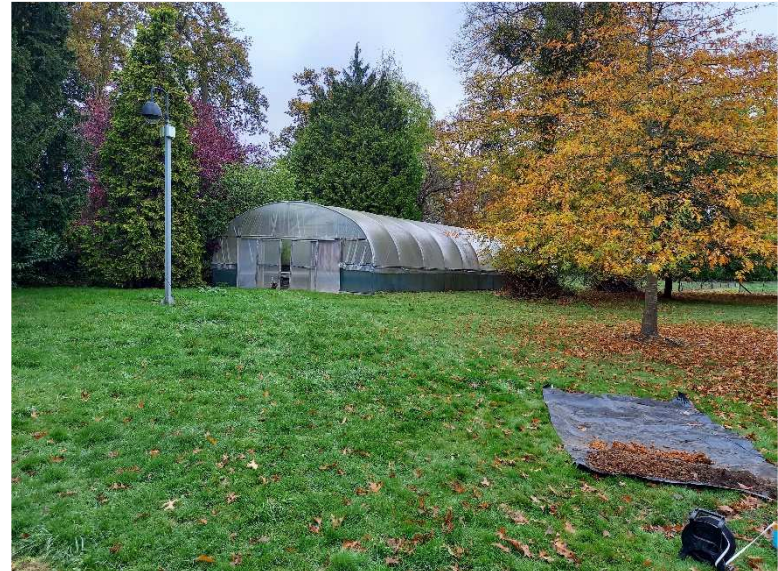
Greenhouse within the Satellite field to the east

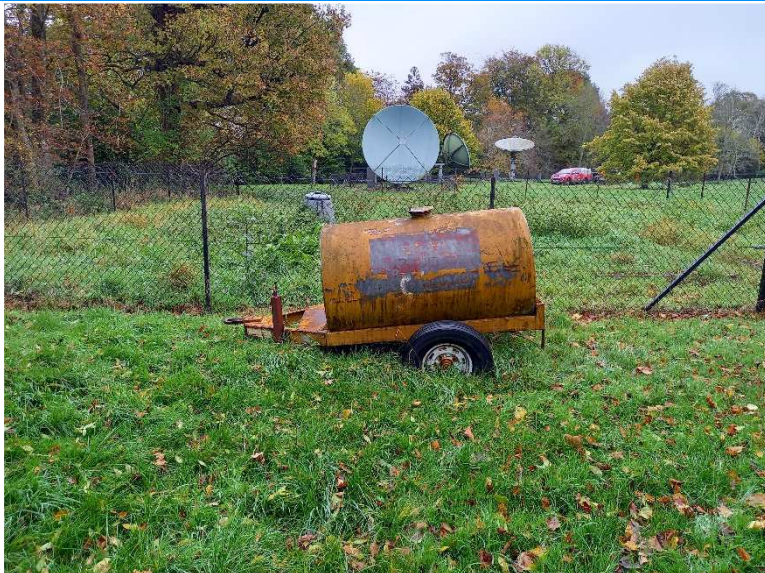
Empty fuel tank and allotment within the Satellite field

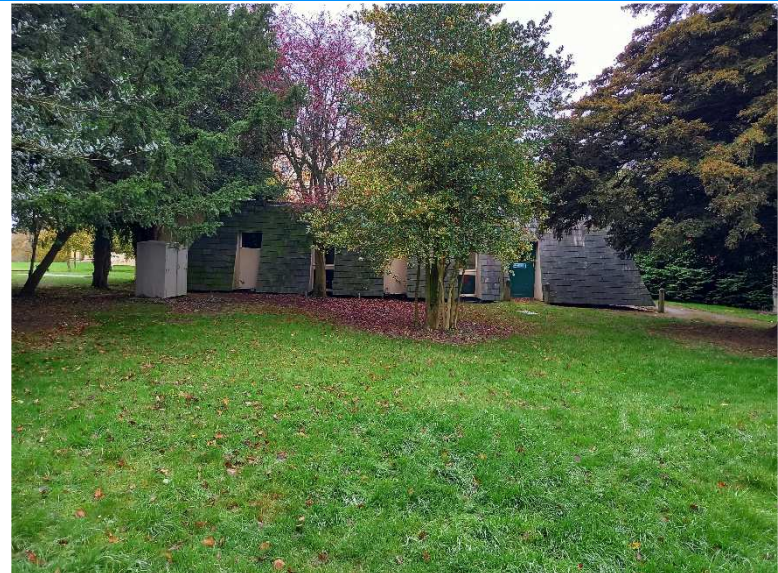
western view of the satellite field

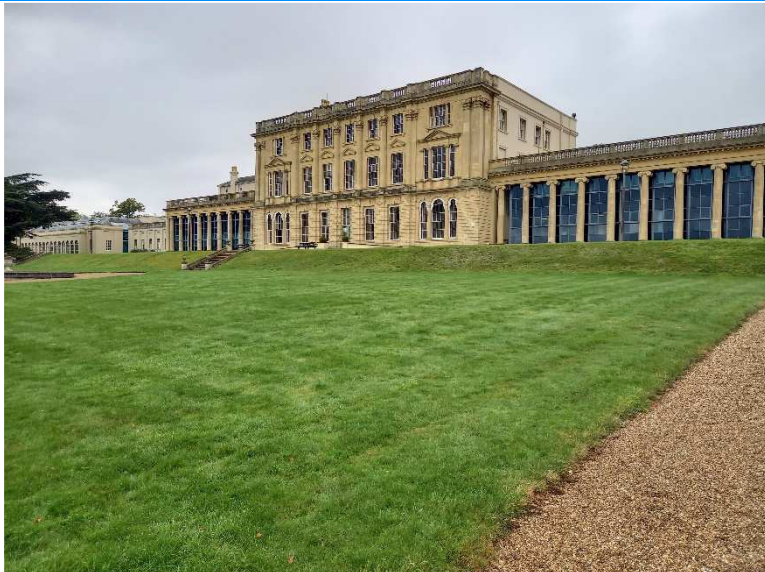
View of the Manor House and the formal garden from the south

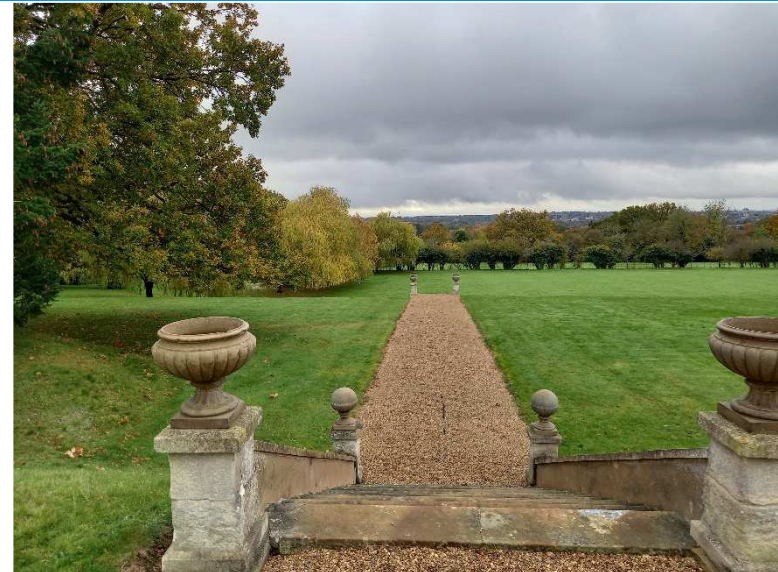
Facing south – the formal garden south of the Manor House

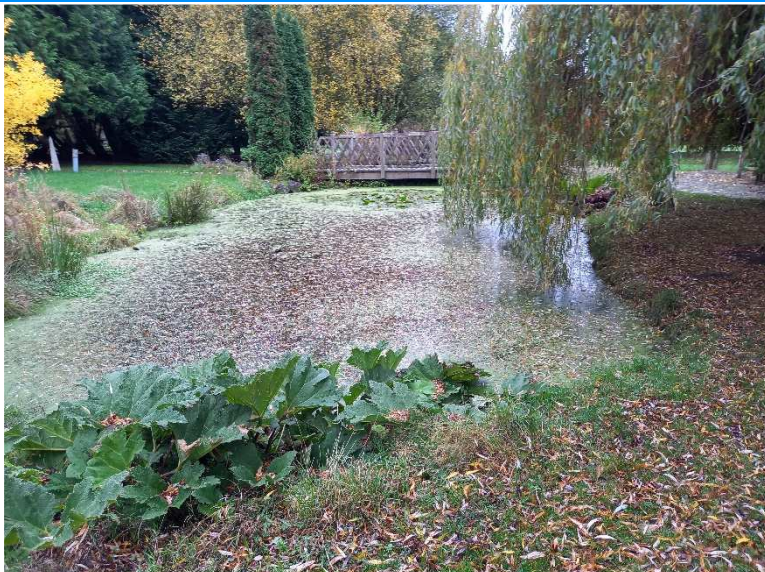
A pond located southeast of the Manor House

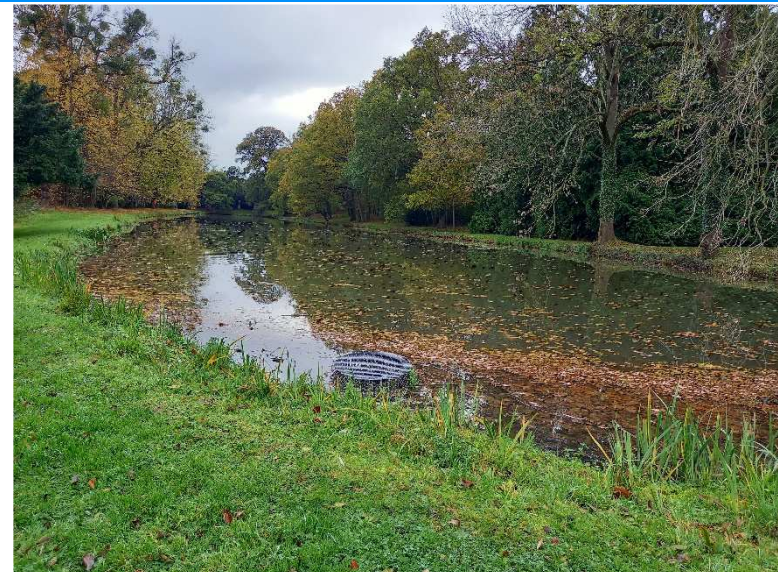
A lake located to the southwest of the Manor House

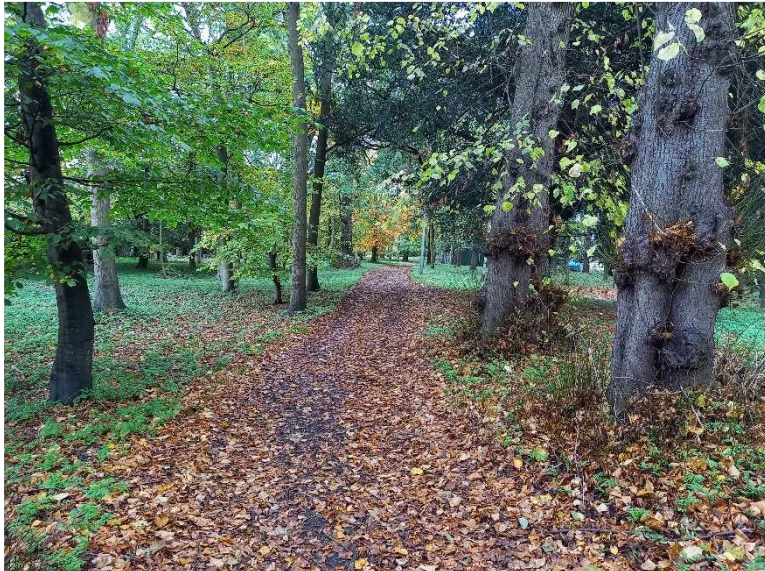
Woodland southwest of the Manor House

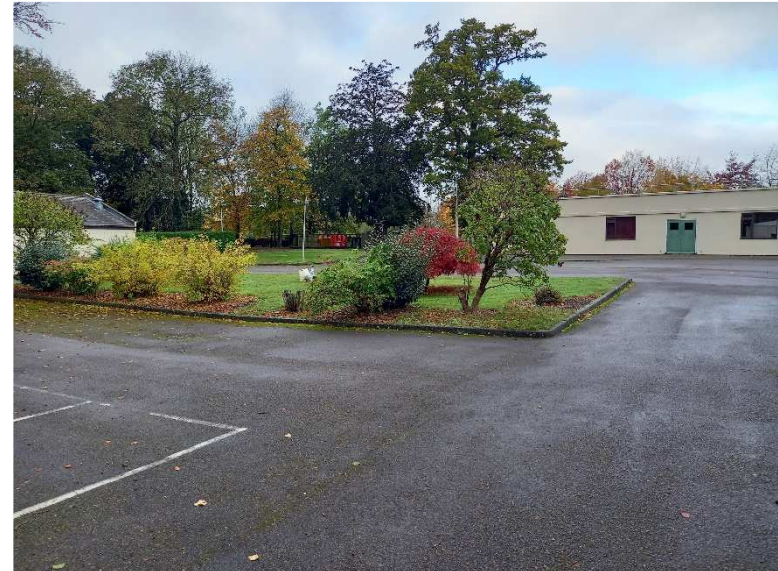
A number of small buildings west of the Manor House

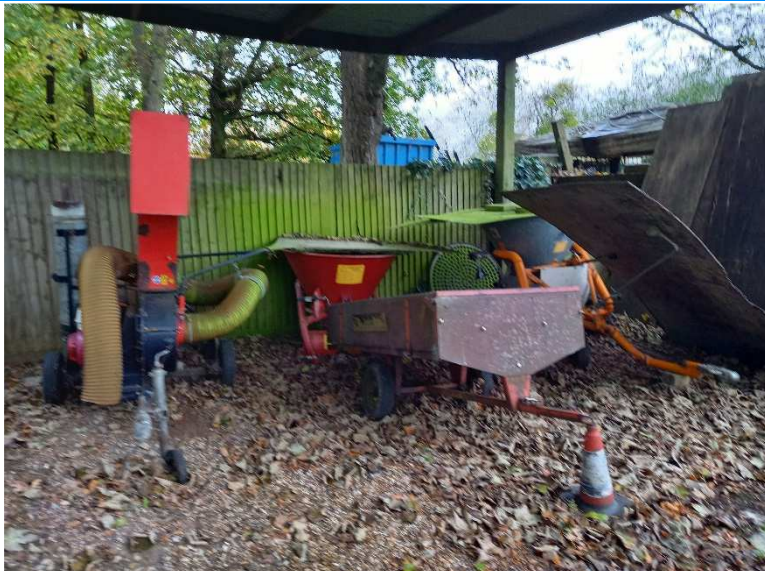
Ground Maintenance Compound west of the Manor House

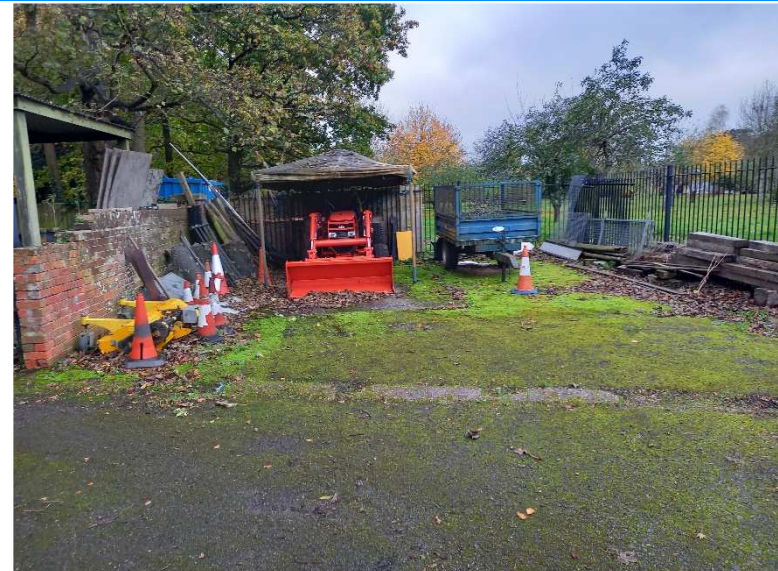
Ground Maintenance Compound to the west of the Manor House.

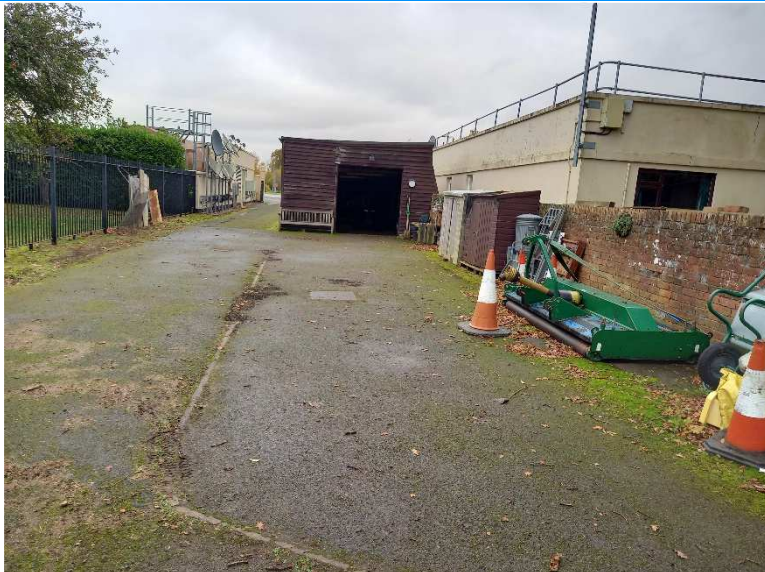
Ground Maintenance Compound to the west of the Manor House.

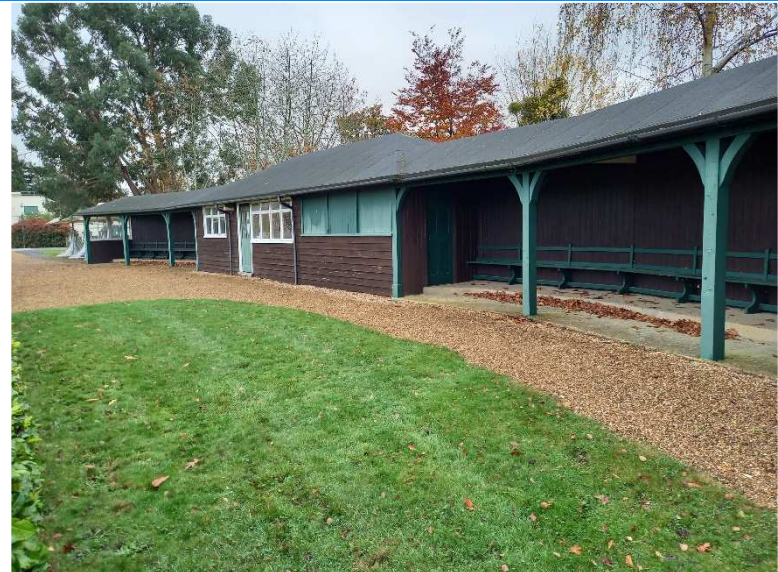
Pavilion to the north

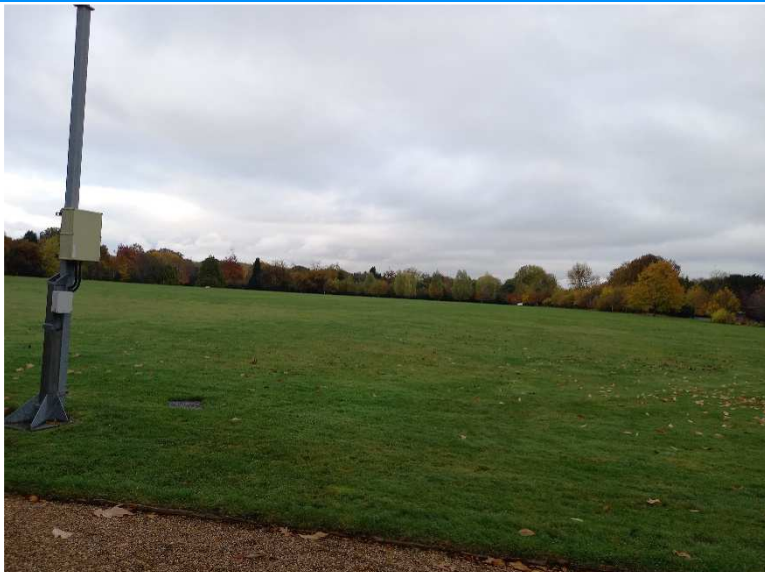
Playing field to the north

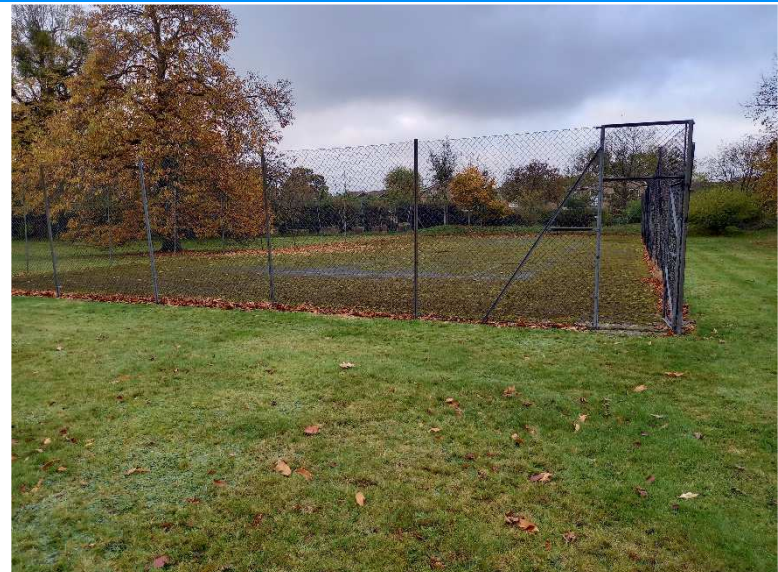
A tennis court to the northwest

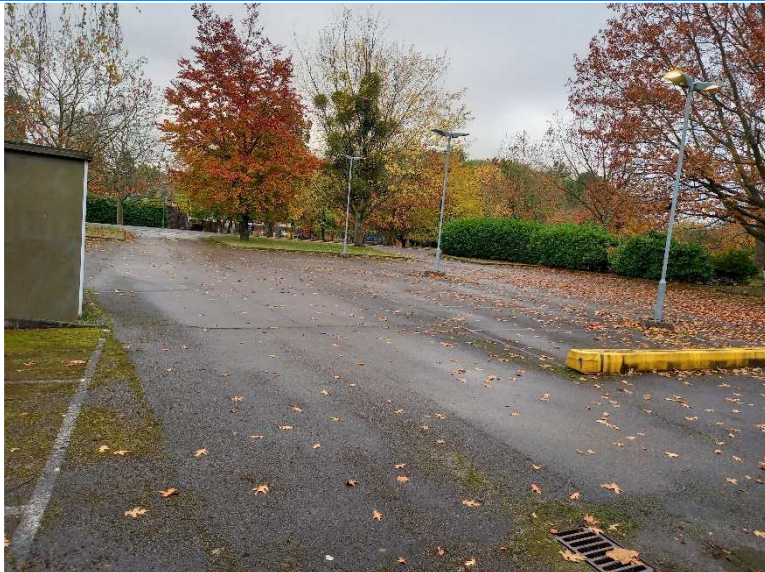
A car parking area to the northwest

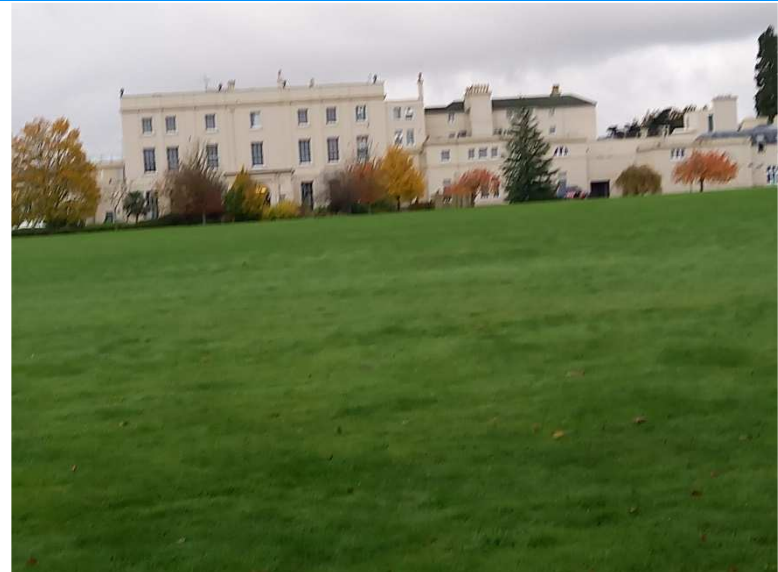
View of the Manor House from the north

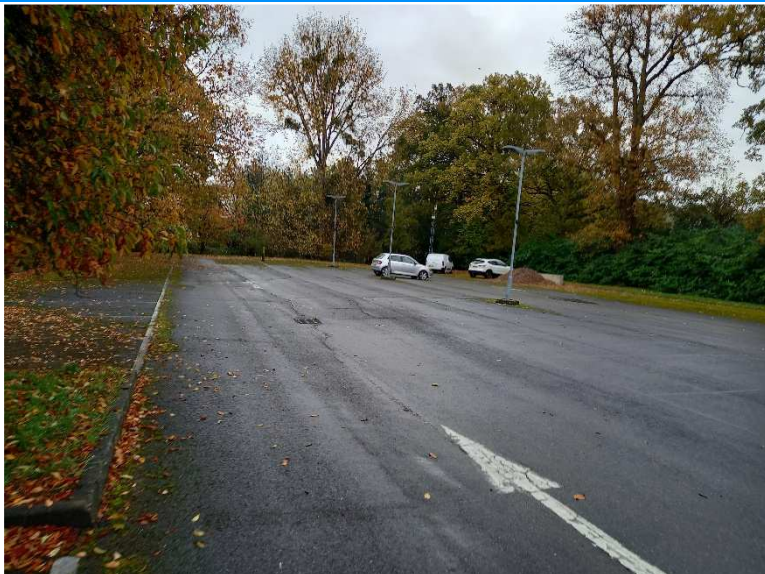
A car parking area to the northeast

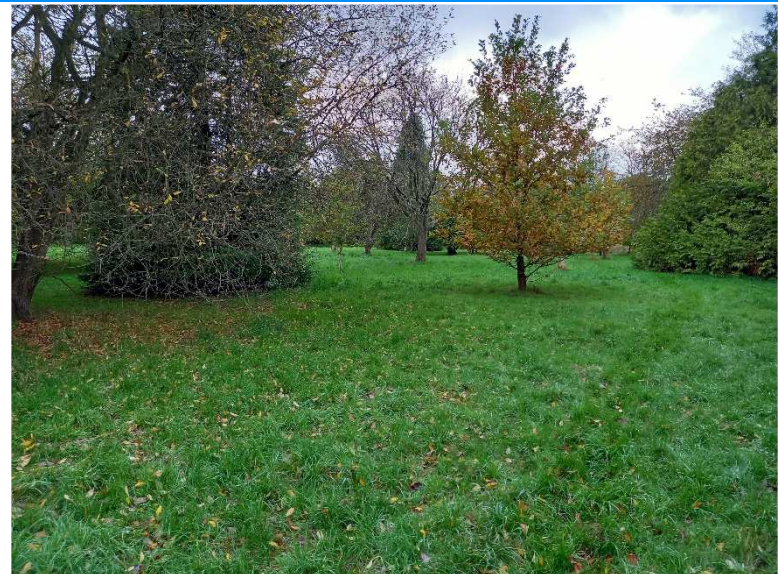
Wooded area to the north east.
