9548: 43a CHURCH ROAD, CAVERSHAM, BERKSHIRE

## **BRIEFING NOTE: BAT BUILDING ASSESSMENT**

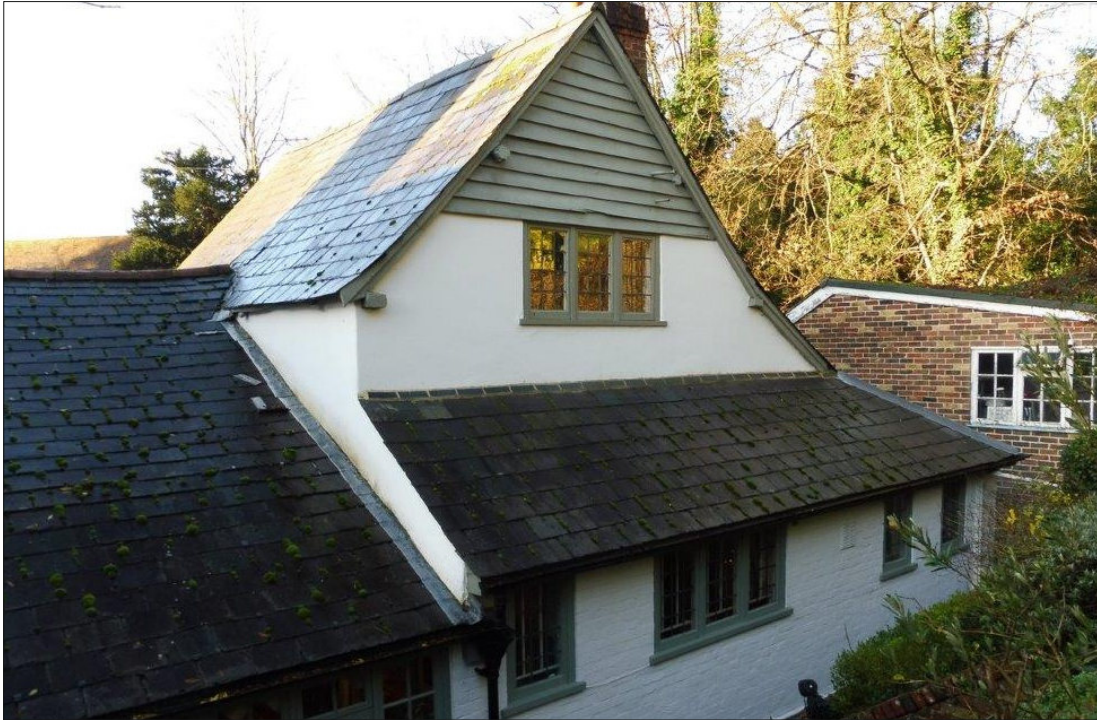
PHOTOGRAPH 1: Building B1

7. Building B1 is a Grade II listed brick-built residential property (see Photograph 1). There are three sections, each containing a separate loft void. B1a is a single storey section with a pitched slate tile roof with ridge tiles. The roof is in good condition with only a few gaps under the slate tiles and ridge tiles. The void of section B1a is small with a wooden frame and sarking boards (see Photograph 2). The height is approximately 1m at the apex. It is 2.5m wide and approximately 5m long. Half of the space is in use as miscellaneous storage. No access points were recorded.

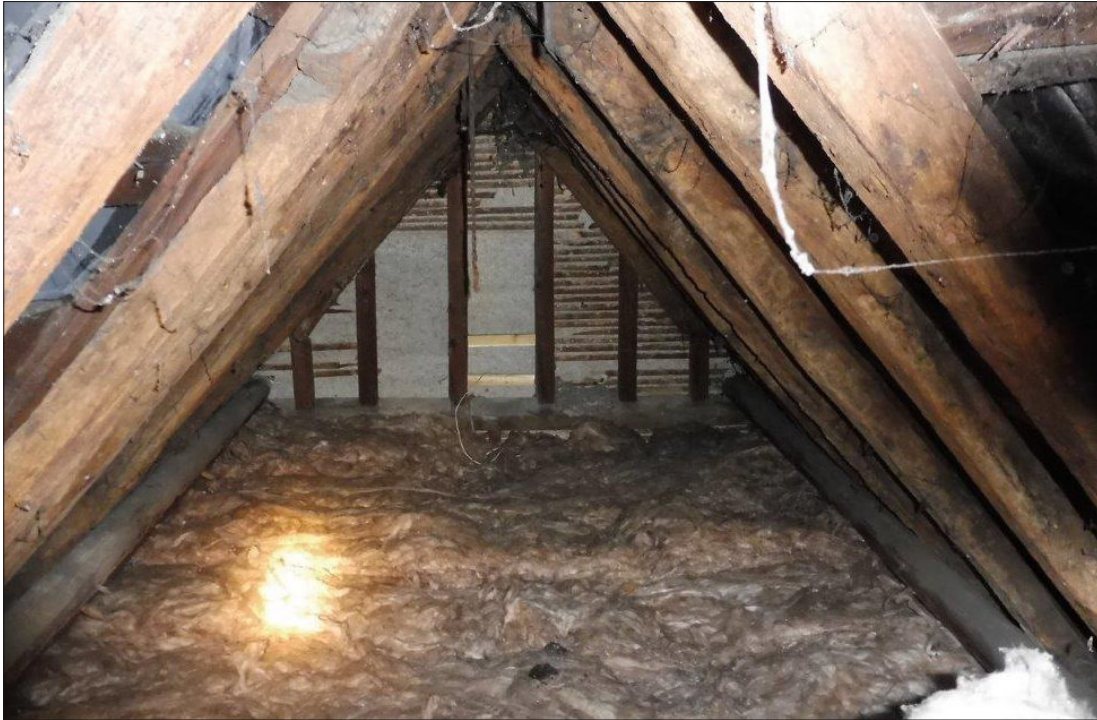
PHOTOGRAPH 3: Loft Void within Building B1b

8. B1b is the two-storey section with a pitched slate tile roof and ridge tiles. The majority of the roof is in good condition with a few gaps under the slate tiles and ridge tiles. Lead flashing is present at the join with B1a and surrounding the chimney. Good condition wood cladding is present in the gable at the rear of the building. The void of section B1b is larger with access to the southwestern end blocked by the water tank (see Photograph 3). The remainder of the void is used for miscellaneous storage. The void is approximately 2m at the apex, with a width of 2m and length of 8m. The loft has a wooden frame and no lining which provides access to the slate tiles. A number of potential access points are present.

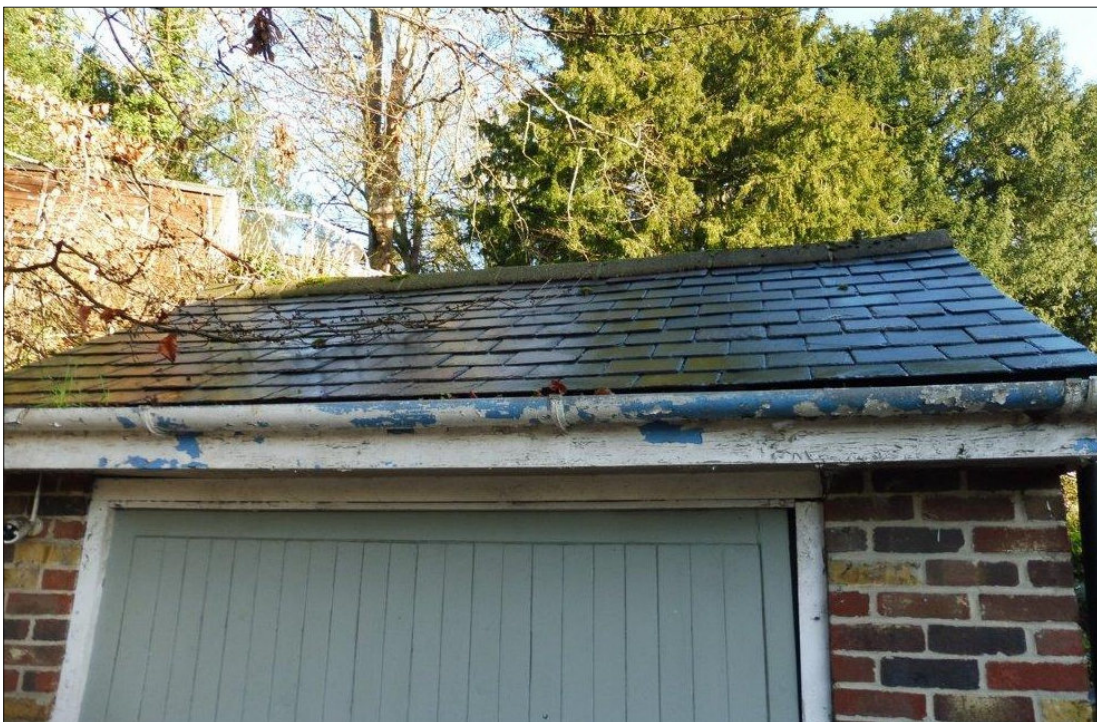
PHOTOGRAPH 4: Building B2

10. Building B2 is a single storey garage with a pitched roof (see Photograph 4). The front of the roof has slate tiles and ridge tiles whereas the rear comprises a shallower bitumen felt section of roof. A wooden soffit is present at the front of the garage. Significant Ivy *Hedera helix* is present at the rear of the building. A small number of gaps were recorded under the ridge tiles.

11. No signs of bats were recorded during the internal surveys. The majority of the roofs are in good condition with only a number of gaps under slate tiles and ridge tiles. It is considered that building B2 and sections B1a and B1c have low potential for roosting bats. Section B1b is considered to provide moderate potential due to the higher suitability of the loft void.

12. Given that only section B1c and building B2 are to be affected by the proposed works, only these areas are considered to require further surveys.
13. Due to their low potential for roosting bats, and in line with current bat survey guidelines<sup>1</sup> it is recommended that section B1c and building B2 are subject to a single bat emergence survey. These surveys can be undertaken from May to August / September inclusive. Two surveyors would be required to observe the buildings from fifteen minutes before sunset to two hours after sunset, and record any bat emergence from the building and also record any bat activity in the vicinity.
