Arboricultural Impact Assessment and Method Statement  
Rose Kiln Court, Reading

Reference: 80-535-R2-3  
Date: July 2021

Rose Kiln Court  
Reading

**Report Ref: 80-535-R2-3**  
**Date Issued: 07/07/2021**

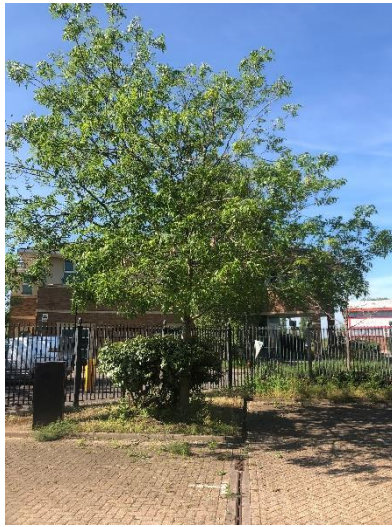
PLATE 1

| TREE NO. | SPECIES | HEIGHT (M) | DBH (MM) | CROWN SPREAD | | | | HEIGHT OF C.C | AGE | COMMENTS | ERC | CATEGORY | RPA (M <sup>2</sup> ) | RPA RADIUS (M) |
|---|---|---|---|---|---|---|---|---|---|---|---|---|---|---|
| T1 | Ash ( <i>Fraxinus excelsior</i> ) | 6 | 175 | 4 | 4 | 3 | 4 | 2 | Y | No signs of ill health or significant structural defects. | 20+ | B1 | 14 | 2.1 |

Tree T1

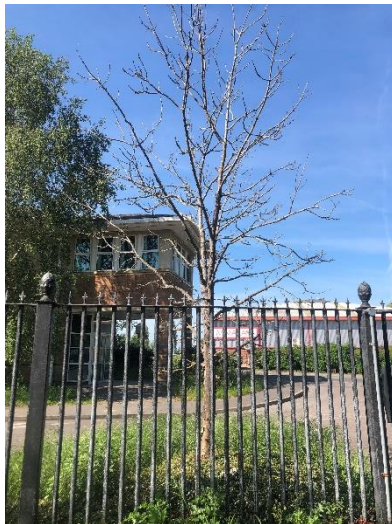
PLATE 2

Tree T2

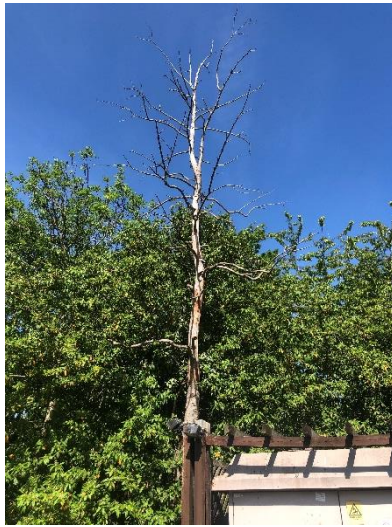
PLATE 3

Tree T8

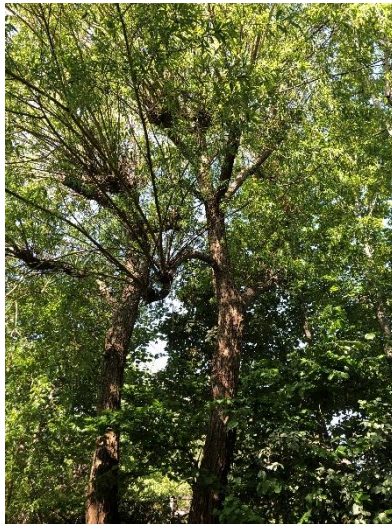
PLATE 4

| <b>T23</b> | Crack willow<br>( <i>Salix fragilis</i> ) | 12 | 430 | 2 | 5 | 5 | 4 | 3 | M | Previously crown reduced. | 10+ | C1 | 84 | 5.16 |
| <b>T24</b> | Crack willow<br>( <i>Salix fragilis</i> ) | 12 | 415 | 5 | 5 | 3 | 4 | 3 | M | Previously crown reduced. Branches touching building. | 10+ | C1 | 78 | 4.98 |

Trees T23, T24

The proposed conversion of the office building will require access facilitation pruning (minimum 2 m clearance of building.) on the south side of crown of trees T24, T31, T32, T33, T35, T37, T39, T40, T41, T42, T43, T44, T46, T47, T48, T49 to obtain sufficient clearances for construction activities and prevent future direct damage to the building.
