**28 Sheridan Avenue  
Caversham  
Reading  
Berkshire  
RG4 7QD**

# **Preliminary Bat Roost Assessment**

**Ref: R2859/a**

**August 2021**

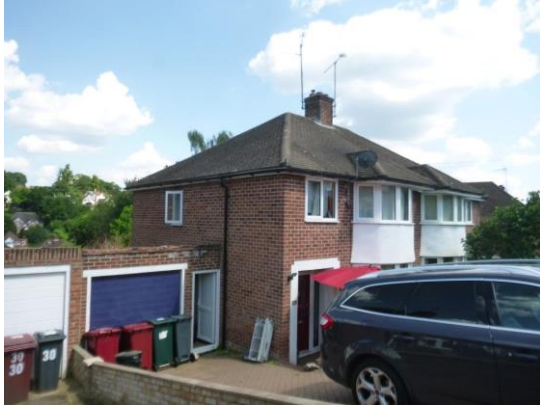
1. Front of property viewed from west.

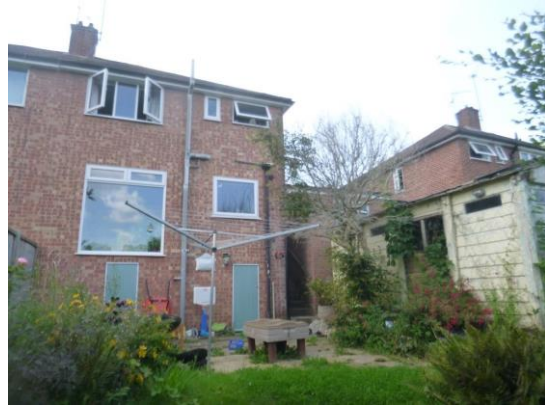
2. Rear of property viewed from east.

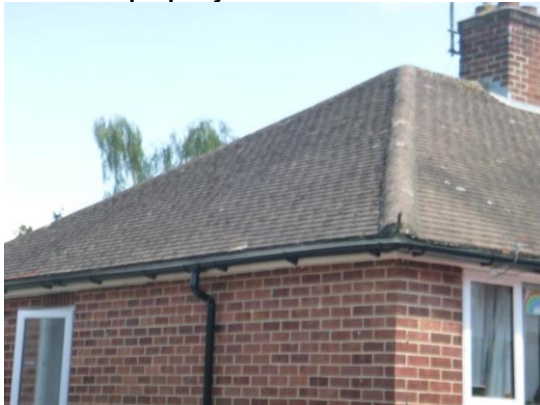
- 4.2.1** The semi-detached house was of modern brick cavity wall construction and had a hipped roof covered in tight overlapping tiles with fully mortared hip and ridge tiles offering no visible roosting opportunities for bats (**Photographs 1, 2 & 3; Target notes 1 & 2**). Similarly, the small hipped gable end over the front bay window had tight roof tiles and fully mortared hip tiles (**Photograph 4; Target note 3**). The lead flashing around the chimney was tightly fitted and all soffits were sealed to the brickwork (**Photographs 5 & 6; Target notes 4 & 5**).

3. Flat overlapping roof tiles and fully mortared hip and ridge tiles (front/northwest elevation).

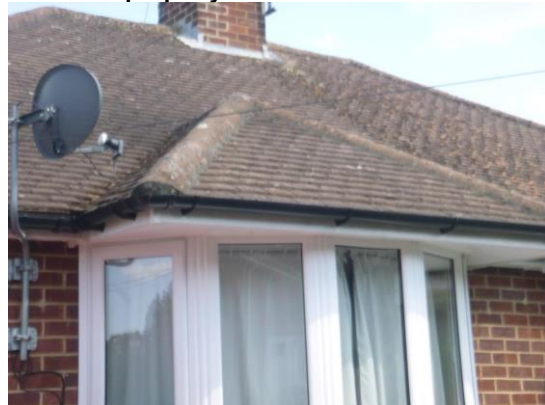
4. Tight hipped end above bay window (front elevation).

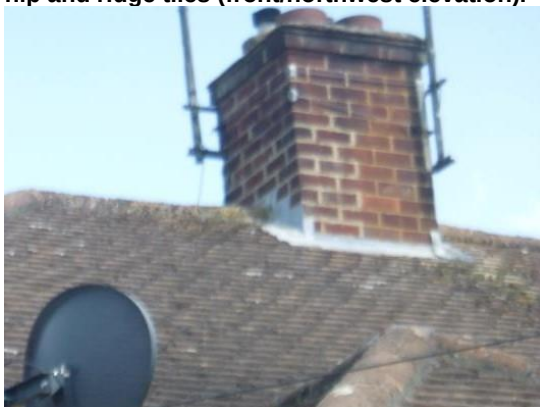
5. Tight lead flashing around chimney (front elevation).

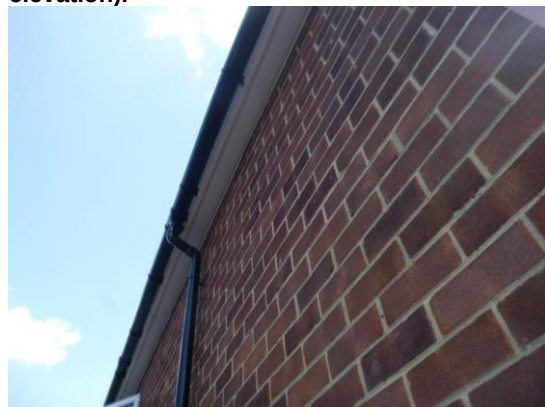
6. Sealed soffits (northwest elevation).

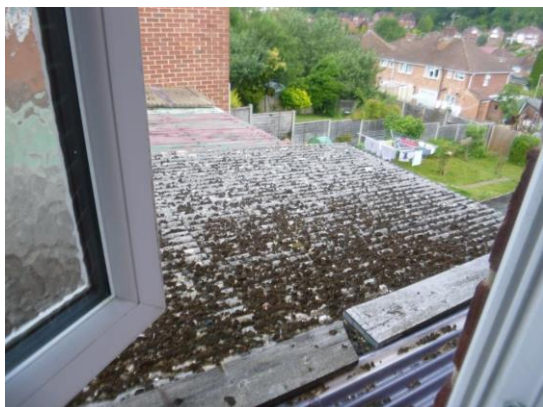
- 4.2.2** The single-storey side garage had single-skin brick walls with a corrugated asbestos cement roof offering very limited suitable opportunities for roosting bats (**Photograph 7; Target note 6**). An alley between the garage and house had a corrugated uPVC roof and concrete steps leading down to the rear garden (**Photograph 8; Target note 7**). The garage had a gap of limited extent behind its barge board that was closely inspected and cobwebbed (**Photograph 9; Target note 8**).

**7. Corrugated asbestos cement roof on garage viewed from house window.**

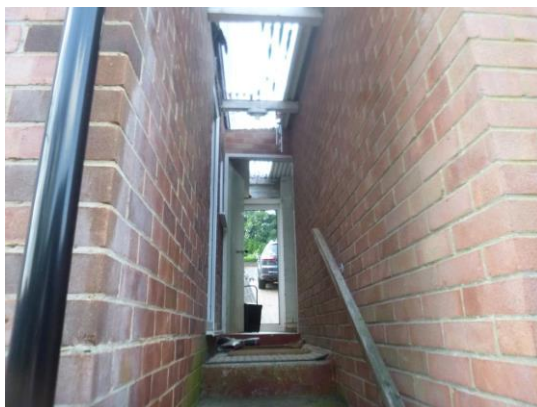
**8. Alley between garage and house (rear elevation).**

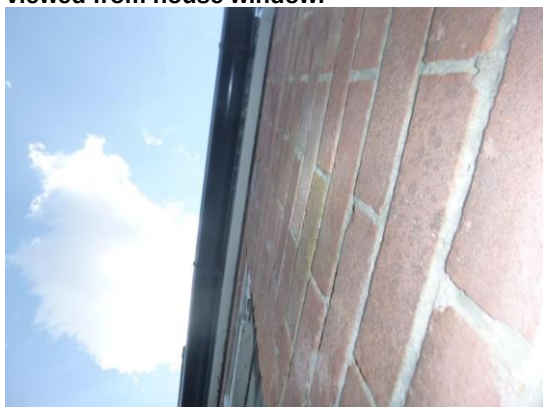
**9. Gap of limited extent behind barge board on garage (rear elevation).**

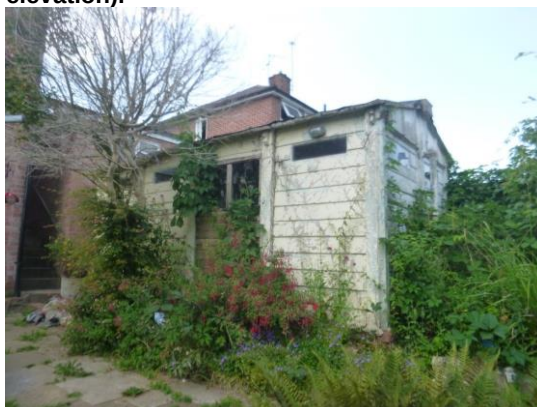
- 4.2.3** There was a neglected pre-fabricated concrete shed in the rear garden (**Photograph 10; Target note 9**). The shed had a pitched roof covered in old bitumen roofing felt, a missing door and a broken windowpane. Two undercroft doors to the rear of the house were tightly secured (**Photograph 11; Target note 10**).

**10. Neglected pre-fab shed (southeast elevation).**

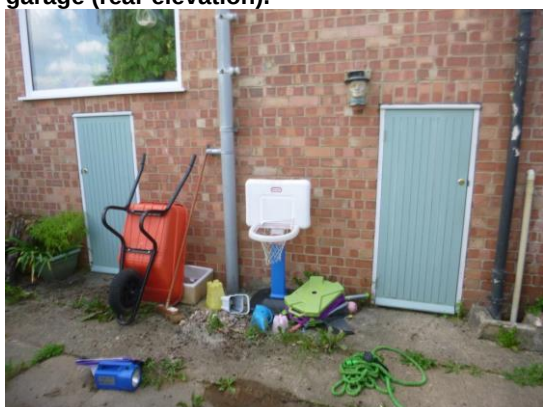
**11. Tightly secured undercroft doors.**

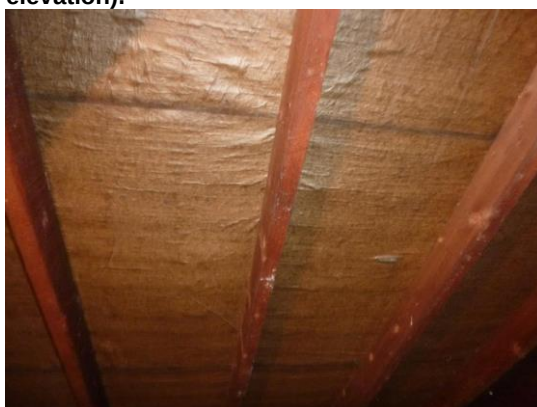
- 4.2.4** No evidence of roosting bats was observed at the time of the external inspection of the buildings.
- ### **4.3 Internal Survey**
- 4.3.1** The roof void covered the two-storey footprint of the house and was accessible via a first-floor loft hatch. The void had an approximate floor-to-ridge height of 2m and was of 'cut and pitch' hipped roof construction. The roof was lined with mostly intact paper-backed bitumen roofing felt and the ridge was heavily cobwebbed, which can

**12. Intact paper-backed bitumen roofing felt.**

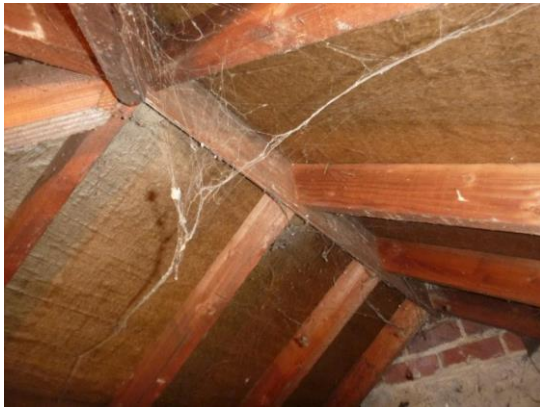
indicate a lack of void-dwelling bat activity (**Photographs 12 & 13; Target notes 11 & 12**). There was daylight visible through roofing felt corresponding to the front hipped end above the bay window (**Photograph 14; Target note 13**). The floor was insulated with foil-wrapped fibreglass and the eaves were mostly exposed (**Photograph 15; Target notes 14 & 15**). The party wall was part brick, part breezeblock and there were gaps either side of the chimney and behind the end rafter leading into the neighbouring roof void (**Photographs 16, 17 & 18; Target notes 16, 17 & 18**). There was poison bait and a couple of small wasp nests inside the roof void.

**13. Heavily cobwebbed ridge.**

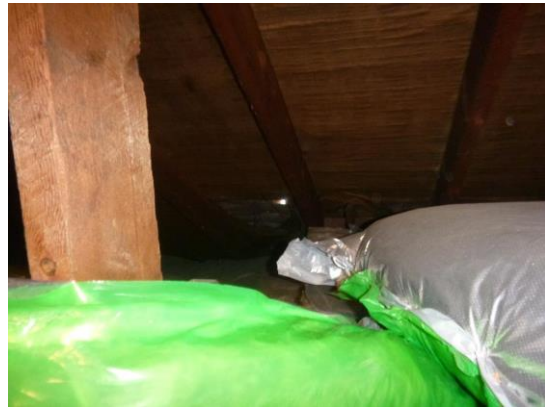
**14. Daylight visible at front bay window.**

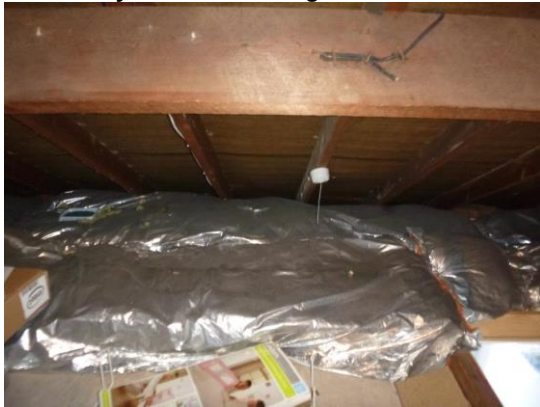
**15. Foil-wrapped fibreglass floor insulation and exposed eaves.**

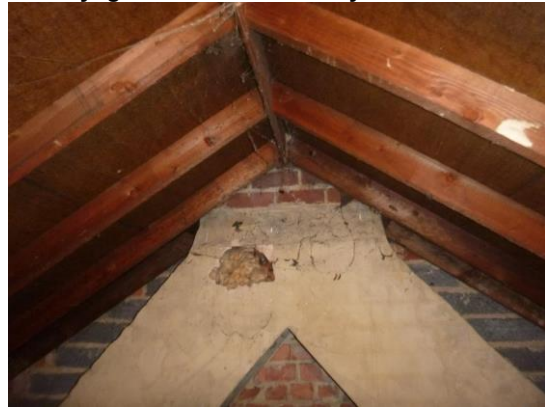
**16. Party wall and chimney.**

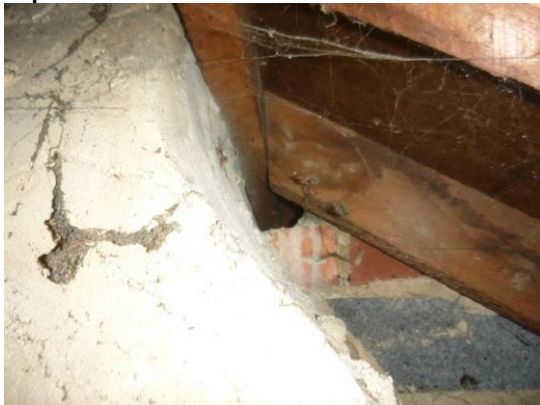
**17. Gap into neighbouring void next to chimney.**

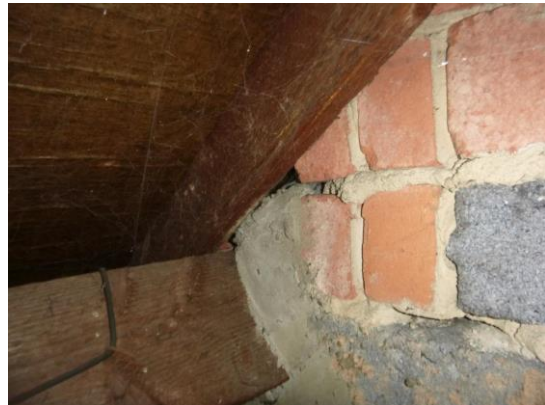
**18. Gap behind end rafter at party wall.**

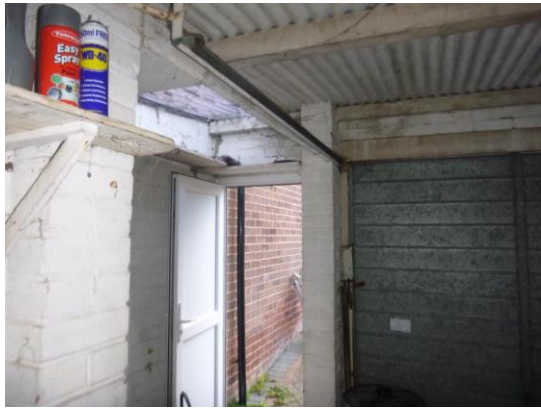
**4.3.2** The single-storey side garage and pre-fabricated shed were of simple construction and offered no potential bat roost opportunities (**Photographs 19 & 20**). The undercroft rooms were used for storage and no potential bat access was found (**Photograph 21**).

**19. Garage interior.**

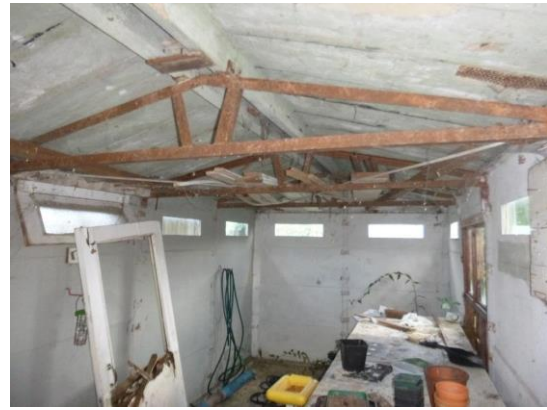
**20. Pre-fab shed interior.**

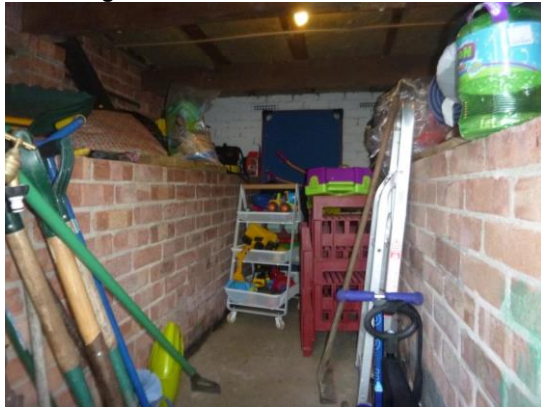
**21. Undercroft interior.**
