PRELIMINARY ECOLOGICAL  
APPRAISAL

37 SOUTH VIEW AVENUE, CAVERSHAM  
READING RG4 5AD

Date: 3<sup>rd</sup> December 2020

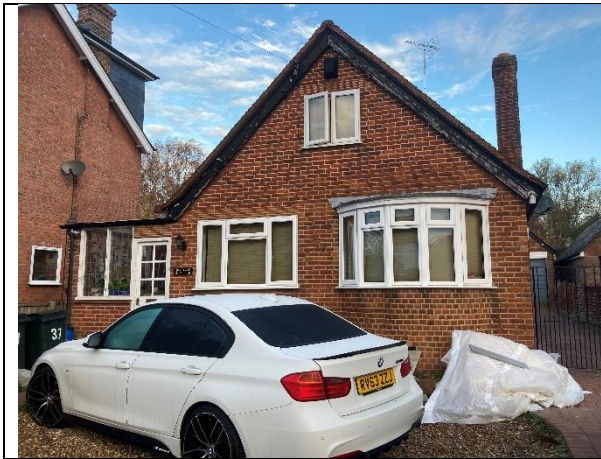
3.1.1 The house was a brick structure with a hipped roof with a dormer to the north elevation and a pitched gable to the north and south elevations. The roofs were clad with clay plain tiles with half-round clay ridges at the ridges and hips. The roof appeared to have been well-maintained and all roof sections were in good condition and well-sealed at all elevations. The timber soffits and fascia boards had also been well-maintained and were also well-sealed. Five vertical joints could be seen at the south gable that appeared to present PRFs, although on closer inspection were found to be shallow and had been bored into by mortar bees where poor-quality mortar had been used, but the gaps were not sufficient to allow bats to pass through. No evidence of bats or features for nesting birds could be found at the exterior.

Photo 1 South elevation

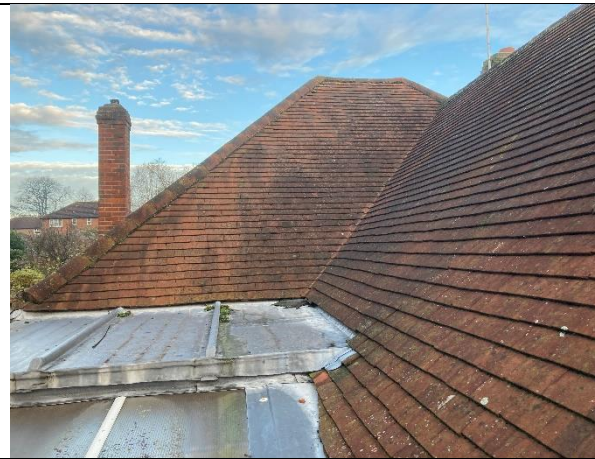
Photo 2 West pitch and south hip well-sealed

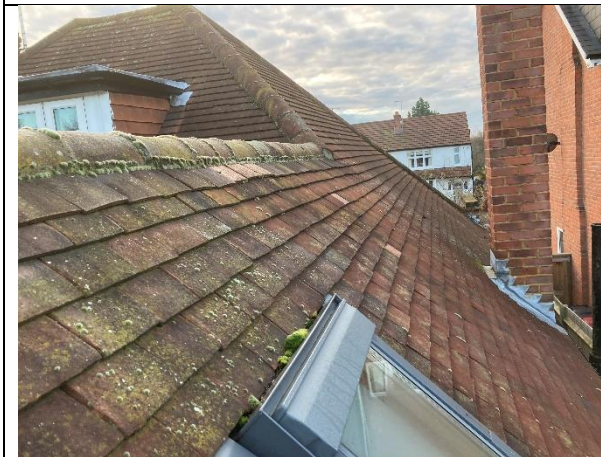
Photo 3 West hip and pitch well-sealed

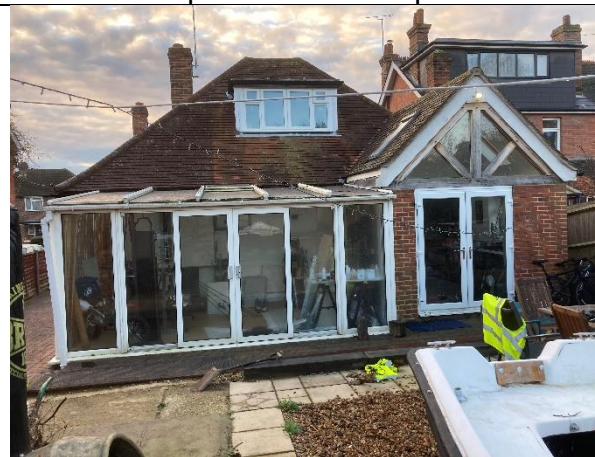
Photo 4 North elevation

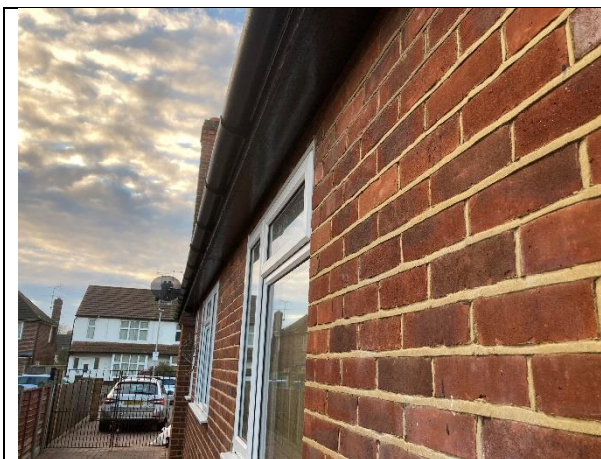
Photo 5 Sealed soffit

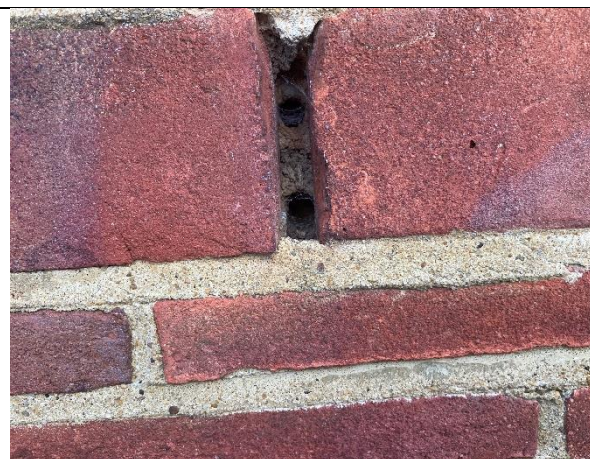
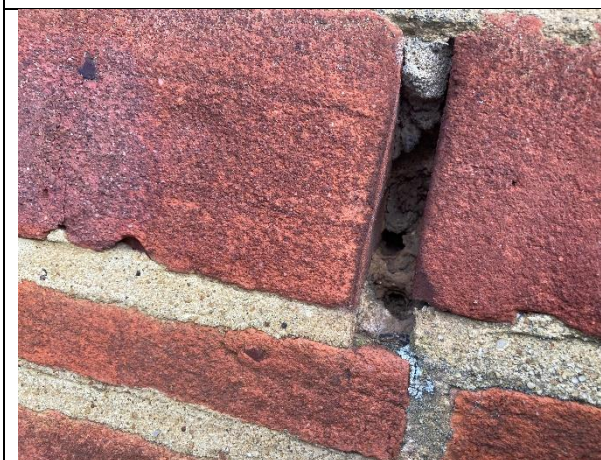
Photo 6 Example of PRF at north gable found to be insignificant

Photo 7 Example of PRF at north gable found to be insignificant

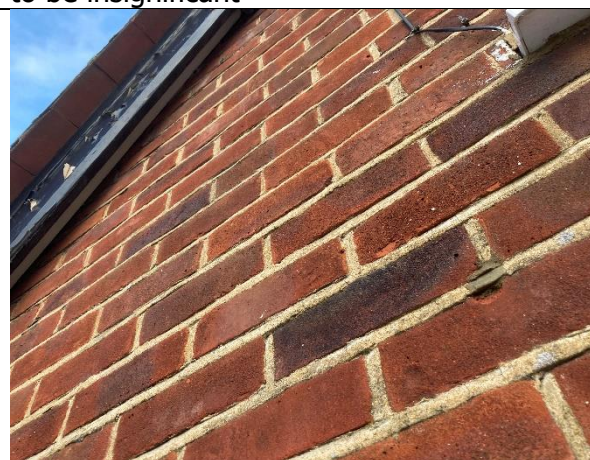
Photo 8 Sealed fascia board north gable

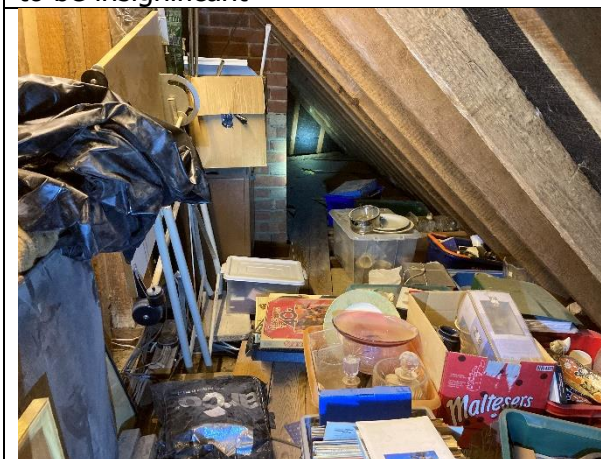
Photo 9 East loft void situation

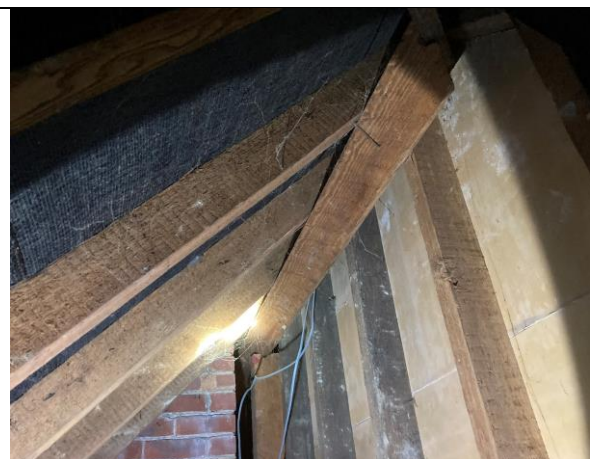
Photo 10 Old cobwebs at roof timbers

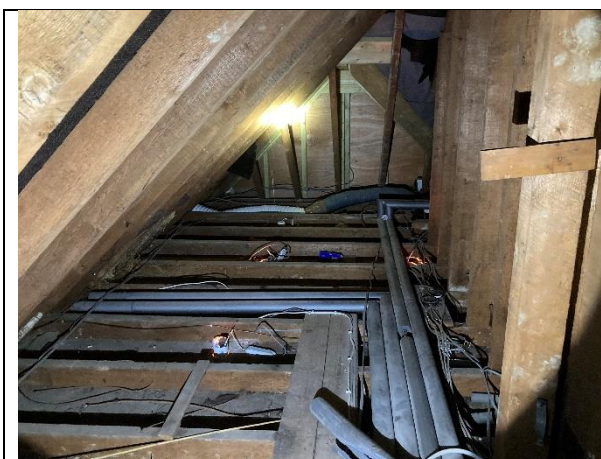
Photo 11 West loft void situation

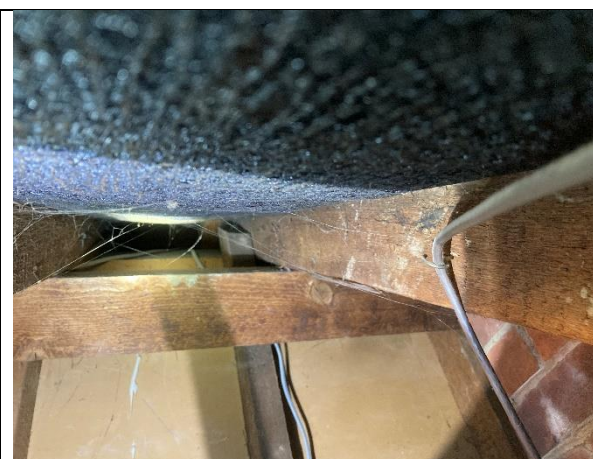
Photo 12 Example of cobwebbed void between vaulted roof and felt

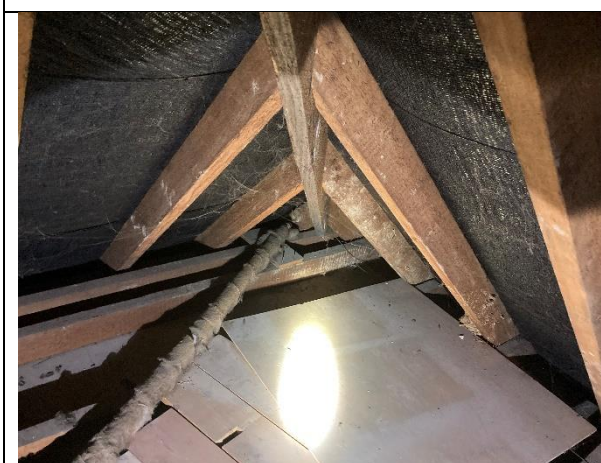
Photo 13 Cobwebbed hip timbers

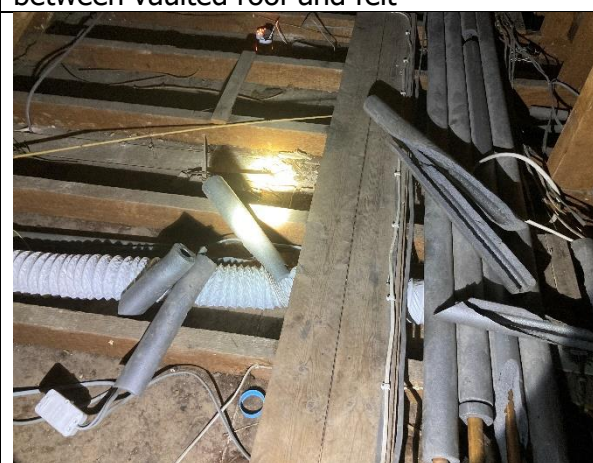
3.1.3 No evidence of bats was encountered within the loft void.

Photo 14 No evidence of bats at loft floor

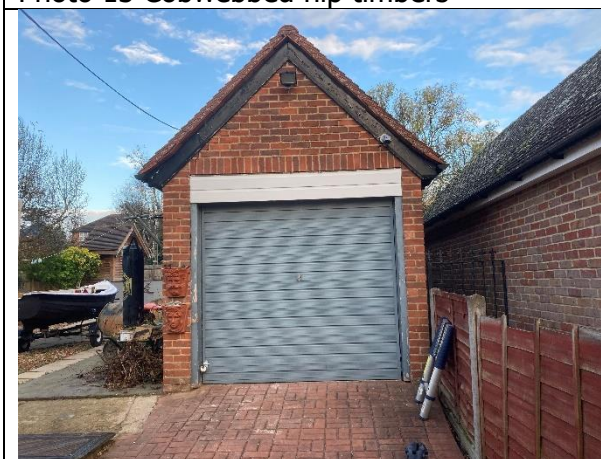
Photo 15 Garage south elevation

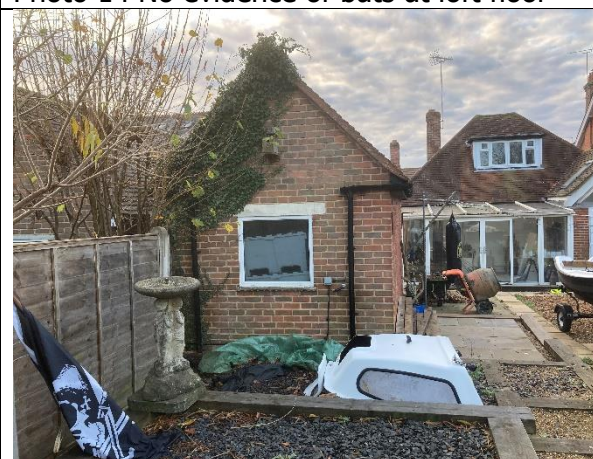
3.1.6 At the north gable of the garage ivy had part covered the brickwork, although the growth was perhaps not significantly thick to support breeding birds.

Photo 16 Garage north elevation

4.5 It is recommended that the ivy at the garage north gable is immediately removed to prevent the growth from becoming substantial enough to provide breeding habitat for birds. This should not be undertaken between March and September in case any birds are able to breed within the feature.

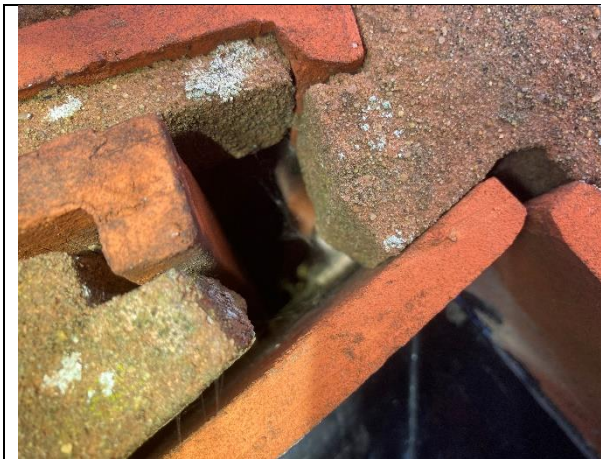
3.1.4 The single storey side garage was brick structure with a hipped roof clad with clay plain tiles. The roof was well-sealed with the exception of a single gap at the south gable that presented a PRF. A good view was attained of the interior of the PRF using the full length of the endoscope and the void between the bitumen felt could be well-explored, though the hole was covered with old cobweb at the entrance, which suggested that no bats had passed through the feature and no evidence of bats could be seen inside the void. The feature was too small to allow birds any access.

Photo 17 PRF Garage south gable verge

4.2 The garage is also well-sealed with the exception of the small gap at the south gable verge (photo 17) which showed no evidence of bats.

4.3.1 It is recommended that the PRF at the garage north gable verge immediately blocked off to prevent any bats from gaining access via this potential ingress point prior to demolition.

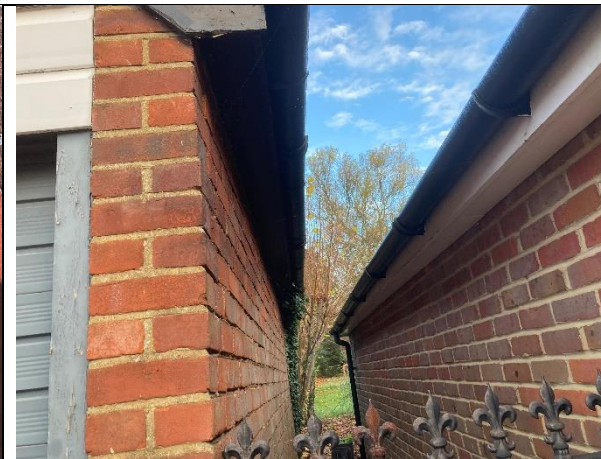
Photo 18 Sealed soffit at garage

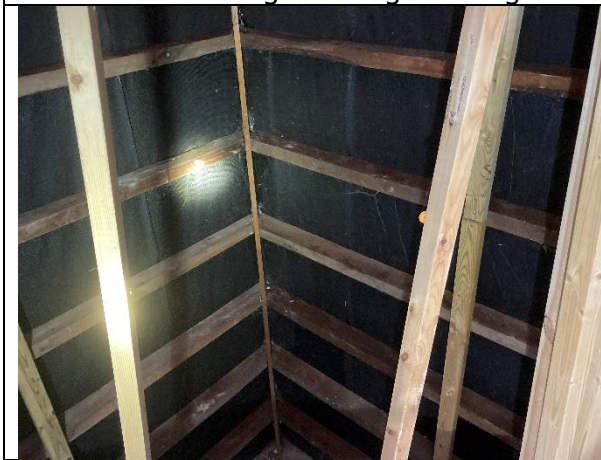
Photo 19 Cobwebbed garage ridge

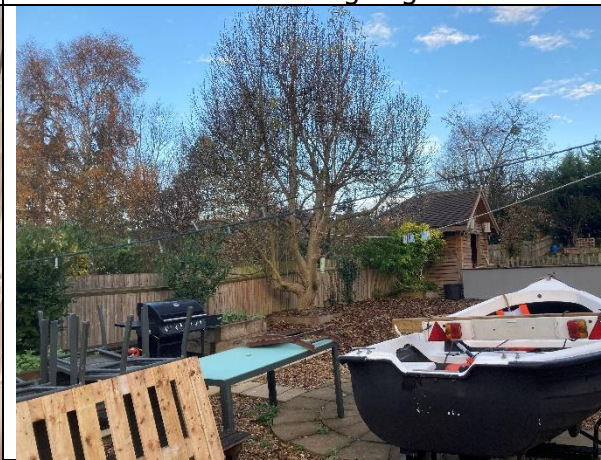
Photo 20 garden context
