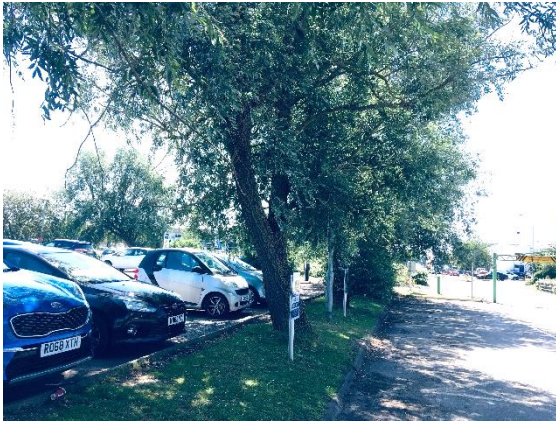
There were four willow trees (*Salix* sp.) along the eastern side of the existing car park. Four magpies (*Pica pica*) were observed feeding in the middle two trees, with wood pigeon (*Columba palumbus*), great tit (*Parus major*), blue tit (*Cyanistes caeruleus*) also observed in the trees (**Photograph 1**).

**1. Semi-mature willow trees to the west of the existing car park.**

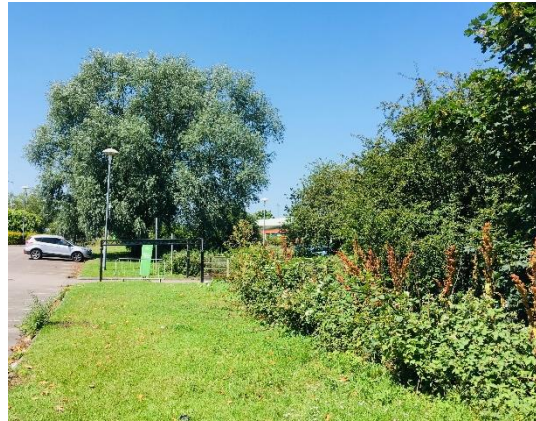
To the south of the site was a water filled ditch, bordered by an area of dense scrub, which included hawthorn (*Crataegus monogyna*), elder (*Sambucus nigra*) and bramble (*Rubus fruticosus* agg.). A mature willow tree was present to the south of the ditch, and two collared doves (*Streptopelia decaocto*) were seen and heard calling within the tree, with one seen flying to a nearby lamppost and scrub before flying back into the tree (**Photograph 2**).

**2. Mature willow tree, with dense scrub along the ditch (southern side of the site).**

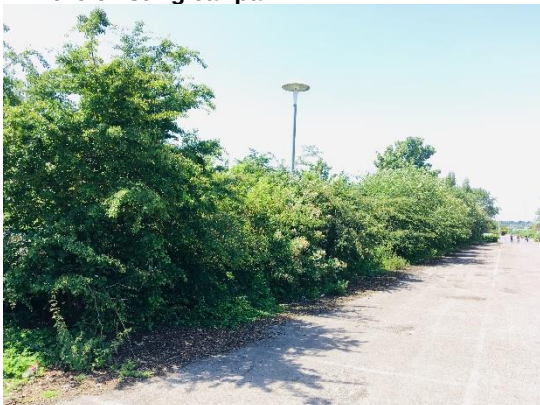
To the south-east of the site was a row of cherry trees (*Prunus* sp.), field maple and willow, with occasional dog rose (*Rosa canina*) and bramble present (**Photograph 3**). Two wood pigeons were observed flying into the vegetation and feeding on berries. A blackcap (*Sylvia atricapilla*), robin (*Erithacus rubecula*) and female blackbird (*Turdus merula*) were seen and heard calling from the vegetation.

**3. Dense scrub and scattered trees along the ditch (southern side of the site).**

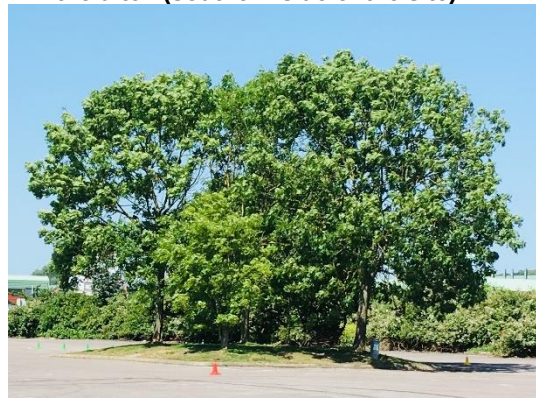
At the centre of the car park was a group of four ash trees, with no bird activity observed during the course of the survey (**Photograph 4**).

**4. Group of ash trees in the centre of the car park.**

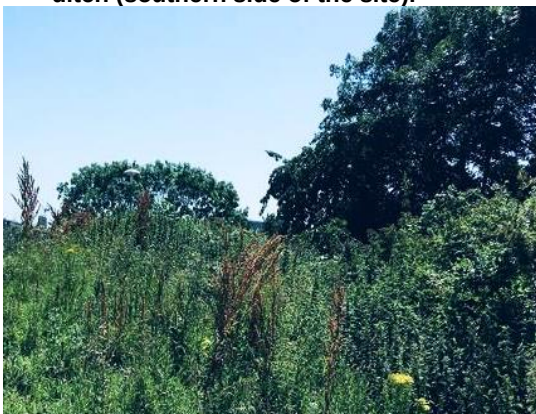
Between the car park and the playground was a strip of tall ruderal vegetation, consisting of bramble (*Rubus fruticosus* agg.), nettle (*Urtica dioica*) with occasional buddleia (*Buddleja davidii*) (**Photograph 5**). To the eastern end of the scrub were scattered trees including a cherry tree, firethorn (*Pyracantha* sp.), cotoneaster (*Cotoneaster* sp.) and several immature ash trees. A greenfinch (*Chloris chloris*), blackbird and robin were observed foraging within the trees and bushes, with a dunnoek (*Prunella modularis*) and goldfinch (*Carduelis carduelis*) observed within the bramble and nettle towards the eastern end.

**5. Group of semi-mature ash and willow trees adjacent to an area of tall ruderal.**

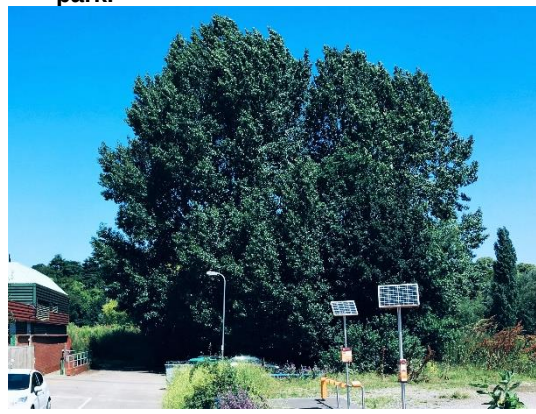
Just north of the site boundary, to the east of the existing leisure centre, was an area of mature trees including aspen (*Populus tremula*), field maple and ash (**Photograph 6**). Two magpies were seen flying towards and then away from the trees, with robin and blackbird also heard within the trees. Starlings (*Sturnus vulgaris*) and a goldfinch (*Carduelis carduelis*) were observed flying past the trees but did not enter them.

**6. Group of mature trees to the east of existing building (northern end of the site).**
