## PRELIMINARY ECOLOGICAL APPRAISAL

507 BASINGSTOKE ROAD  
READING RG2 0SH

Date: 9<sup>th</sup> April 2021

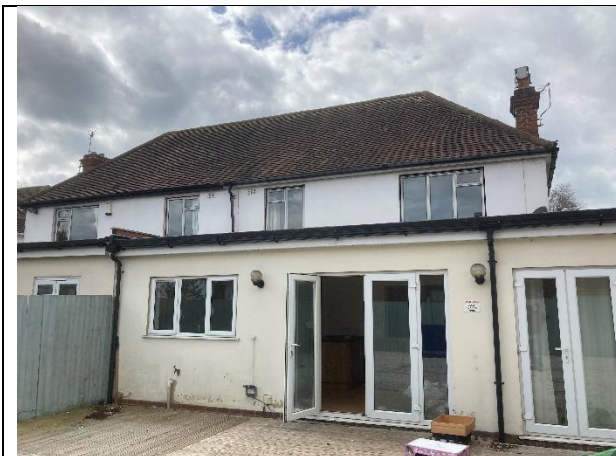
Photo 1 East elevation

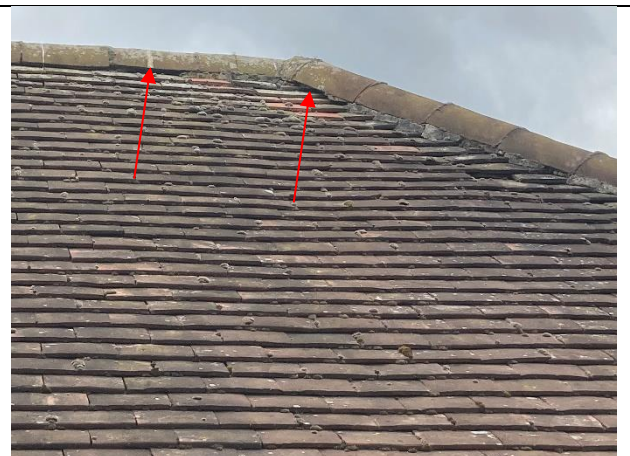
3.1.1 The house appeared to have been built during the 1920s or 1930s, and was a brick double storey structure and had a pitched roof, with a hip at the north elevation and gable to the west elevation and the roof was clad with clay plain tiles. Overall, the roof was in sound order, although several PRFs could be seen at the ridge of the south elevation and north east hip where mortar had fallen away. The PRF at the hip was easily access for a close inspection by carefully lifting the tile to inspect the area beneath, and no evidence of bats or breeding birds could be found.

Photo 2 PRFs east elevation

4.2 Although it is considered that no bat roosts are currently present, the PRFs found at the east elevation show potential for bats to ingress the roof at any time in the future. To safeguard any bats that may incidentally use these features (even for a single night) it is recommended that the destructive works to the roof are undertaken by hand with the expectation that bats could be found. If any bats are encountered during this time, then work will pause indefinitely, and tiles replaced around the roost area until Natural England has been contacted (0300 060 3900) for advice on how best to continue legally. It is likely that a license from Natural England would be required before any further work can continue.

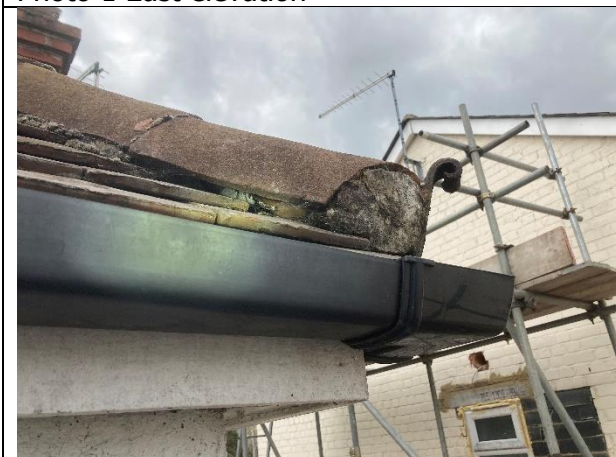
Photo 3 PRF north east hip

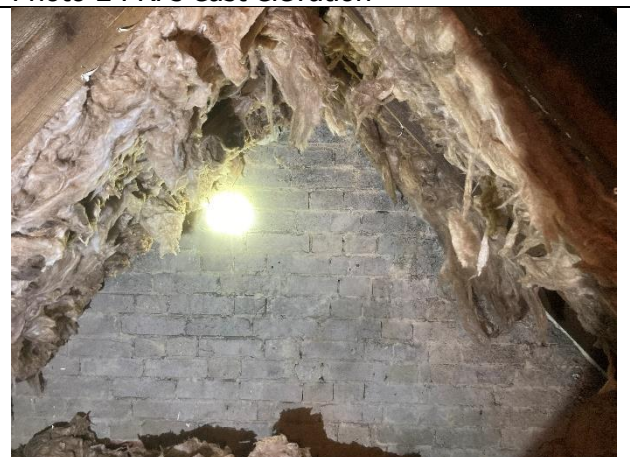
3.1.3 Inside the roof void it was apparent that the roof was supported by light weight timbers and the roof was not lined, and the tiles were torched. Wool insulation had been retro-fitted between the rafters by crudely stuffing the material in place, and this had disturbed the loft and roof and had had a cleaning effect in the void which had removed most cobwebs which would have been present prior to this. The insulation was easily removed to obtain a good view of the interior roof and areas behind the PRFs noted from the exterior. No evidence of bats or breeding birds could be found in association with the PRFs. The loft floor was covered in a thick layer of insulation, and the floor was boarded beneath. The insulation was lifted to check for evidence of bats, and none was found.

Photo 4 Insulated roof

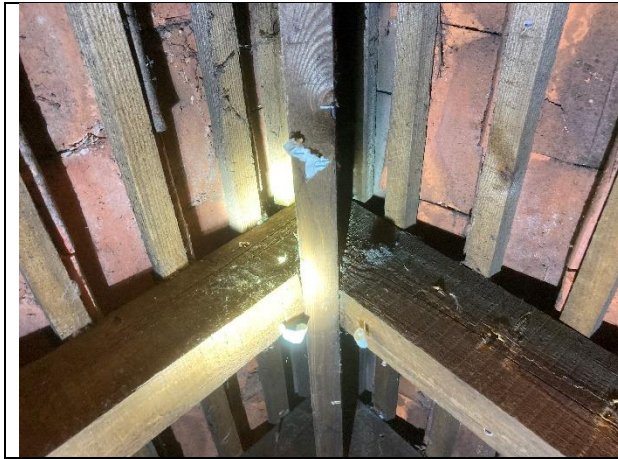
Photo 5 Clean ridge

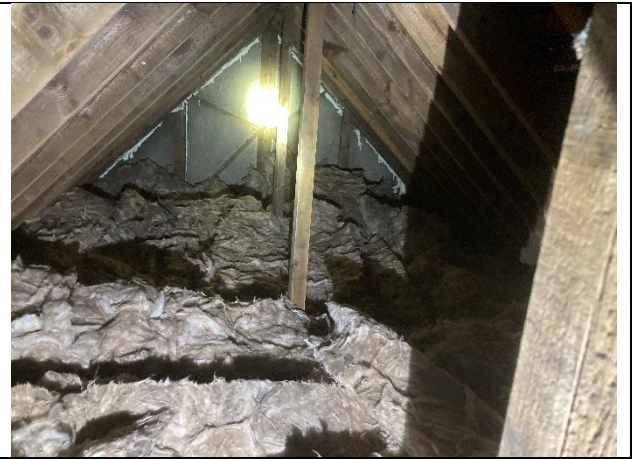
Photo 6 West interior gable

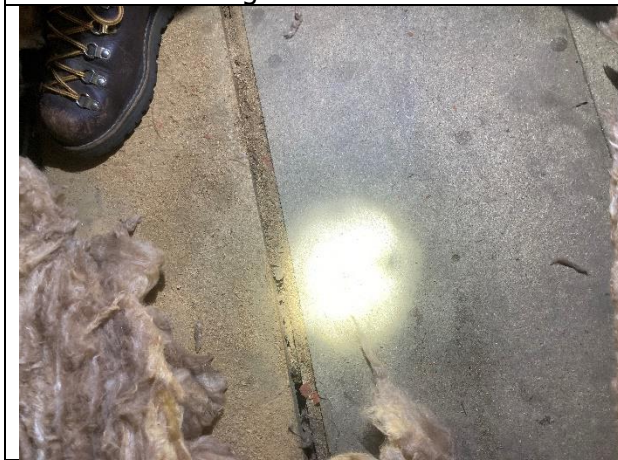
Photo 7 Clean floor beneath insulation

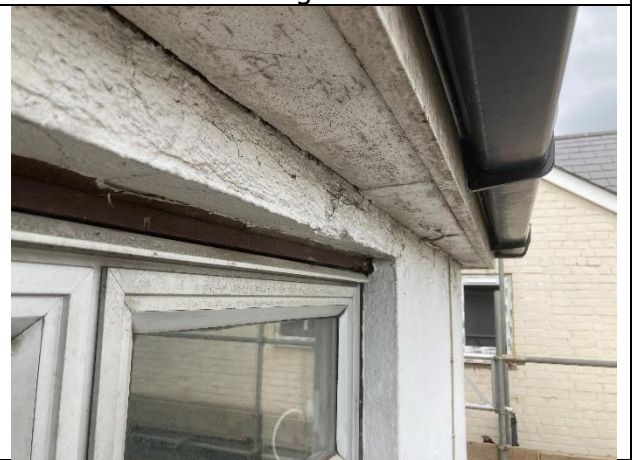
3.1.2 The soffit was a solid timber construction and this was well-sealed, no with evidence of bats or birds present in association with this feature.

Photo 8 Sealed soffit
