# Bat Survey Report – Preliminary Roost Assessment

107a St Michaels Road,  
Tilehurst, RG30 4RY

January 2021

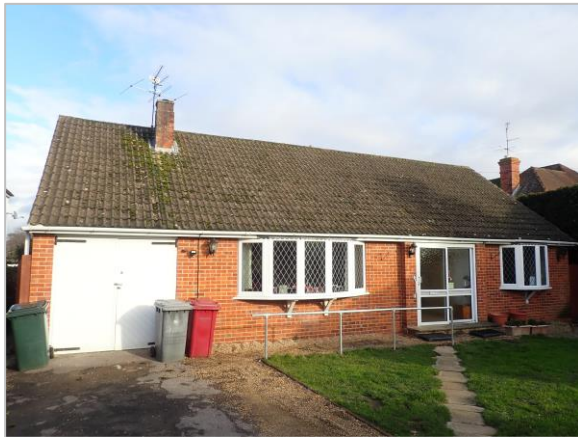
*Photo 1 Front of house*

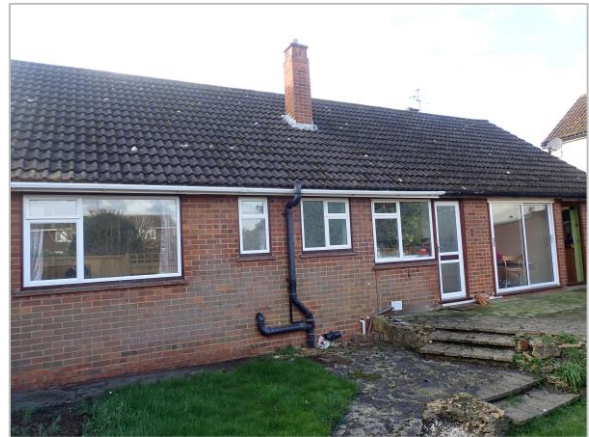
*Photo 2 Rear of house*

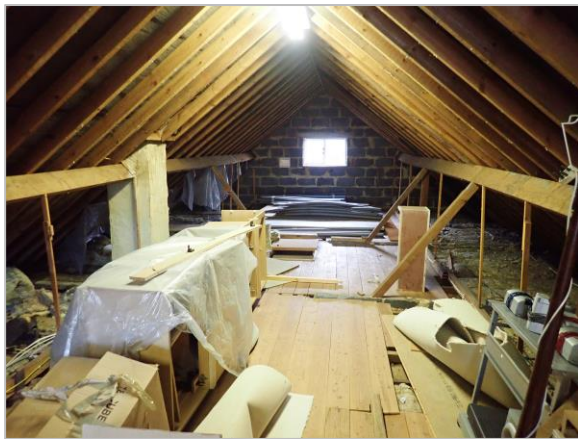
- 3.8. Internally, the loft was fully inspected. Photos 3 and 4 show the conditions in the loft. Examination of all surfaces, including internal timbers, floor, walls, and domestic services was carried out. Particular attention was paid to features such as the gable apexes at either end of the loft and joints in the timber work.

*Photo 3 General conditions in loft*

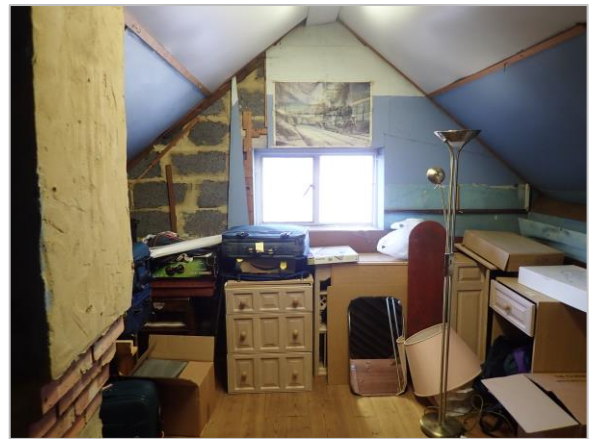
- 3.9. The loft is well boarded across the central section, and the north-western section is more formally boarded out on the floor and ceiling as can be seen in Photo 4. There are windows to each gable end and as a result the loft is very light internally.

*Photo 4 General conditions in loft*

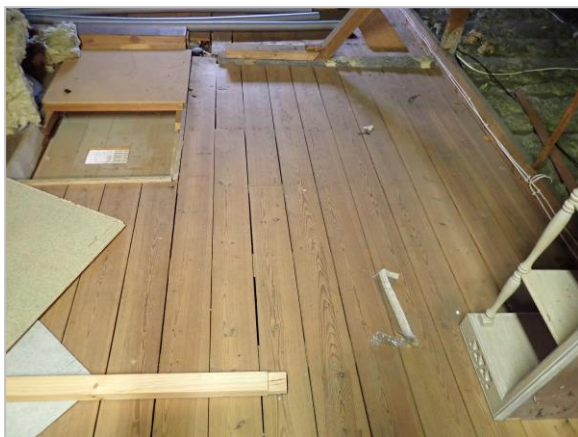
- 3.10. No droppings were seen on the floor (Photo 5) or under any of the insulation during spot checks beneath this (Photo 6), on any stored items, or the internal timbers or brickwork. No droppings were seen on the windowsills (Photo 7)

*Photo 5 Loft floor boarding*

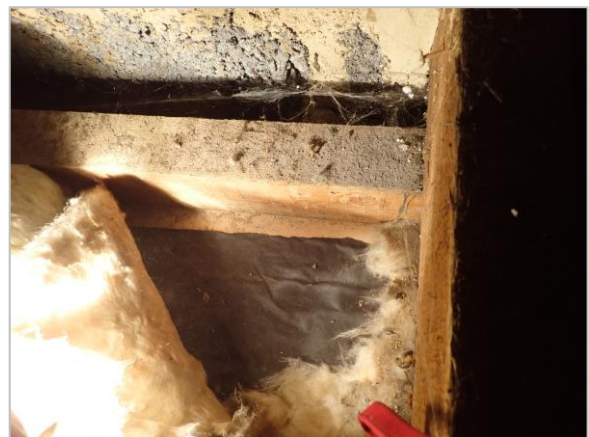
*Photo 6 Spot check under insulation*

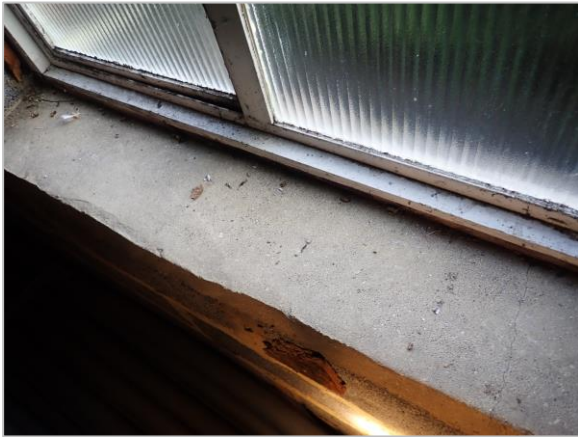
*Photo 7 Windowsill*

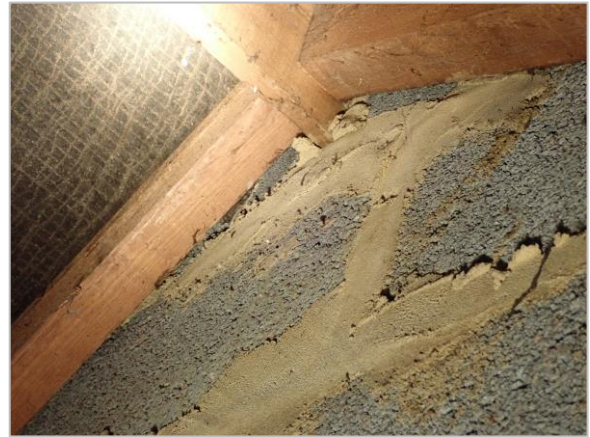
- 3.11. The gable apexes were carefully inspected, as were the floor areas beneath these (Photos 8 and 9). No evidence of bat roosting activity was seen. The render around the chimneys was inspected and no evidence seen of any roosting activity, nor was there any sign of bat activity on the floor areas adjacent to the chimneys (Photos 10 and 11).

*Photo 8 Internal gable apex*

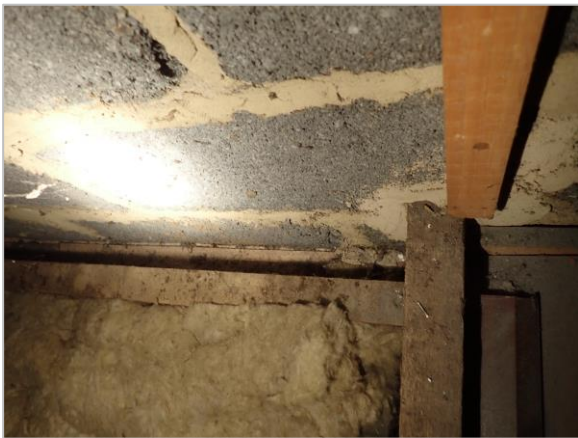
*Photo 9 Floor at base of internal gable end wall*

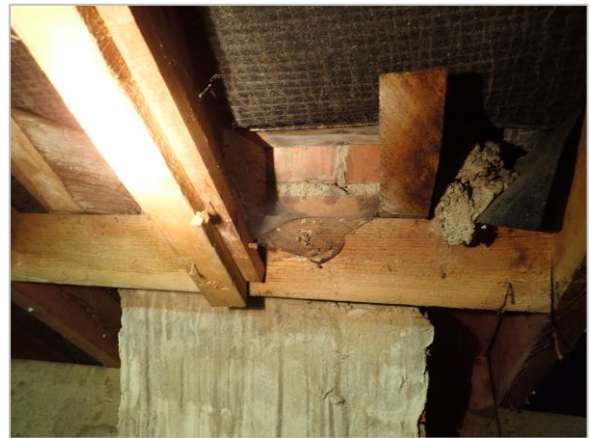
*Photo 10 Top of chimney inside loft*

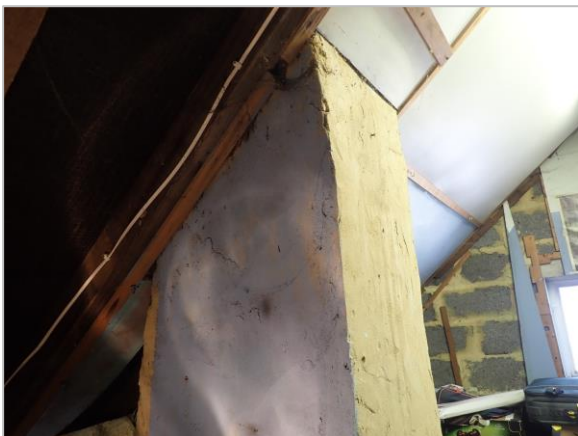
*Photo 11 Chimney inside loft*

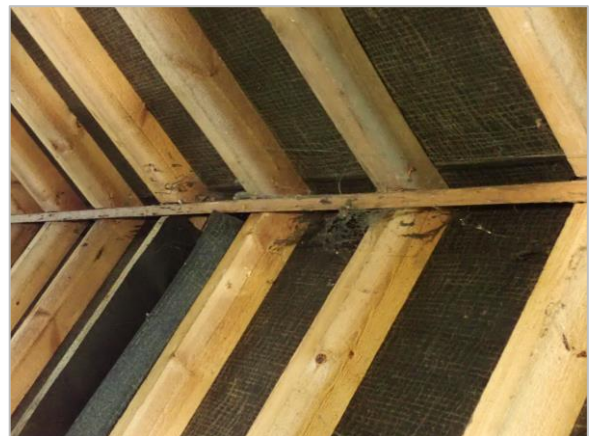
- 3.12. The roofing felt was in generally good condition (Photo 12).
- 3.13. No evidence of recent or historic bat roosting activity was seen in any areas.

*Photo 12 Ridge and roofing felt*

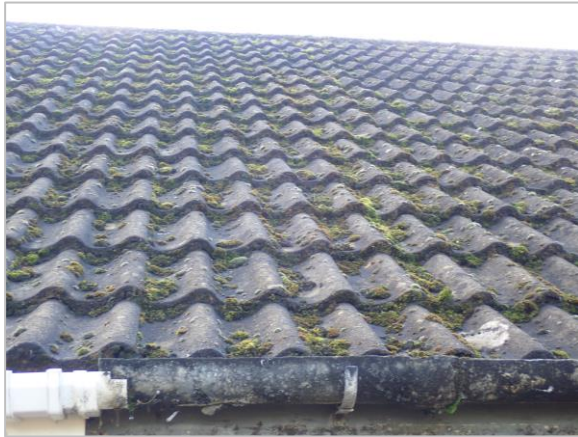
- 3.14. Externally, the roof tiles to the front and rear were in good condition with no damaged, missing, or slipped tiles (see Photos 13 and 14). There were no significant areas of lifting or gaps; however, some slight gapping was noted on the left-hand side of the front elevation near the ridge (Photo 15). Examination of this area concluded that these gaps are too small to allow bat access.
- 3.15. The chimney flashing was in good condition with no areas of lifted leadwork or other damage (Photos 16 and 17). The gable ends were both carefully inspected – the verge bedding mortar on both side elevations was found to be in excellent condition with no deterioration or gaps (Photos 18 and 19).

*Photo 13 Tiles to front of house*

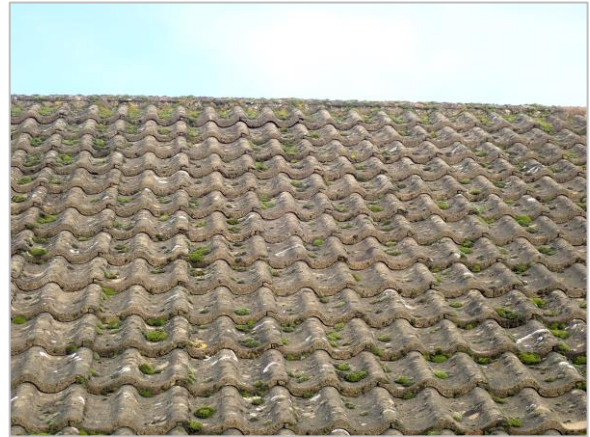
*Photo 14 Tiles to rear of house*

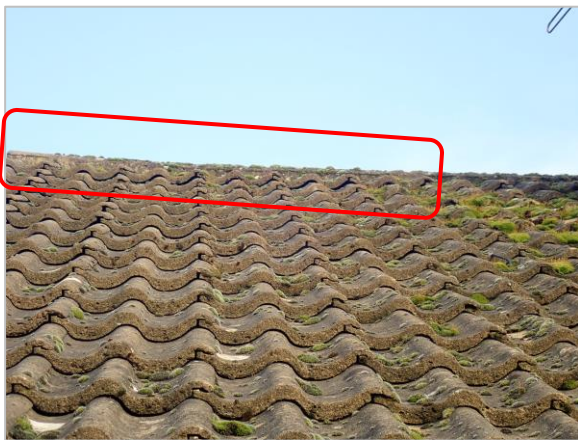
*Photo 15 Slight gaps to tiles to left hand side of front elevation*

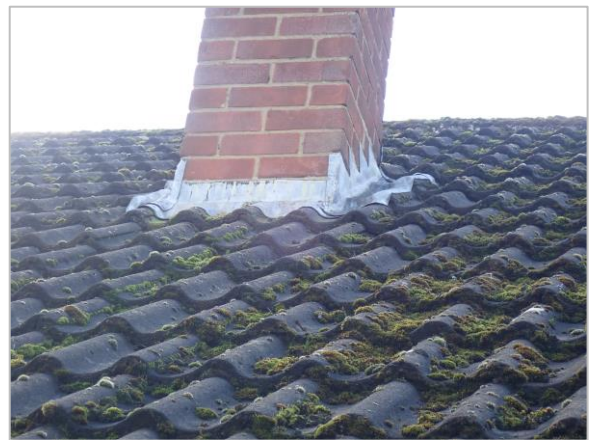
*Photo 16 Chimney flashing (rear)*

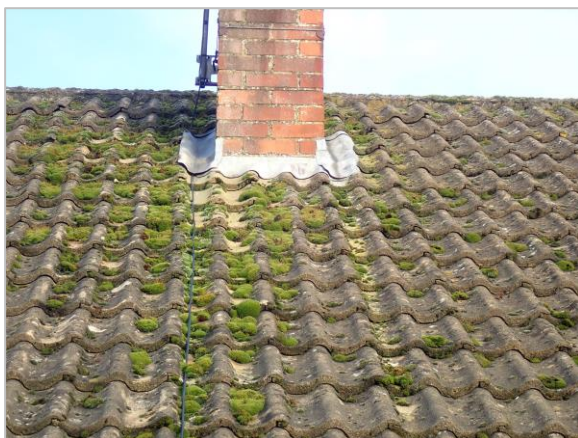
*Photo 17 Chimney flashing (front)*

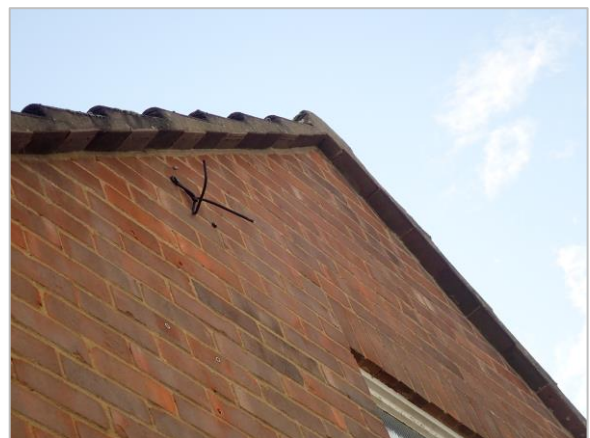
*Photo 18 Gable end and verge mortar*

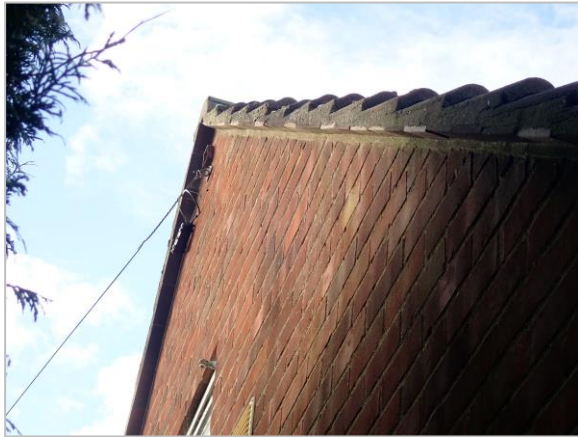
Photo 19 Gable end and verge mortar

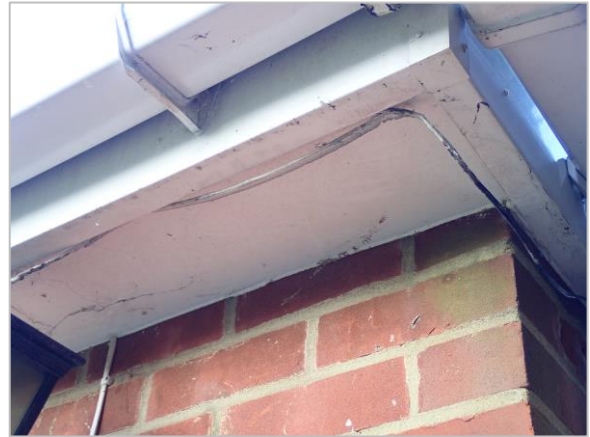
- 3.16. The soffits and fascias are in good condition, tight to the external walls with no gaps that would allow bat access, see Photos 20 and 21.
- 3.17. No direct evidence of bat activity was noted to any of the external features.

Photo 20 Soffit box

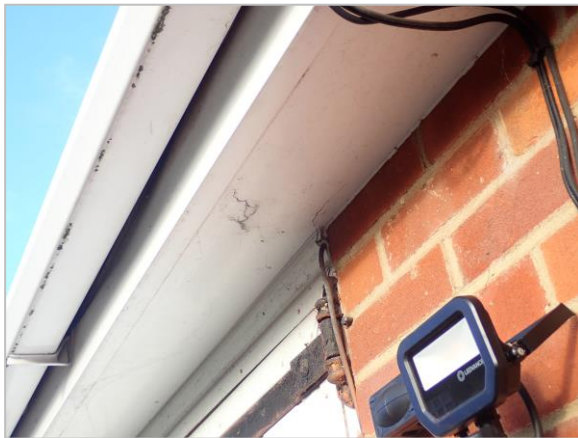
Photo 21 Soffit box
