**Arboricultural Impact Assessment**

**Yeomanry House**

**131 Castle Hill**

| <b>Document ref:</b> | ARB1578 |

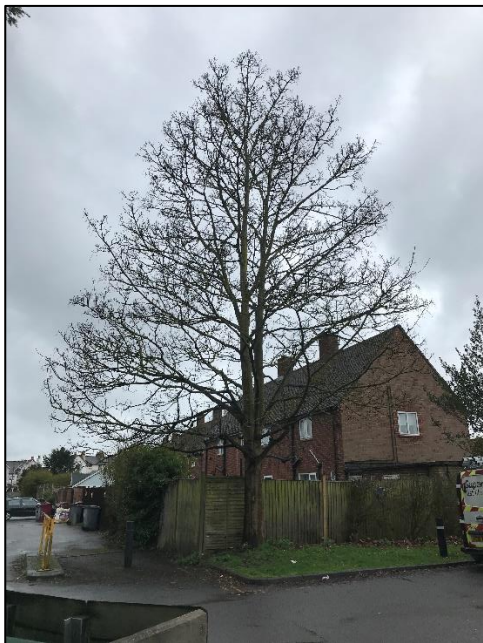
**Photograph 1:** T1

- 3.10 There were two individual category B1 trees subject to survey, T1 and T14.
- 3.11 T1 was a semi-mature sycamore *Acer pseudoplatanus*. T1 had two co-dominant leaders but the union appeared structurally sound. The tree was growing within 0.5m of the adjacent properties garden fence.
- 3.12 T14 was a mature sycamore. T14 had two co-dominant leaders but the union appeared structurally sound. T14 was growing well and in overall good health.

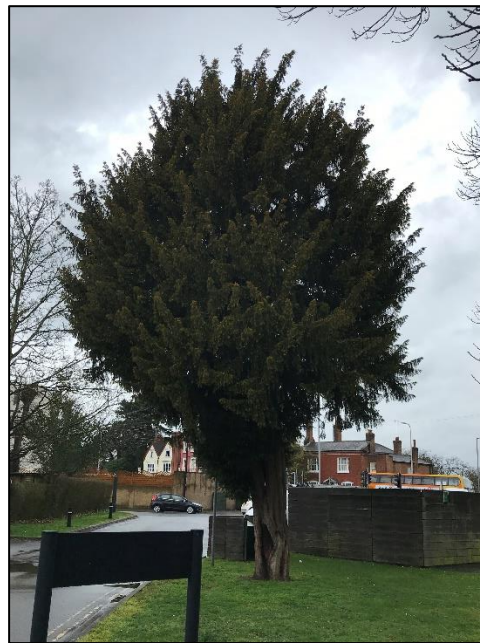
- 3.14 T2 was an early-mature European yew *Taxus baccata*. T2 had two co-dominant stems from the base, the union was weak and showing signs of failure. There was also a large bark wound with prevalent decay on the easterly side of the stem as well as multiple areas of bark damage. The tree had developed a lower secondary crown implying it was under stress. It is recommended that T2 is removed.

| Tree number | Tree species | Age class | Estimated remaining contribution (years) | Tree Height (m) | Number of stems | Stem diameter (mm) | Crown spread (m) | | | | Height to underside of canopy (m) | Physiological condition | Structural condition | Quality Assessment Category | Comments and observations | Recommended works | Root Protection Area Radius (m) for |
|---|---|---|---|---|---|---|---|---|---|---|---|---|---|---|---|---|---|
| T2 | European yew | EM | 10 -20 | 13 | 2 | 440<br>545 | 3 | 3 | 3 | 3 | 2 | F | P | C1 | Weak union from base. Bulges present with minor lean to the south implying decline and failure. Secondary crown growth present - tree under stress. | Remove | 8.4 |

**Photograph 2:** T2, bulge in stem visible lower right of stem.

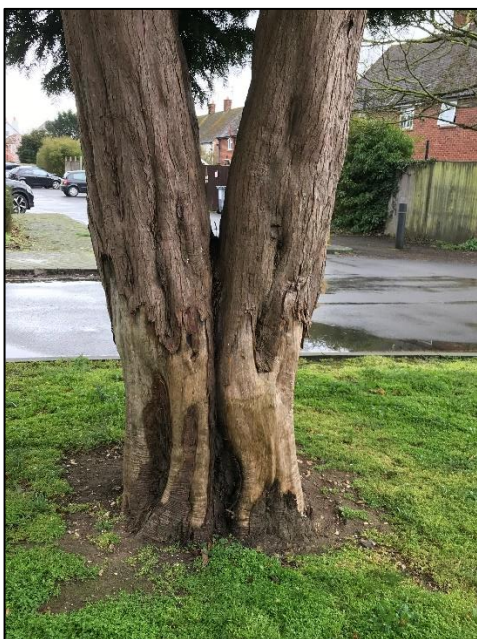
**Photograph 3:** T2's weak union, co-dominant stems and bark damage.

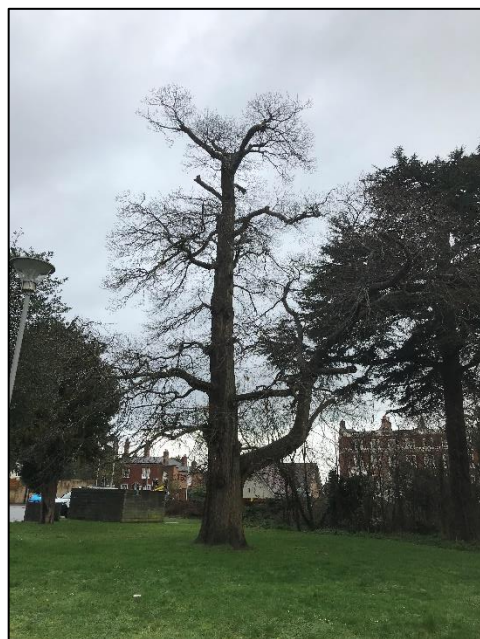
**Photograph 4:** T3

- 3.3 There were seven individual category A1 trees subject to survey, T3, T6, T7, T8, T13, T17 and T18.
- 3.4 T3 was a mature sweet chestnut *Castanea sativa*. T3's crown had been kept compact, but it was a good example of the species growing in relatively open ground with good levels of new growth.

- 4.9 Whilst the incursion into the RPA of T3 is minimal, precautionary excavation methods will need to be considered when installing the new hardstanding in the RPA of T3.

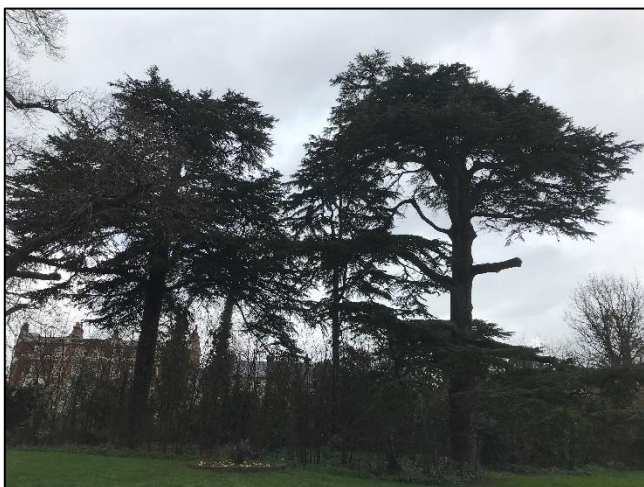
- 3.5 T6 was a mature cedar of Lebanon *Cedrus libani*, it was an excellent example of the species with good form and healthy growth habits.
- 3.6 T7 was an early-mature cedar of Lebanon. T7 was slightly suppressed and growth had been restricted due to its proximity to T6 and T8. The tree was slightly drawn up but was displaying healthy growth levels and made a positive contribution to the amenity value of the site overall.

- 3.7 T8 was a mature cedar of Lebanon. T8 had been pruned relatively severely on the eastern side of its crown with large lateral branches having been removed. There was limited occlusion at the site of the pruning wounds but there was no evidence of decay and the tree appeared in overall excellent health.

**Photograph 7:** T6 left, T7 centre, T8 right.

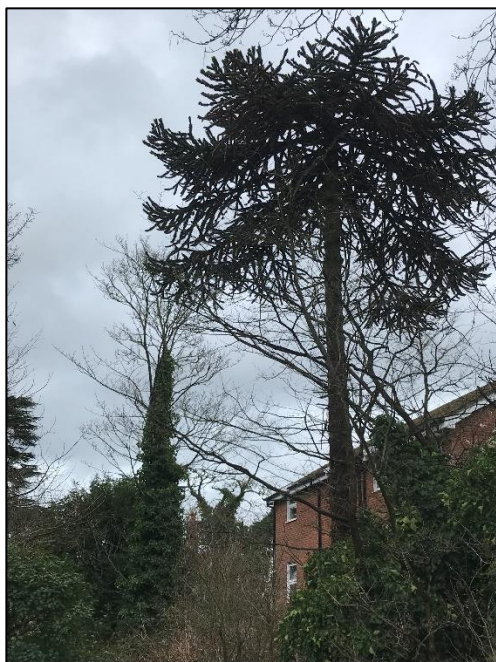
- 3.8 T13 was a semi-mature monkey puzzle *Araucaria araucana*. T13 was a good example of the species with a healthy and even crown. T13 has never been pruned which is ideal for this species.

- 3.19 T12 was a young sycamore, the tree was self-sett, drawn up and very close to the adjacent building to the east. This tree does not have a useful life expectancy in its current position and is therefore recommended for removal.

**Photograph 9:** T12 left, T13 right.

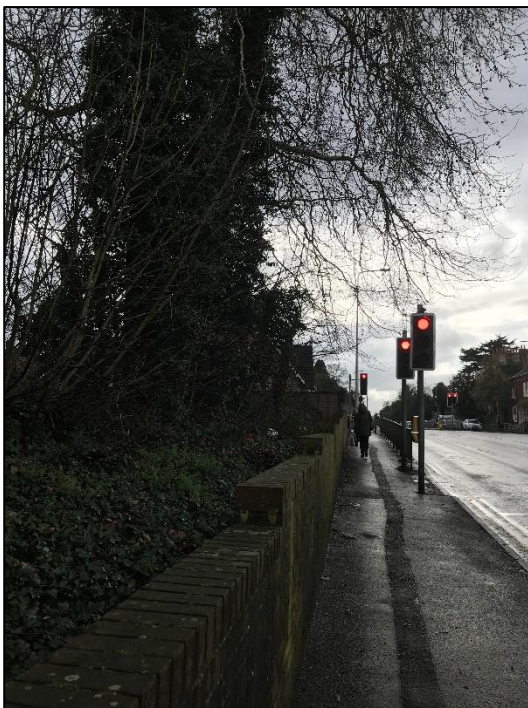
- 3.9 T17 and T18 were early-mature London planes *Platanus × hispanica*. T17 and T18 were rooted close to the adjacent footpath and highway on Castle Hill. Small areas of the tree's crowns were overhang the traffic lights on the junction. It is recommended that T17 and T18 have their crowns lifted away from the traffic lights on Castle Hill.

**Photograph 15: T17 and T18 overhanging traffic lights on junction of Castle Hill and Coley Avenue.**

- 6.9 It is recommended that the ivy is severed at the base of T16 to allow for future monitoring and inspection.
- 6.10 T17 and T18 are overhanging the traffic lights on the adjacent Castle Hill. It is recommended that the crowns of these trees are lifted so the traffic lights are fully visible.

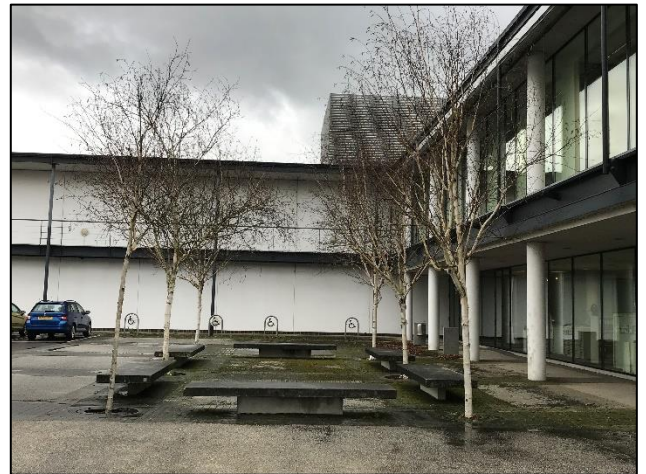
**Photograph 16: G1**

- 3.22 G1 was a young group of West Himalayan birch *Betula utilis* var. *jacquemontii*. There were six trees in G1 rooted in hard standing with grates. The trees form part of a seating area between Yeomanry House and Reading Records Office. The trees in G1 were developing well but would benefit from formative pruning to encourage healthy future growth habits.
