# READING INTERNATIONAL BUSINESS PARK

1219-G509 EASTERN WOODLAND AREA PHOTOS  
OCTOBER 2020

The following images have been taken on the morning of 7th October 2020. The images show a range of views from within the 'Woodland' area to the south east of the site where we propose to create the Unit 1 car park.

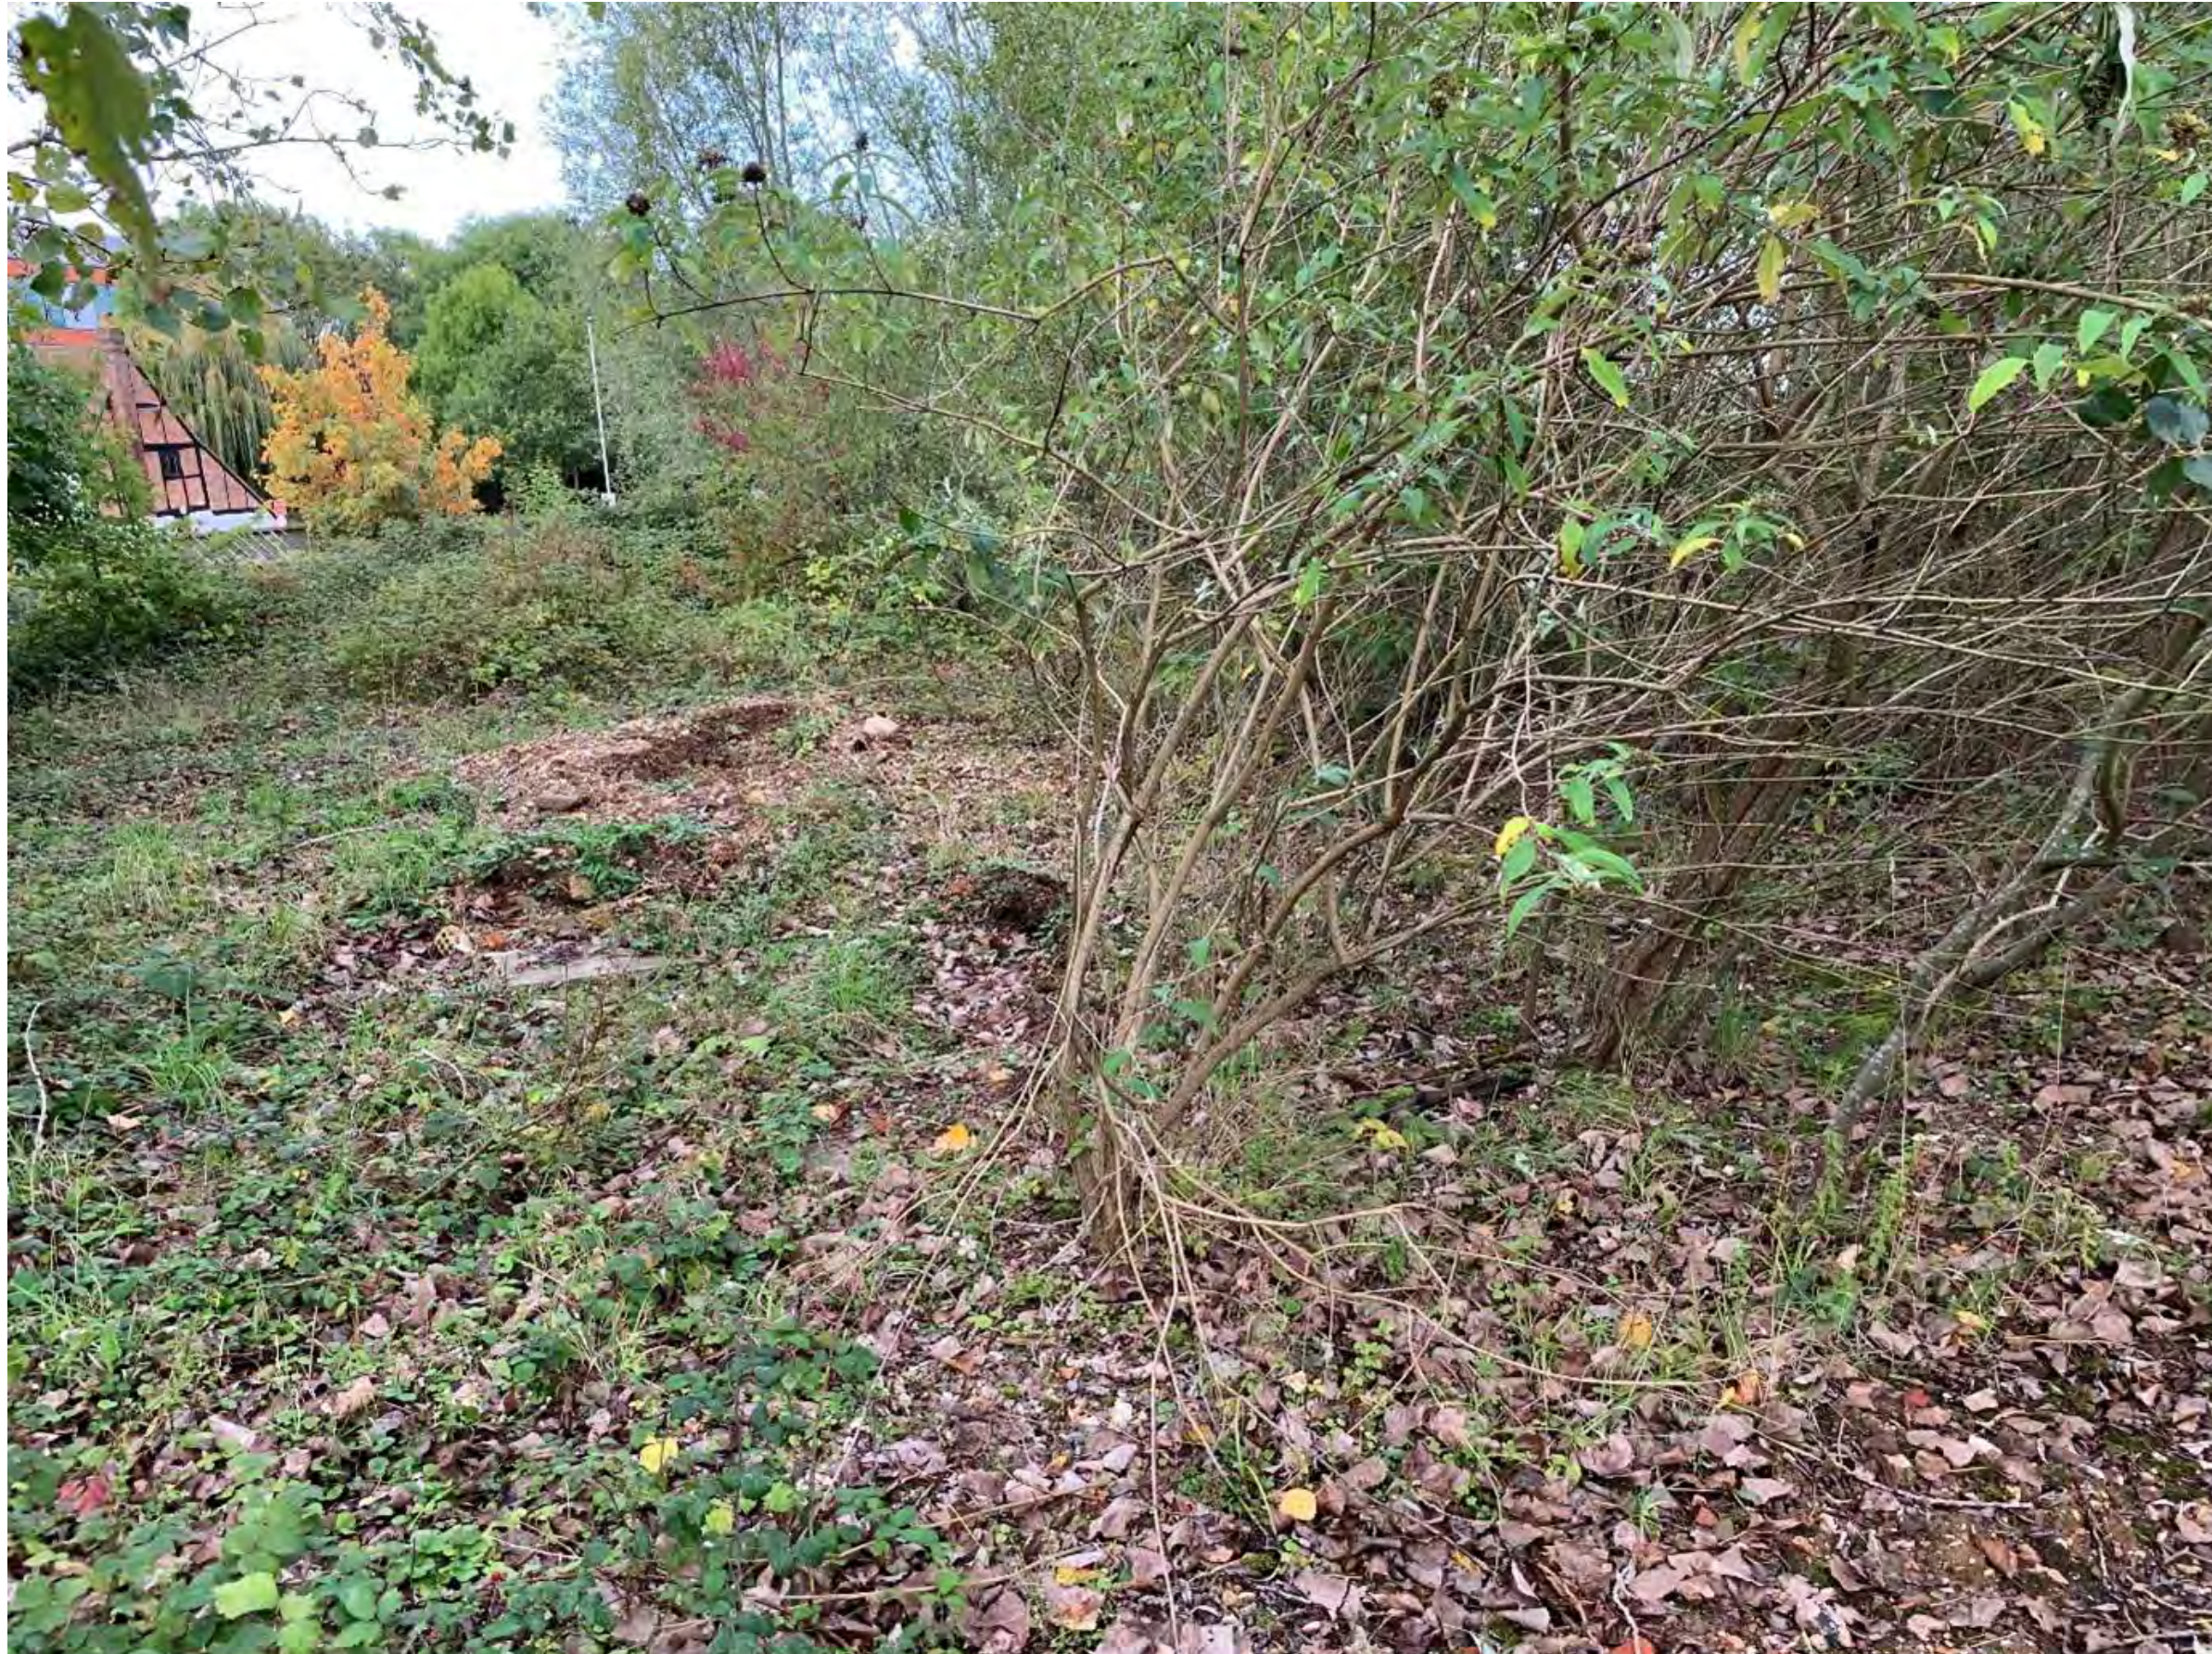
## VIEW 1

View from within Woodland TPO Area  
Looking south to the Lee Farmhouse.

Image shows low quality self-seeded  
shrubs/ small trees with areas of  
bramble thicket.

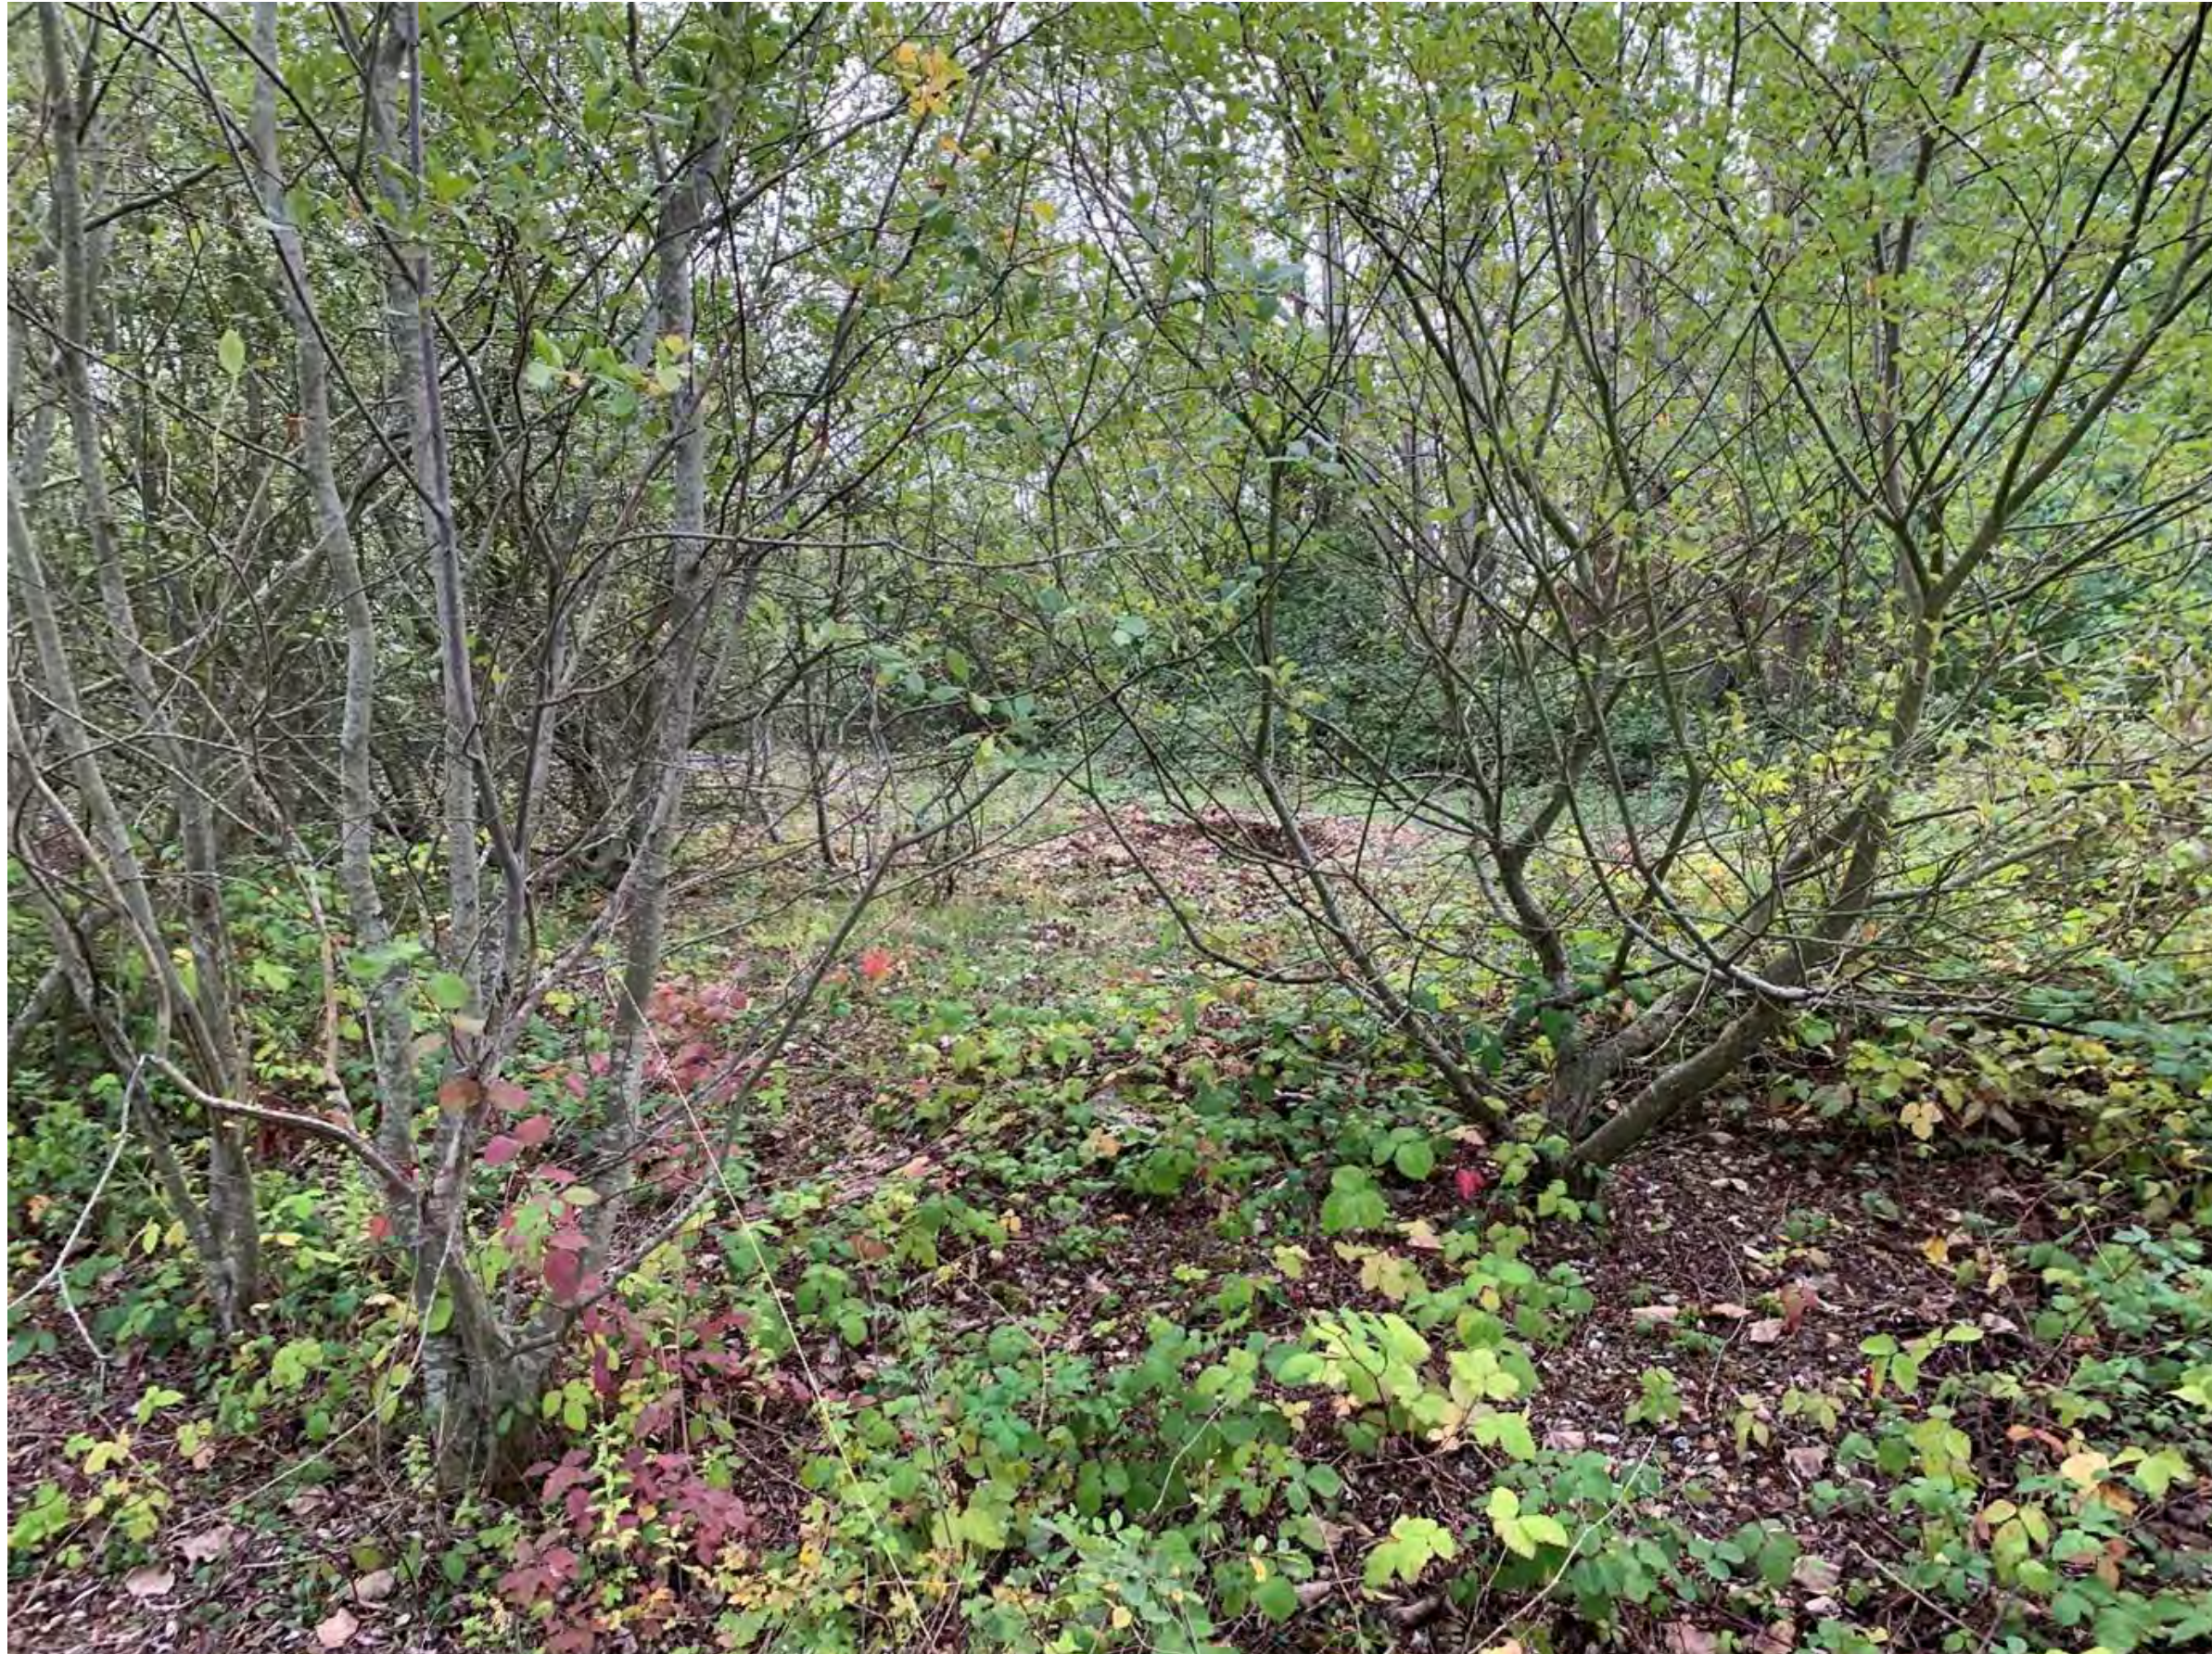
## VIEW 2

View from within Woodland TPO Area  
Looking west. Image shows small  
self-seeded trees in front of area of  
partially re-colonised hard standing

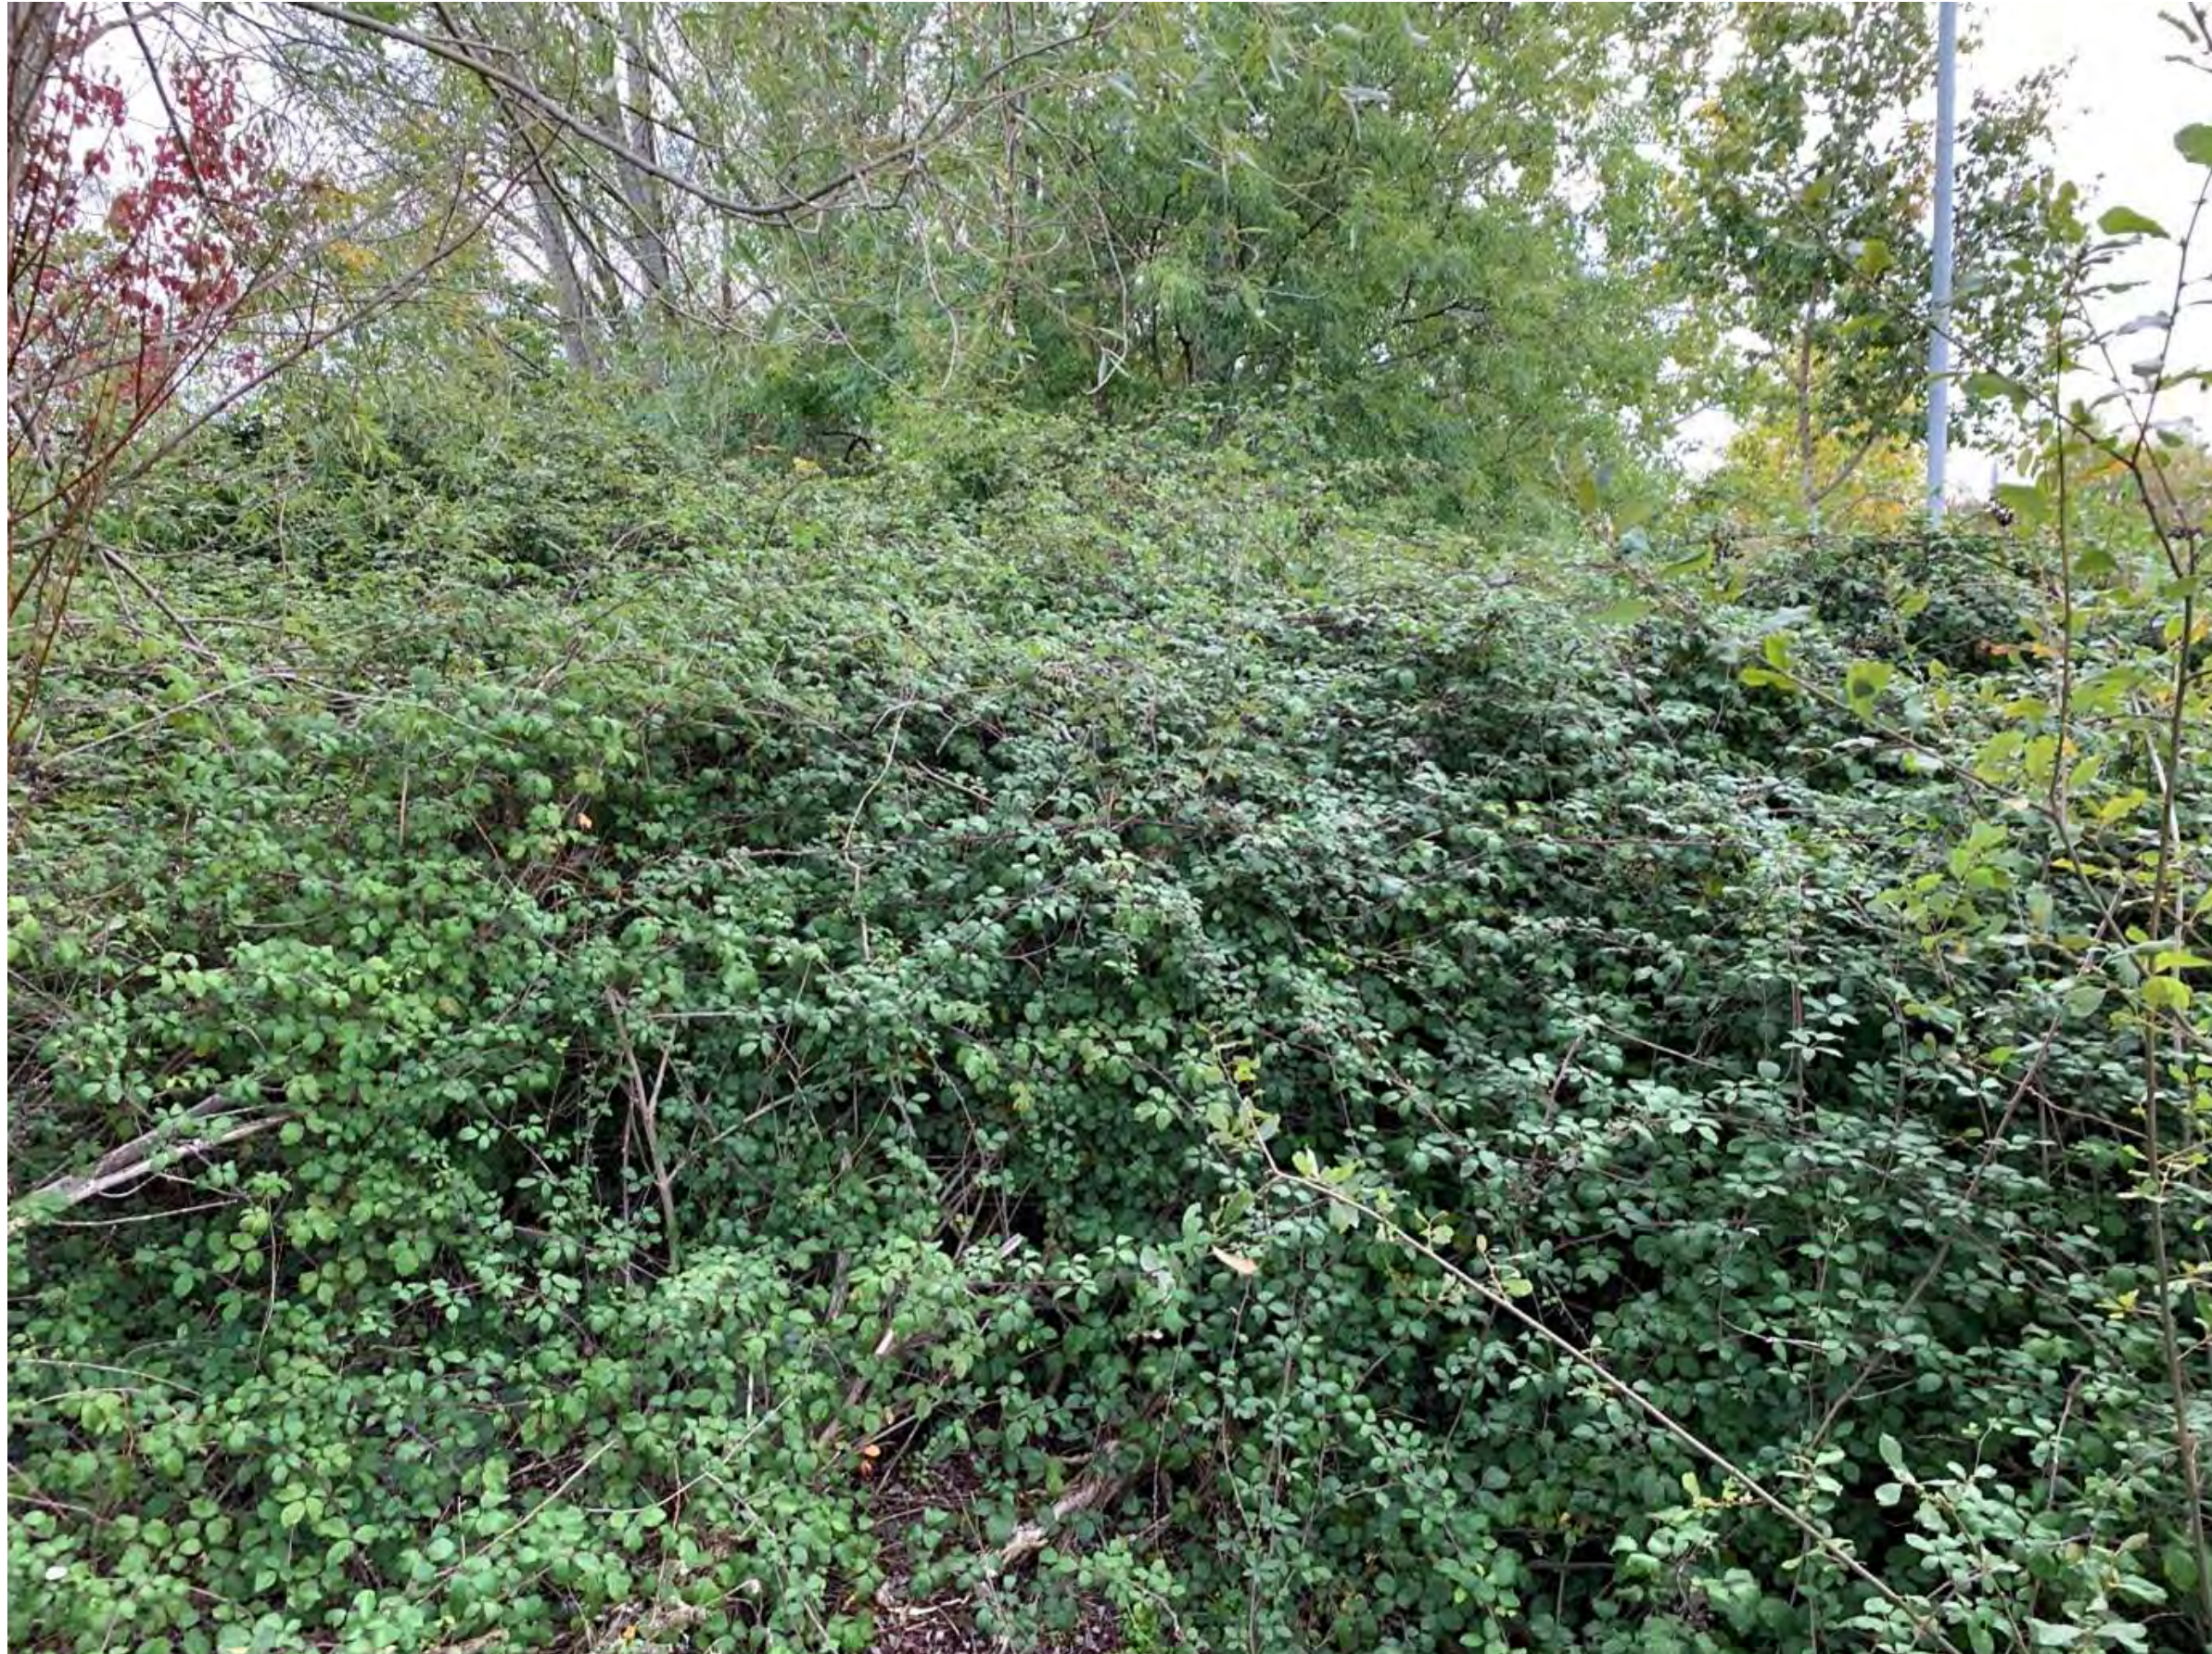
## VIEW 3

View from within the Woodland TPO near the plot entrance off Reading International Business Park roundabout.

Dense bramble thicket dominates the view with a large poplar and willow trees growing through it in the background.

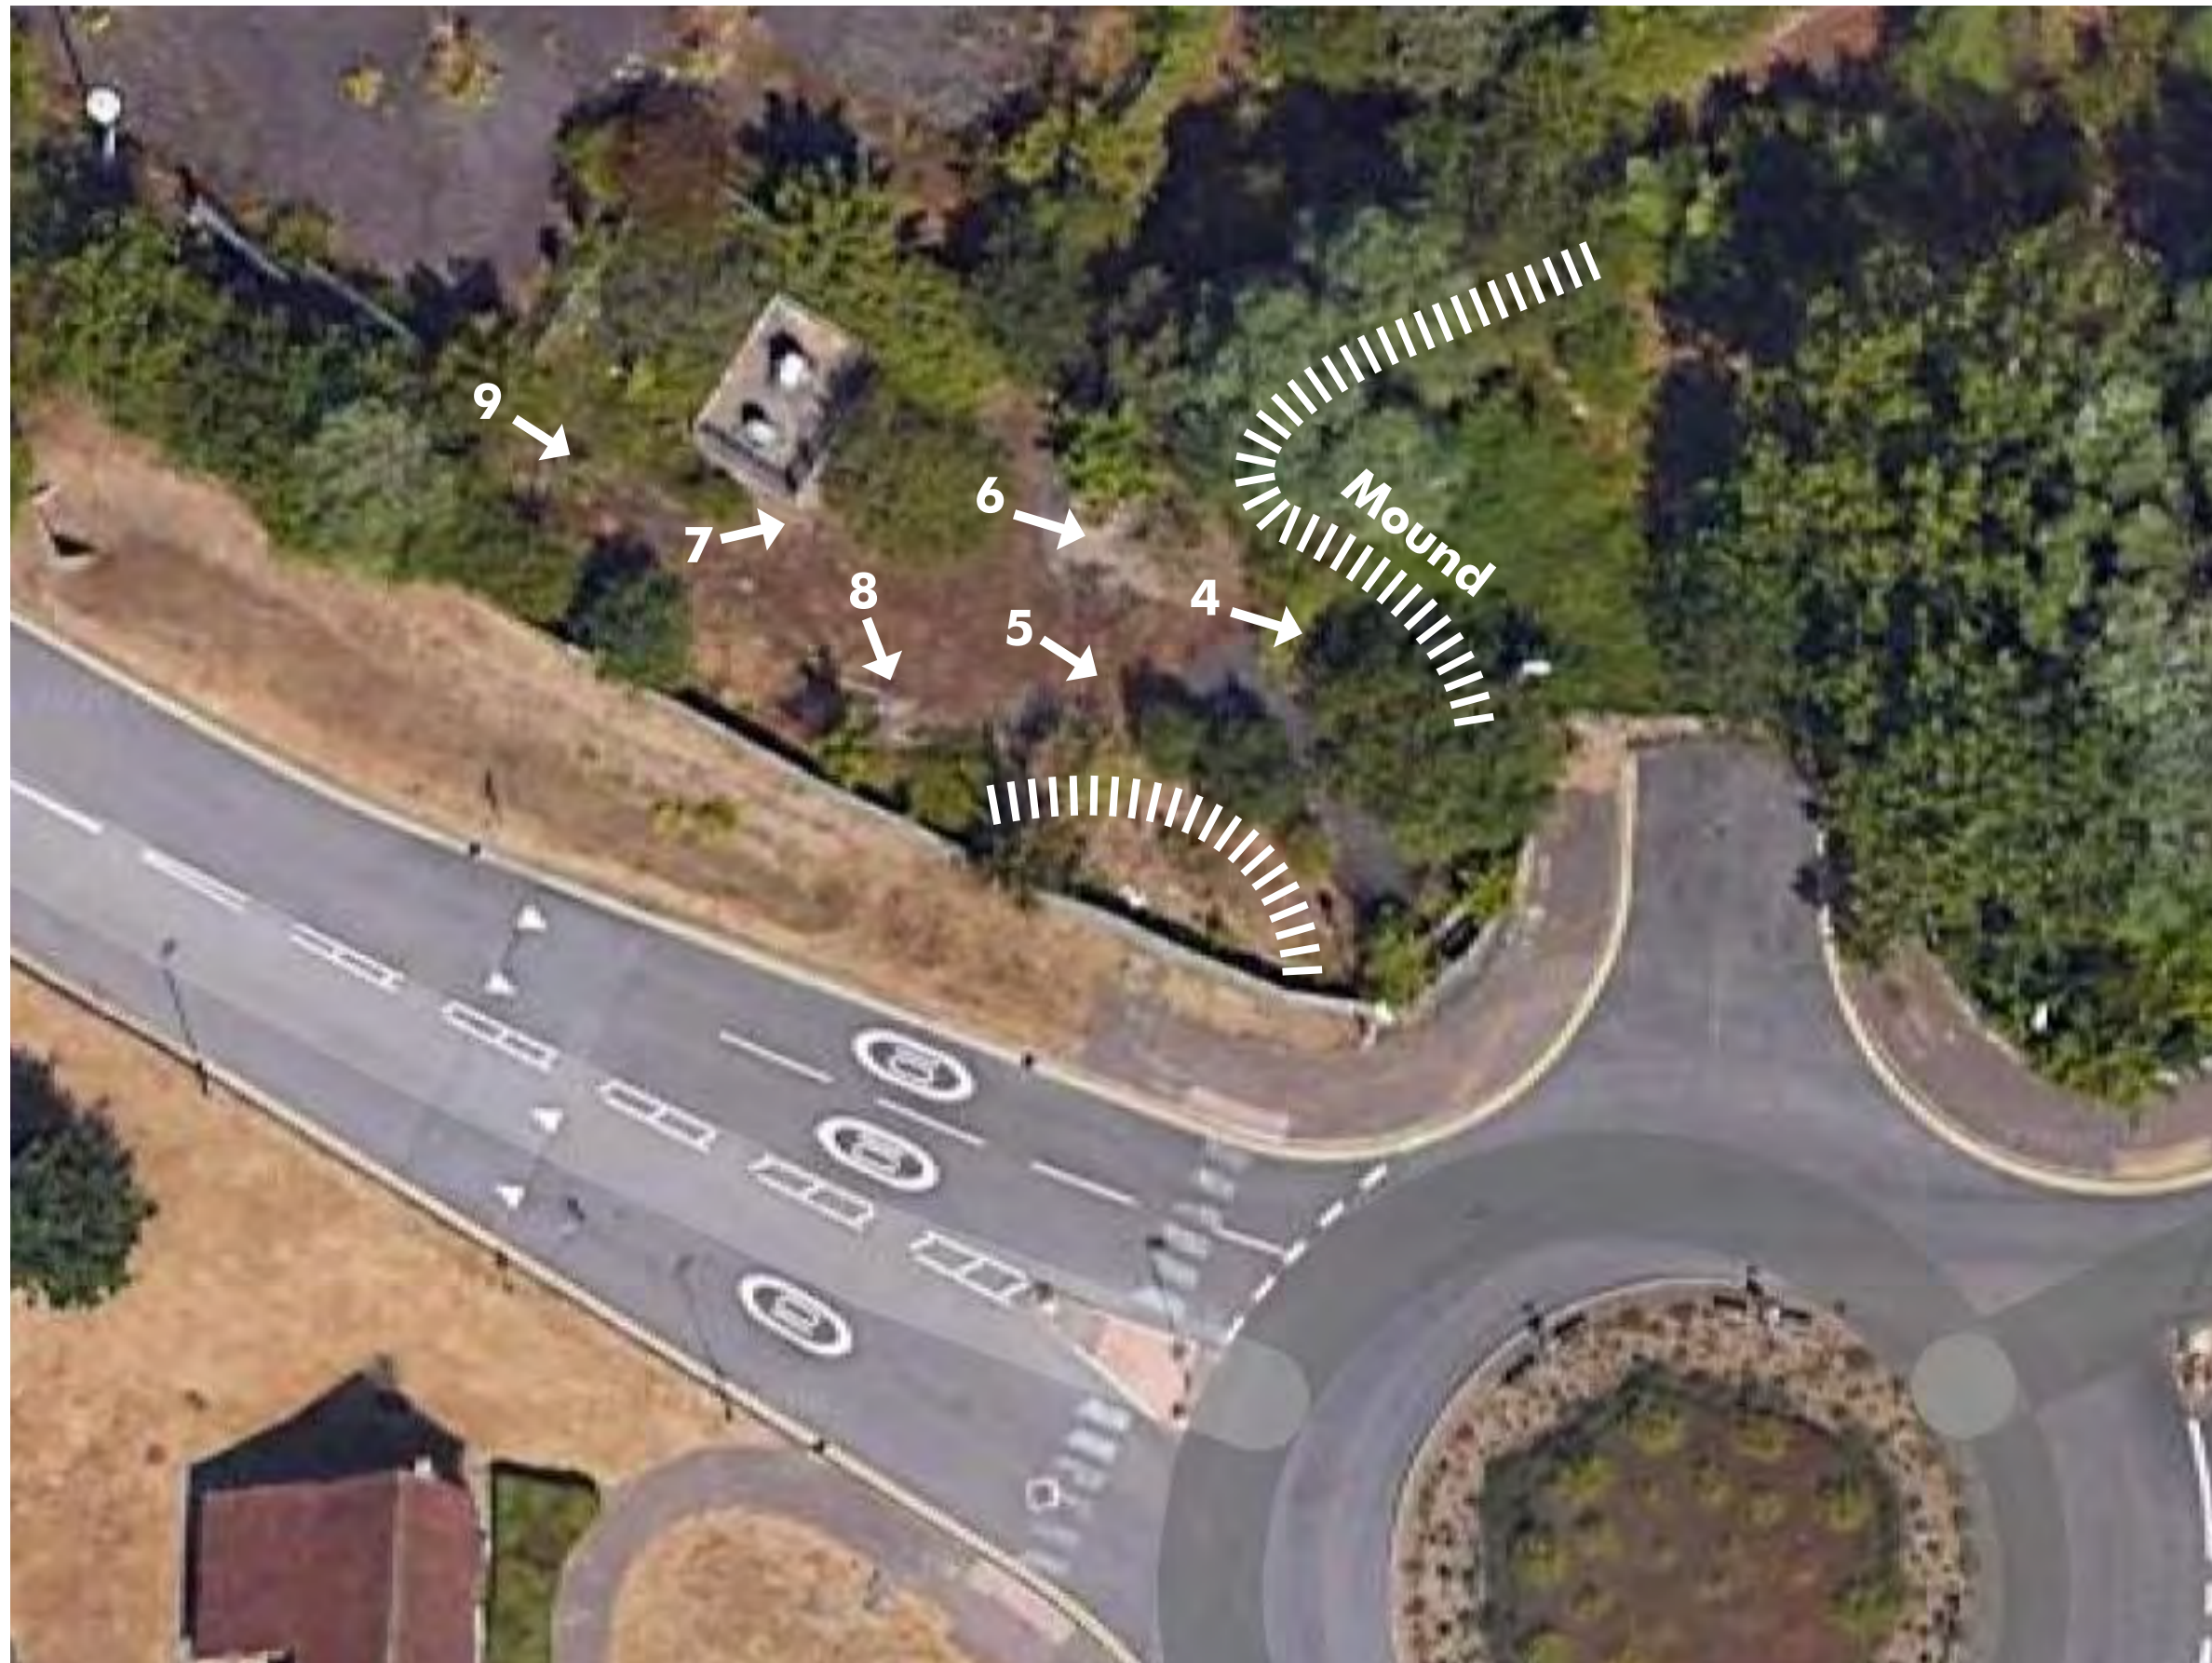
View 4,5,6,7,8 & 9 show additional views around the plot entrance of the Reading International Business Park roundabout.

A mound covered in weeds and scrub blocks the entrance off the Reading International Business Park roundabout.
