# READING INTERNATIONAL BUSINESS PARK

1219-G509 EASTERN WOODLAND AREA PHOTOS  
OCTOBER 2020

The following images have been taken on the morning of 7th October 2020. The images show a range of views from within the 'Woodland' area to the south east of the site where we propose to create the Unit 1 car park.

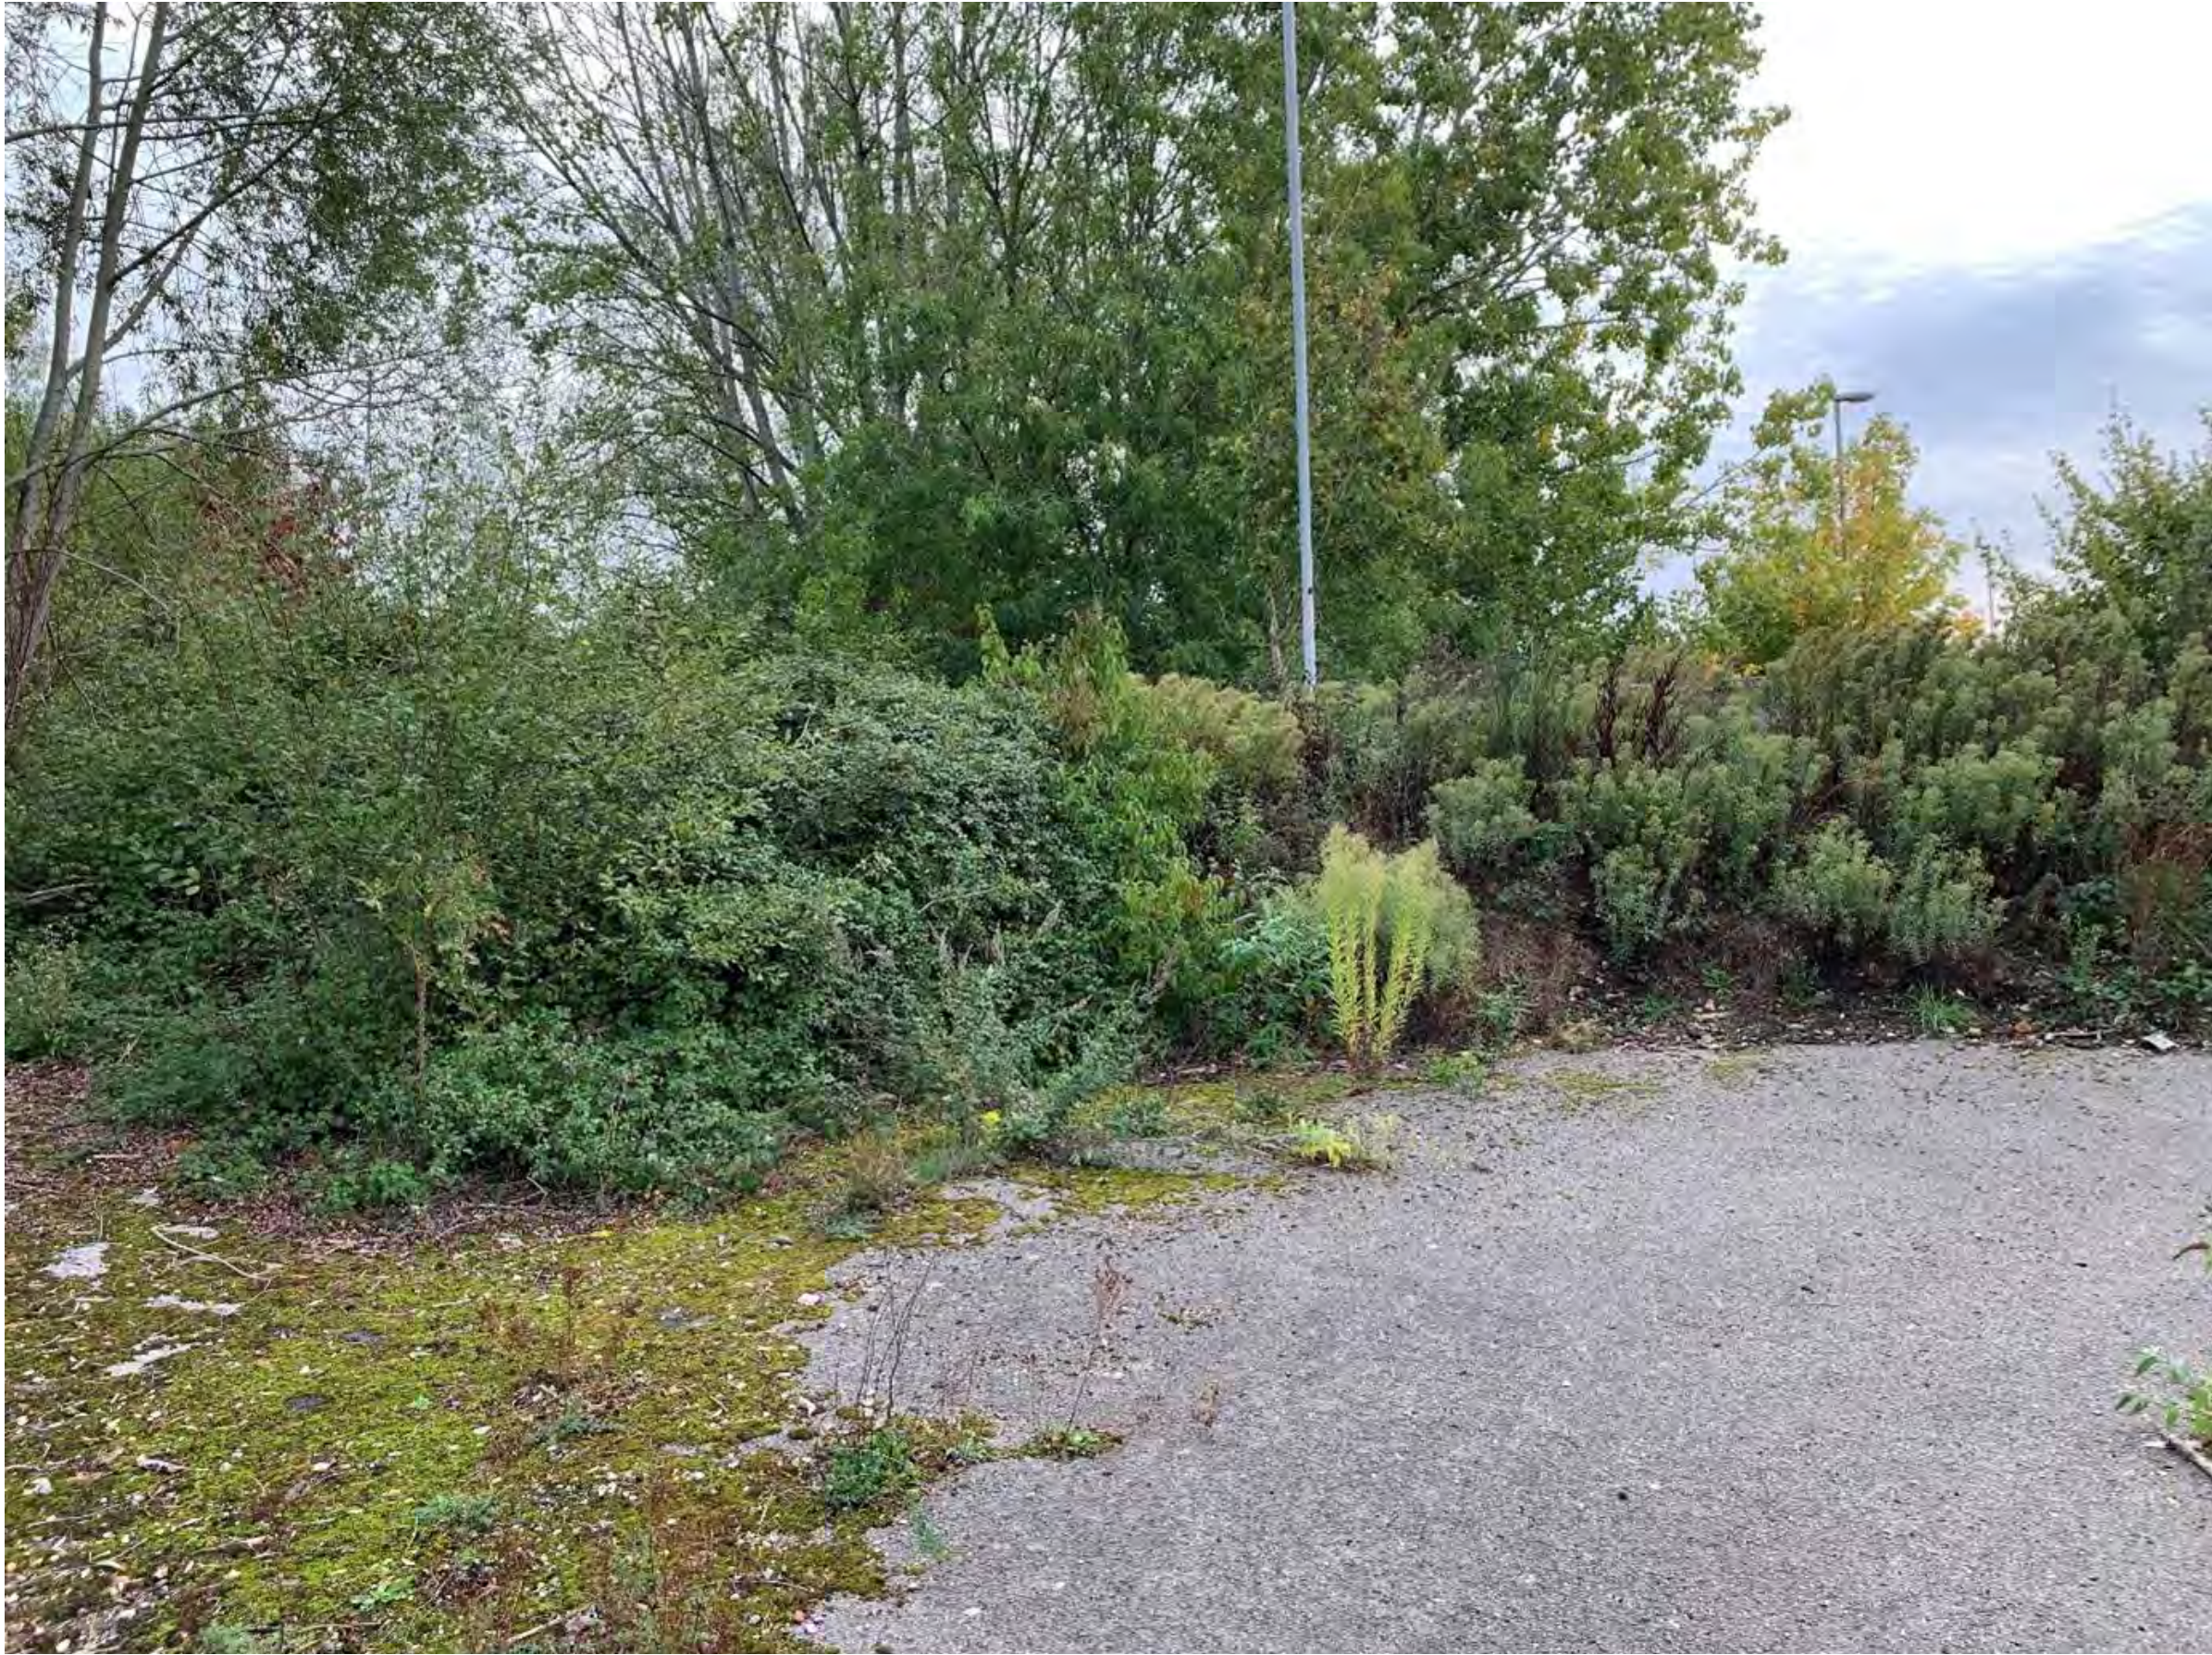
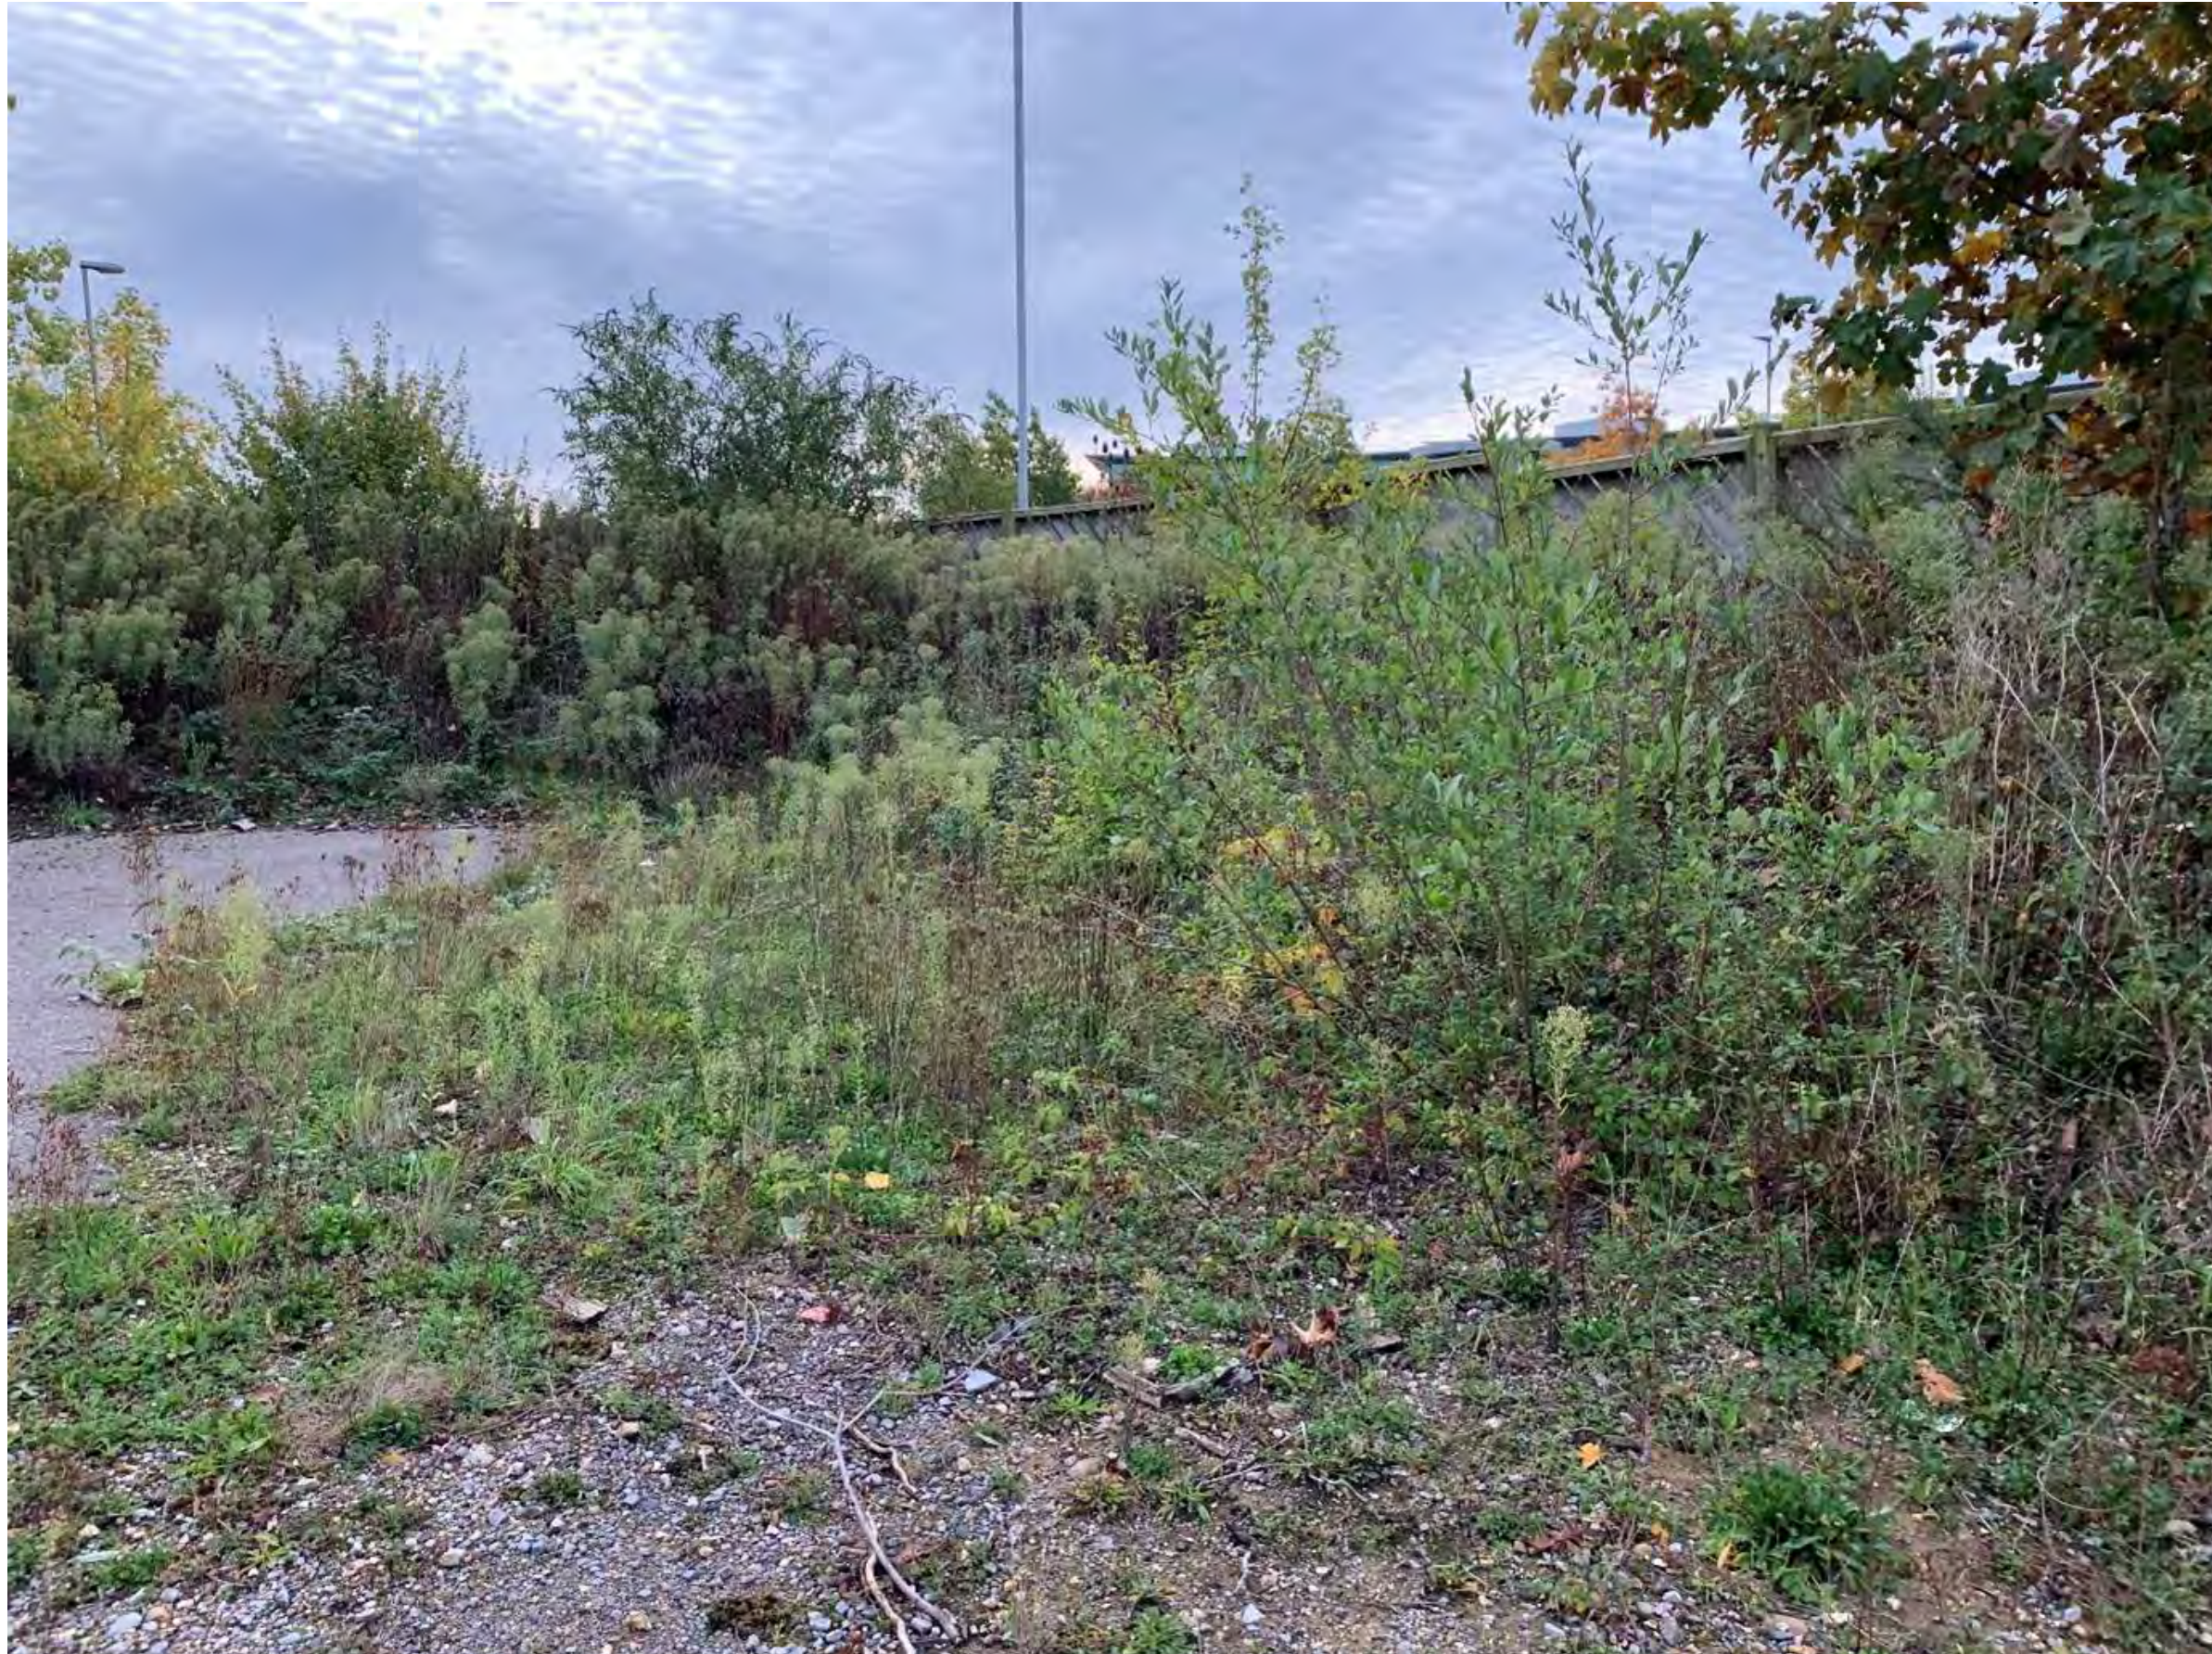
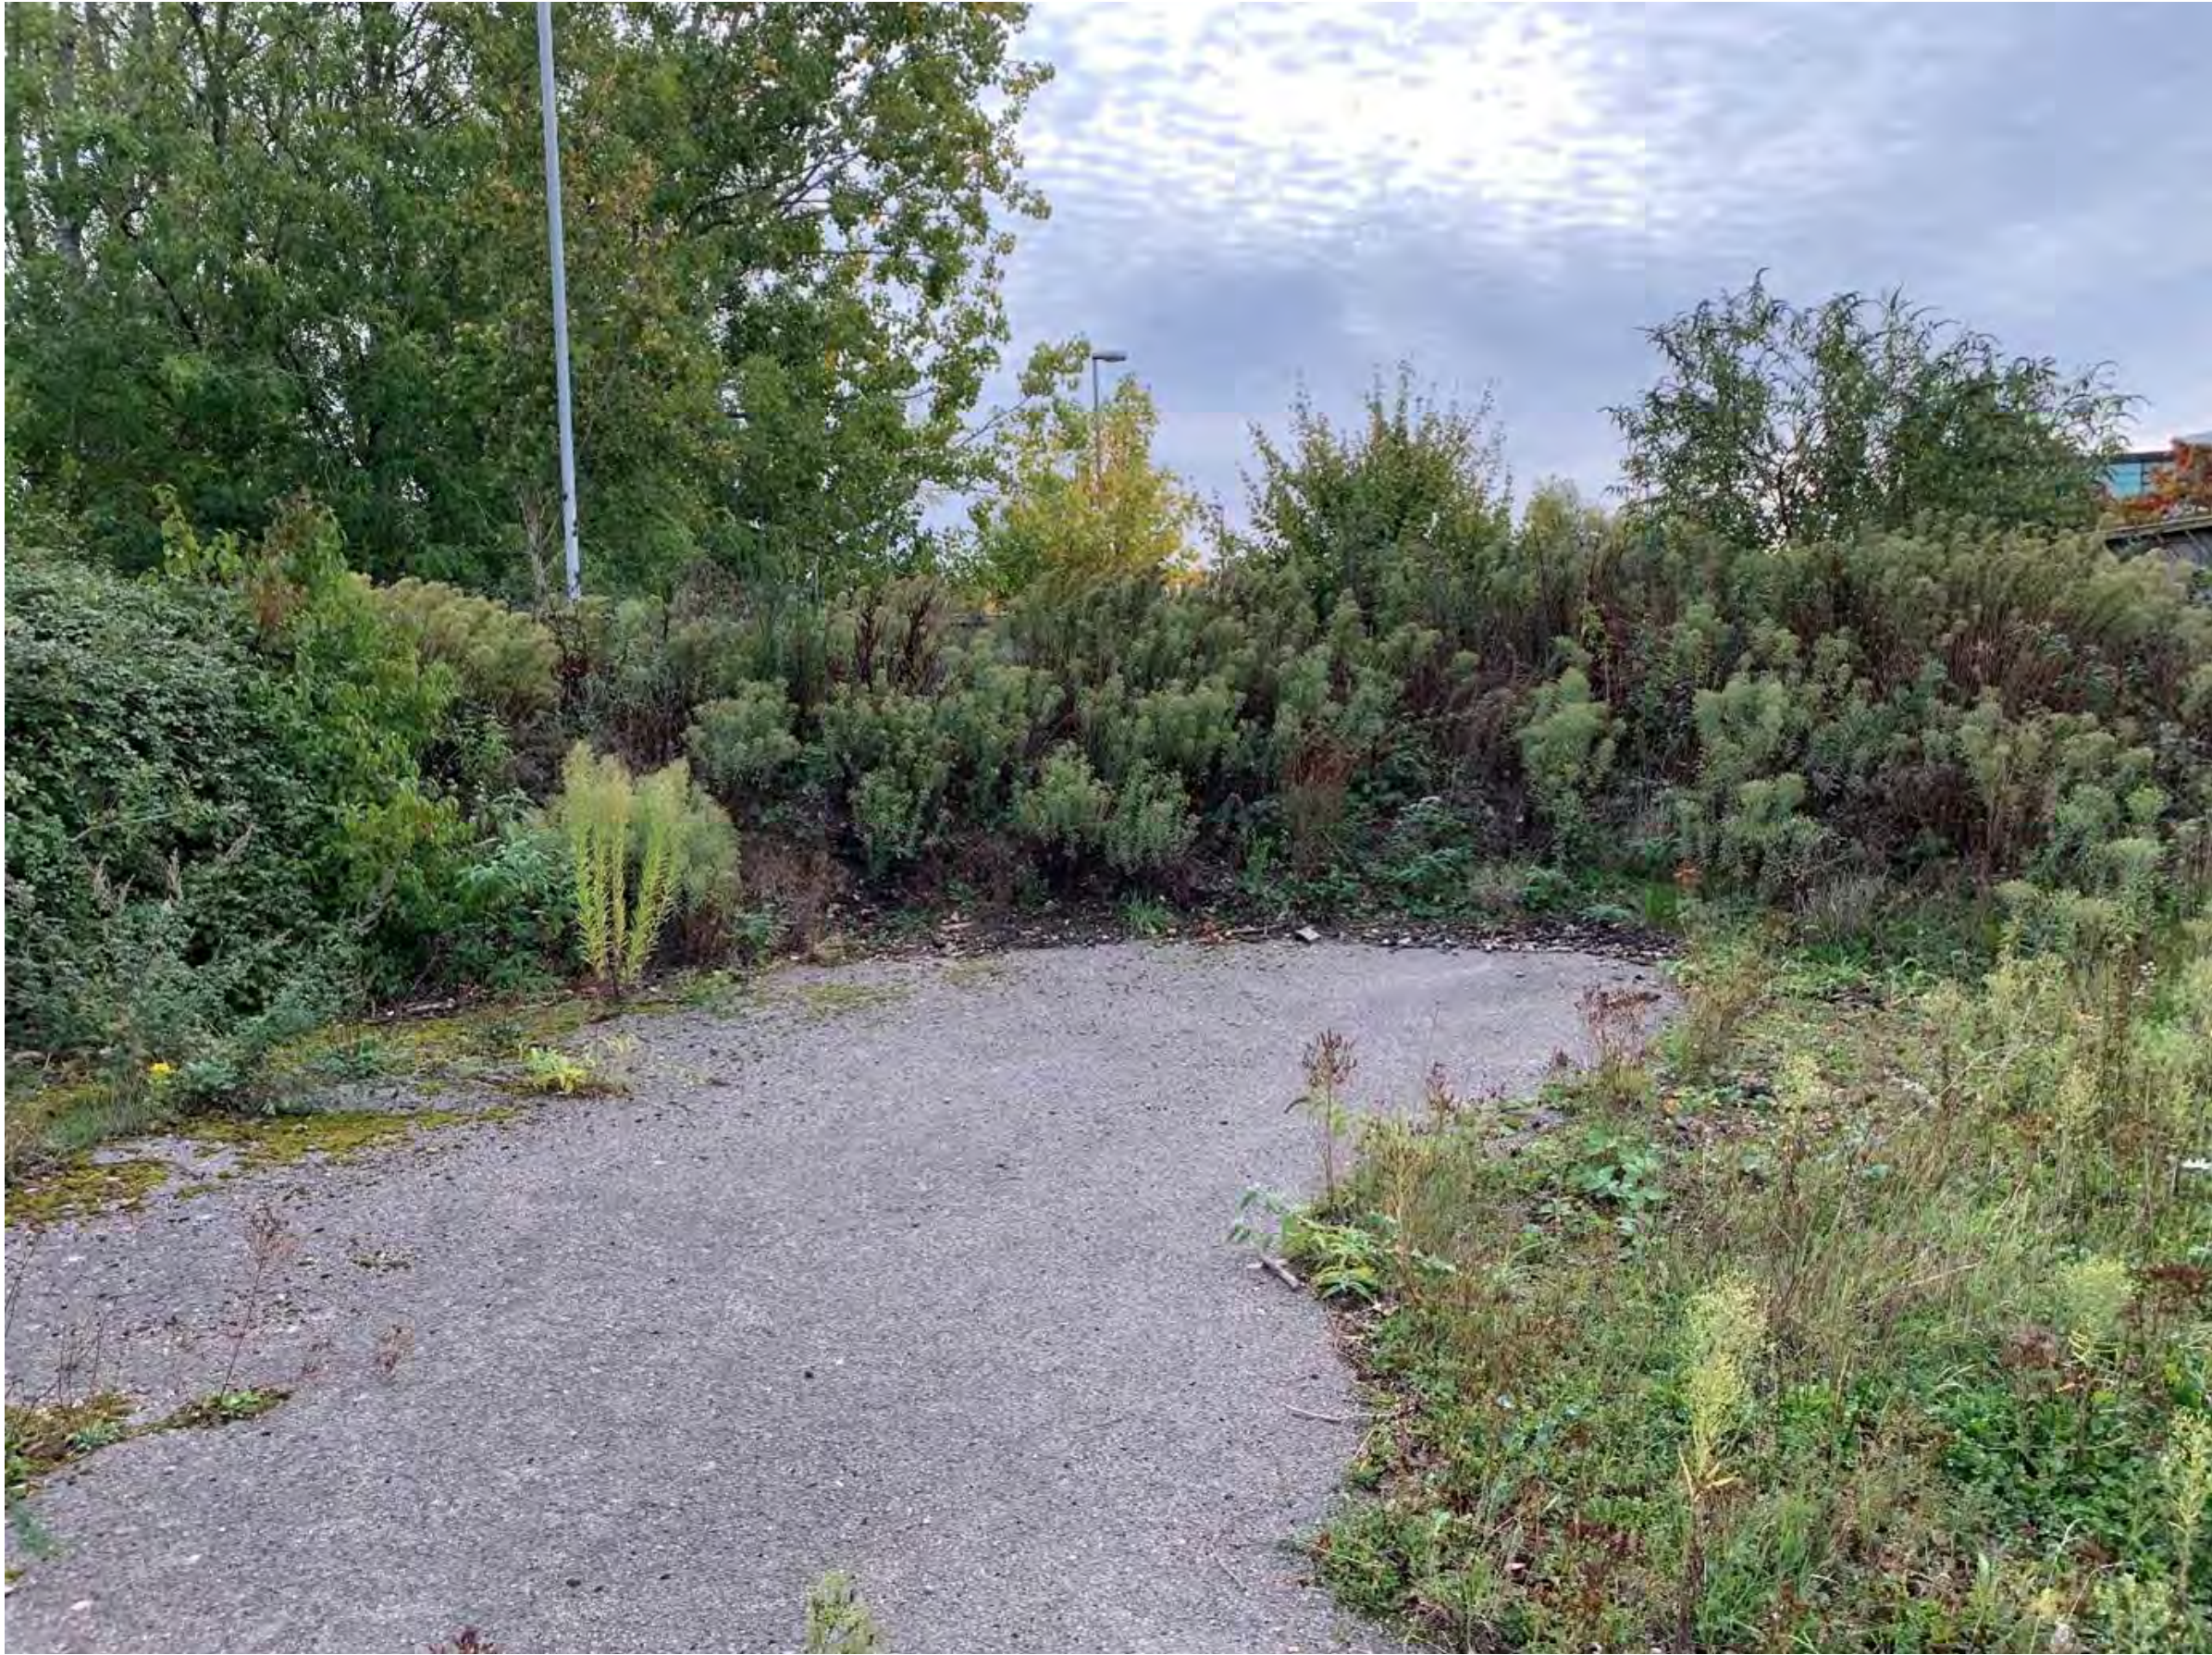
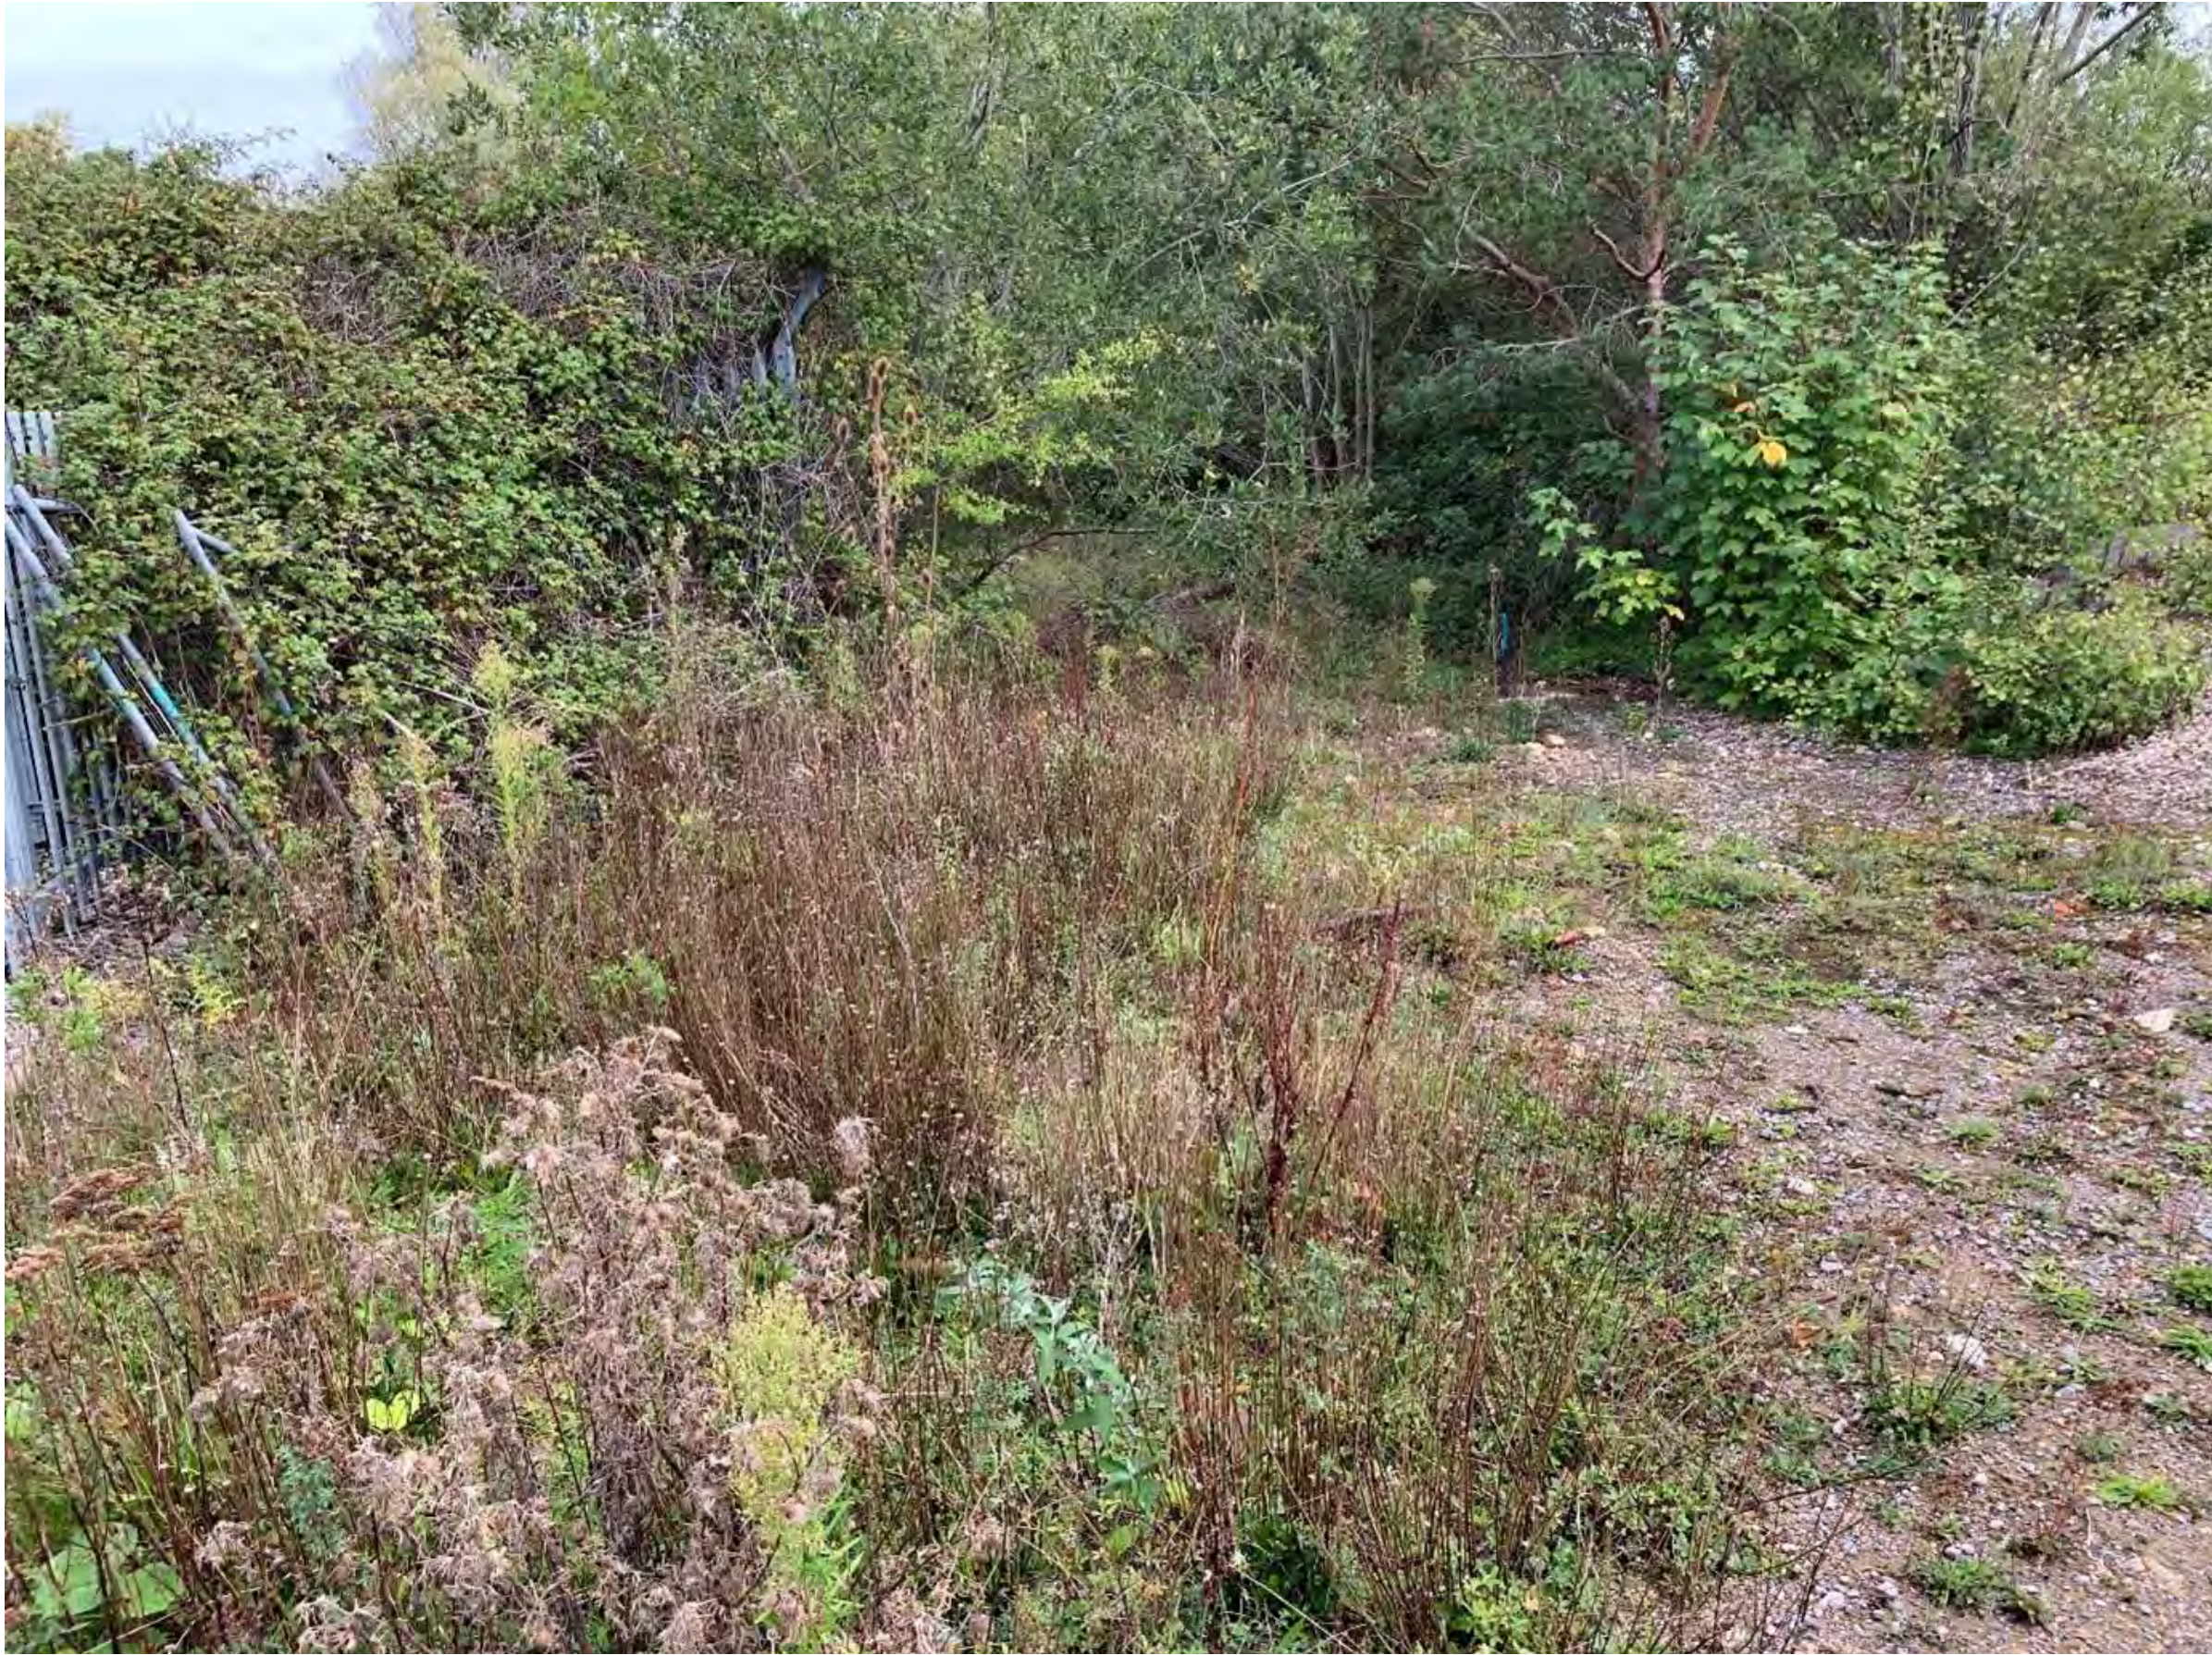
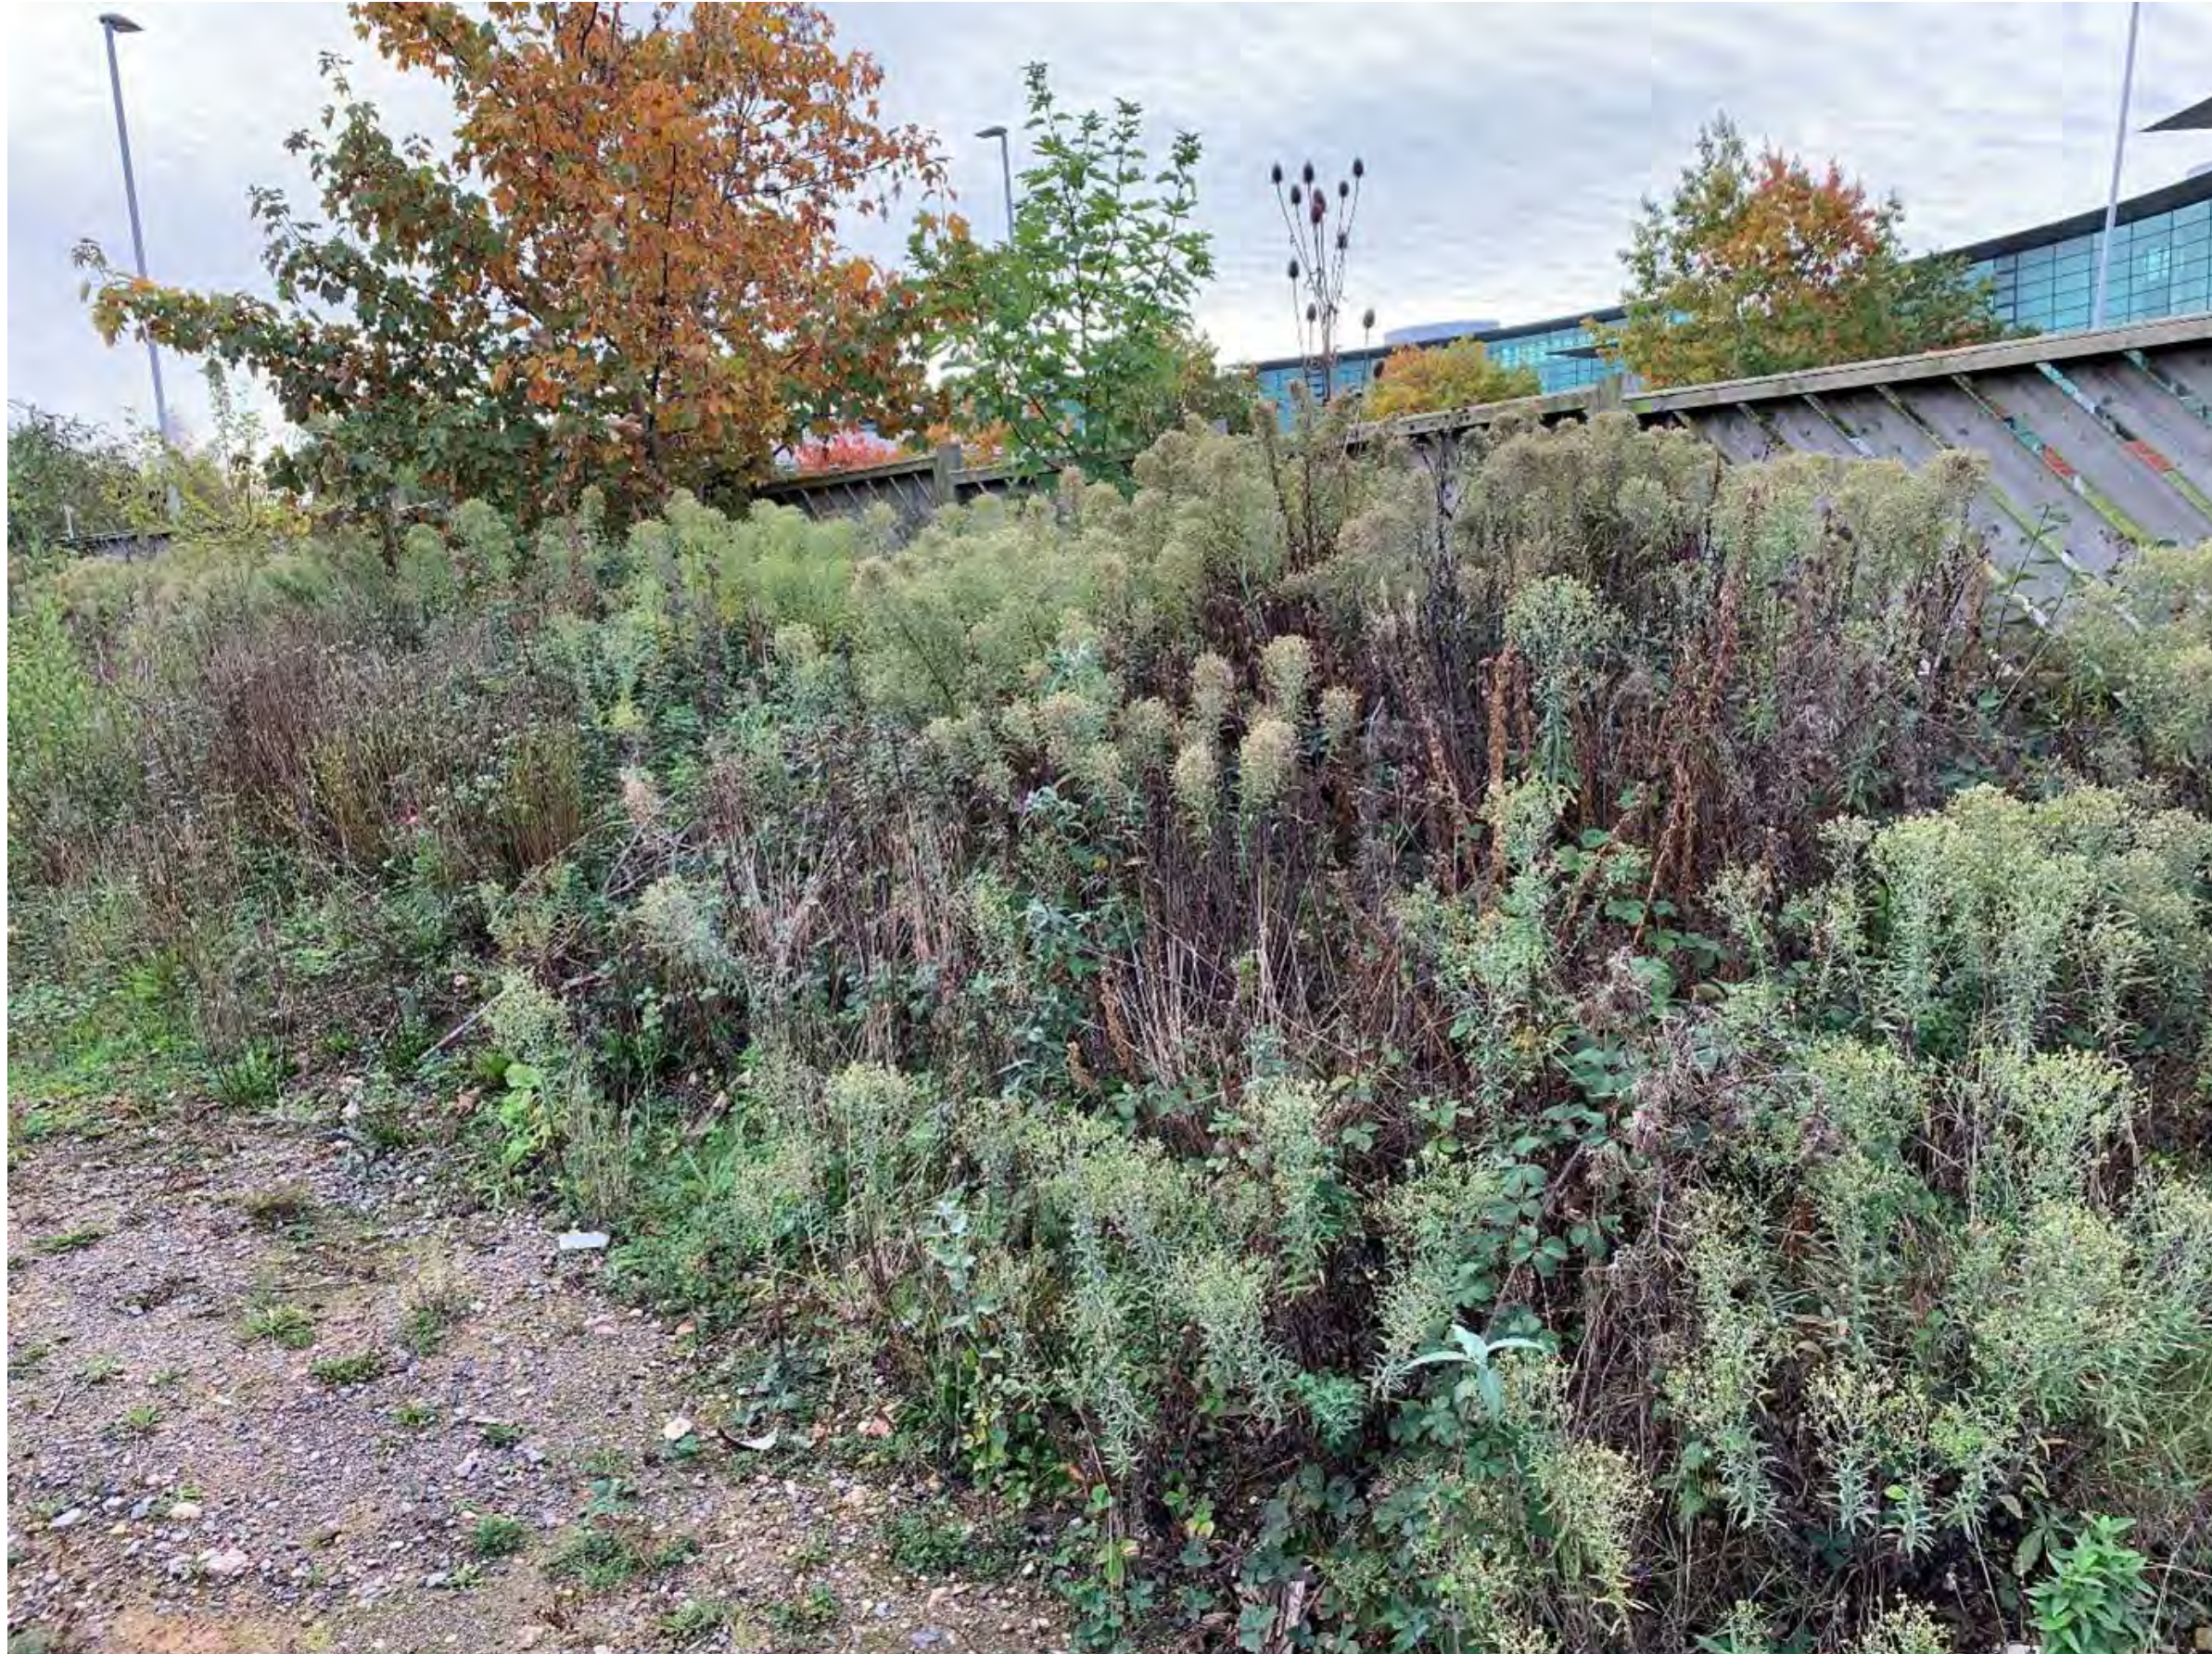
View 4,5,6,7,8 & 9 show additional views around the plot entrance of the Reading International Business Park roundabout.

A mound covered in weeds and scrub blocks the entrance off the Reading International Business Park roundabout.

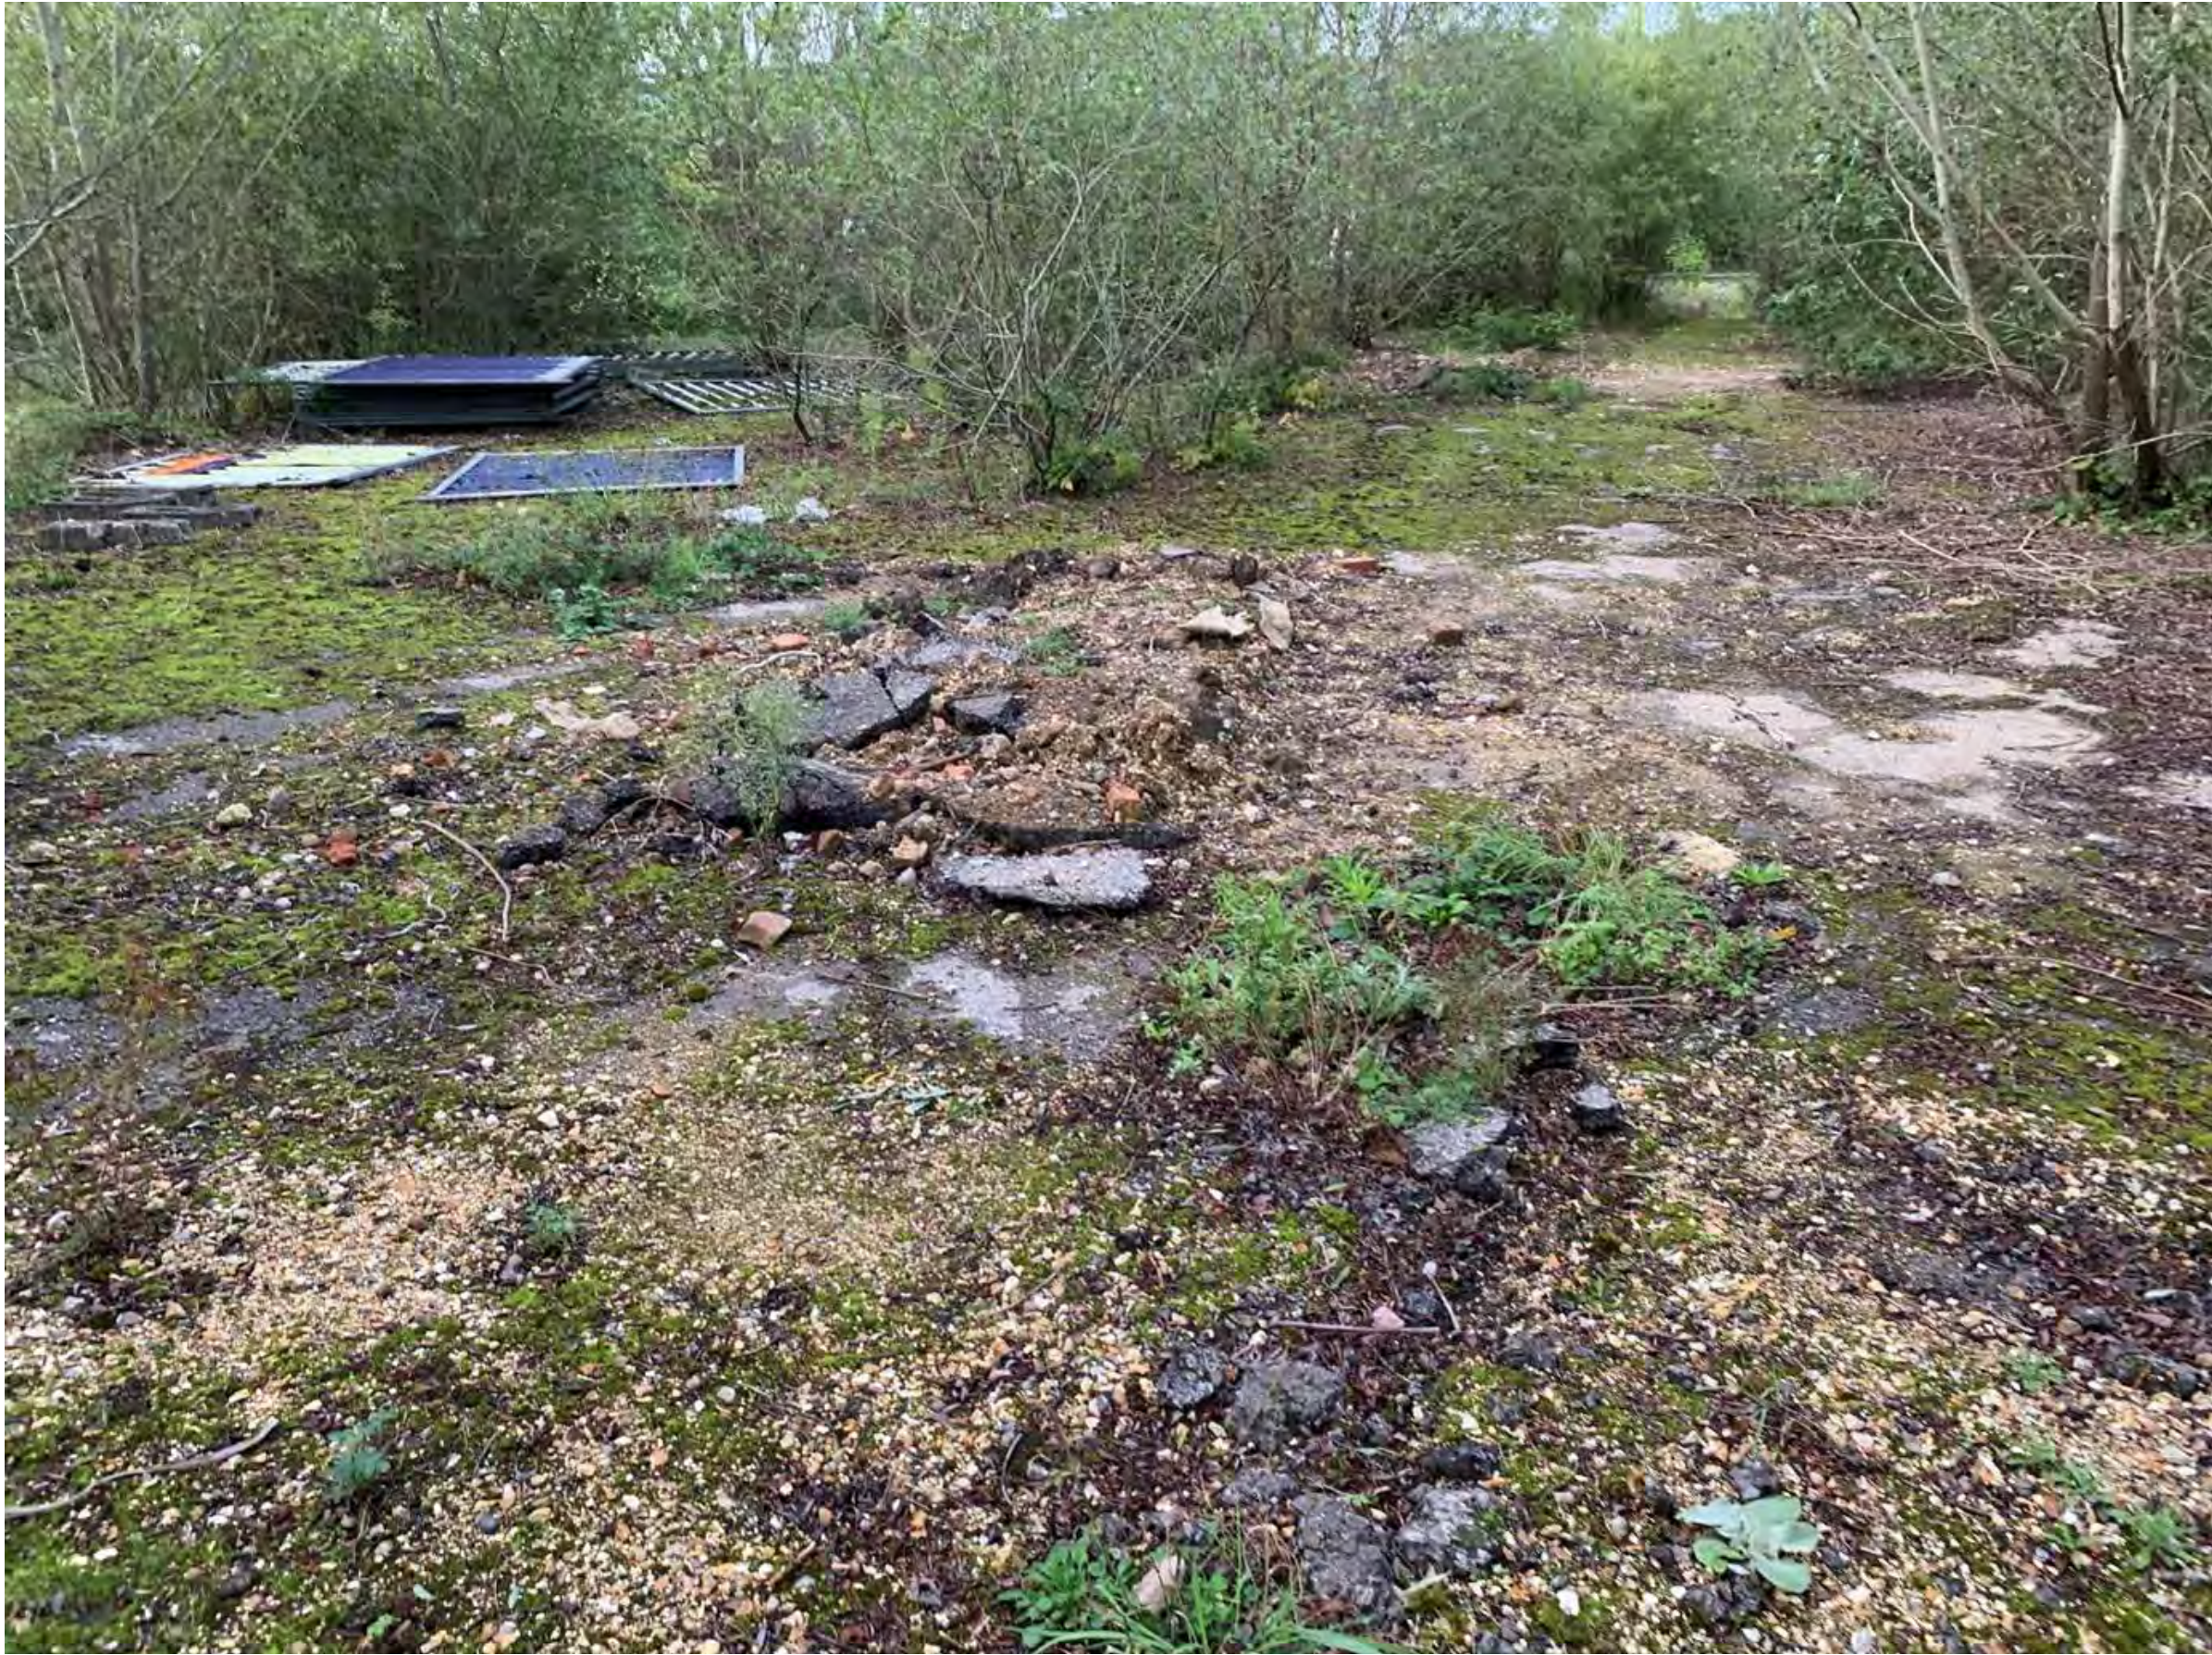
VIEW 11

View from within Woodland TPO Area  
Looking south towards Reading  
International Business Park

Image shows low quality self-seeded  
shrubs/ small trees breaking through  
asphalt hard standing of old car park.
