# READING INTERNATIONAL BUSINESS PARK

1219-G509 EASTERN WOODLAND AREA PHOTOS  
OCTOBER 2020

The following images have been taken on the morning of 7th October 2020. The images show a range of views from within the 'Woodland' area to the south east of the site where we propose to create the Unit 1 car park.

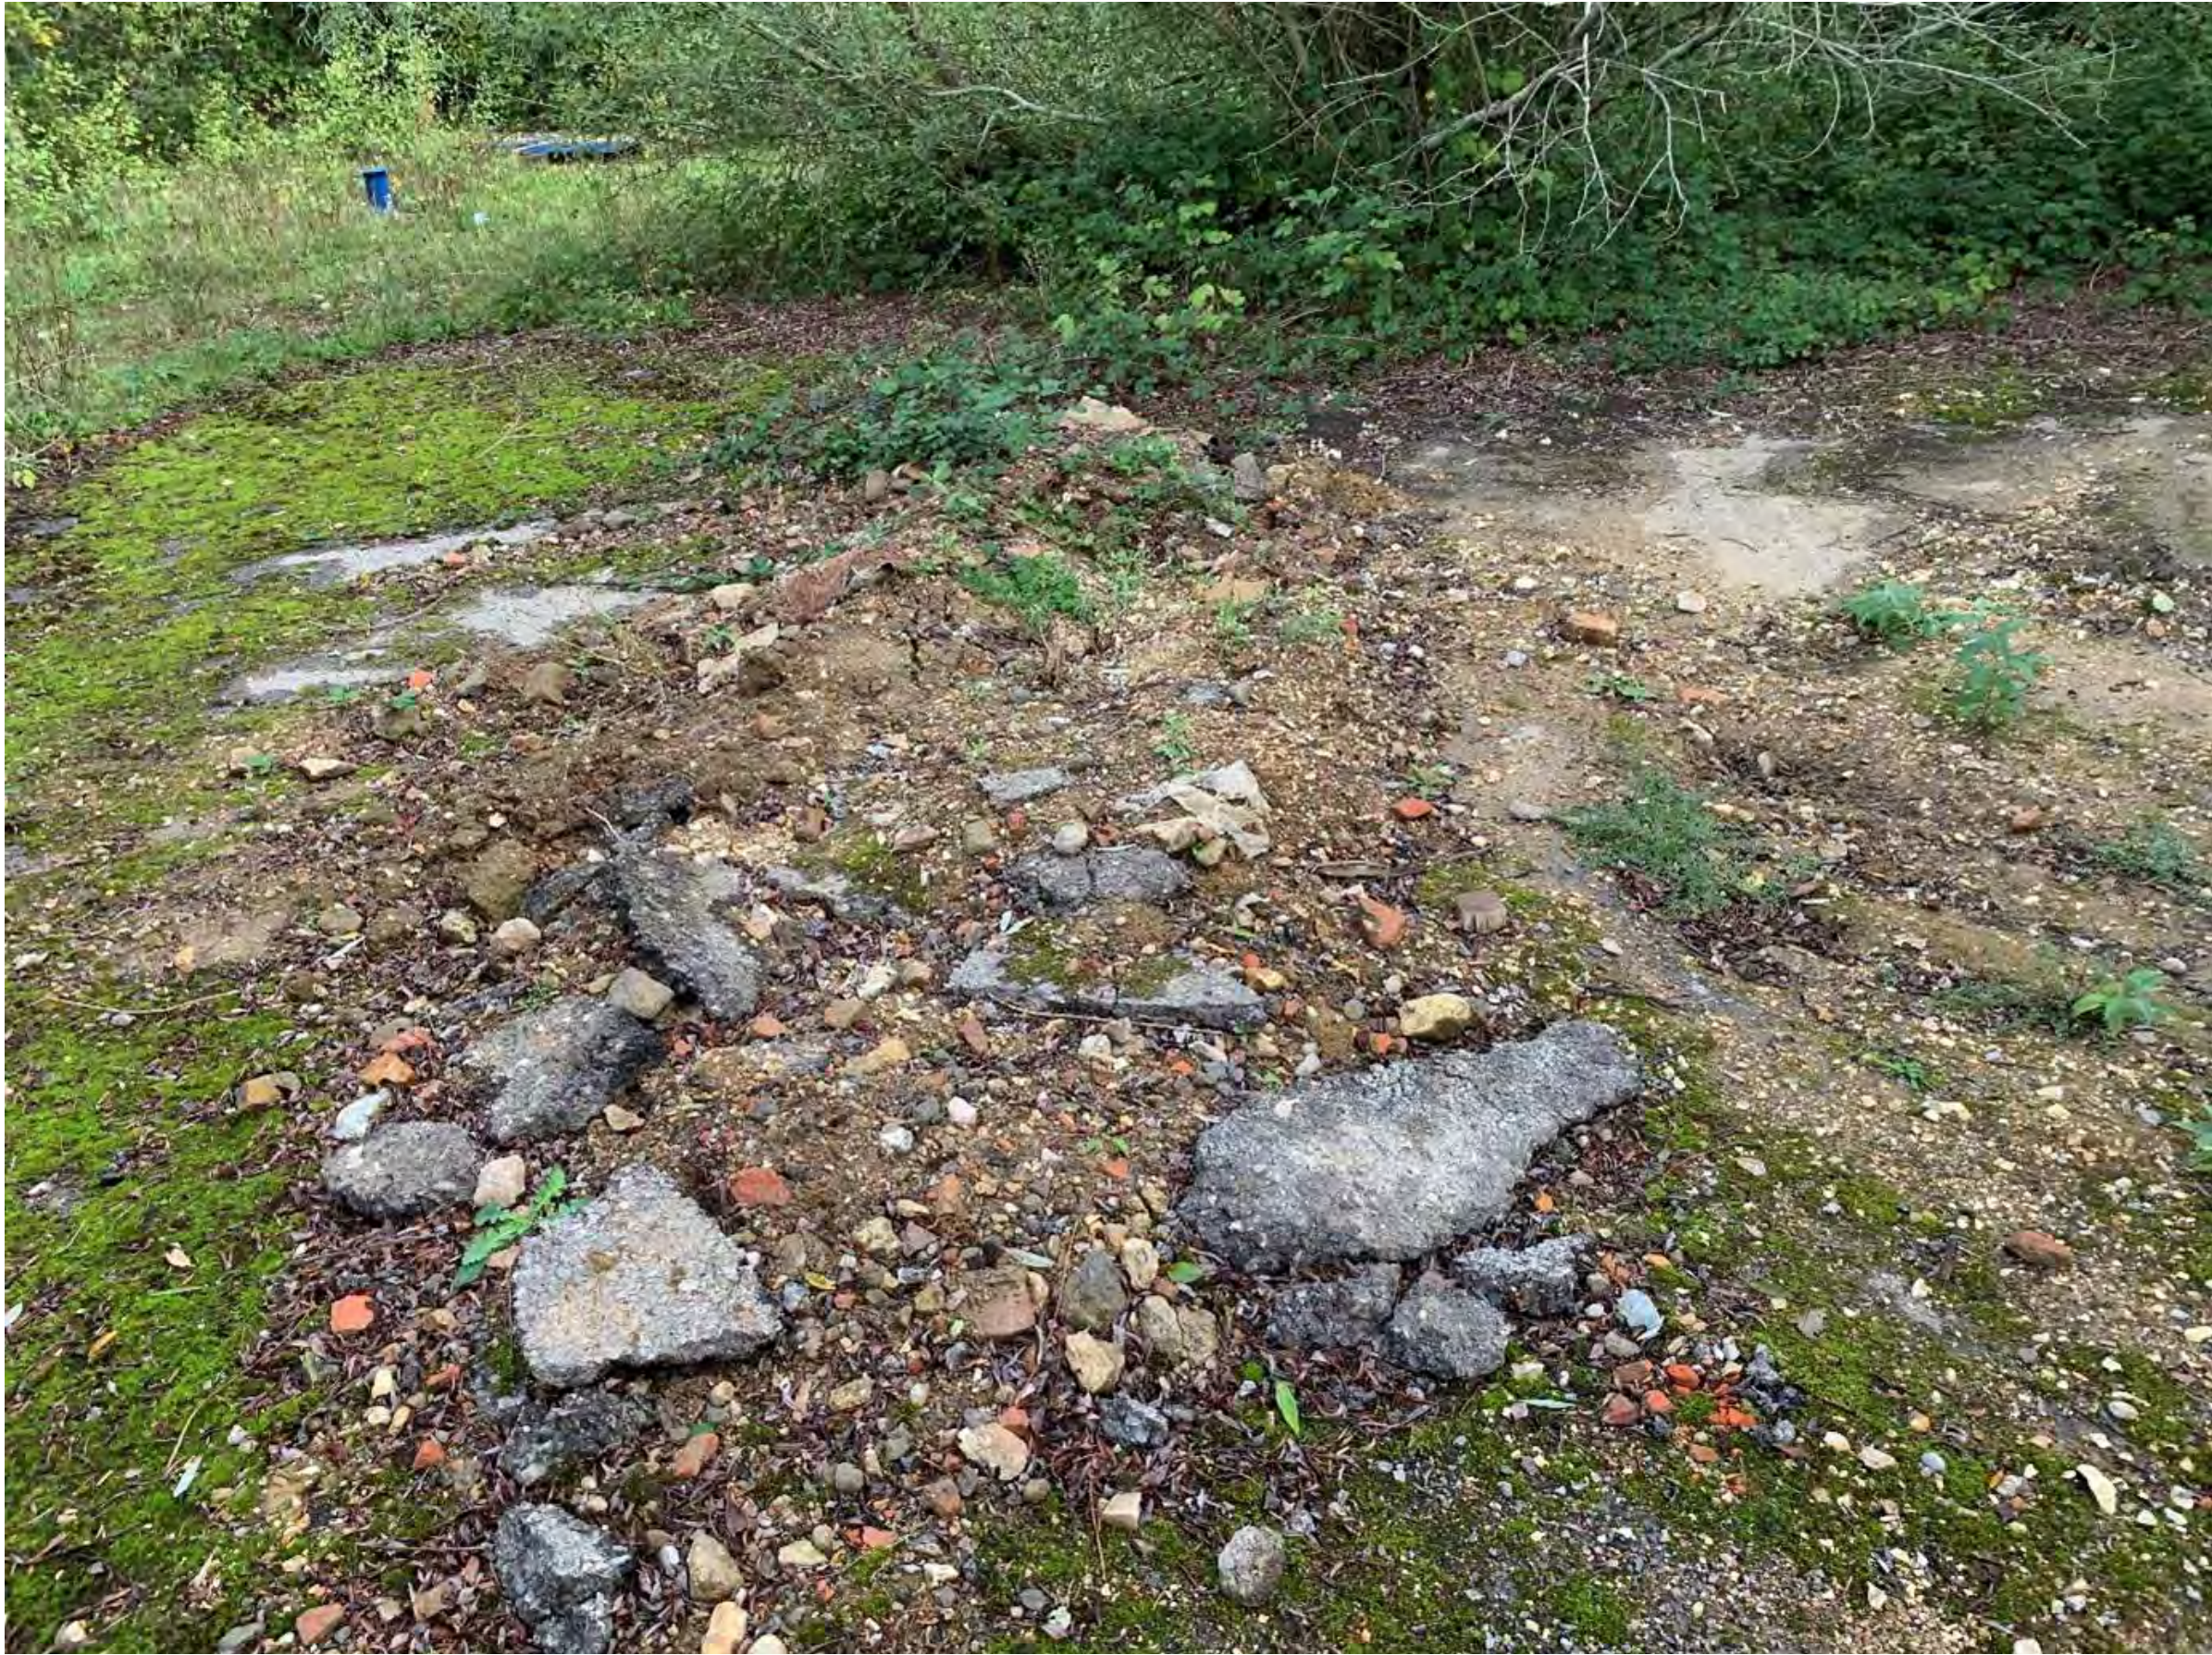
VIEW 12

View from within Woodland TPO Area  
Image clearly shows the ground is  
asphalt / hard standing.

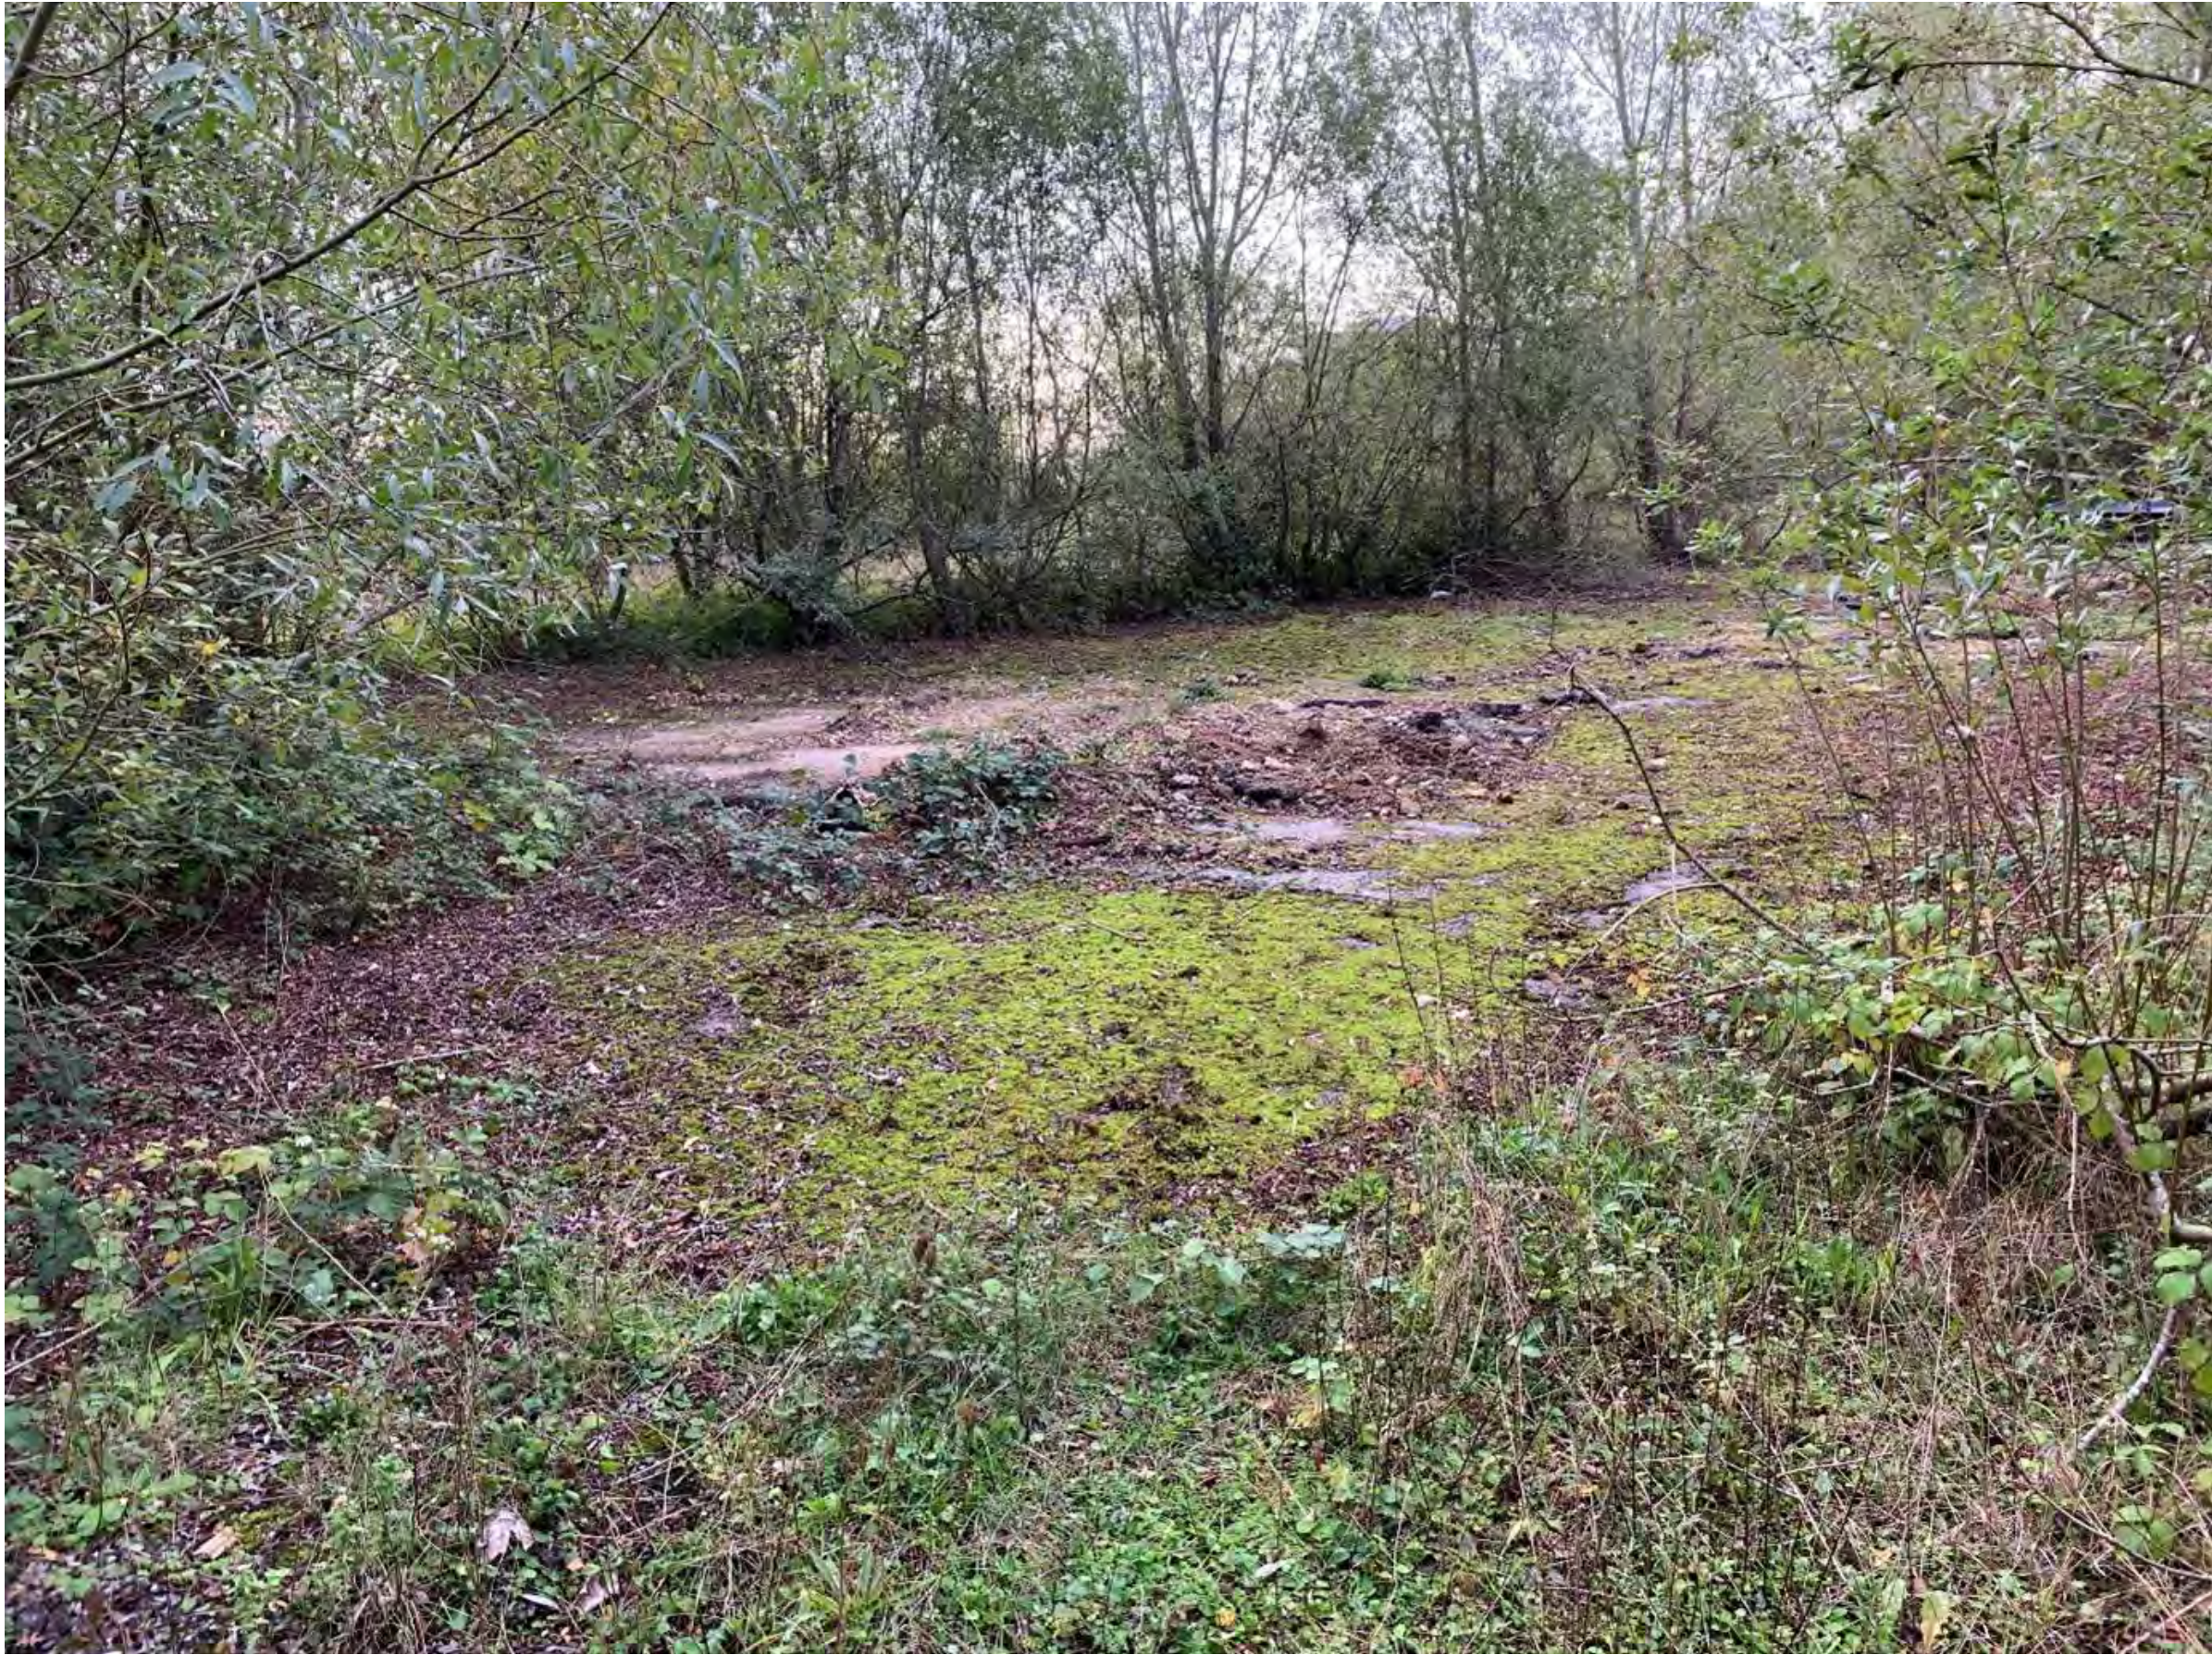
VIEW 13

View from within Woodland TPO Area  
Looking south east towards A33  
junction.

Image shows low quality self-seeded  
shrubs/ small trees breaking through  
asphalt hard standing of the old car  
park.

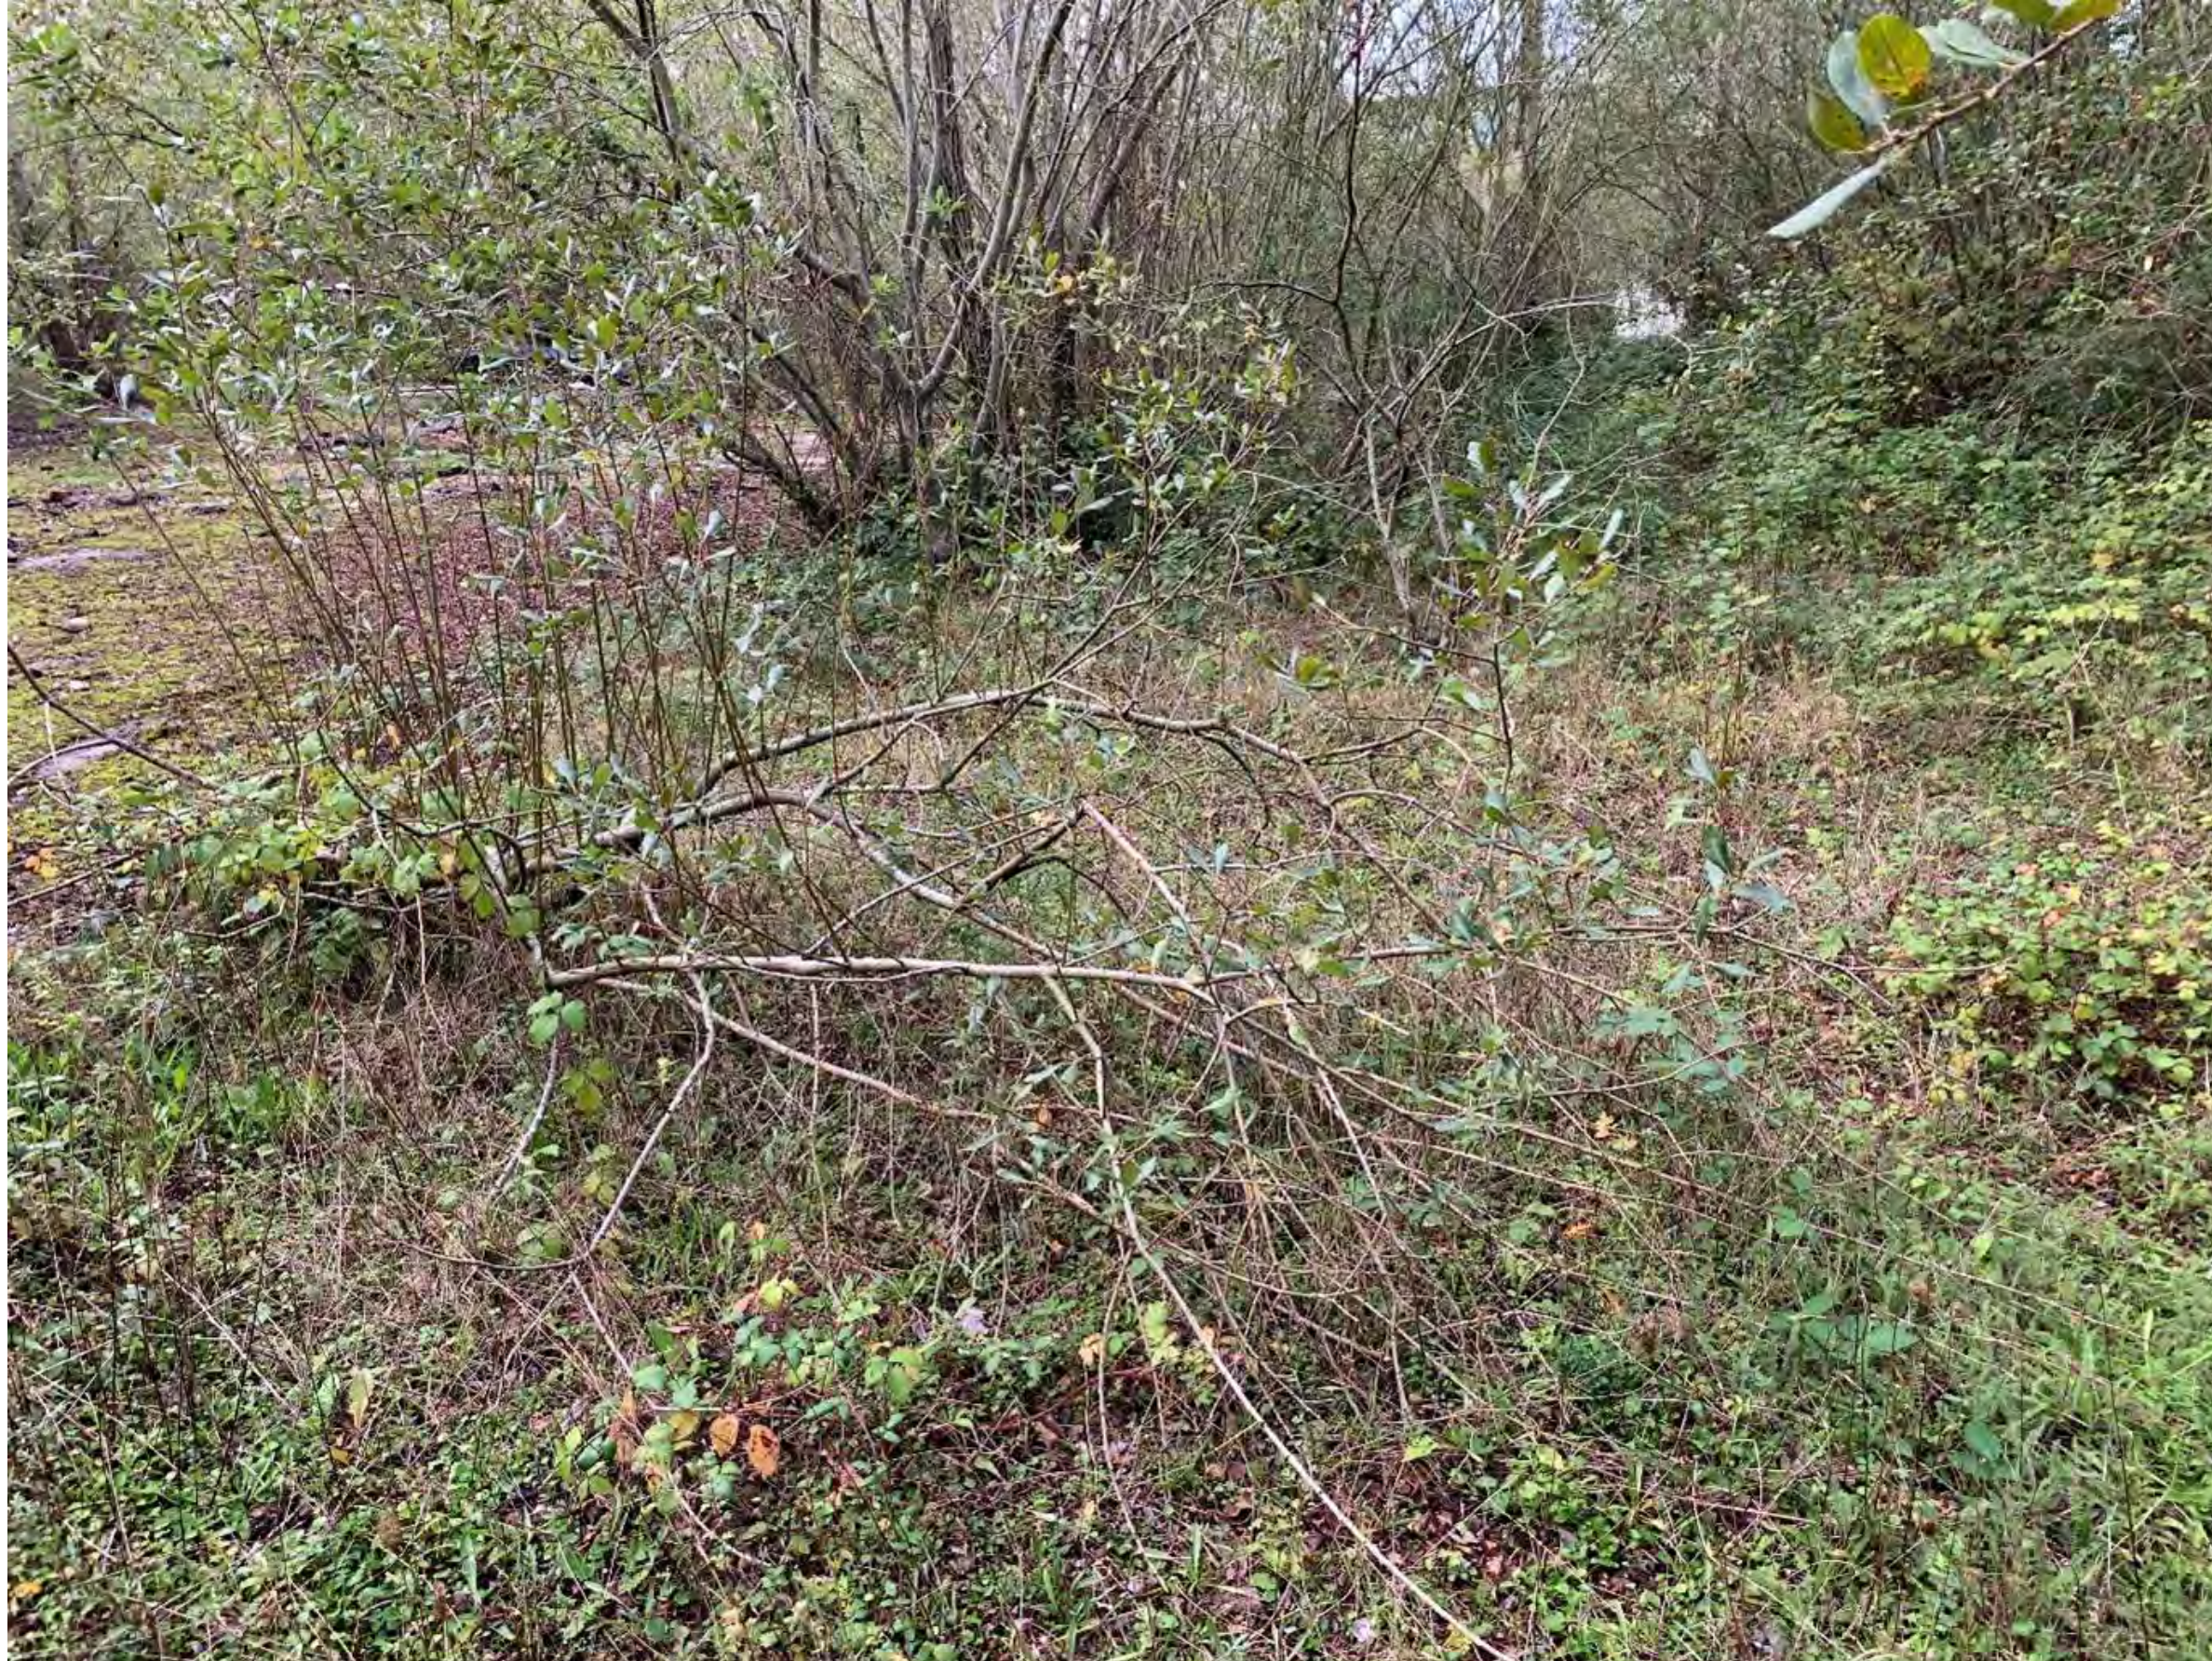
## VIEW 14

View from within Woodland TPO Area  
Looking south to the Reading  
International Business Park.

Image shows recolonised ground at the  
western side of the old car park. Low  
quality, self seeded trees and shrubs.

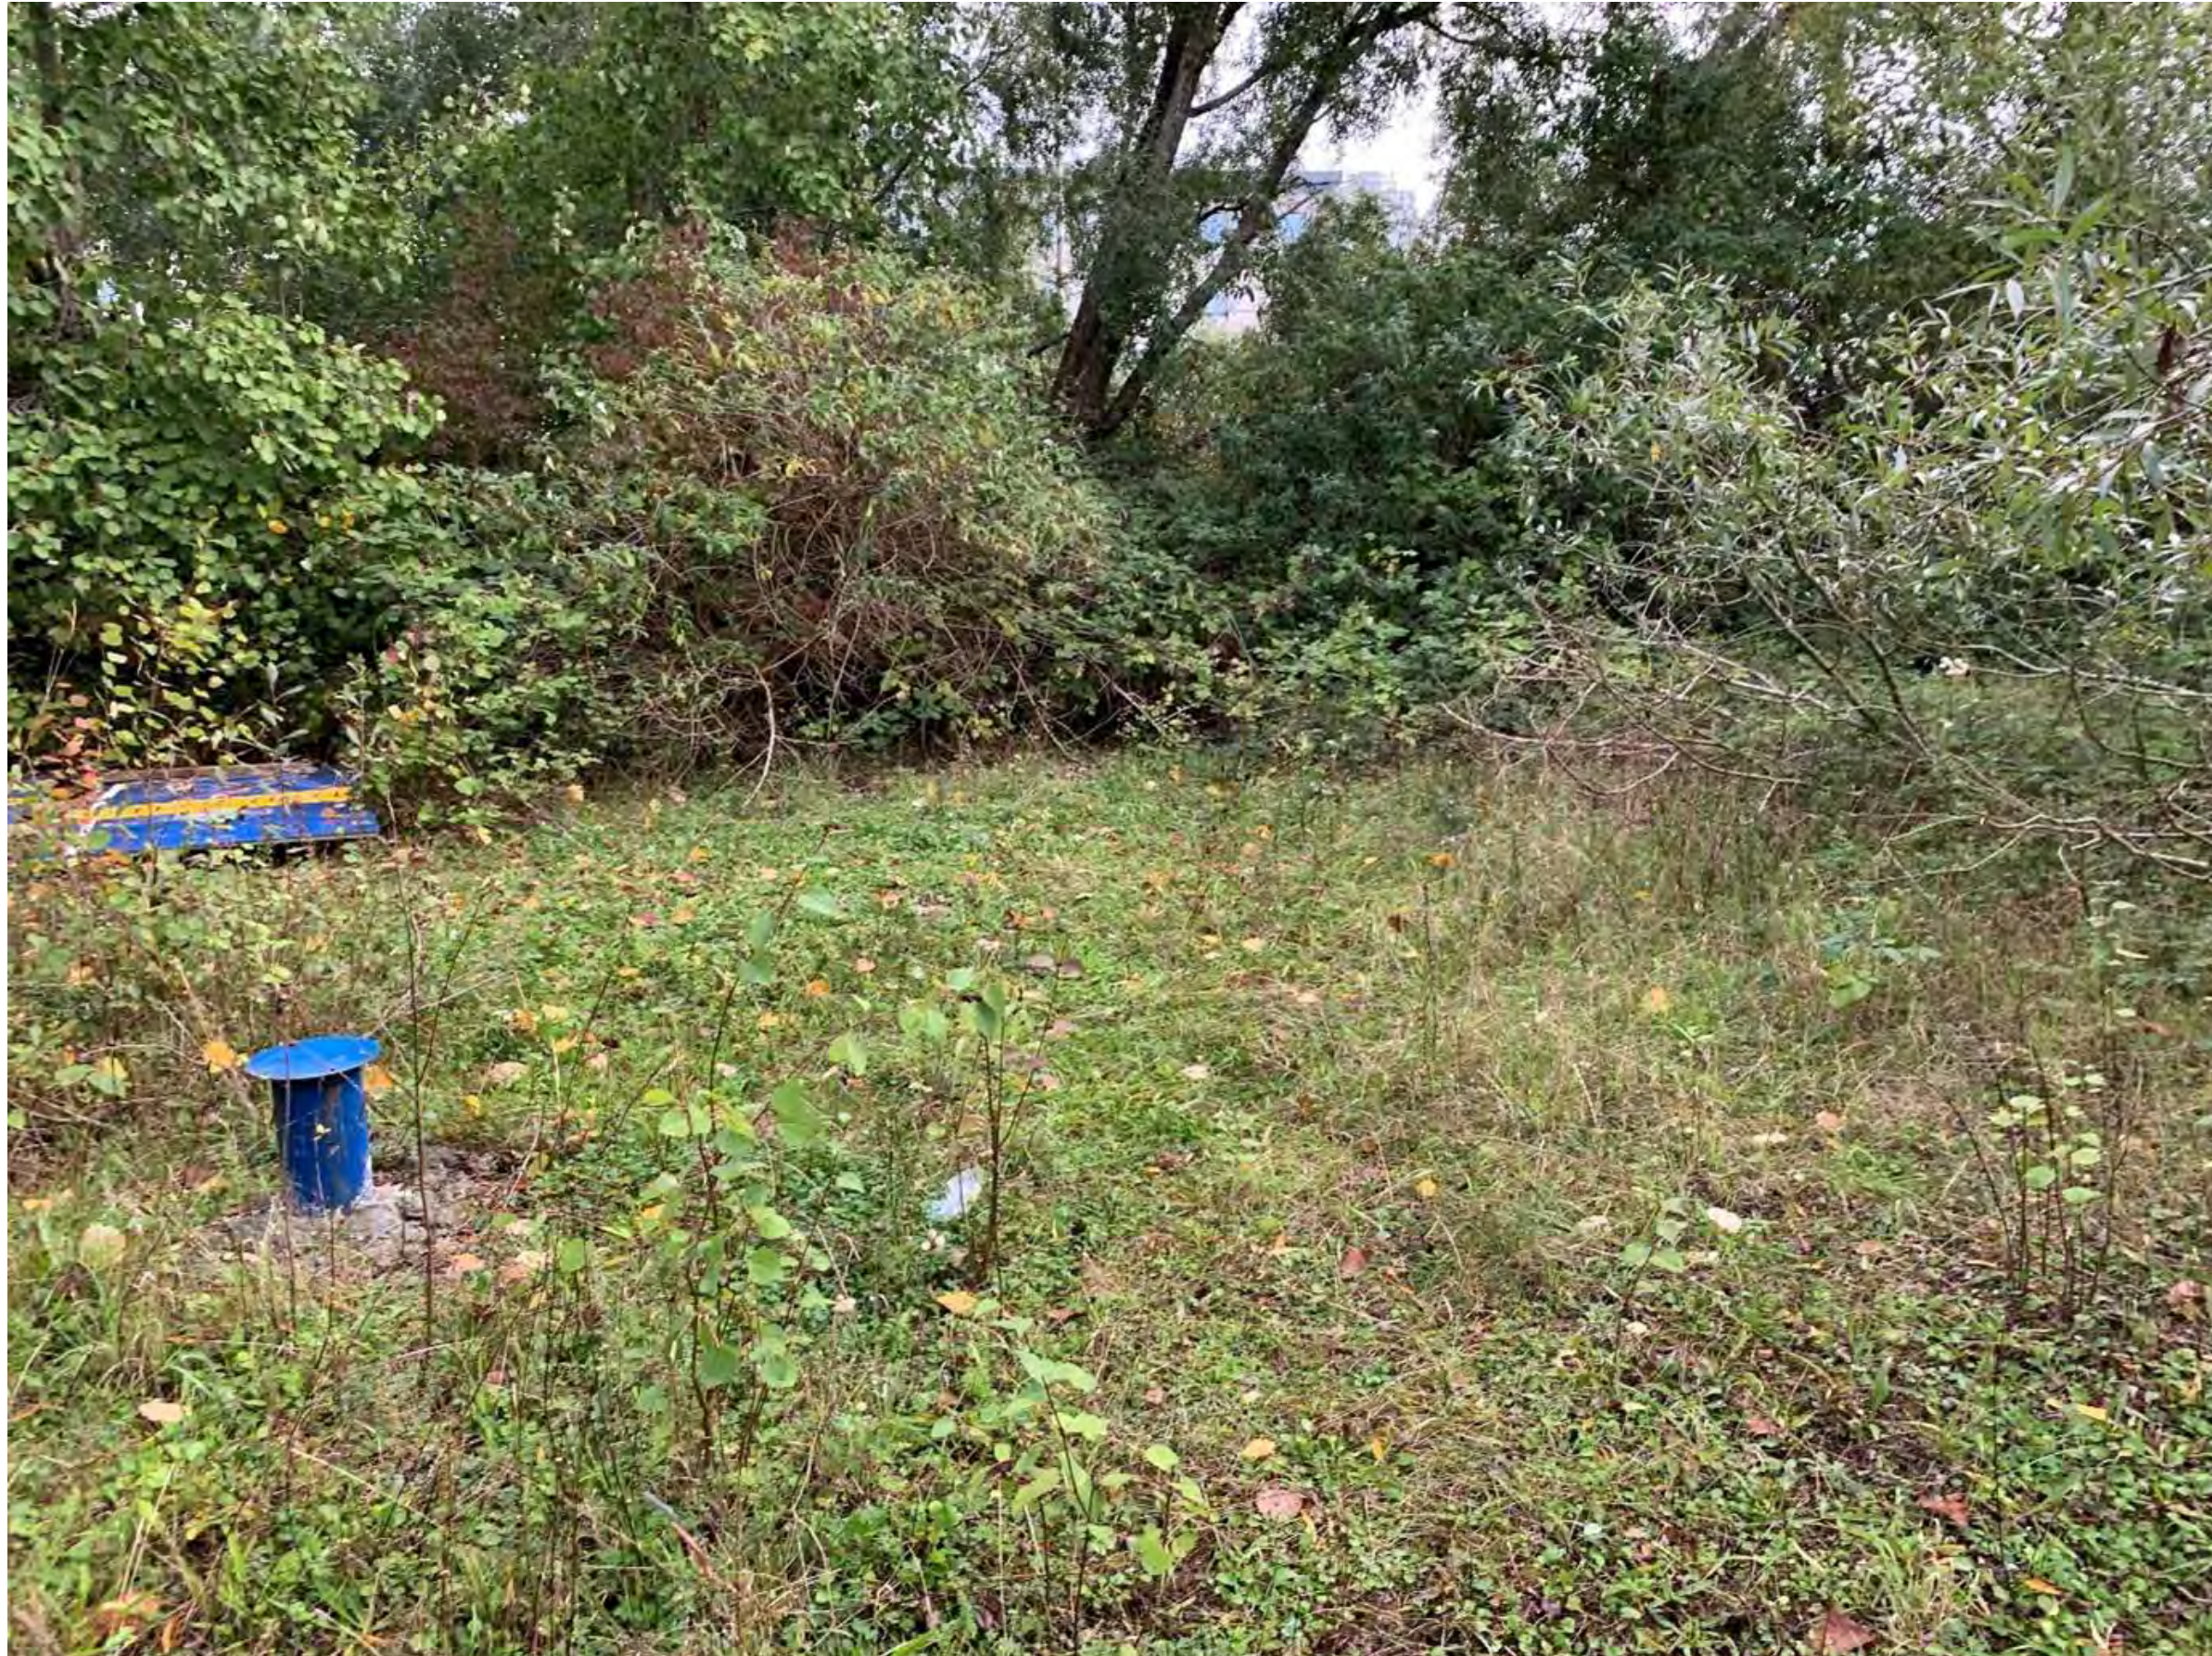
## VIEW 15

View from within Woodland TPO Area  
Looking north to the Premier Inn hotel

The image shows area of grassland  
with low quality self seeded trees and  
shrubs around it's perimeter.

The image also shows a group of  
larger trees in the background  
consisting of Ash and willow.

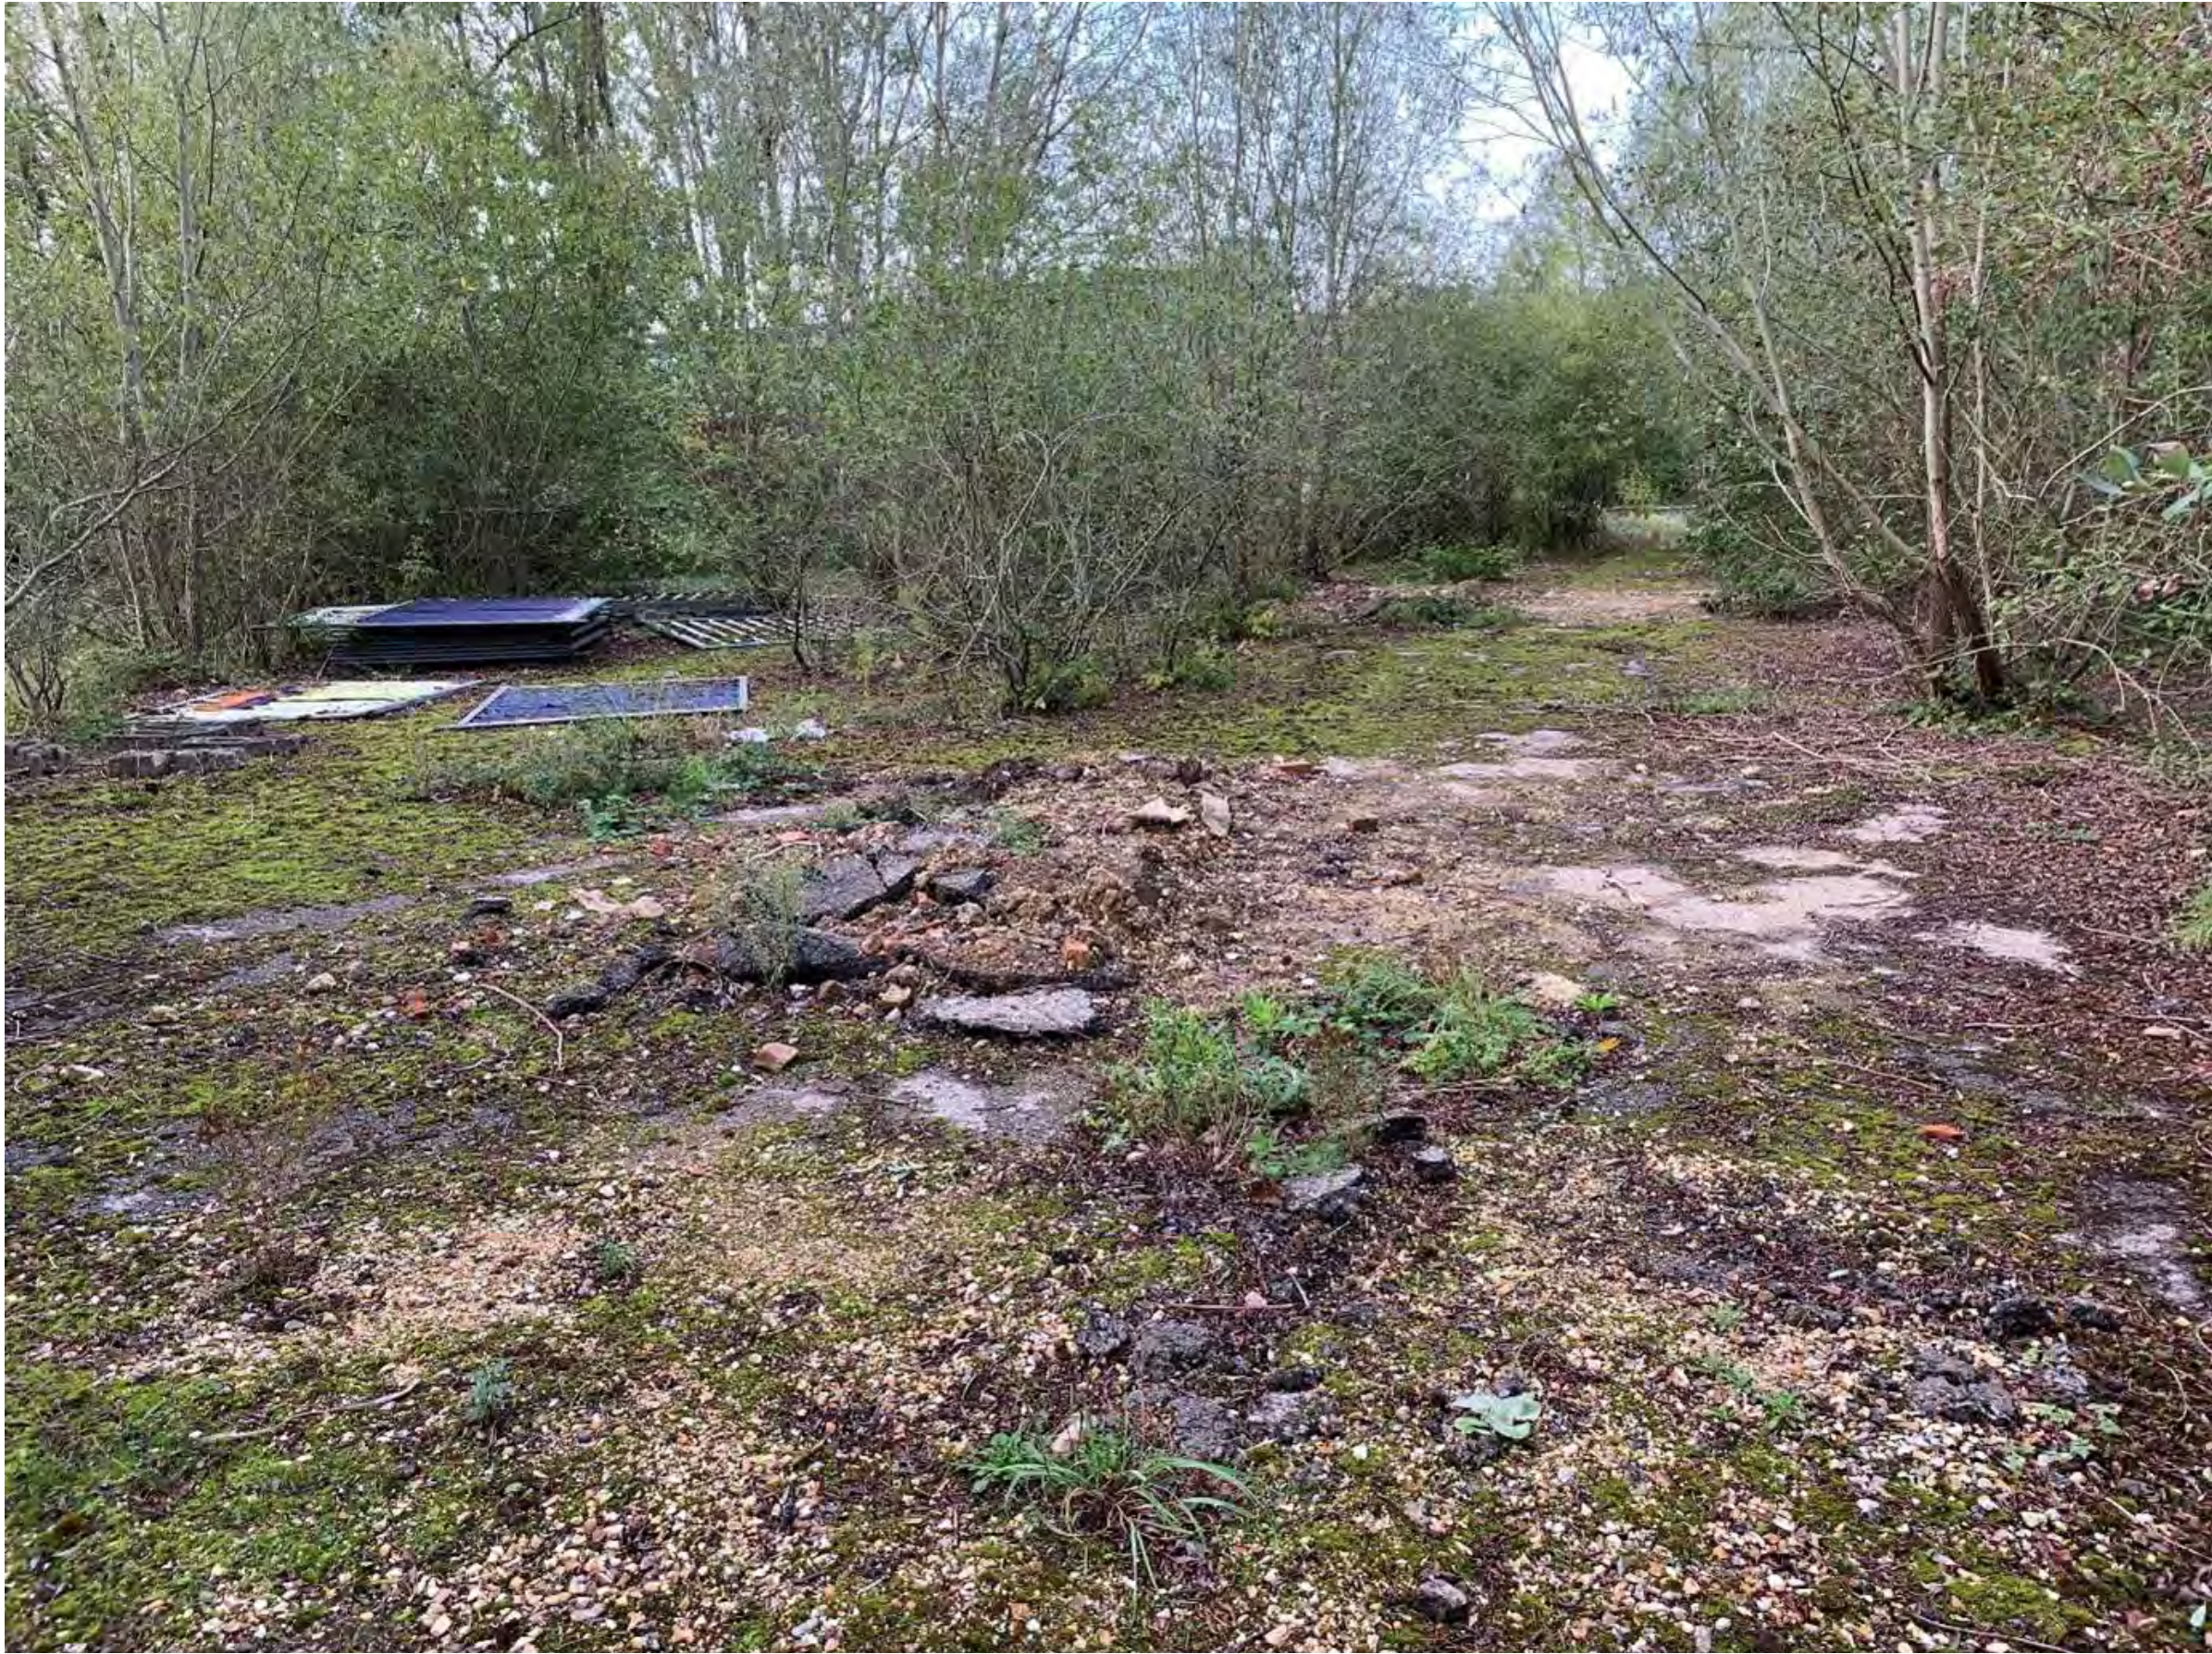
VIEW 16

View from within Woodland TPO Area  
Looking south to the Reading  
International Business Park.

Image shows self-seeded shrubs/ small  
trees breaking through asphalt hard  
standing of the old car park.

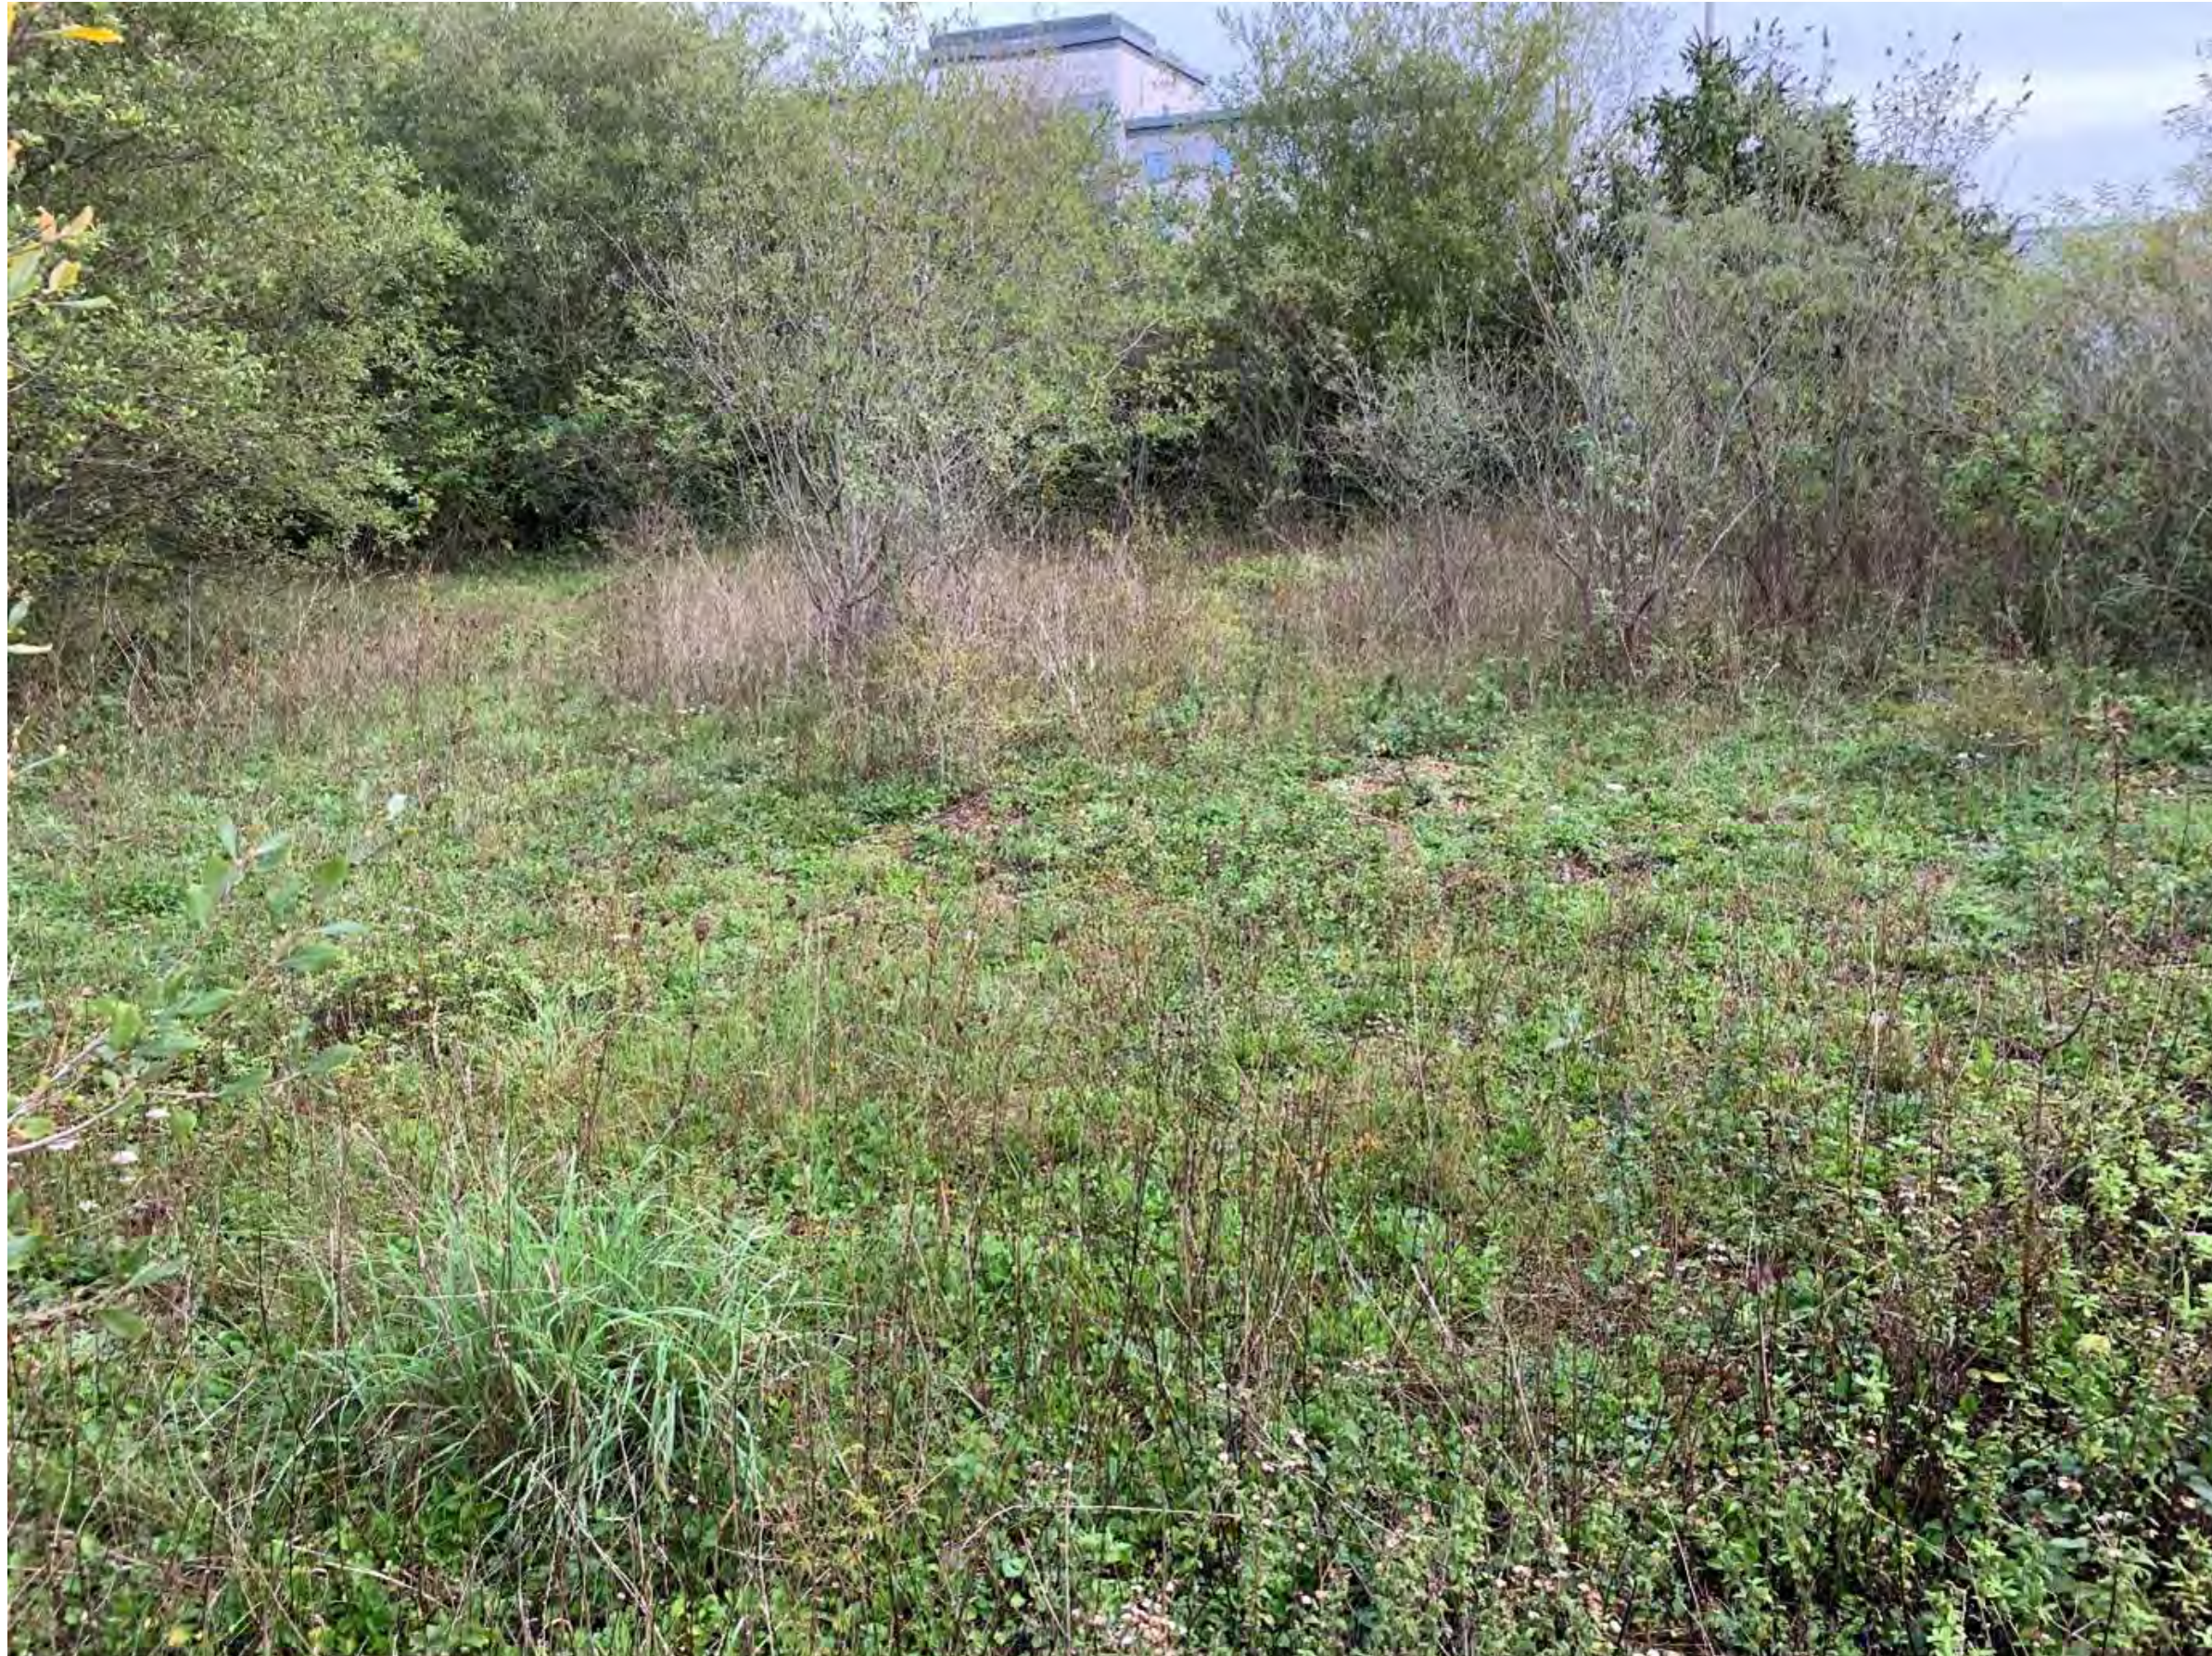
## VIEW 17

View from within Woodland TPO Area  
Looking north to the Premier Inn.

Image shows low quality self-seeded  
willow in re-colonising ground
