# READING INTERNATIONAL BUSINESS PARK

1219-G509 EASTERN WOODLAND AREA PHOTOS  
OCTOBER 2020

The following images have been taken on the morning of 7th October 2020. The images show a range of views from within the 'Woodland' area to the south east of the site where we propose to create the Unit 1 car park.

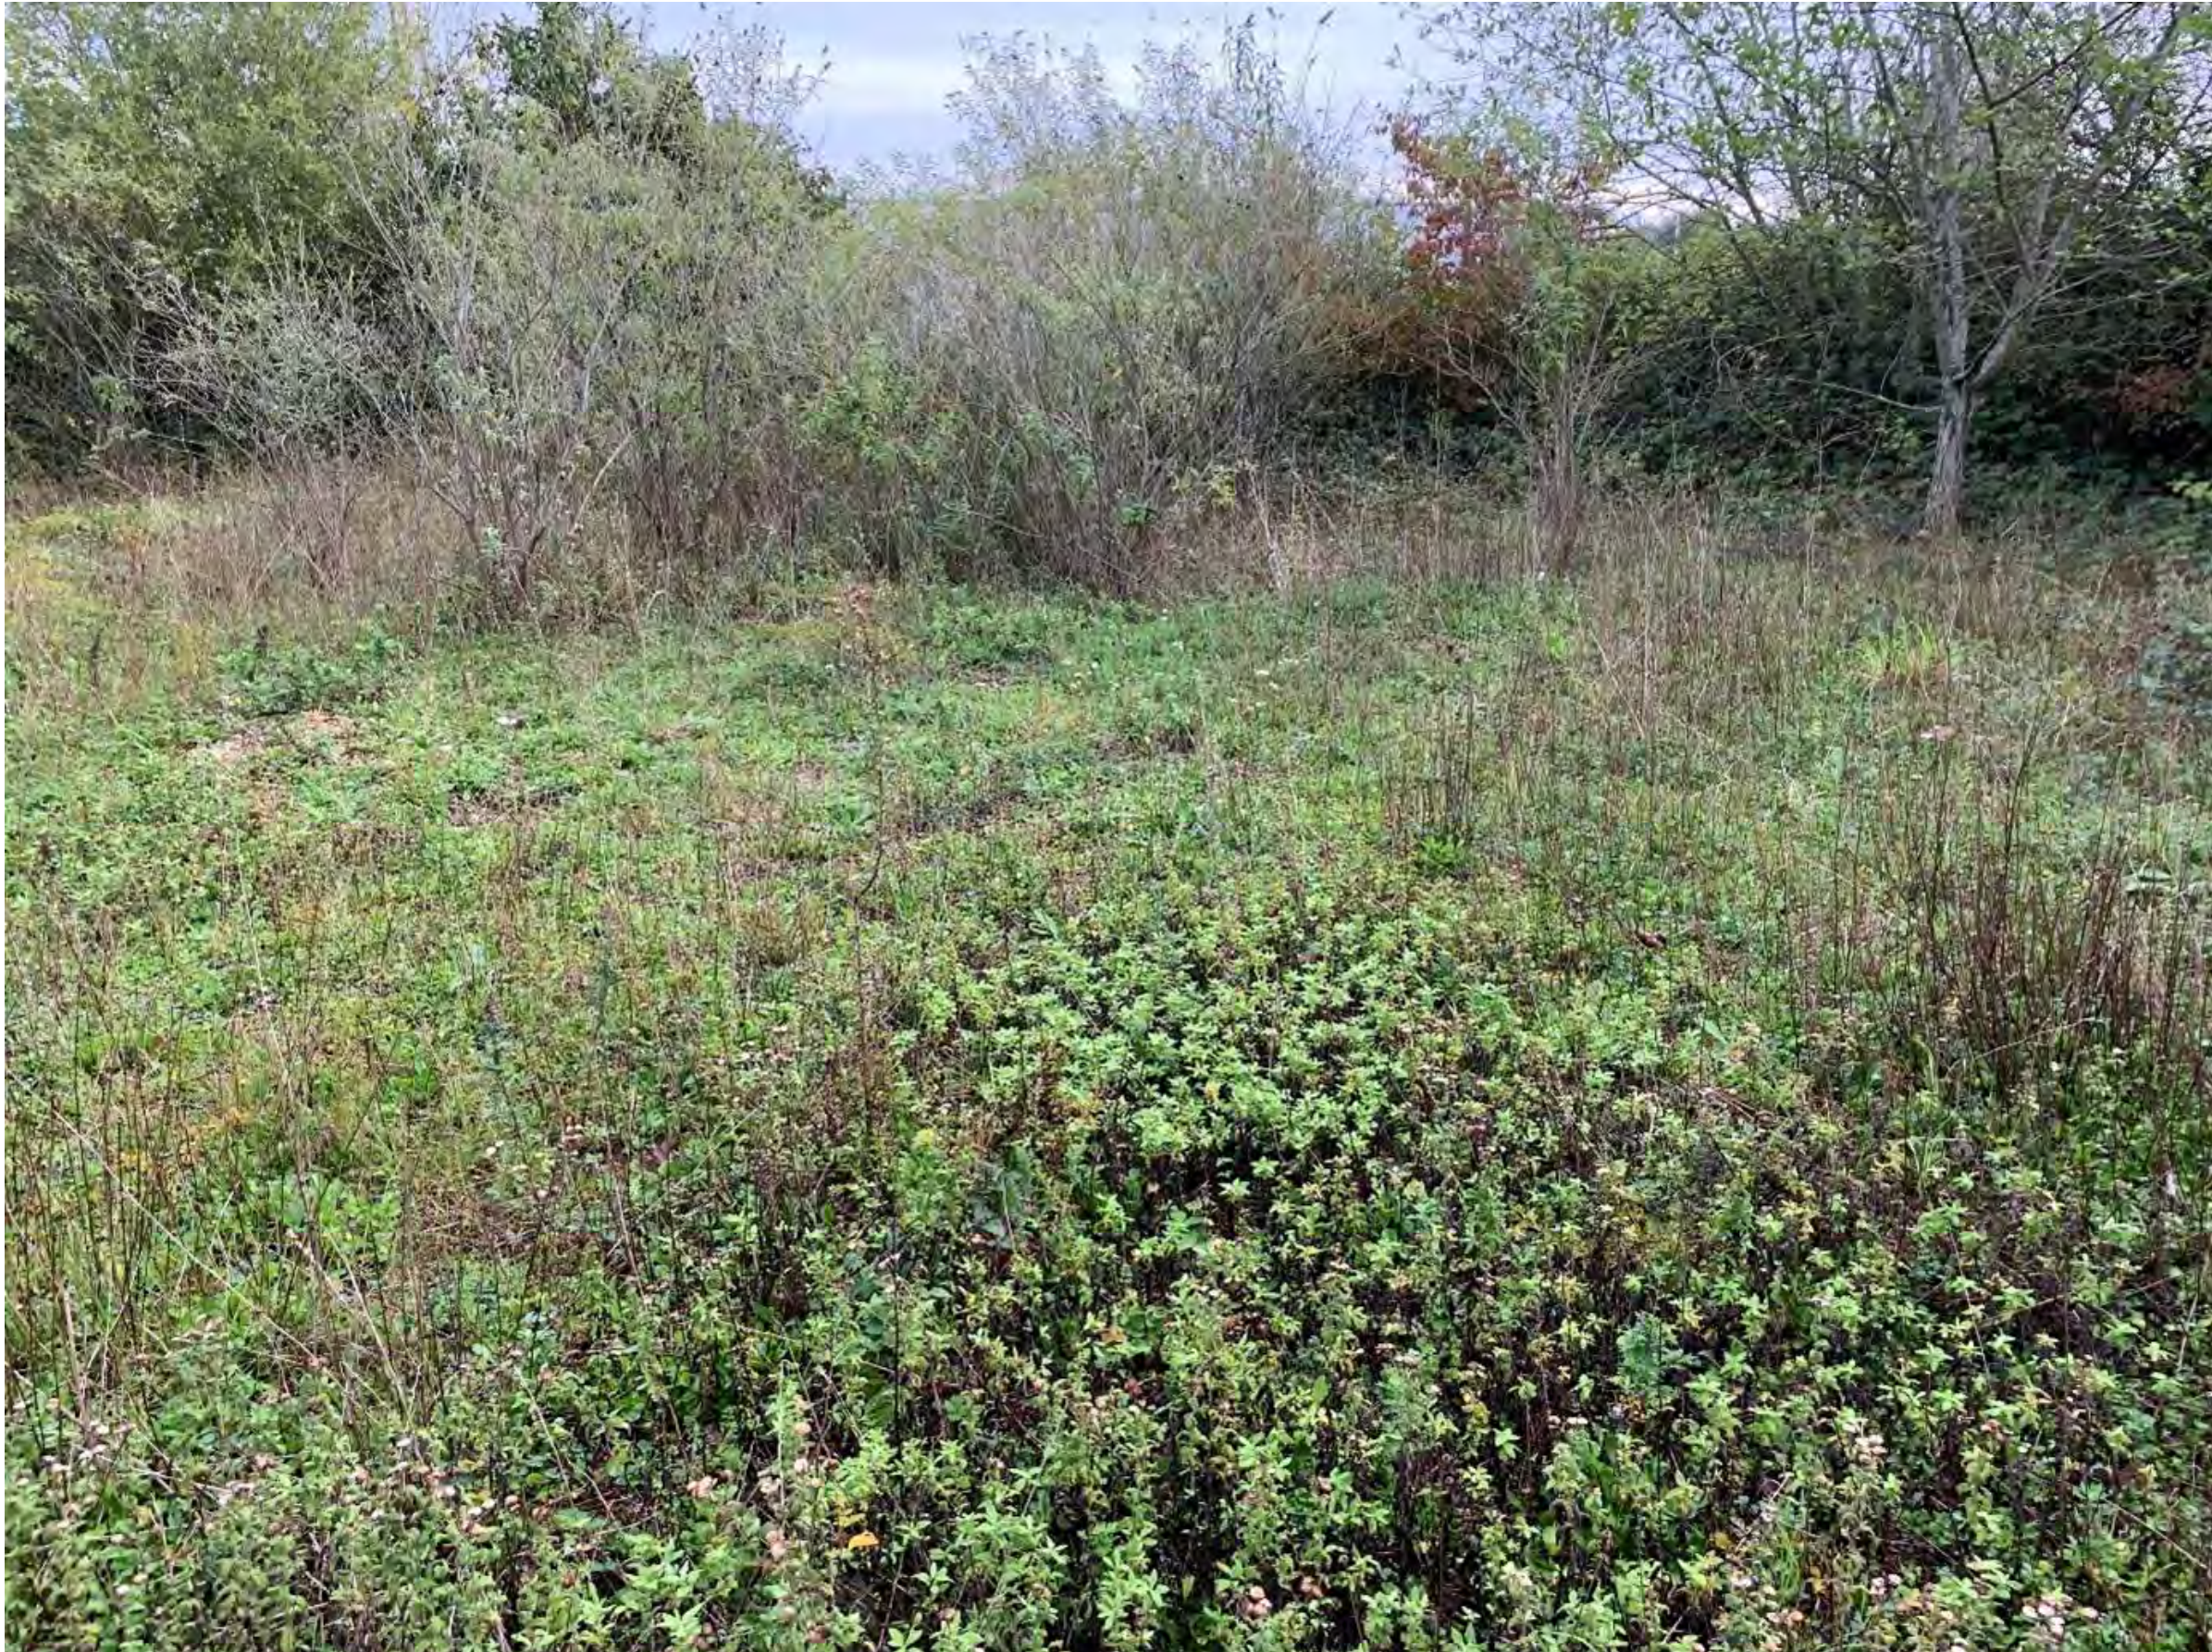
VIEW 18

View from within Woodland TPO Area  
Looking north east towards Toys R Us.

Image shows low quality self-seeded  
willow in re-colonising ground

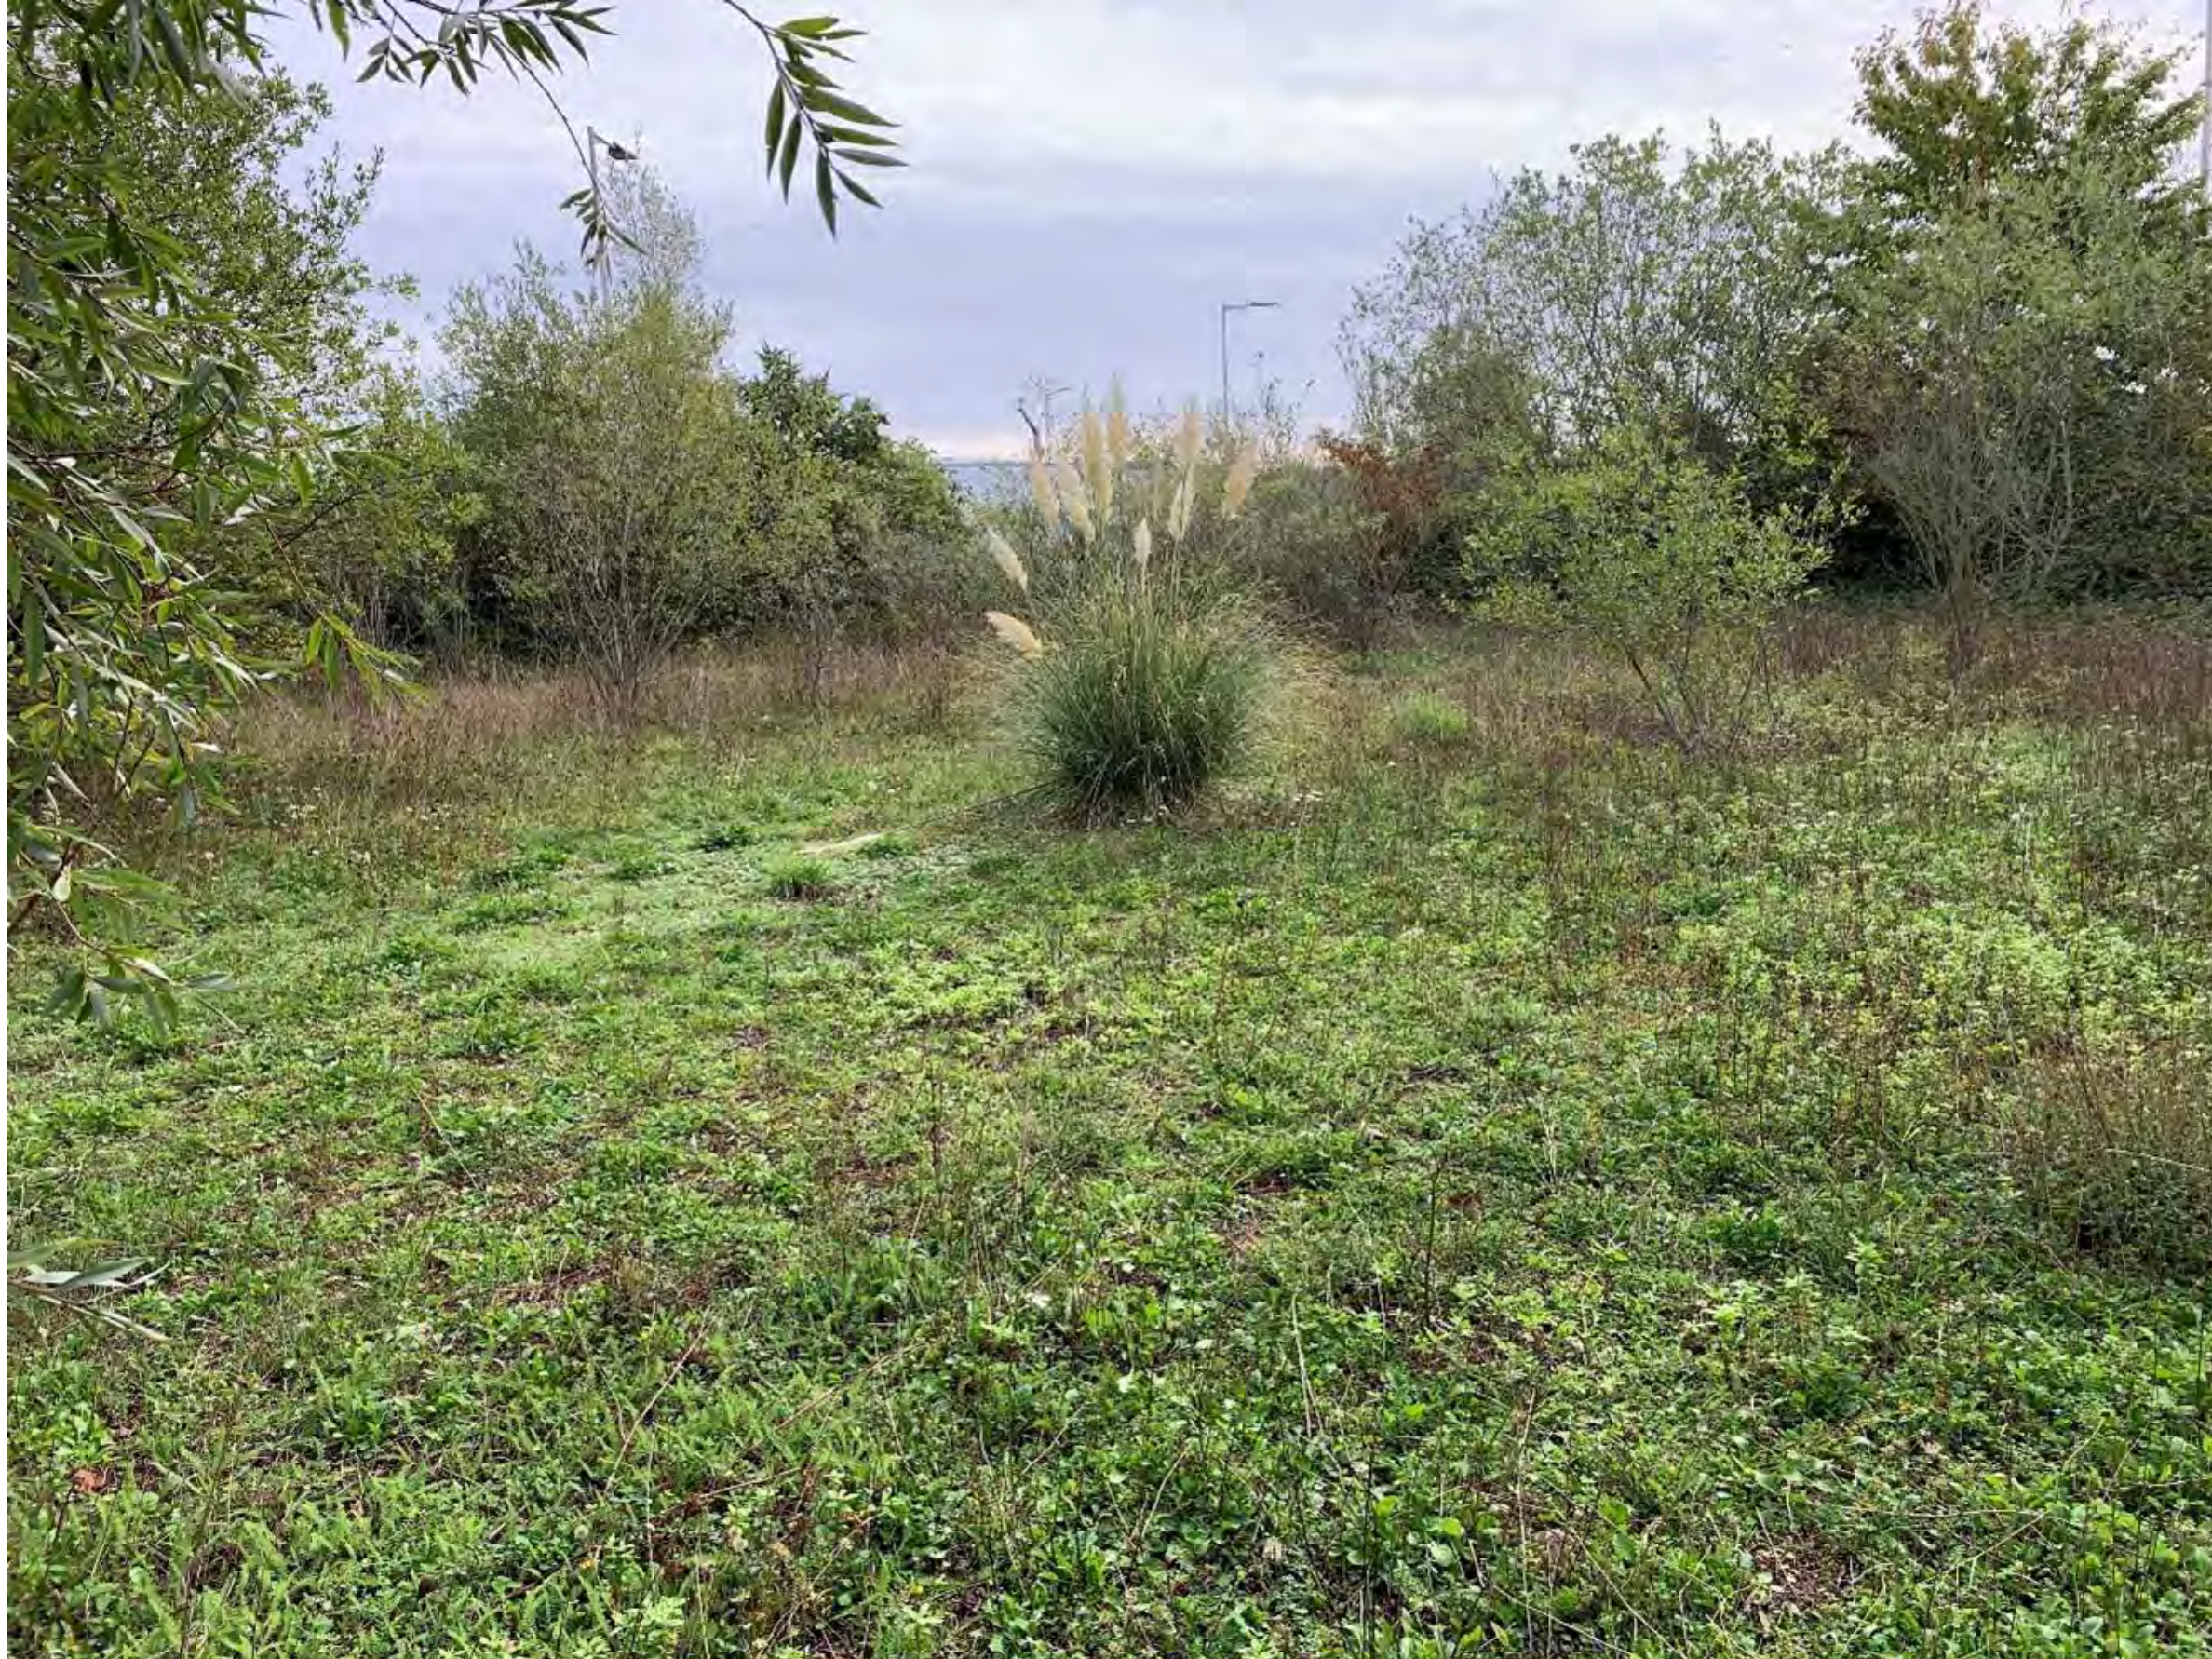
## VIEW 19

View from within Woodland TPO Area  
Looking north east towards Toys R Us.

Image shows low quality self-seeded  
scrub and pampas grass in  
re-colonising ground.

Background trees are mostly willow  
with one wild cherry

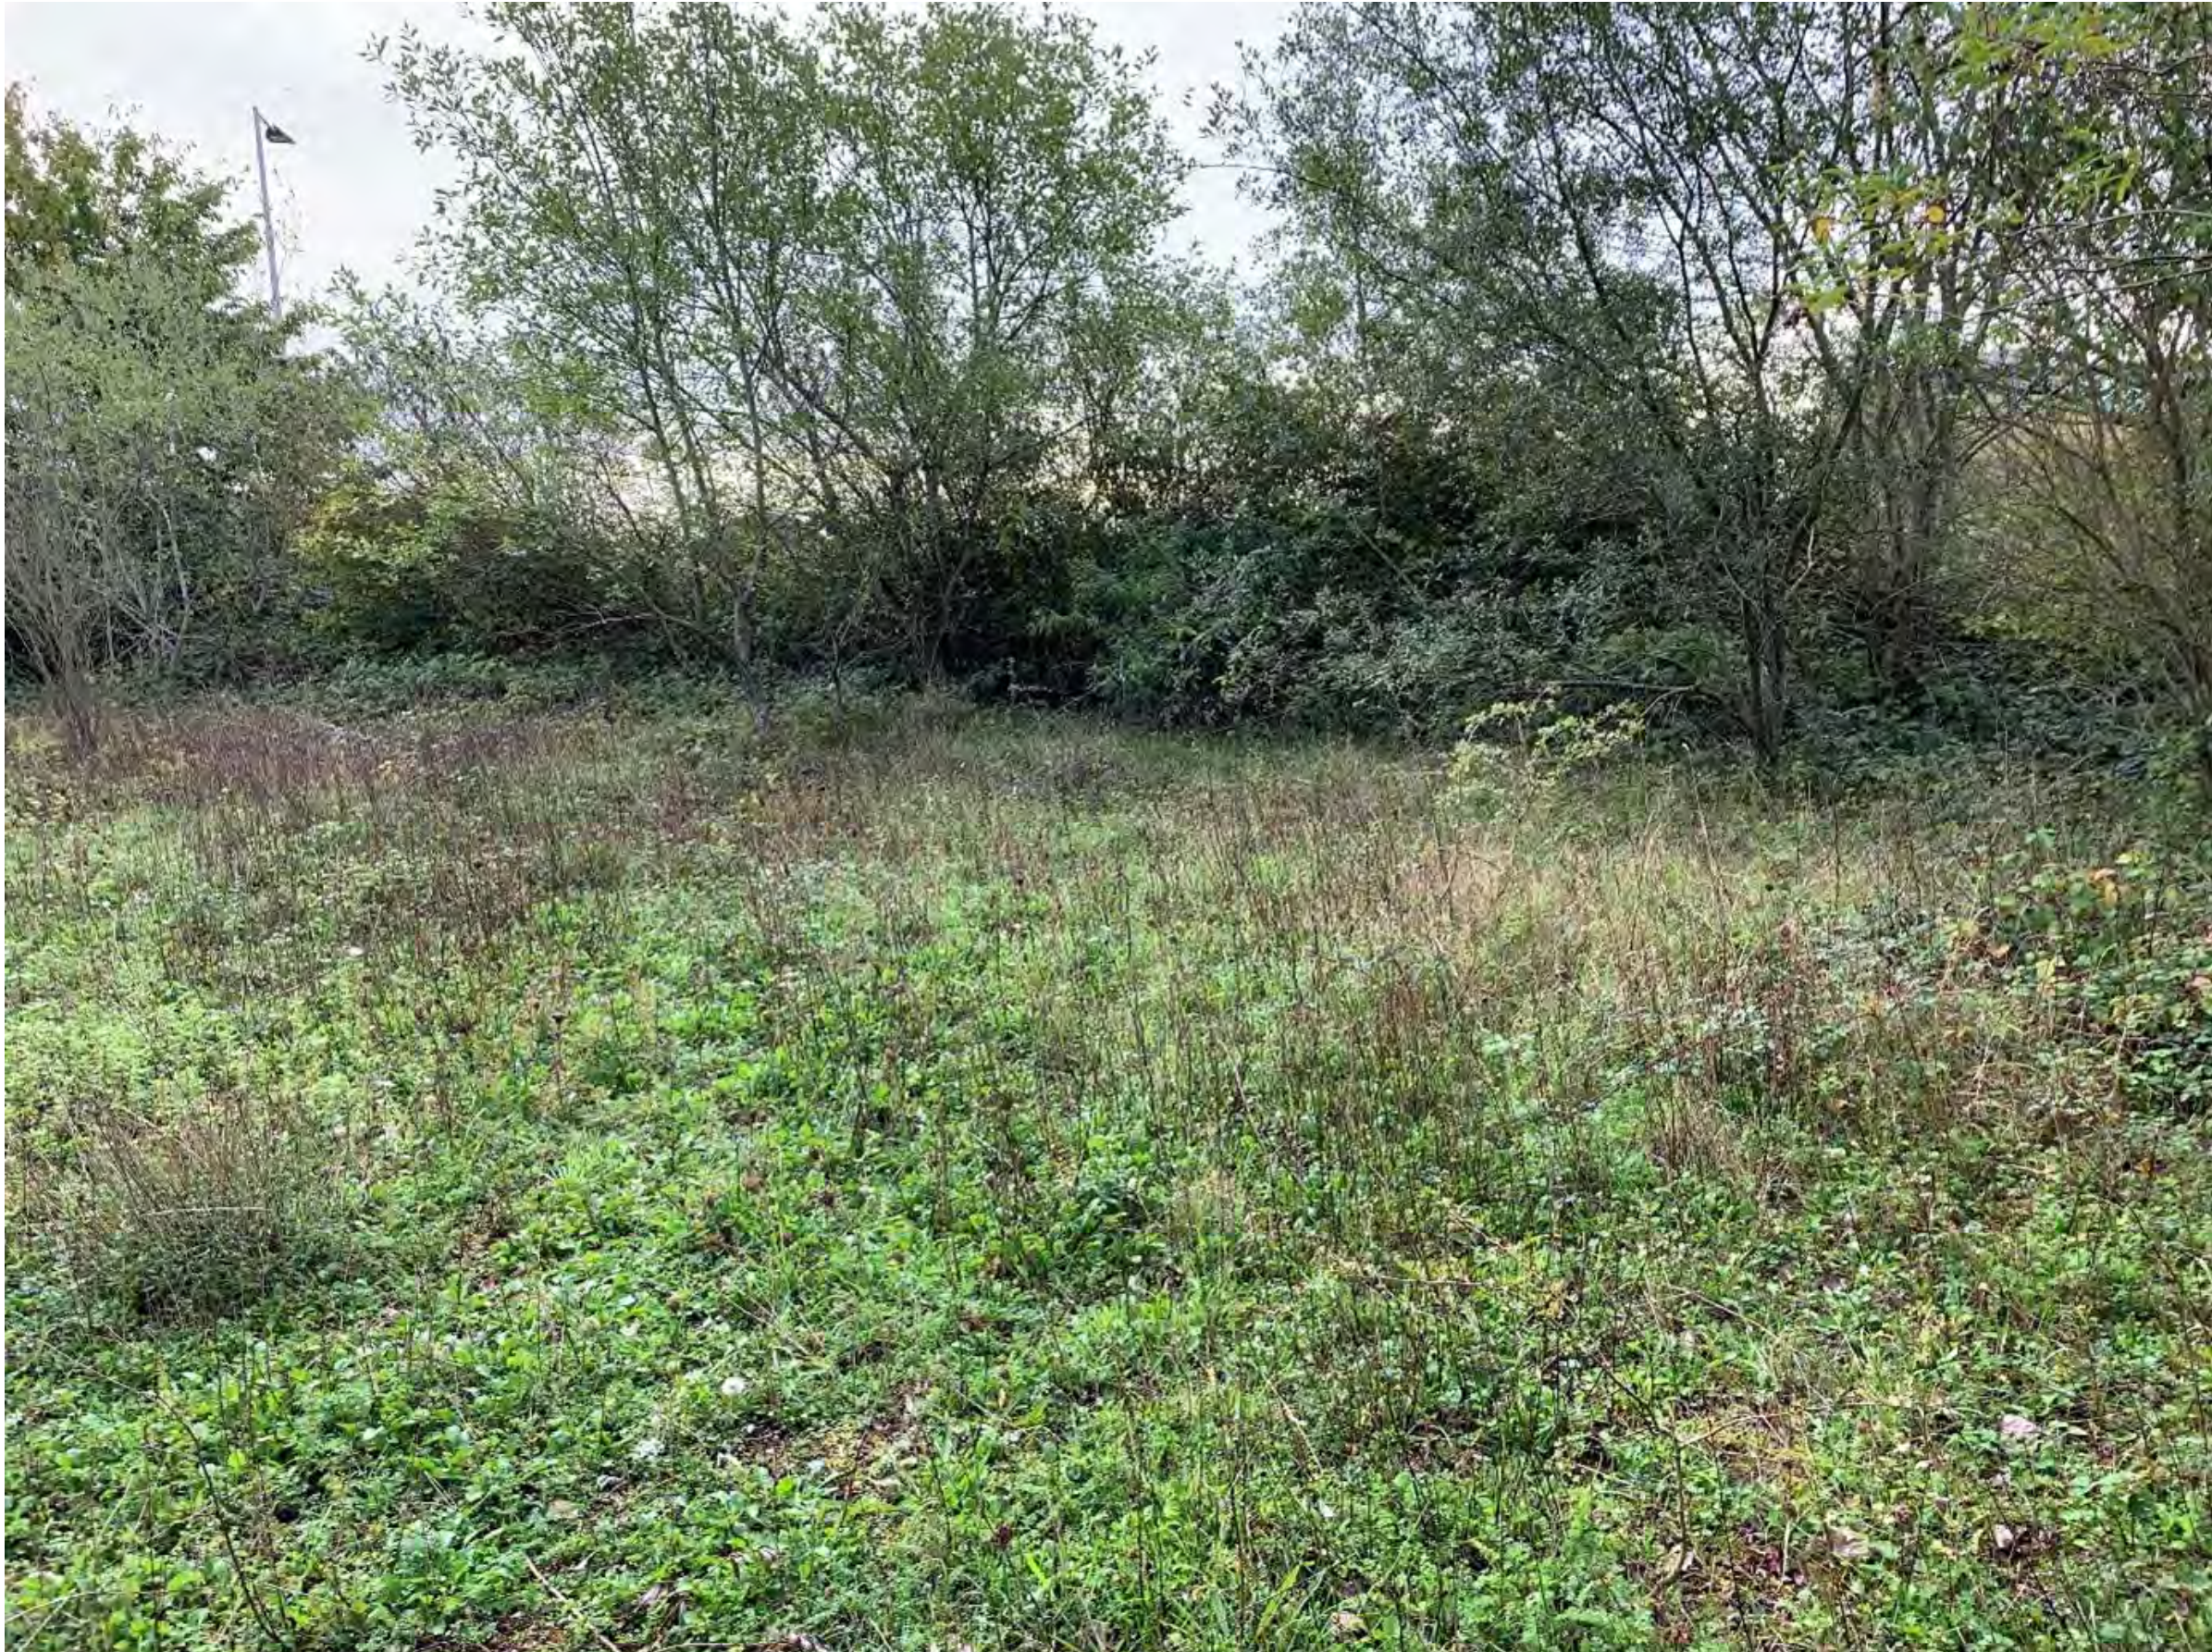
VIEW 20

View from within Woodland TPO Area  
Looking south east to the Reading  
International Business Park

Image shows re-colonising ground with  
a group of self seeded willow.

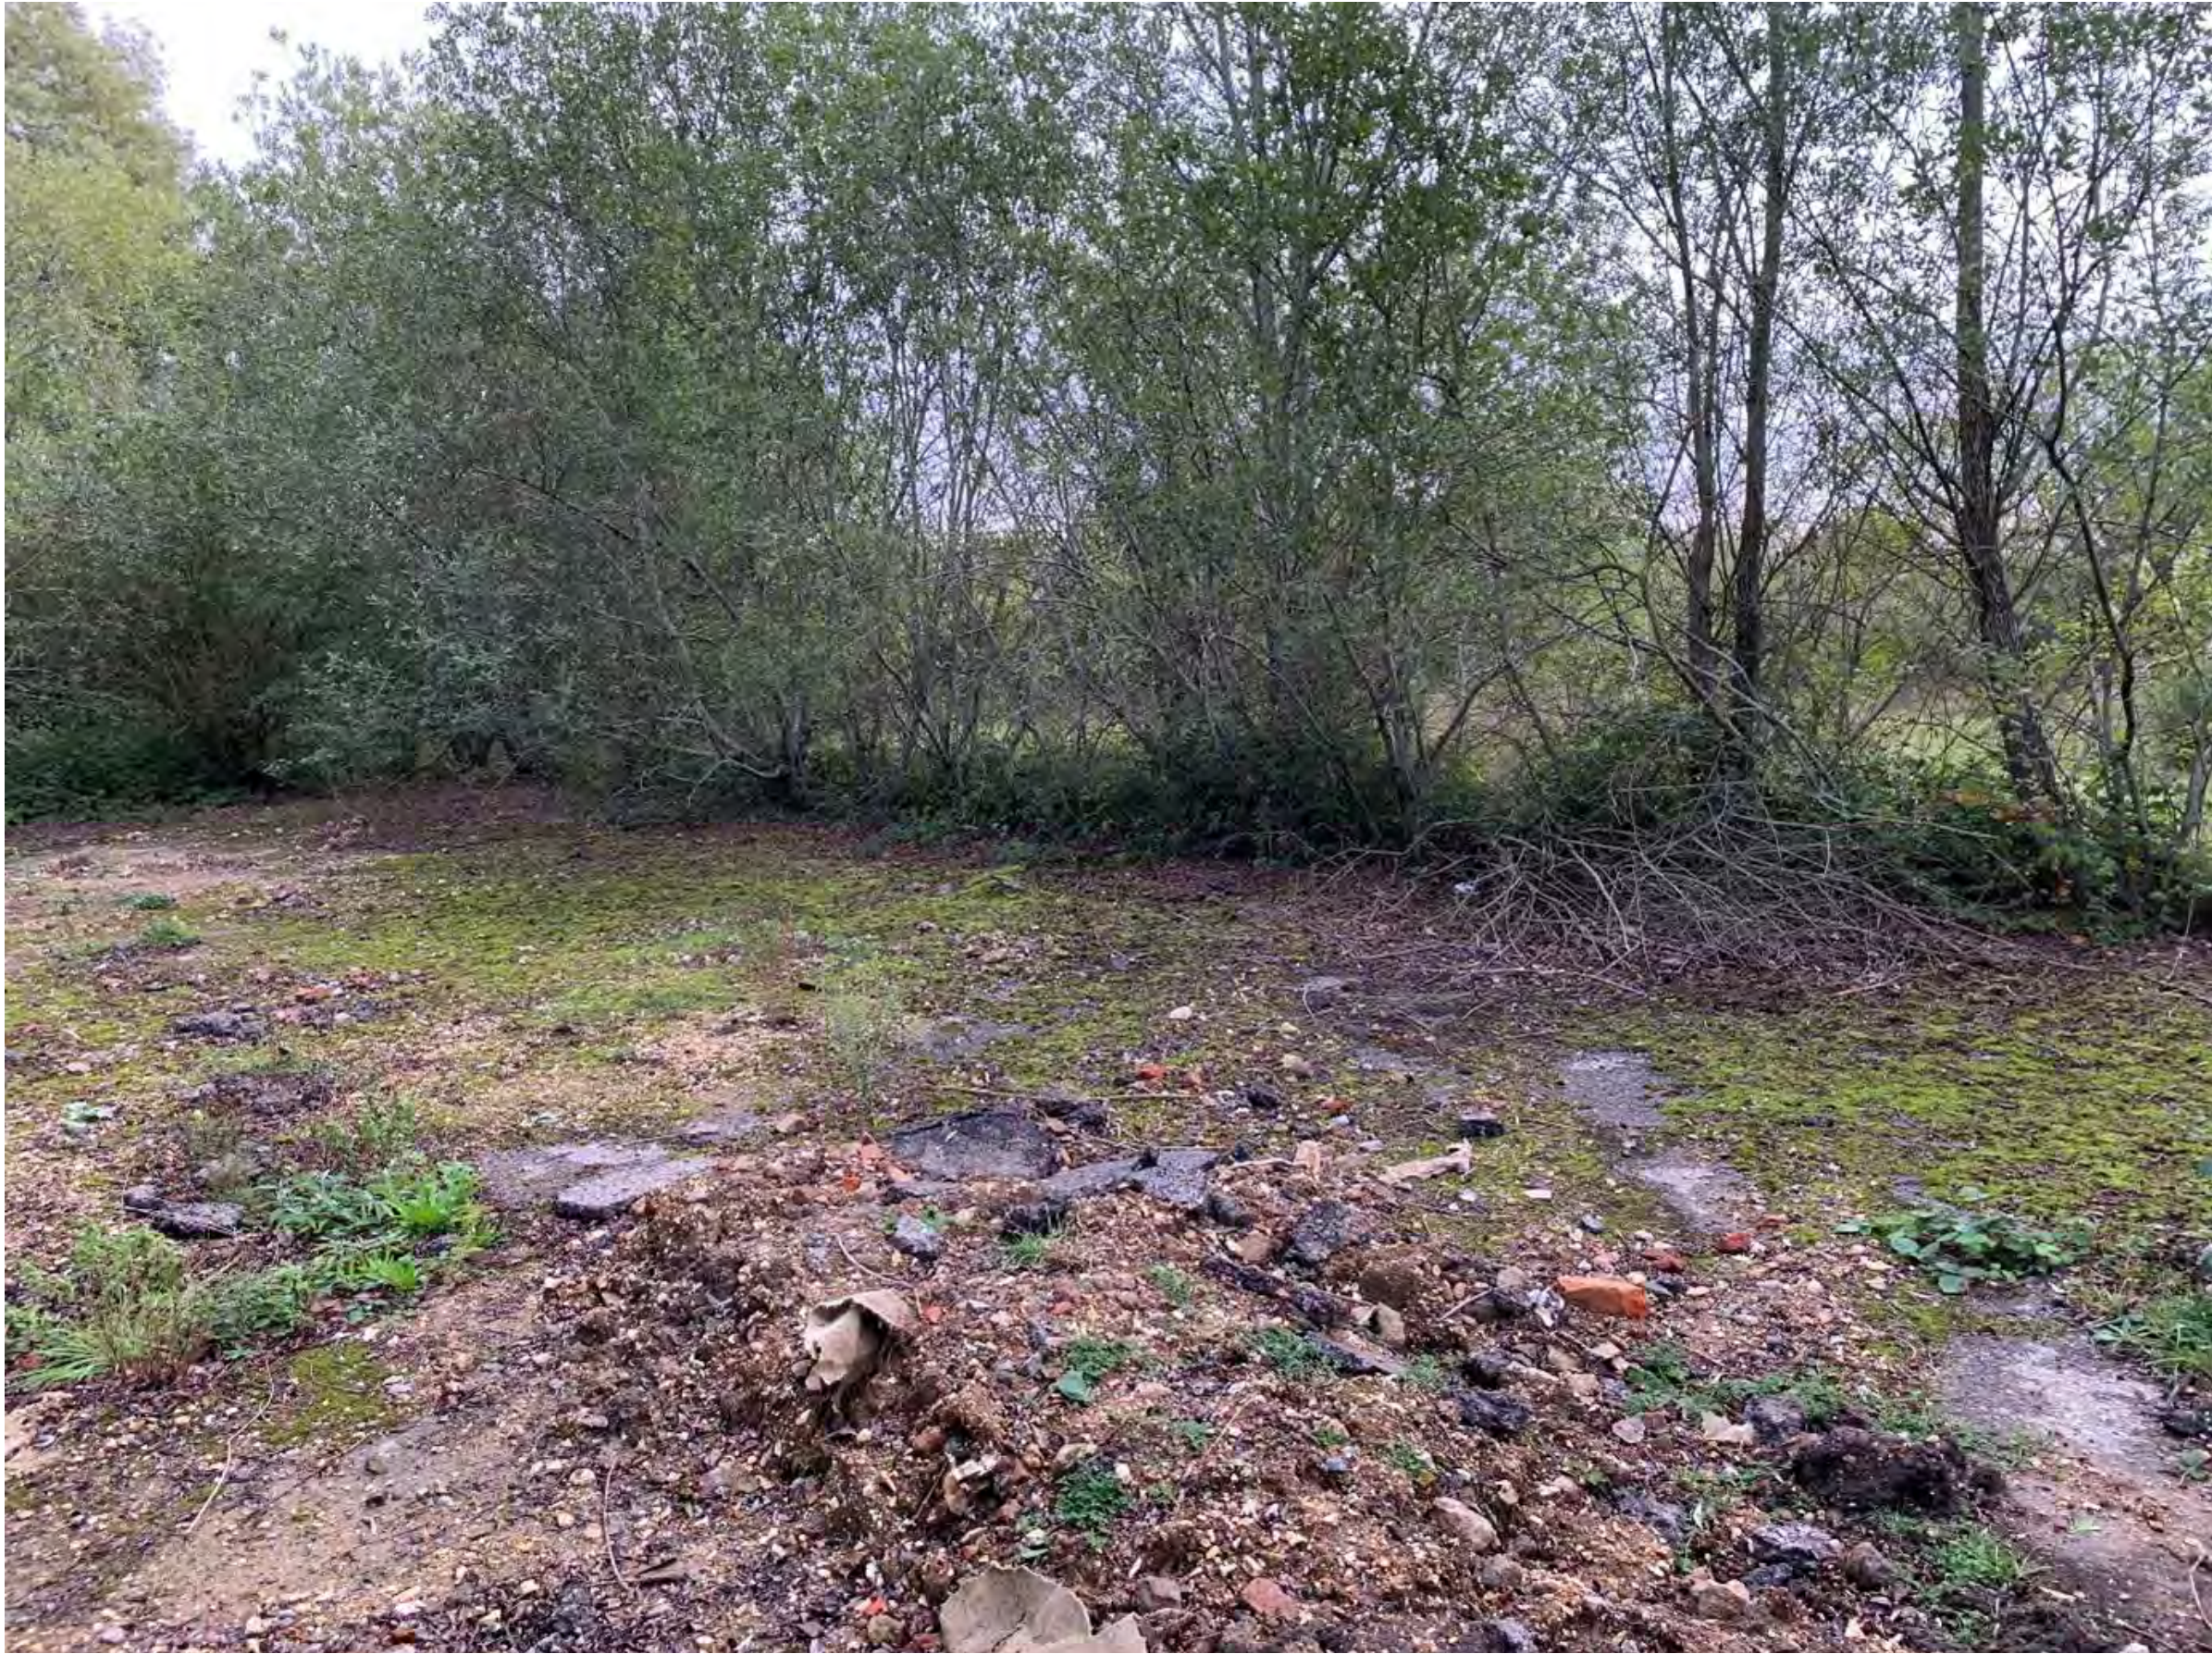
**VIEW 21**

View from within Woodland TPO Area  
Looking north east

Image shows low quality self-seeded  
willow breaking through asphalt hard  
standing of old car park.

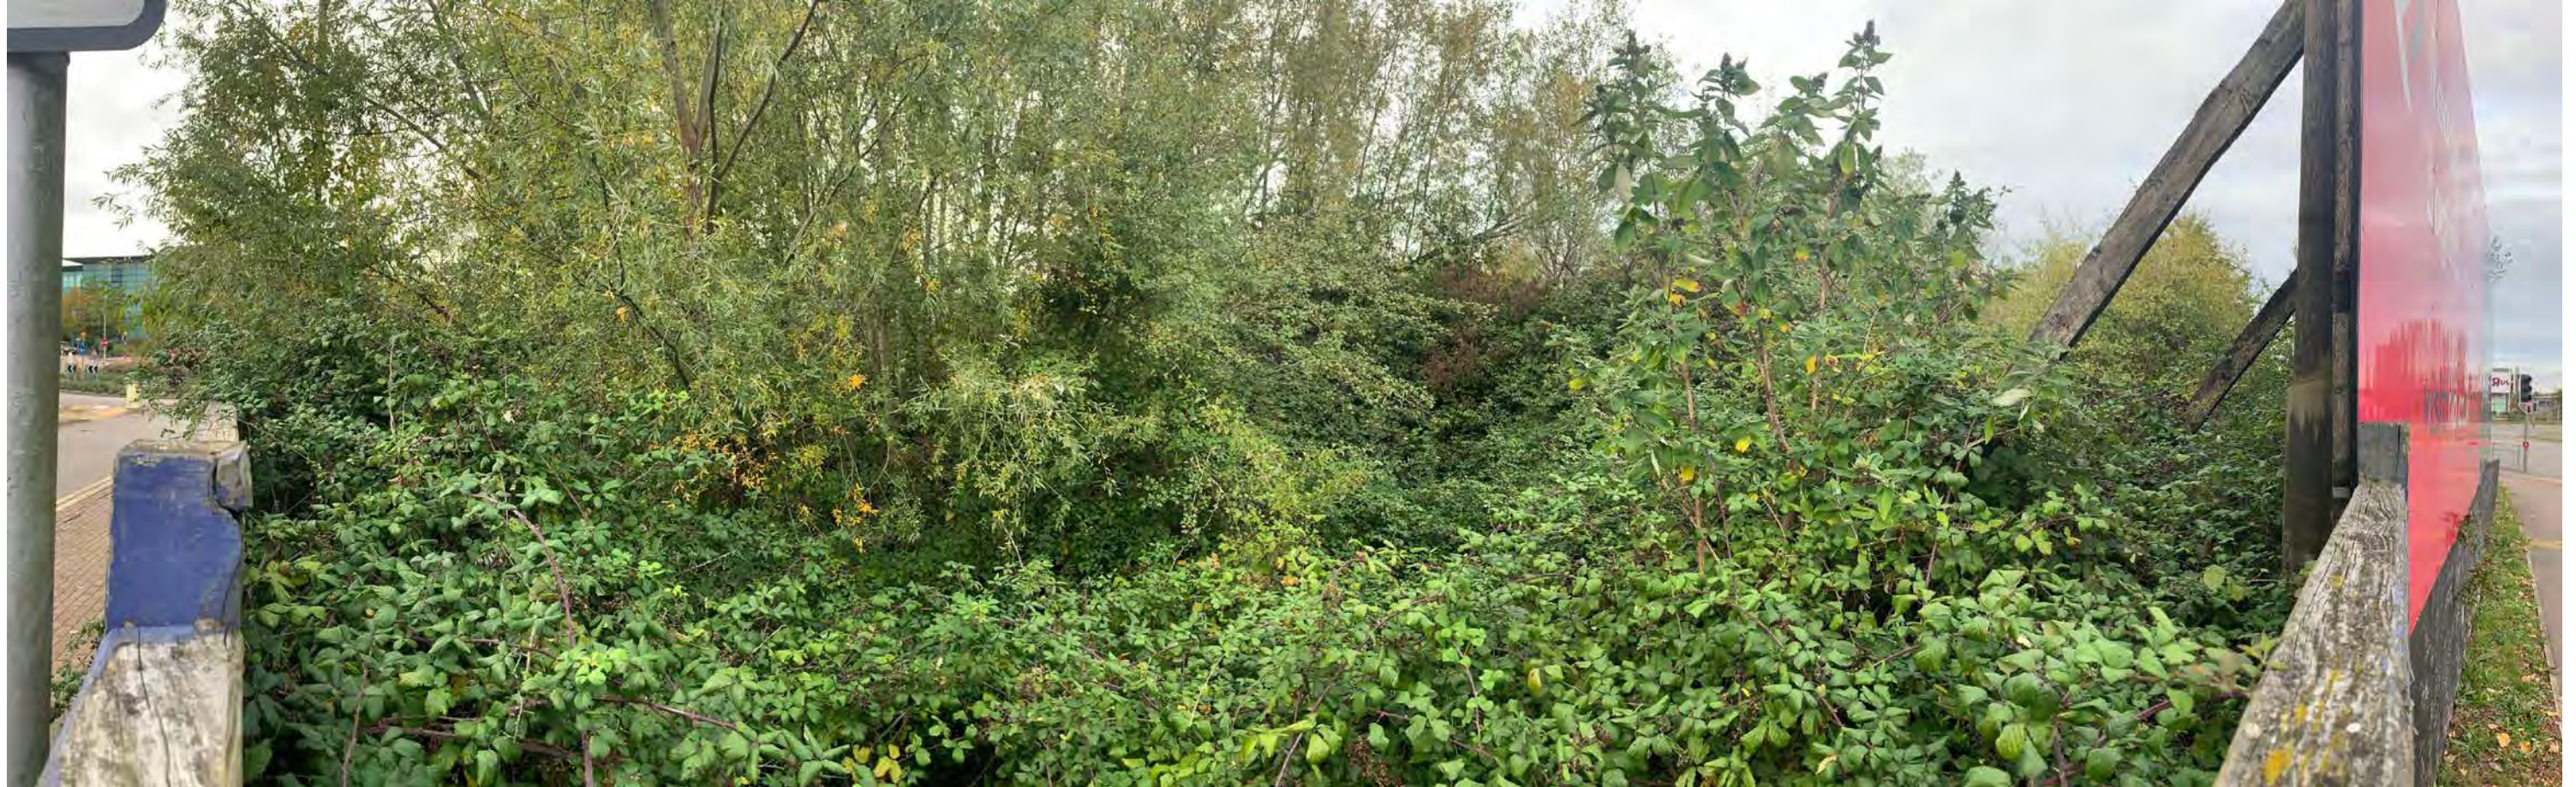
## VIEW 22

View over the boundary fence along the A33. The outer edge of the site, behind the boundary fence is mostly dense bramble thicket with self seeded willow trees approx. 3-6m behind it.

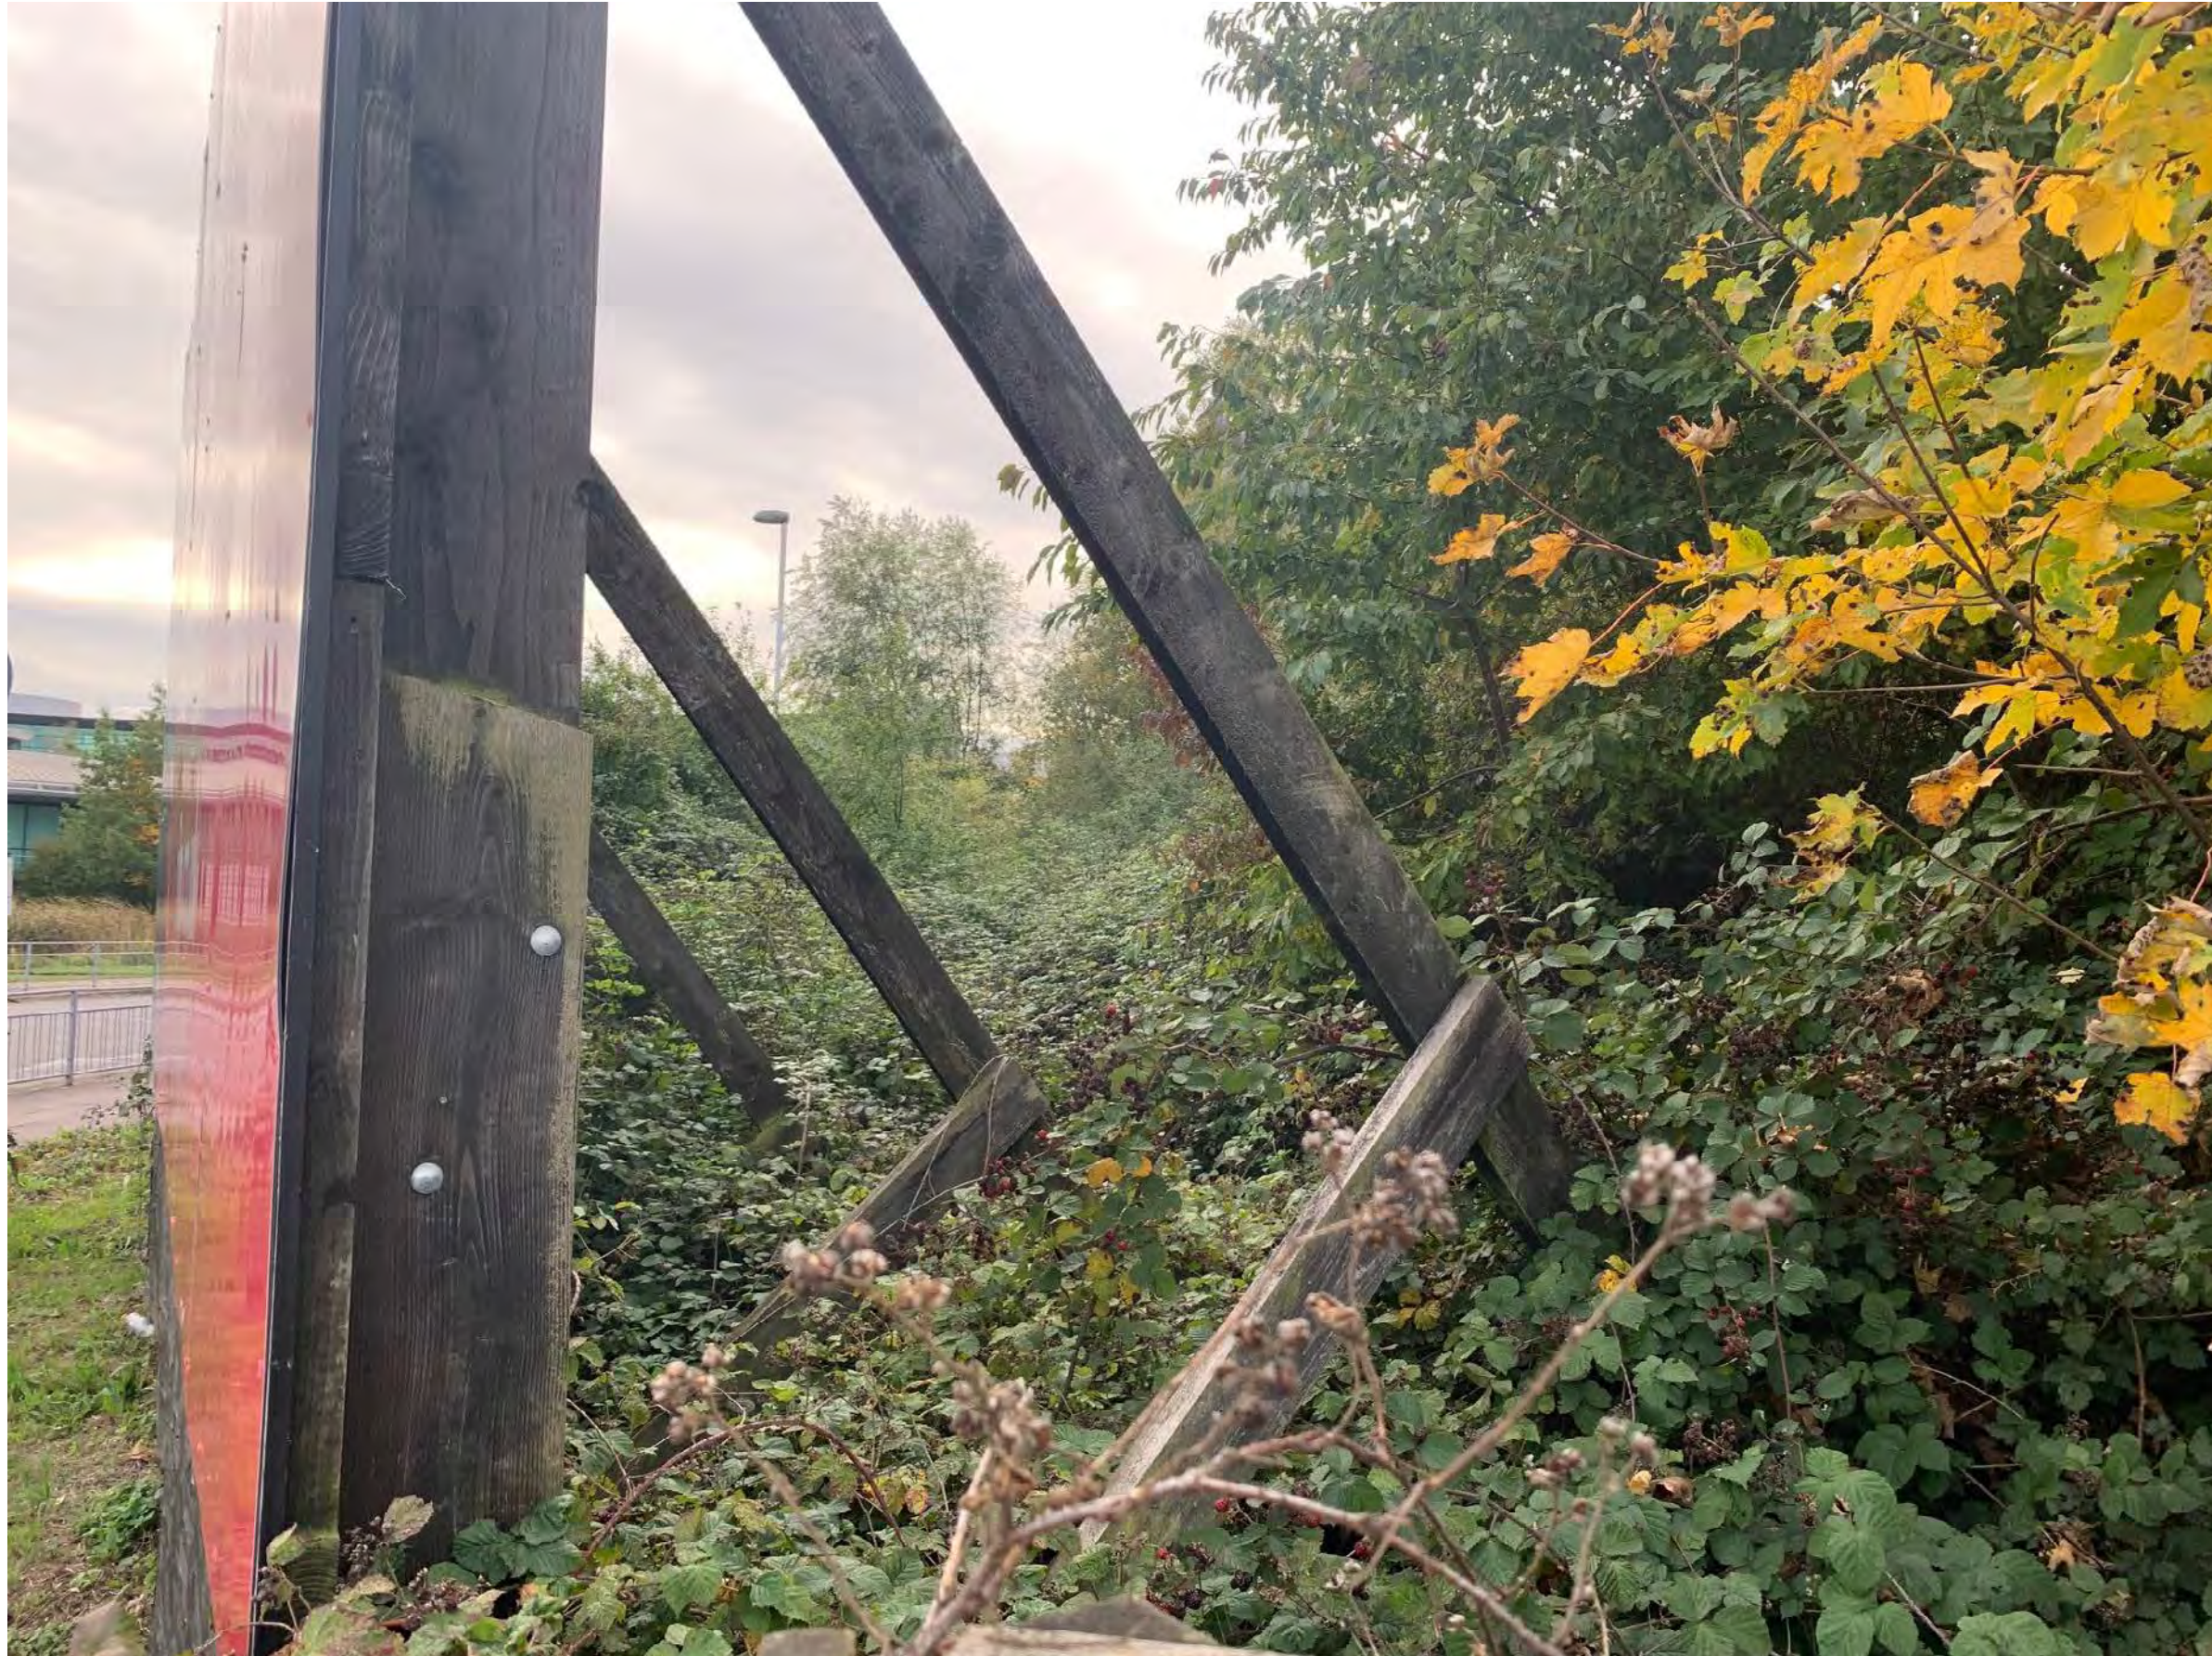
## VIEW 23

View over the boundary fence along the A33. The outer edge of the site, behind the boundary fence is mostly dense bramble thicket with self seeded willow trees and individual wild cherry and sycamore trees also visible
