# READING INTERNATIONAL BUSINESS PARK

1219-G509 EASTERN WOODLAND AREA PHOTOS  
OCTOBER 2020

The following images have been taken on the morning of 7th October 2020. The images show a range of views from within the 'Woodland' area to the south east of the site where we propose to create the Unit 1 car park.

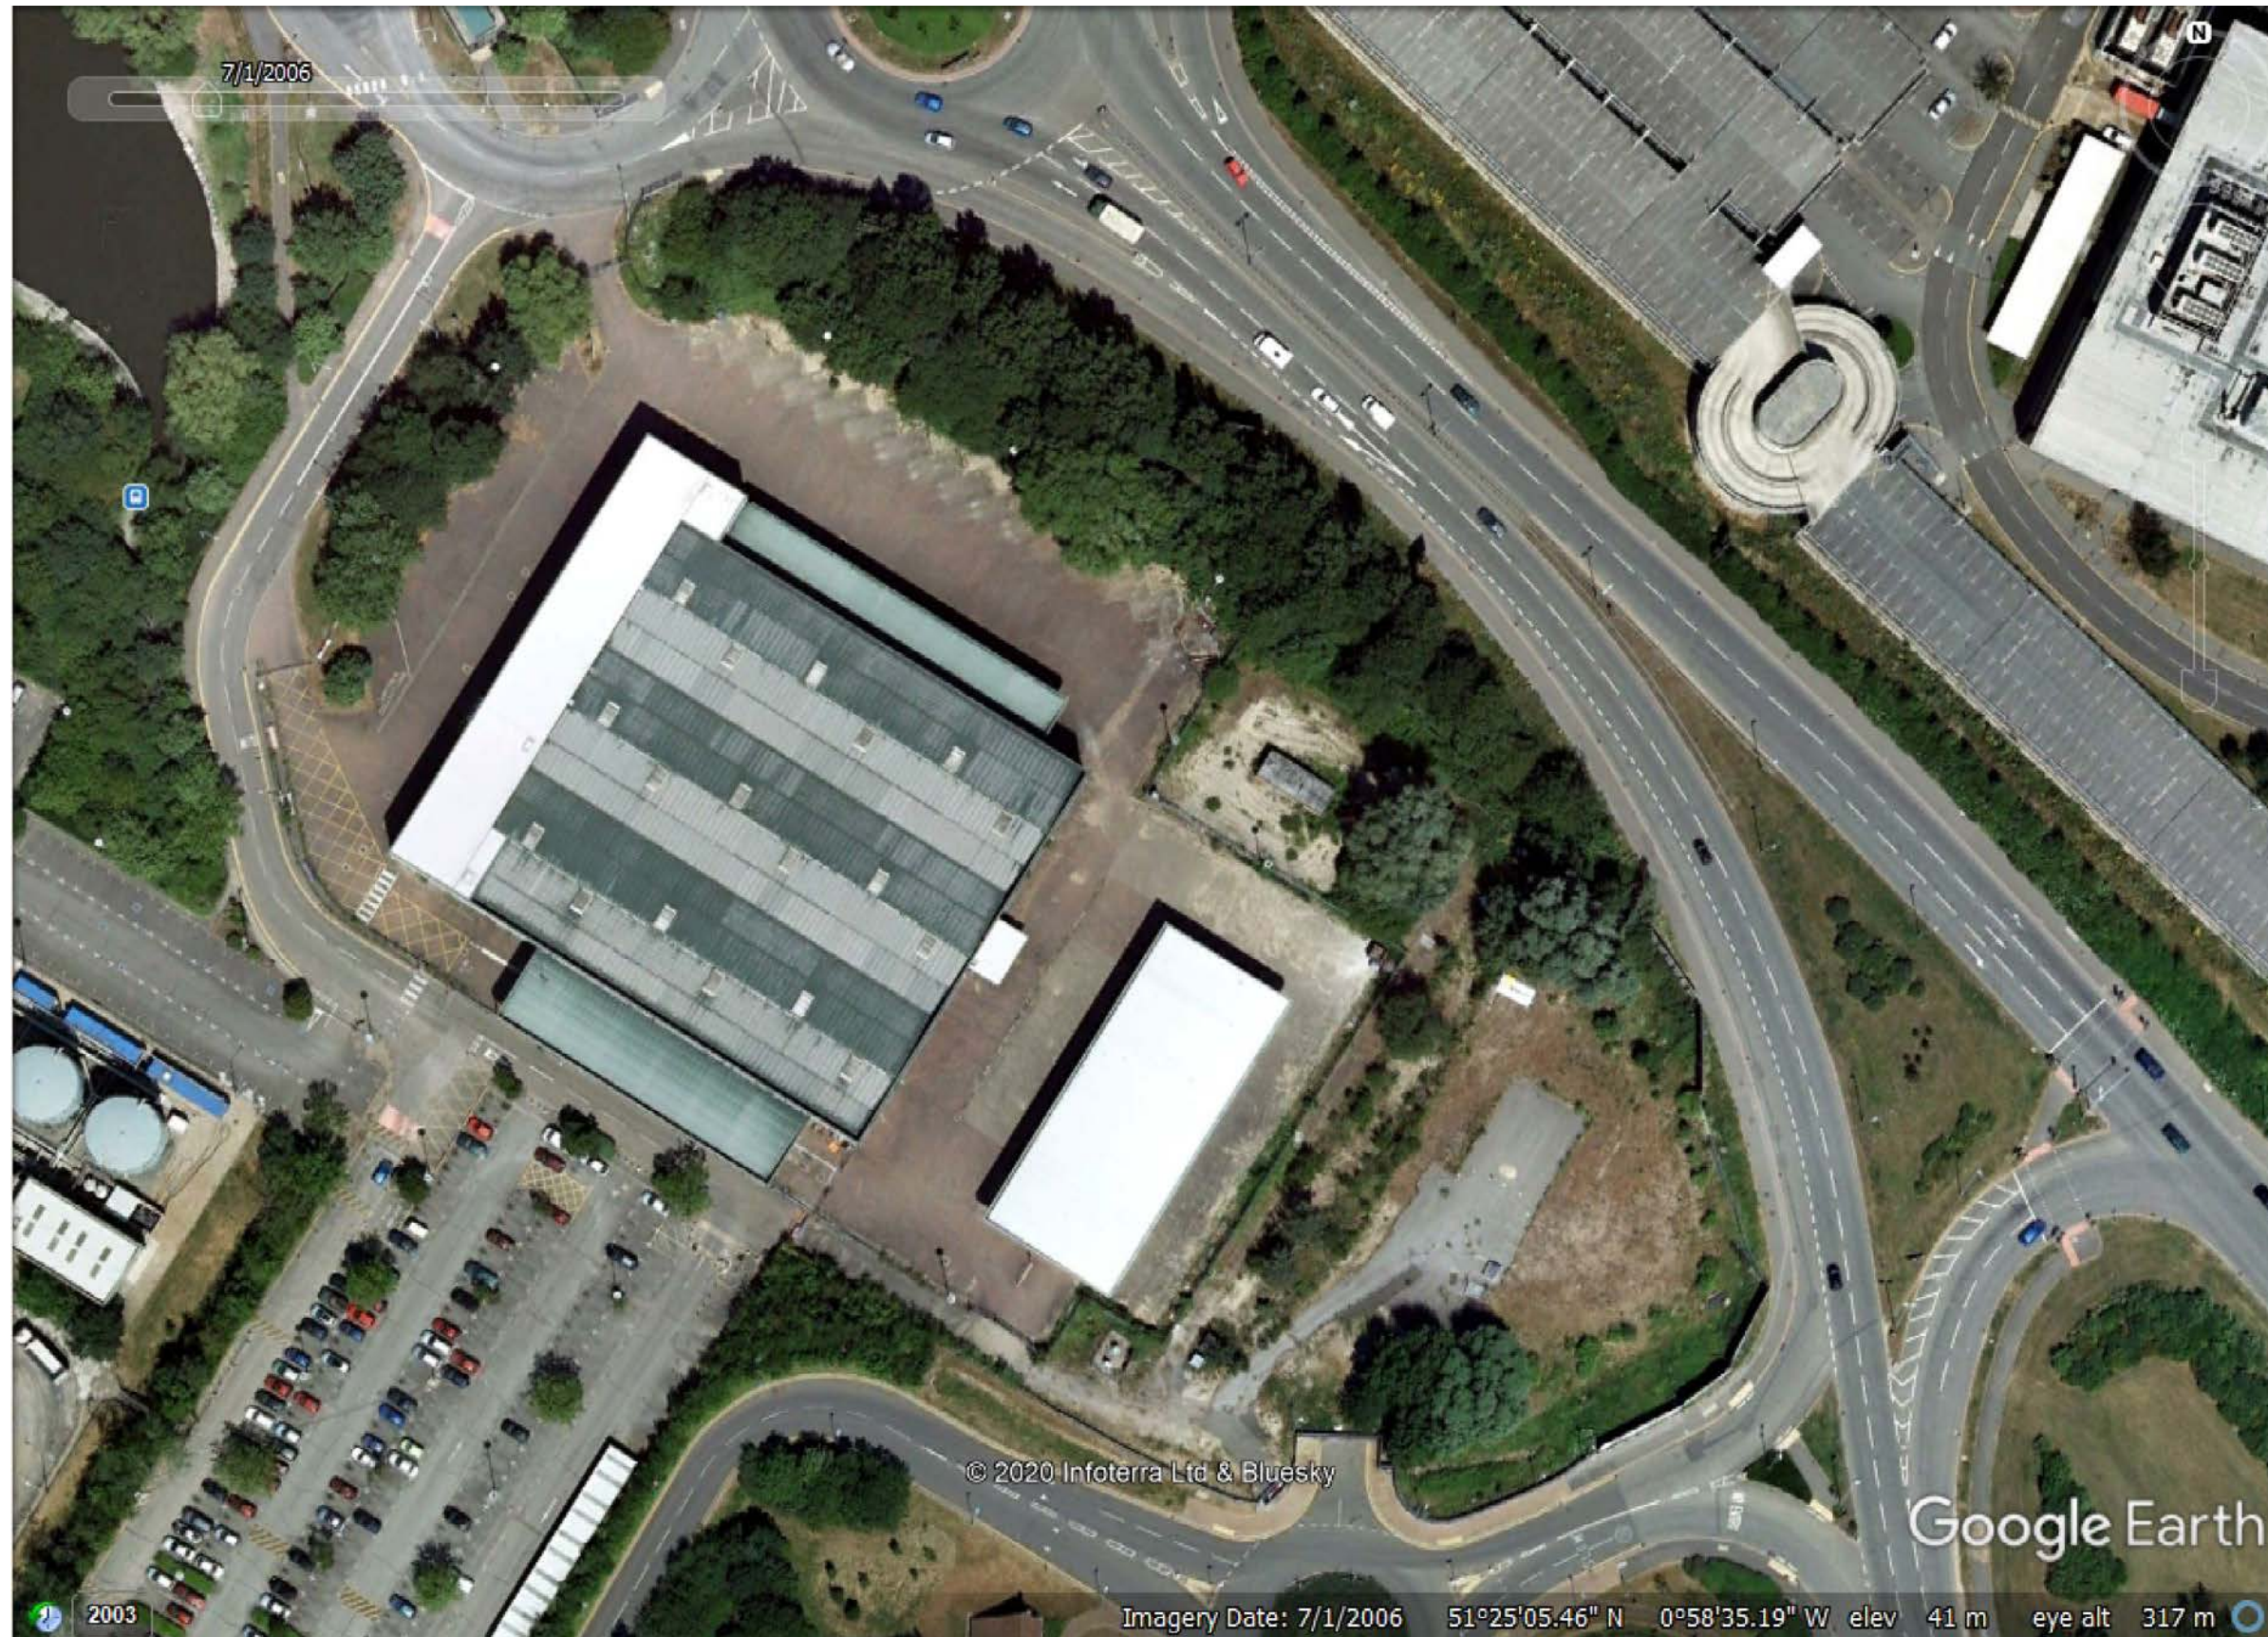
## Google Earth 2006

Google Earth View from 2006 before the previous development was demolished shows the eastern side of the woodland area mostly clear of trees with the car park hard standing clearly defined.

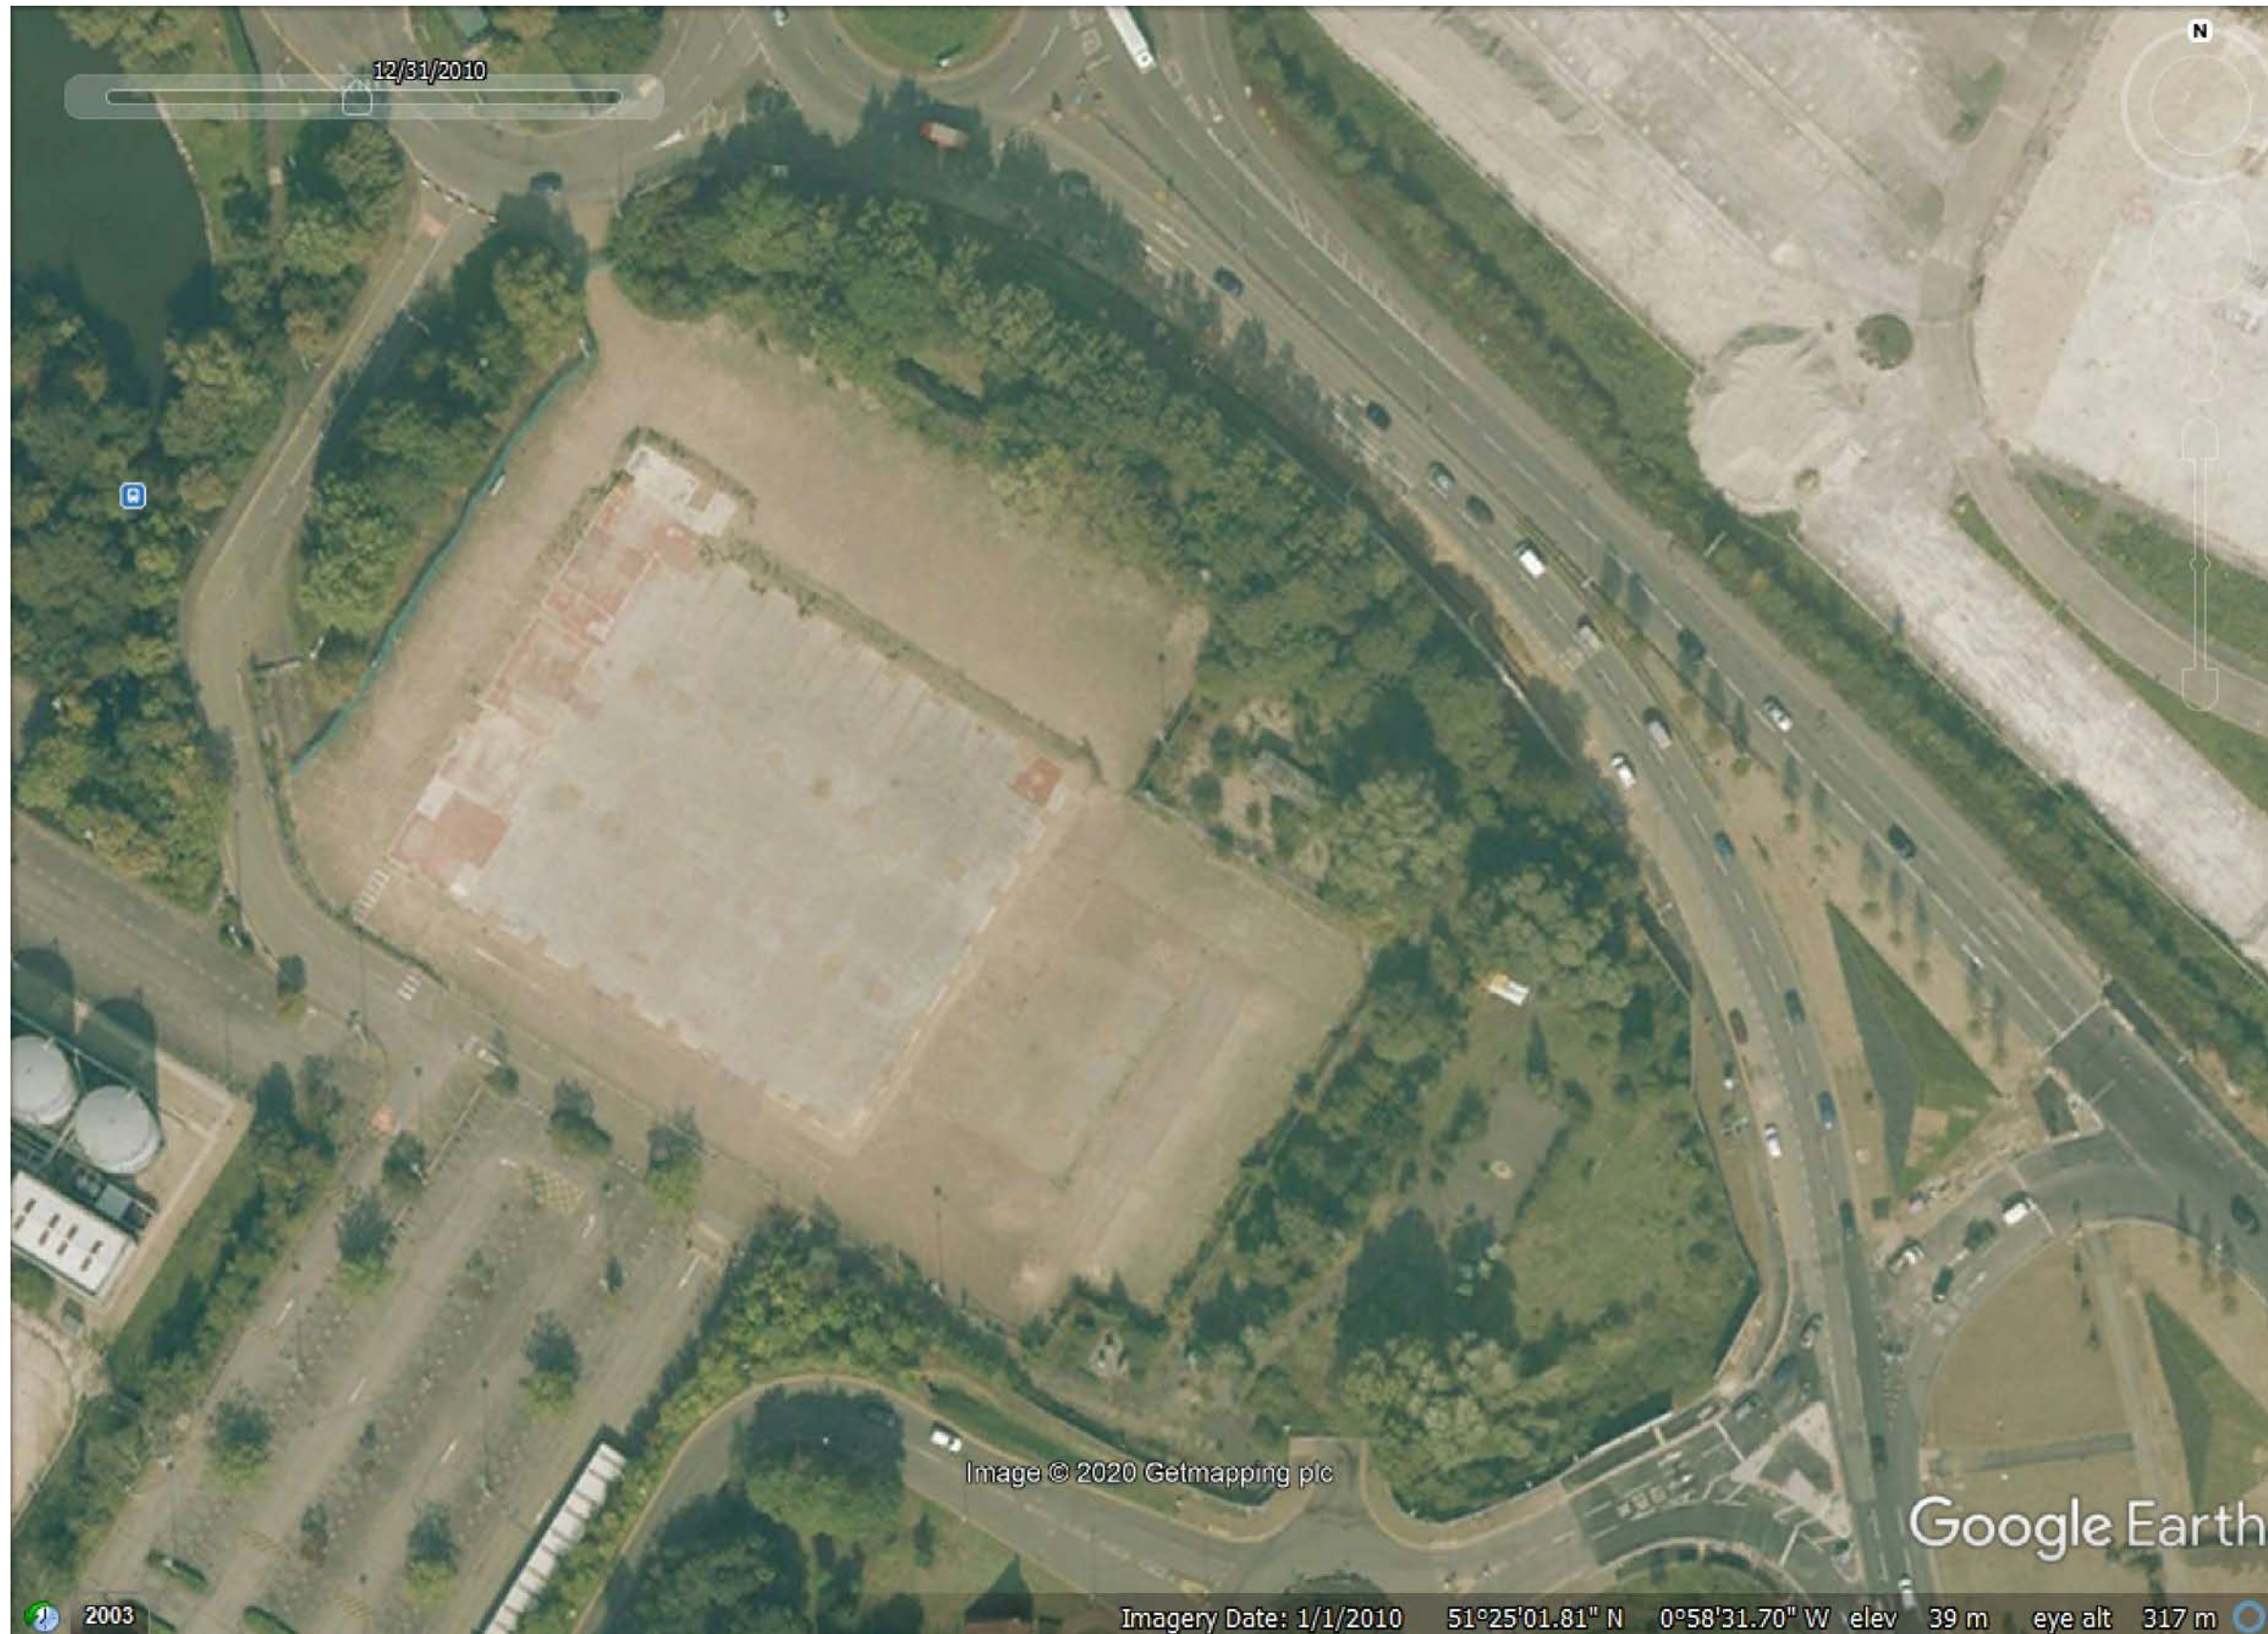
## Google Earth 2010

Google Earth View from 2010 after the previous development was demolished shows growth of trees around the perimeter of the eastern end of the woodland. The central area around the car park is mostly clear of trees

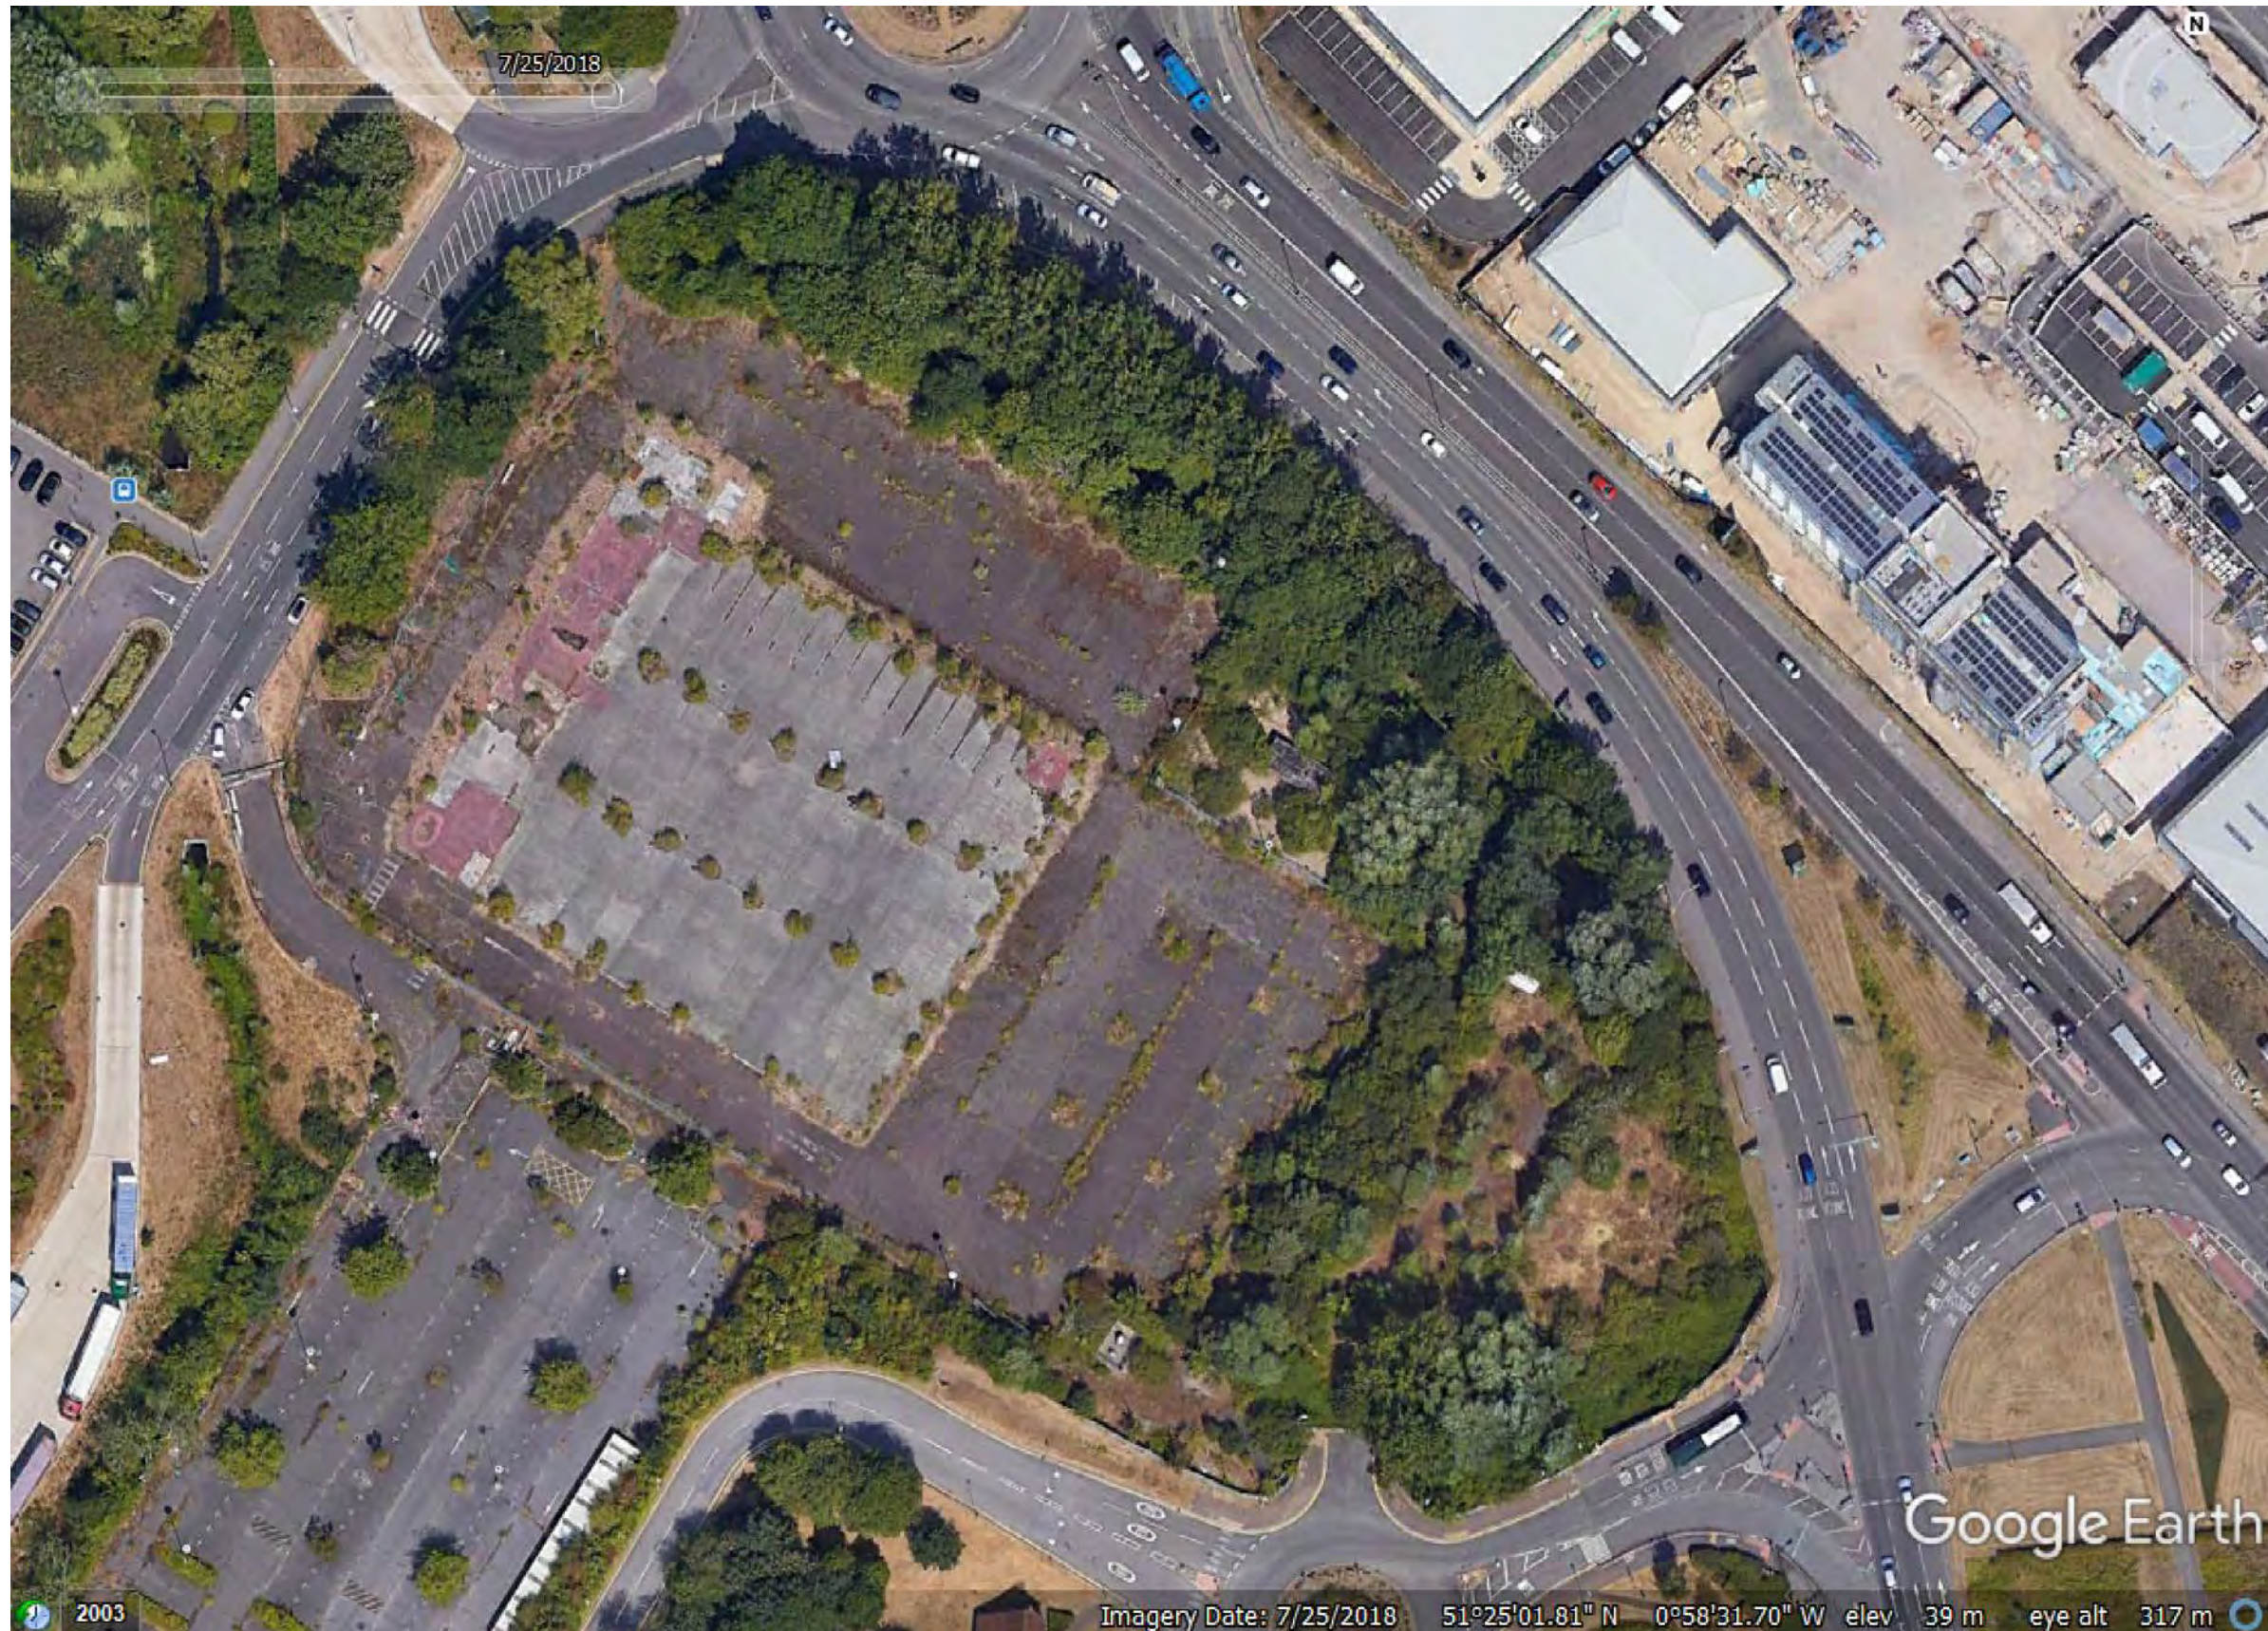
## Google Earth 2018

Google Earth View from 2018 shows woodland area close to what it is today. trees around the perimeter have grown further and the site has been recolonised by pioneer species due to inactivity.
